## Environmental Representative (ER) Quarterly Report Project: SSD-10448 – Aspect Industrial Estate Stage 1 Period: December 2023 to February 2024

## Environmental Representative (ER) Quarterly Report Project: SSD-10448 – Aspect Industrial Estate Period: December 2023 to February 2024

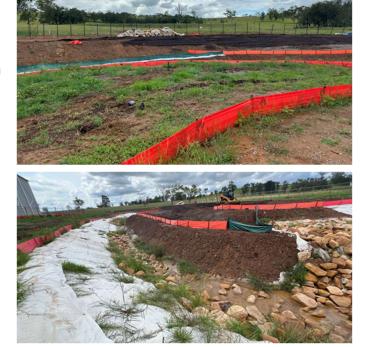
## **Riparian Channel (WEM)**

The sediment fences along the riparian channel impacted by rehabilitation of the area were being maintained (Photo 21/02/24)
