**Environmental Representative (ER) Quarterly Report**  
**Project: SSD-10448 – Aspect Industrial Estate Stage 1**  
**Period: March 2024 to May 2024**

## Environmental Representative (ER) Quarterly Report

Project: SSD-10448 – Aspect Industrial Estate

Period: March 2024 to May 2024

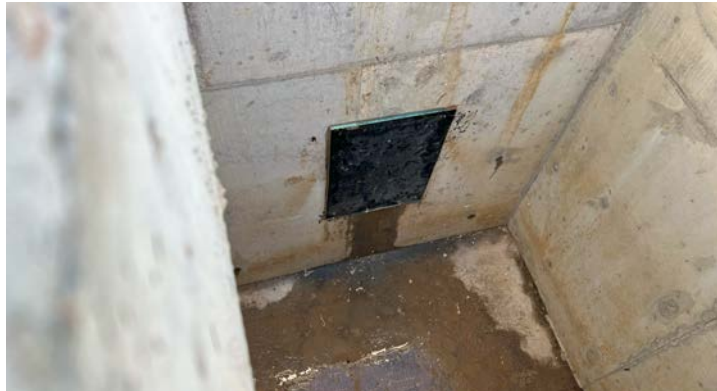
### Estate - Sediment Pond 1 discharge structure

Estate NC 240515-01	Untreated water was knowingly discharging from the low-level orifice within the discharge structure of Sediment Pond 1 between 8/5/24 and 13/5/24. The discharge did not likely meet the site's discharge criteria. The	22/5/24: WEM advised DPHI would be informed on 23/5/24.	Report to DPHI on 23/05/24

A low-level orifice within the discharge structure of Sediment Pond 1 was identified during the inspection on 8/5/24 to be leaking.

During the site inspection on 22/05/24, it was observed that WEM personnel were sealing the leak (Photo 22/05/23).

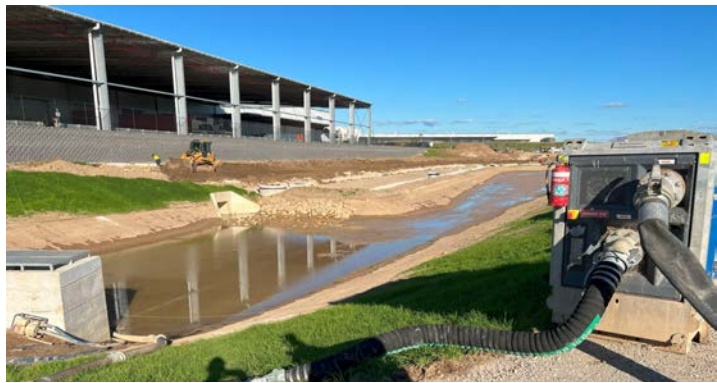
### Estate - Sediment Pond 1

Sediment Pond 1 had been dewatered to near empty in accordance with the dewatering protocol, following recent rain events

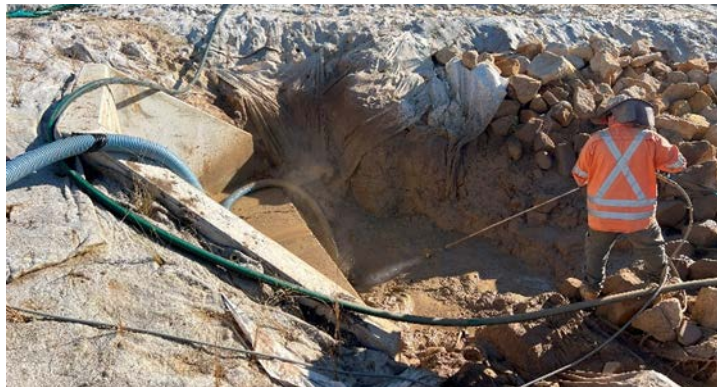
### Estate - Riparian channel

Works were progressing on the removal of silt build-up at the culvert outlet at the start of the riparian channel and from the rock armour within the channel (Photo 22/05/23).

Estate CA 240410-02	Develop a strategy to remove excess sediment from the riparian channel prior to the removal of the weir.	24/4/24: WEM advised that it was considering options for removal of sediment collected upgradient of the weir across riparian channel including sucker truck, however no strategy had been formalised. Corrective Action 240410-02 remains open.	Open 23/4/24
Estate IO 240410-01	Repair sediment fences at the toe of the sediment basin embankment along the western boundary.	Photographic evidence provided	Closed 23/4/24
Estate IO 240410-01	Repair sediment fences across the site including the eastern boundary.	Photographic evidence provided	Closed 23/4/24
LOT 3 CA 240501-01	Install a silt fence at the toe of the embankment prior to forecast rain. Provide photographic evidence.	Evidence provided by Texco	Closed 1/5/24
LOT 3 IO 240501-01	Remove loose debris from western driveway to prevent it from leaving the site via the driveway.	Evidence provided by Texco	Closed 1/5/24

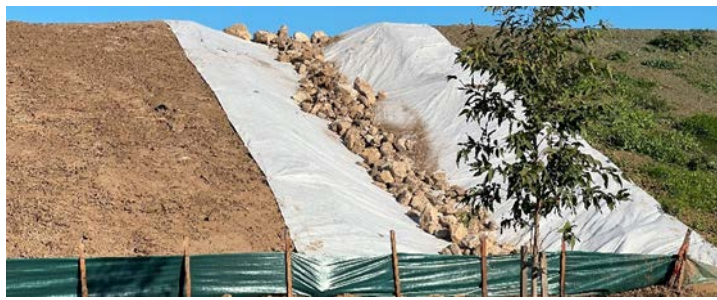
### Estate - Lot 8

Lot 8 sediment pond spillway protection had been reinstated (Photo 22/05/23).

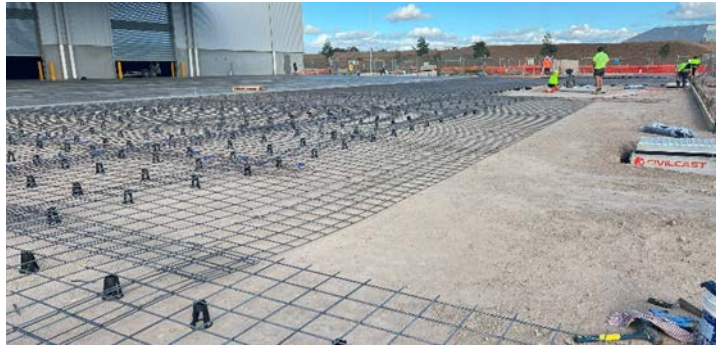
### Lot 3 - Texco

All pavements were complete except for the last pour on western boundary (Photo 1/5/24)

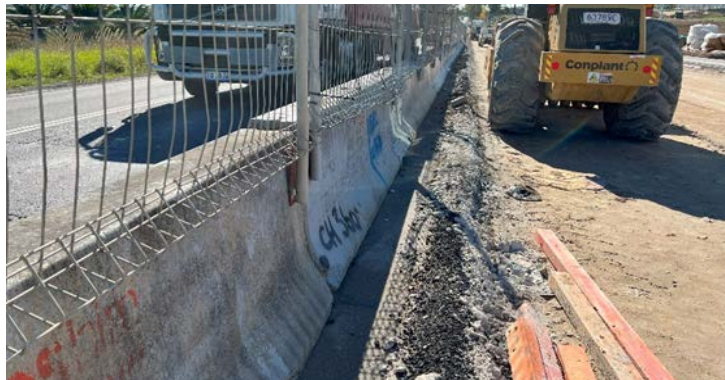
A hot mix bund diverts stormwater runoff from the Mamre Road pavement towards the northern culvert.

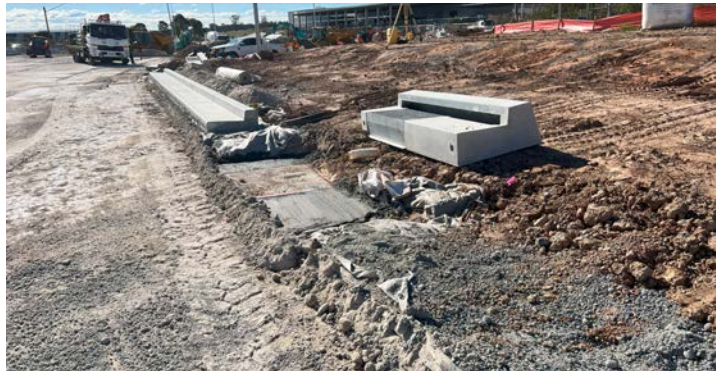
Pits to the live stormwater system were blanked off.

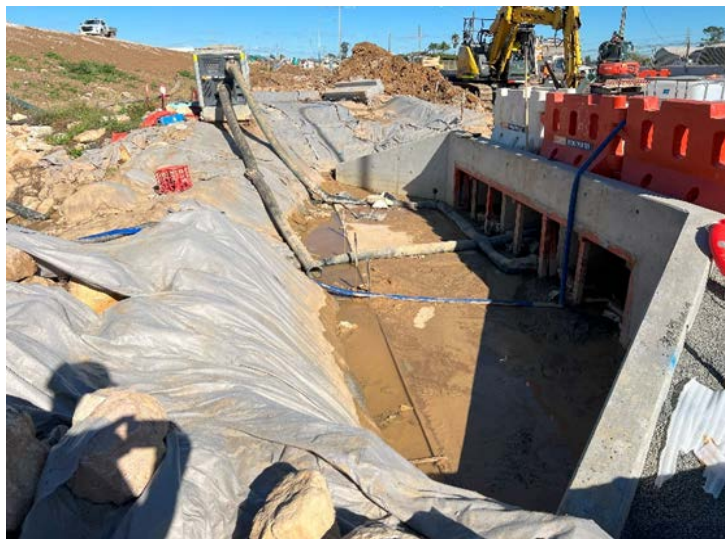
The PESCP 7a prescribes the use of the northern culvert as the last stop sediment pond. The end of the culvert was blanked-off to retain water and allow sediment to settle.
