Ref: 2103.02\_03

**Environmental Representative (ER) Quarterly Report**  
**Project: SSD-10448 – Aspect Industrial Estate**  
**Period: December 2022 to February 2023**

**Project: SSD-10448 – Aspect Industrial Estate**

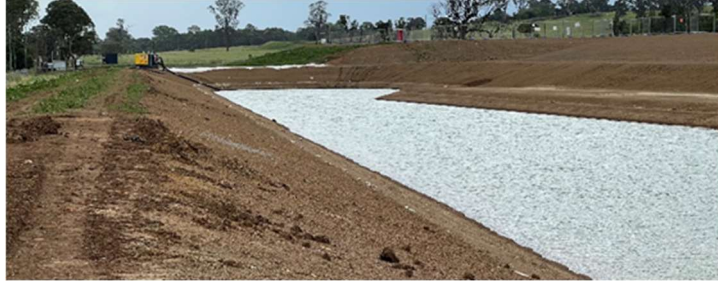
### WEM - Sediment Basins

Sediment basins functioning in accordance with the ESCP (Photo 27/2/23).

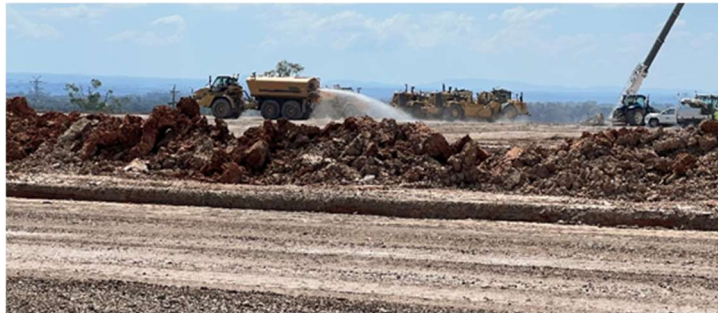
### WEM - Dust mitigation

Water carts were observed on site wetting haul roads. Localised dust was observed around active plant however dust was not observed leaving the site (Photo 6/2/23)

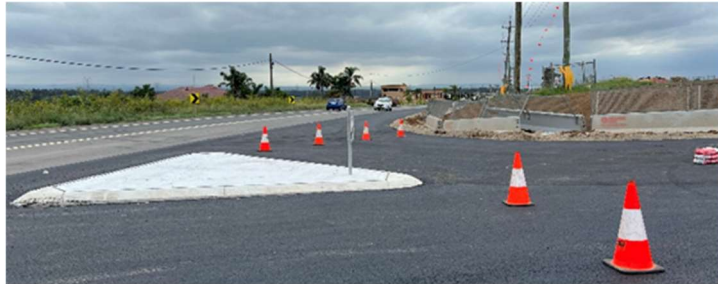
### WEM - New driveway entrance

Night works were undertaken for the new entrance. Erosion and sediment controls for works related to the new entrance continue to be maintained (Photo 27/2/23)

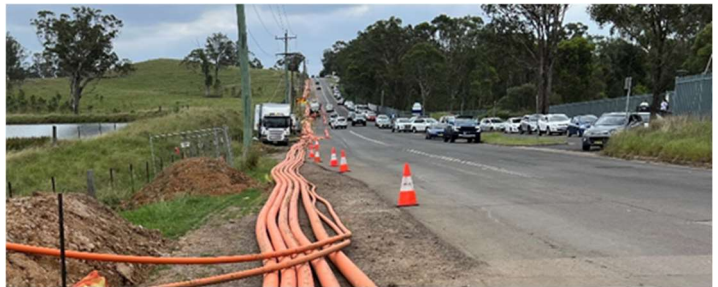
### WEM - Bakers Lane

Electrical work along Bakers Lane including directional drilling to minimise surface disturbance. (Photo 27/2/23)

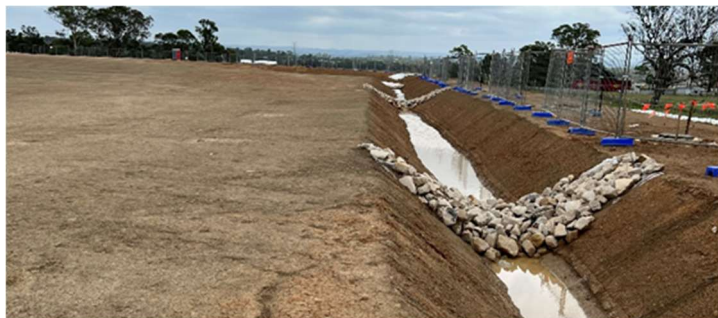
### Richard Crookes (RC) – Pad 1

Contractor (RC) for the construction of the warehouse on Pad 1 has mobilised. Perimeter drains with checks and a sediment pond were installed by WEM prior to handover of the site. The ATF fencing was being installed by RC.
