Environmental Representative (ER) Quarterly Report
Project: SSD-10448 – Aspect Industrial Estate
Period: September to November 2022

Environmental Representative (ER) Quarterly Report

Project: SSD-10448 – Aspect Industrial Estate

Period: September to November 2022

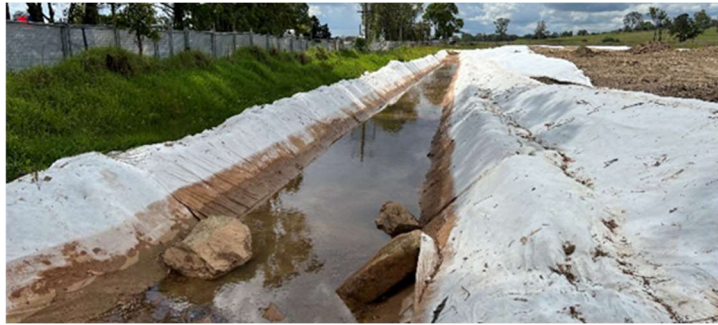
WEM have established robust clean water diversion drains along its north-western and eastern boundary to delineate clean and dirty areas of the site (Photo 7/11/22).

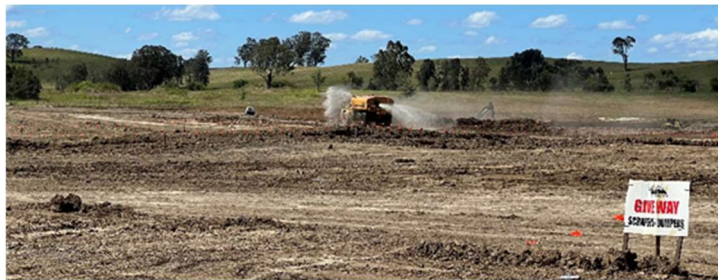
Two water carts were on constant rotation wetting down haul roads and other work areas to minimise the generation of dust. (Photo 21/11/22).

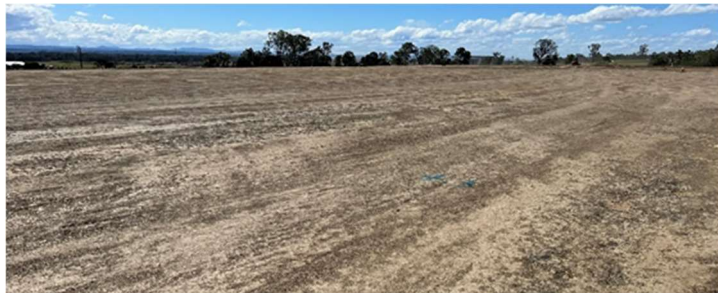
Despite strong wind gusts, areas of the site that were not being worked, including the recently compacted Pad1, embankments and other disturbed areas were not generating dust (photo 21/11/22).

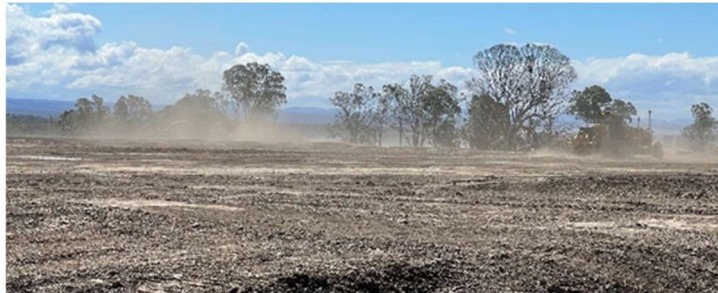
Localised dust was being generated at the site by plant and equipment. WEM advised that it monitors and applies triggers to "stop work" due to dust, if required (photo 21/11/22).

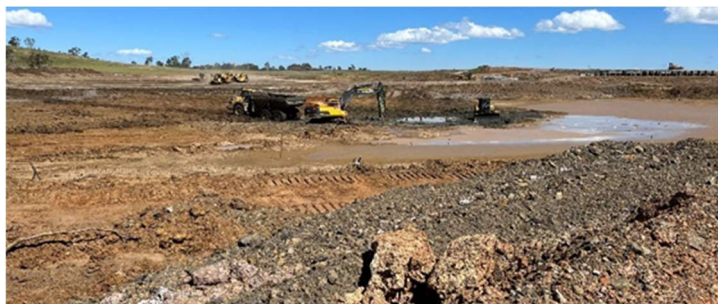
Dam 1 was almost completely dewatered (photo 21/11/22)
