Environmental Representative (ER) Quarterly Report
Project: SSD-10448 – Aspect Industrial Estate Stage 1
Period: June 2023 to August 2023

Project: SSD-10448 – Aspect Industrial Estate

Period: June 2023 to August 2023

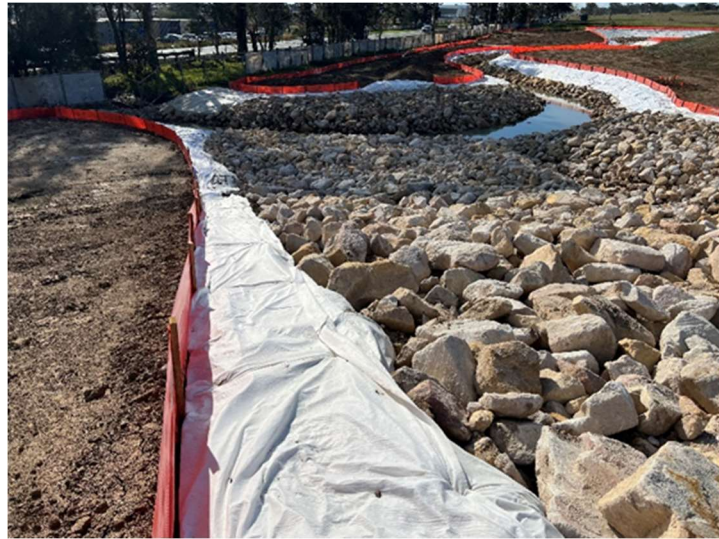
WEM – Western boundary

Riparian channel alignment has been completed with rock armour, geofabric and sediment fence along its perimeter.

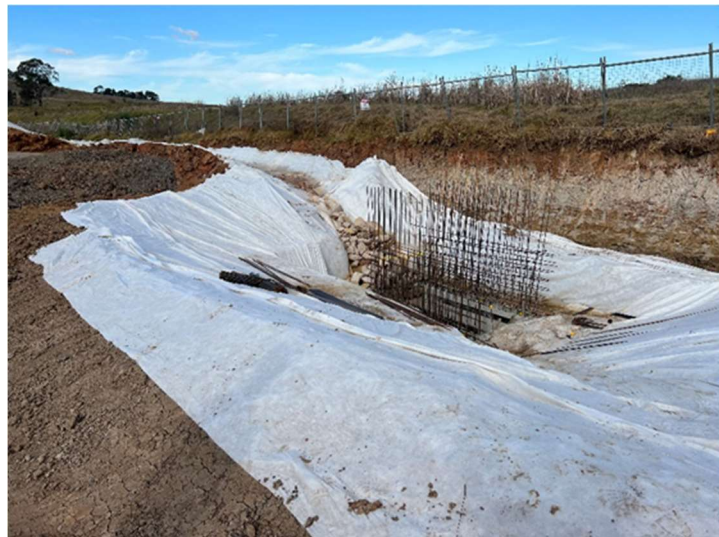
WEM - Eastern underground stormwater system

The eastern stormwater by-pass channel has been decommissioned and replaced with the Eastern underground stormwater system.

Erosion and sediment controls were installed around the incomplete stormwater pits associated with the underground stormwater system along the eastern boundary.

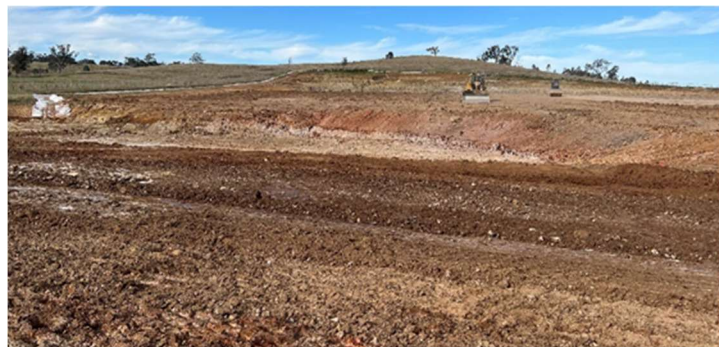
WEM - Sediment Pond 2

Sediment Pond 2 had been dewatered and de-silted.

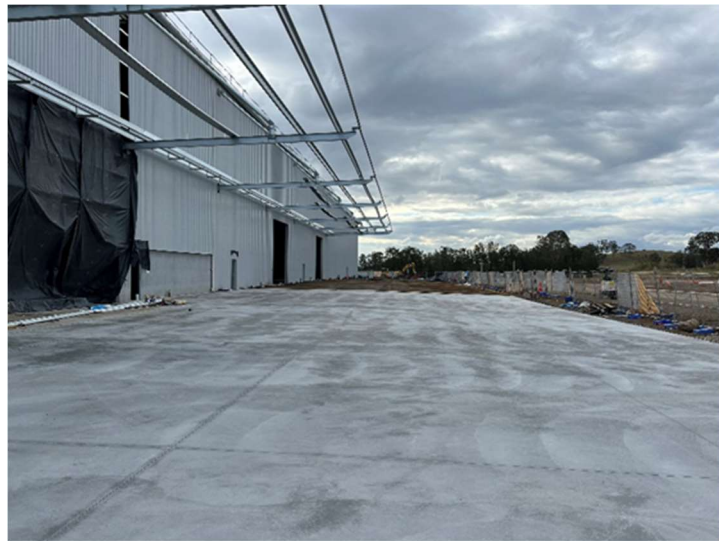
RCC – Eastern boundary

Works on the superstructure and concrete paving were progressing reducing exposed surfaces.

Water contained within the stormwater system and GPT will be pumped into the sediment pond for treatment, prior to discharge.

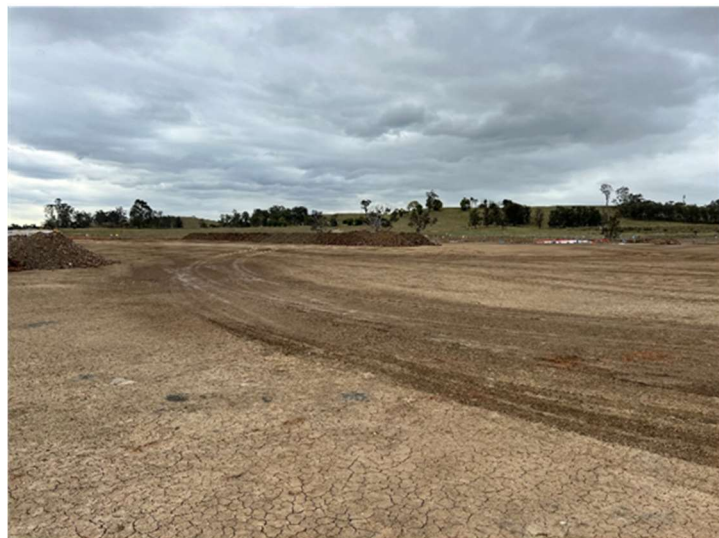
Texco - Lot 3

Earthworks were progressing on site under the WEM CEMP and sub-plans only.
