Annual Inspection Report 2023 'Lightning Protection'

To: Andrew Fitzgerald
Company: PM Electric
Building Usage: Commercial
Location: 101 Miller Street North Sydney
Inspected By: Michael Vassallo
Date: Friday 13th January 2023
Pages: 10, including this.

Type:	Australian Standard – AS/NZS 1768 - 2007 - Lightning Protection System
Downconductor:	Structural Steel
Earthing:	Structural Earth
Location:	101 Miller Street North Sydney

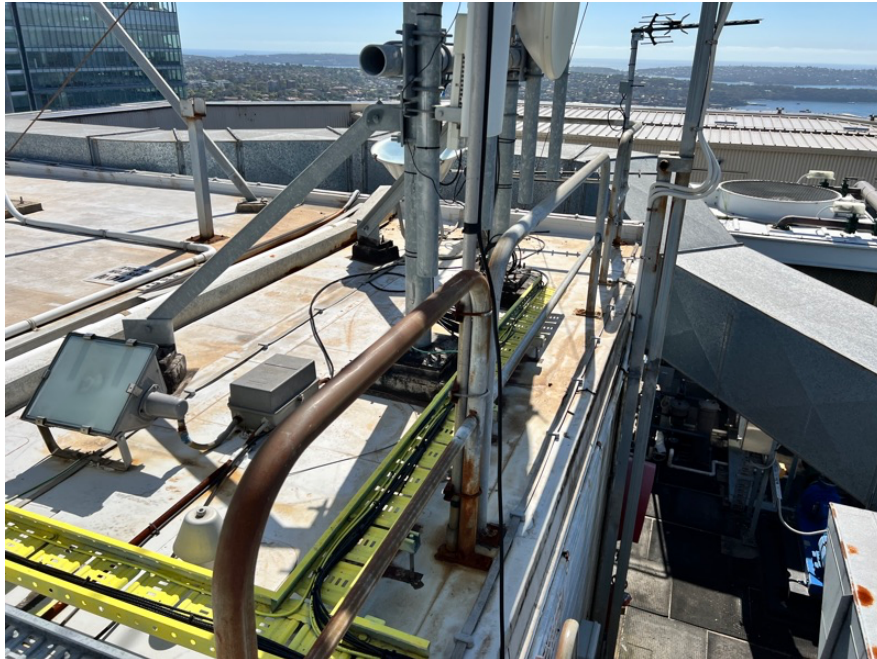
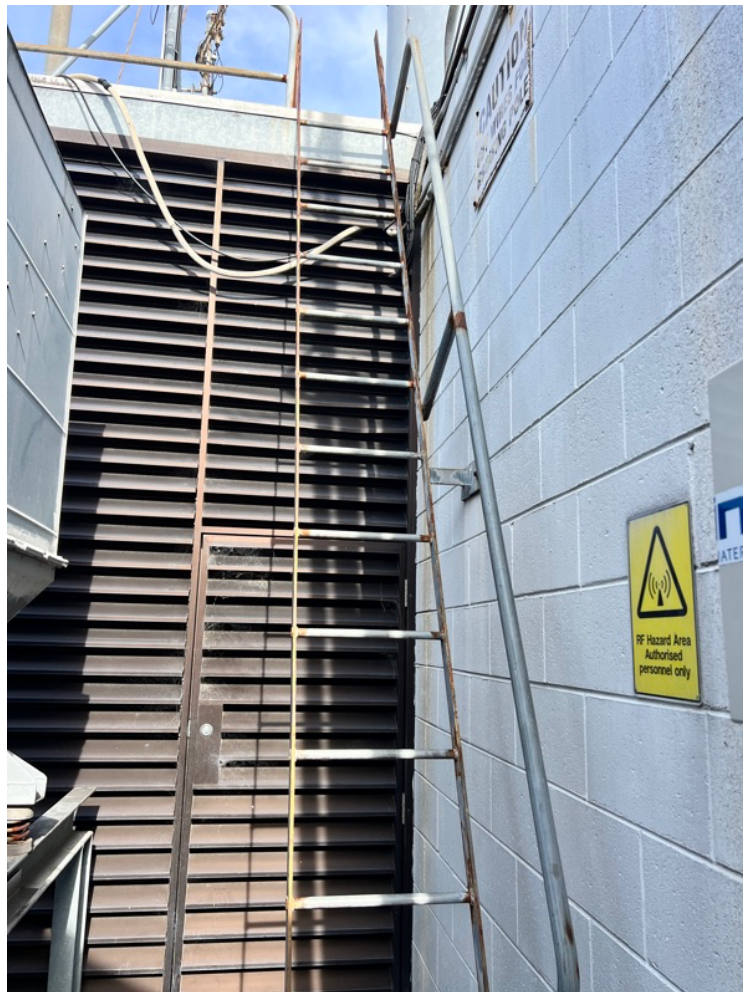
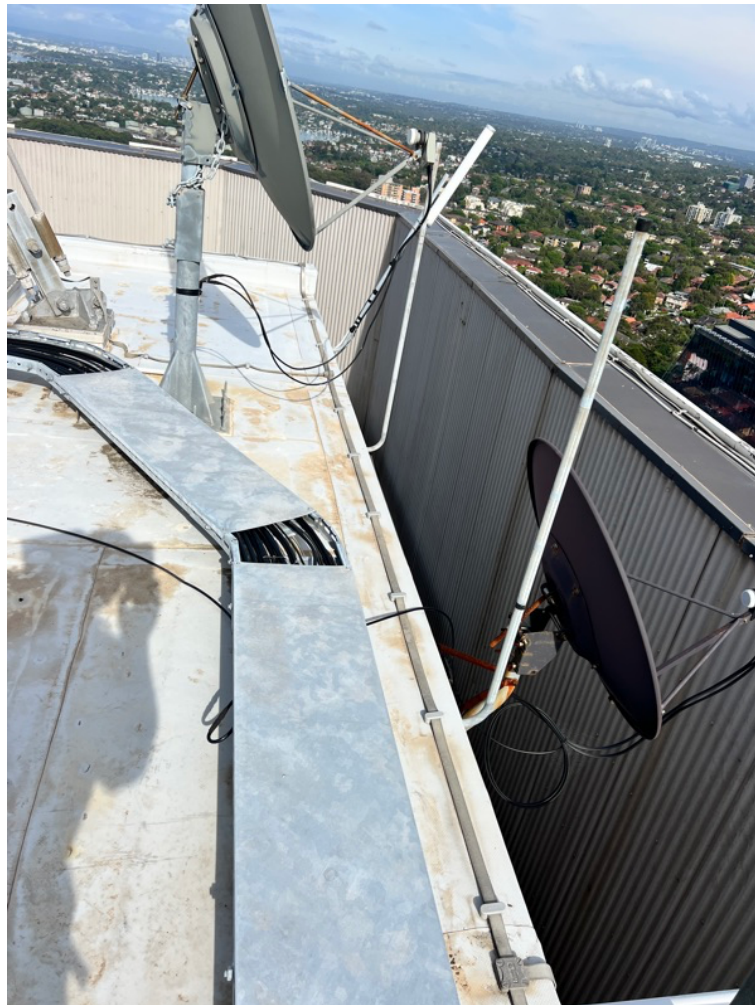
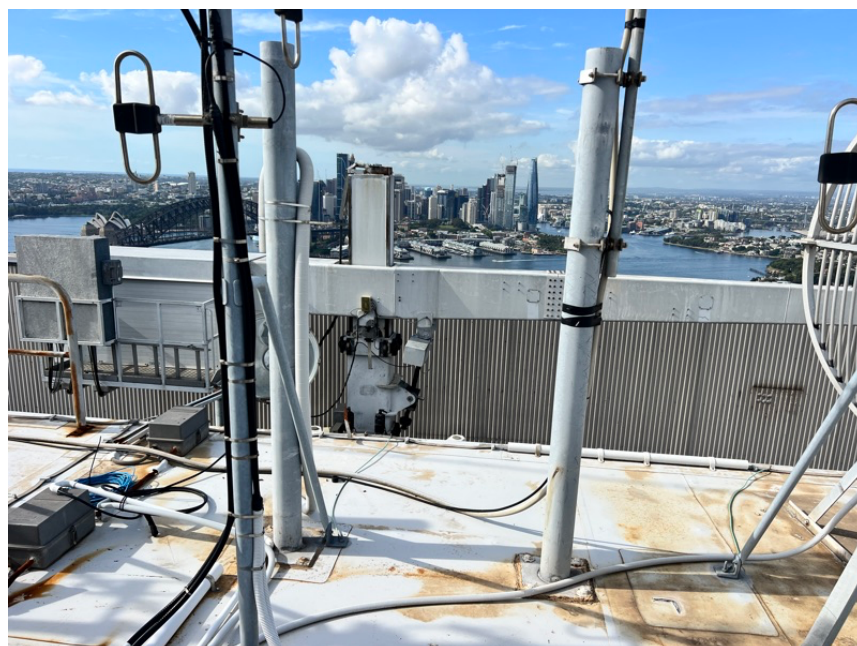
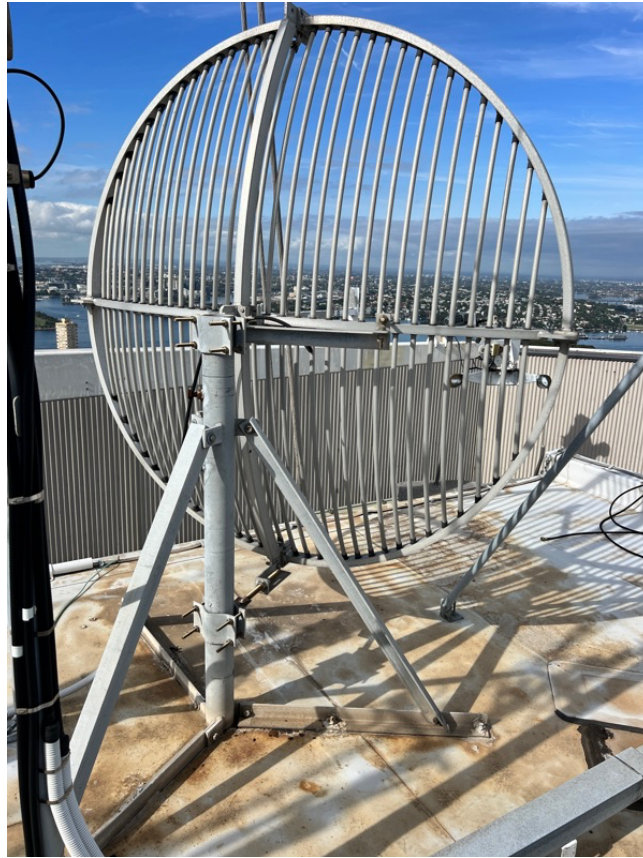
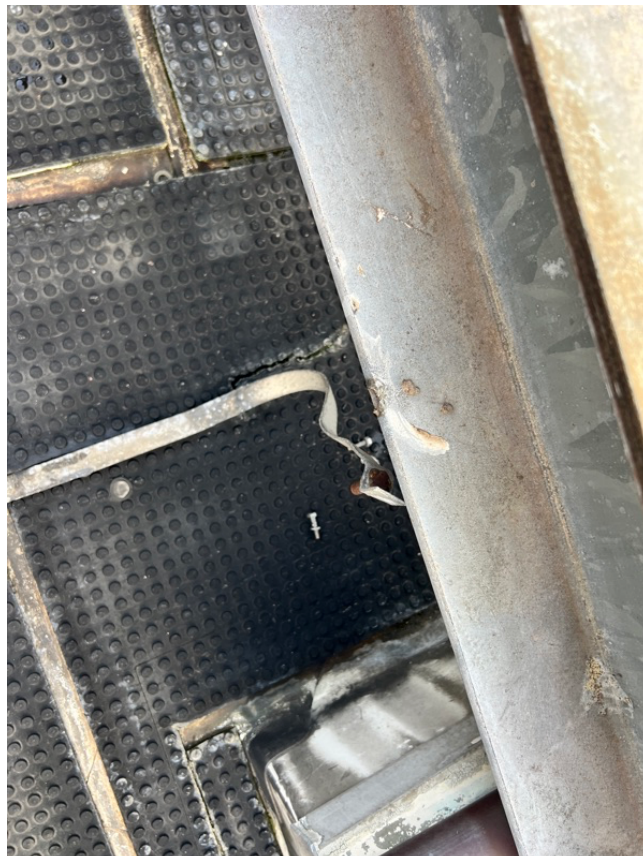
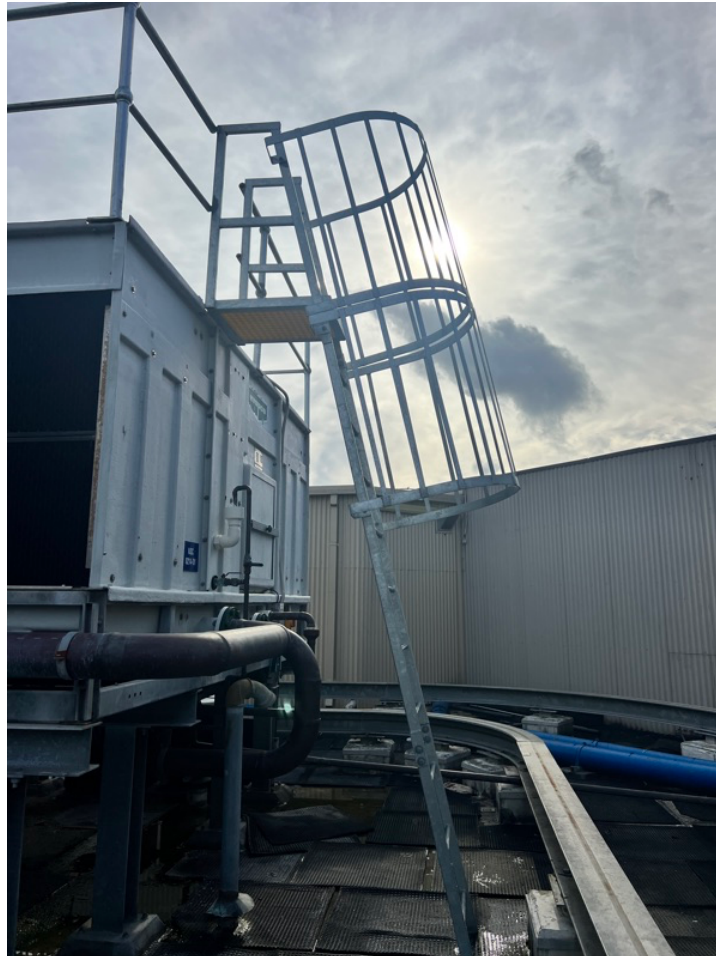
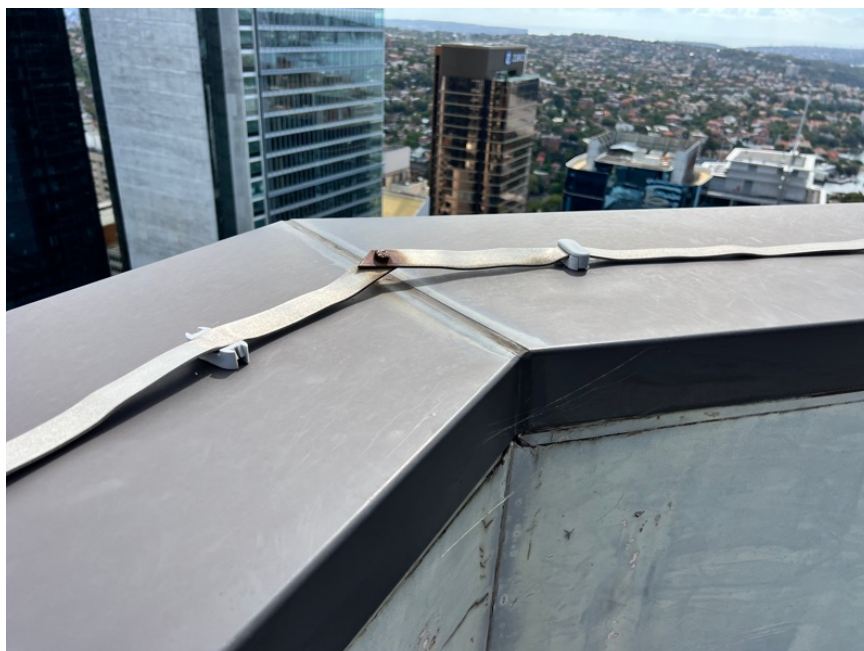
1. Bonded to the lightning protection – 3 x Metal Hand Railings located on the main upper roof area near the roof access that were found not bonded to the lightning protection system.
2. Bonded to the lightning protection – 1 x Metal access ladder to the main upper roof area that was found not bonded to the lightning protection system.

3. Bonded to the lightning protection – 4 x TV Antenna / Satellite Dish located on the northern side of the main upper roof area that were found not bonded to the lightning protection system.

4. Bonded to the lightning protection – 2 x Antenna support poles located on the main upper roof that were found not bonded to the lightning protection system.

5. Bonded to the lightning protection – 1 x Antenna / Satellite located on the main upper roof area that was found not bonded to the lightning protection system.

6. Bonded to the lightning protection – 1 x Satellite Dish located on the main upper roof area that was found not bonded to the lightning protection system.

7. Re-Bonded into the lightning protection in Five (5) locations – the open circuit bonds to the BMU track located on the lower roof area that were found not bonded to the lightning protection system.

8. Bonded to the lightning protection - 1 x Metal access ladder and hand railings to the cooling tower located on the lower roof area that needs to be bonded to the lightning protection system.

9. Re-Bonded into the lightning protection in Five (5) x open circuit bonds on the 25mm x3mm aluminium tape located on the lower roof level 32 South area that was found to have defective joining bonds to the lightning protection system.

10. Re-Bonded into the lightning protection in Five (5) x open circuit bonds on the 25mm x3mm aluminium tape located on the lower roof level 32 North area that was found to have defective joining bonds to the lightning protection system.

11. Replace a number of fixing saddles holding the 25 x 3mm aluminium lightning protection tape which were found missing on level 32 North and South lower roof areas.

The system requires some remedial works to completely comply with Australian Standard 1768-2007. These repairs should be actioned as soon as possible and prior to the next inspection.
