Asbestos & Hazardous Materials Re-Inspection

255 Elizabeth Street, Sydney 2000

21 August 2019

Prepared for
Mirvac

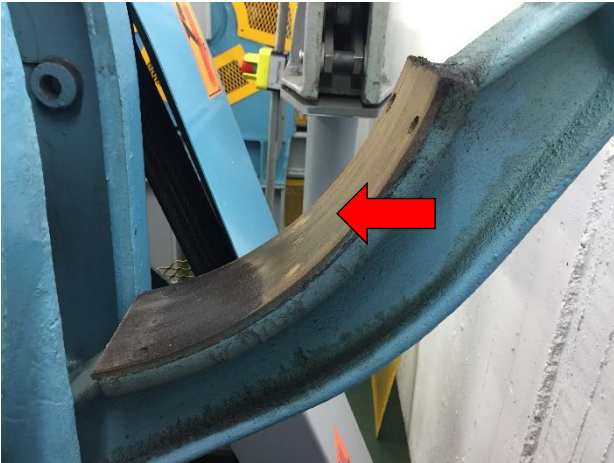
Photograph 1: Level 17, lift motor room, lift motor – Asbestos-containing friction pads.

| Client: Mirvac Properties | | | | Site Name: 255 Elizabeth Street | | | | Site Address: 255 Elizabeth Street, Sydney NSW 2000 | | | | | | | | | | Job No: 754-SYDEN228268 | | | |
|---|---|---|---|---|---|---|---|---|---|---|---|---|---|---|---|---|---|--|---|---|---|
| Level 17 | Lift motor room | Lift motor | Friction pads | Asbestos | L4799 | Chrysotile Asbestos Detected | N | 1 | 2 | 1 | 2 | 0 | 1 | 1 | 2 | 10 | A3 | Confirm status, label as containing asbestos and maintain in current condition if to remain in-situ. Remove under controlled non-friable asbestos removal conditions prior to refurbishment or demolition works by a Class B (non-friable) licensed asbestos removal contractor. | 4 units | Aug-22 | 1 |

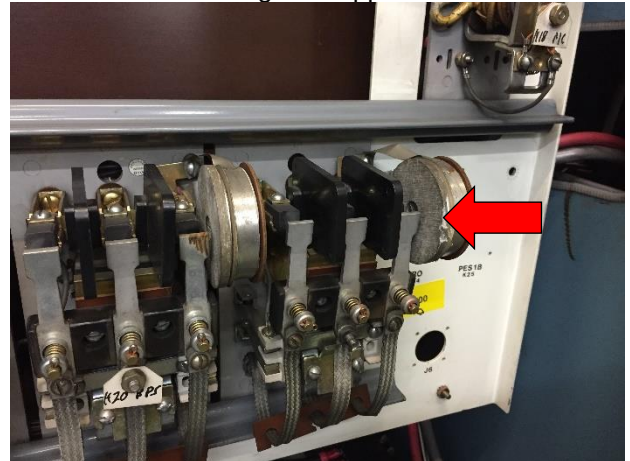
Photograph 2: Level 17, lift motor room, switchboard – Asbestos-containing arc suppressors.

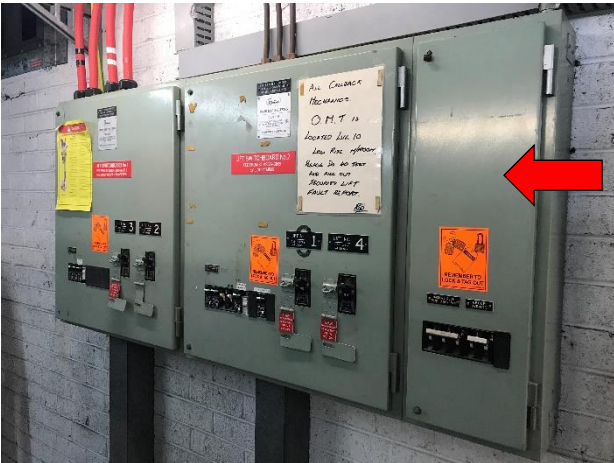
Photograph 3: Level 17, lift motor room, electrical backing board – Suspected asbestos-containing bituminous backing board.

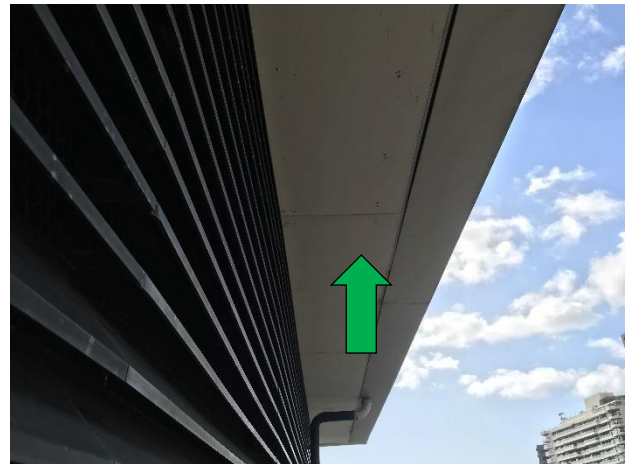
Photograph 4: Level 17, exterior, perimeter, eaves – non-asbestos containing fibre cement sheeting.

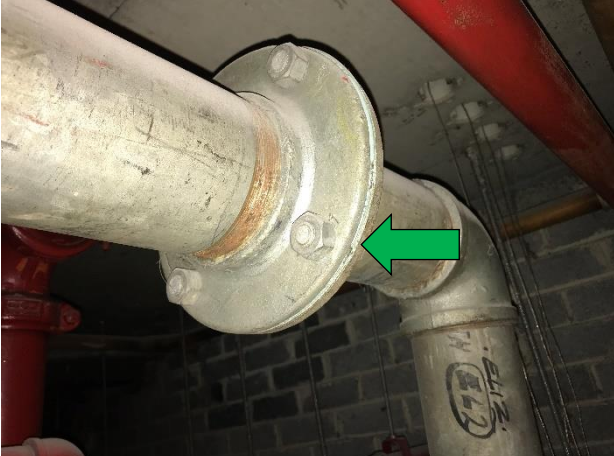
Photograph 5: Level B1, mezzanine plant room, pipework – non-asbestos containing gasket material.

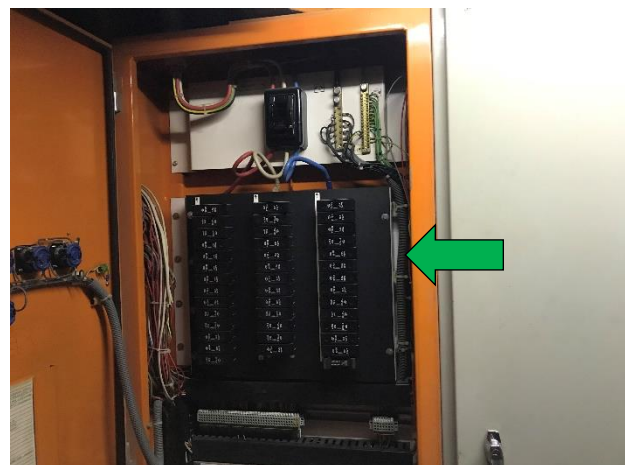
Photograph 6: Level B1, mezzanine plant room, switchboard – non-asbestos containing bituminous backing board.

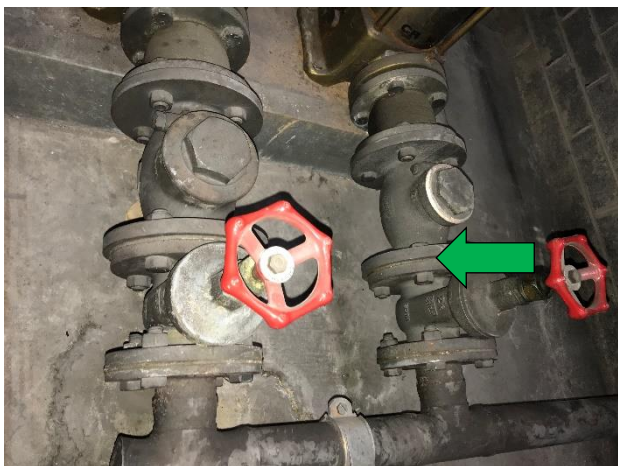
Photograph 7: Level B2, booster pump room, pipework – non-asbestos containing gasket material.

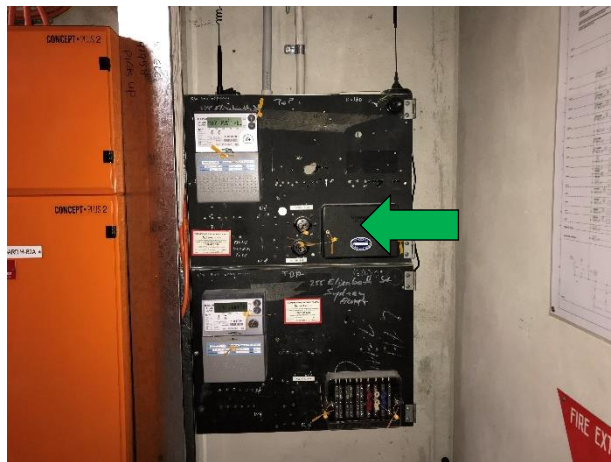
Photograph 8: Level B2, main switch room, electrical backing board – non-asbestos containing bituminous backing board.
