Mirvac Real Estate Pty Ltd

**Asbestos and Hazardous Materials
Re-Inspection**

275 Kent Street, Sydney NSW 2000

19 March 2020

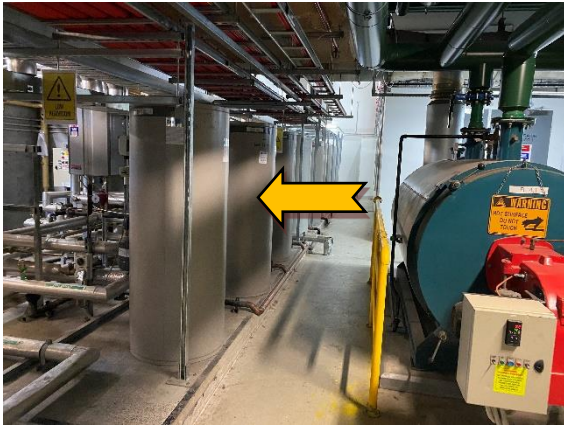
- Interior: level 33, plant room, throughout, hot water heater – suspected SMF containing internal insulation material;
- Interior: level 33, plant room, throughout, air conditioning ductwork – suspected SMF containing internal insulation material;

Photo 1 Interior: level 33, plant room, throughout, hot water heater – suspected SMF containing internal insulation material.

Interior: level 33	Plant room, throughout	Hot water heater	Insulation material - internal	SMF	Visual observation	Suspected SMF	NA	NA	NA	Good	Sealed	Low	NA	NA	NA	Low	-	Maintain in current condition if to remain in-situ. Remove under controlled SMF conditions as per the Code of Practice for the Safe Use of Synthetic Mineral Fibres [NOHSC: 2006 (1990)].	7 units	-	5131
Interior: level 33	Plant room, throughout	Air conditioning ductwork	Insulation material - internal	SMF	Visual observation	Suspected SMF	NA	NA	NA	Good	Sealed	Low	NA	NA	NA	Low	-	Maintain in current condition if to remain in-situ. Remove under controlled SMF conditions as per the Code of Practice for the Safe Use of Synthetic Mineral Fibres [NOHSC: 2006 (1990)].	~200m	-	5130
Interior: level 33	Electrical distribution rooms	Penetrations	Pillow insulation	SMF	Visual observation	Suspected SMF	NA	NA	NA	Good	Sealed	Low	NA	NA	NA	Low	-	Maintain in current condition if to remain in-situ. Remove under controlled SMF conditions as per the Code of Practice for the Safe Use of Synthetic Mineral Fibres [NOHSC: 2006 (1990)].	~20m	-	4313

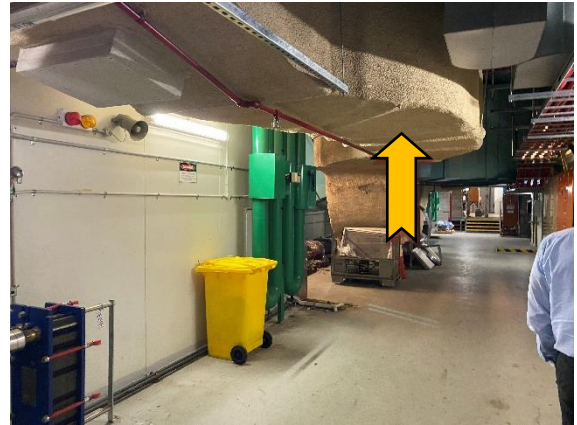
Photo 2 Interior: level 33, plant room, throughout, air conditioning ductwork – suspected SMF containing internal insulation material.

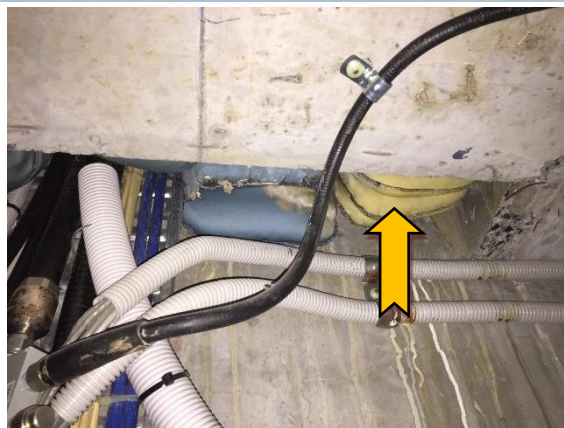
Photo 3 Interior: level 33, electrical distribution rooms, penetrations – suspected SMF containing pillow insulation.

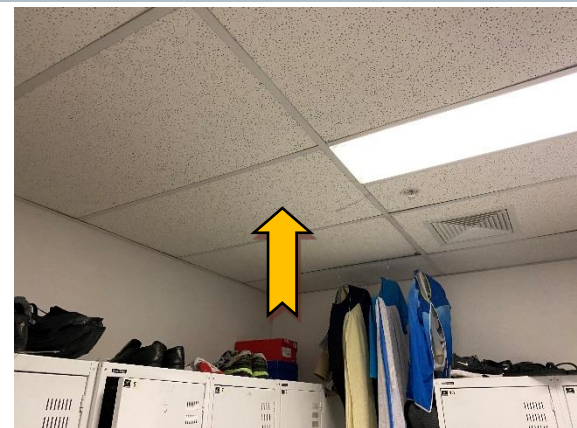
Photo 4 Interior: levels 1 – 32, bathrooms, ceiling – suspected SMF containing compressed ceiling tiles.

Interior: levels 1-32	Bathrooms	Ceiling	Compressed ceiling tiles	SMF	Visual observation	Suspected SMF	NA	NA	NA	Good	Sealed	Low	NA	NA	NA	Low	-	Maintain in current condition if to remain in-situ. Remove under controlled SMF conditions as per the Code of Practice for the Safe Use of Synthetic Mineral Fibres [NOHSC: 2006 (1990)].	~1300m ²		5207
Interior: levels 1-32	Lift lobby	Ceiling	Compressed ceiling tiles	SMF	Visual observation	Suspected SMF	NA	NA	NA	Good	Sealed	Low	NA	NA	NA	Low	-	Maintain in current condition if to remain in-situ. Remove under controlled SMF conditions as per the Code of Practice for the Safe Use of Synthetic Mineral Fibres [NOHSC: 2006 (1990)].	~700m ²		5199
Interior: levels 1-32	Electrical distribution rooms	Penetrations	Pillow insulation	SMF	Visual observation	Suspected SMF	NA	NA	NA	Good	Sealed	Low	NA	NA	NA	Low	-	Maintain in current condition if to remain in-situ. Remove under controlled SMF conditions as per the Code of Practice for the Safe Use of Synthetic Mineral Fibres [NOHSC: 2006 (1990)].	~700 units		-

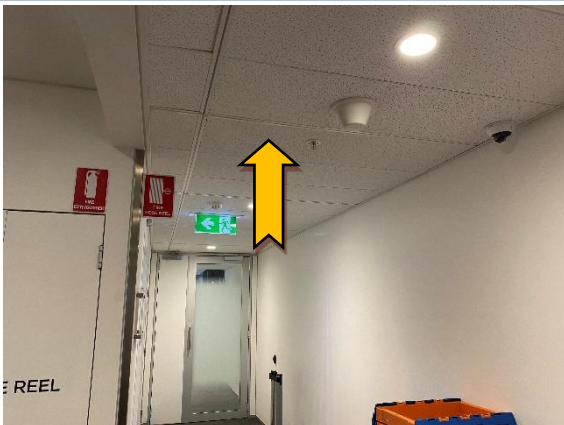
Photo 5 Interior: levels 1 – 32, lift lobby, ceiling – suspected SMF containing compressed ceiling tiles.

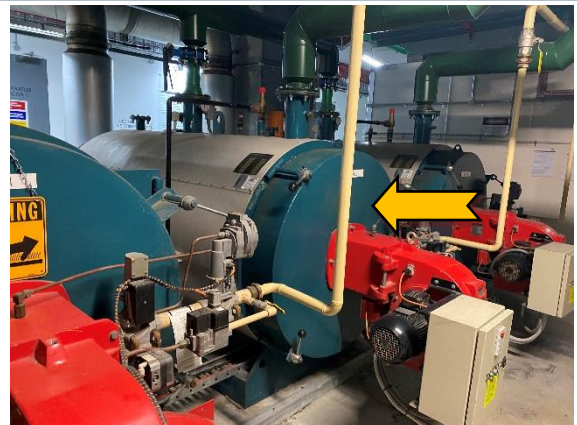
Photo 6 Interior: level 4, plant room, boiler – suspected SMF containing internal insulation material.

Interior: level 4	Plant room	Boiler	Insulation material - internal	SMF	Visual observation	Suspected SMF	NA	NA	NA	Good	Sealed	Low	NA	NA	NA	Low	-	Maintain in current condition if to remain in-situ. Remove under controlled SMF conditions as per the Code of Practice for the Safe Use of Synthetic Mineral Fibres [NOHSC: 2006 (1990)].	3 units	-	5132
Interior: level 4	Plant room	Hot water heater	Insulation material - internal	SMF	Visual observation	Suspected SMF	NA	NA	NA	Good	Sealed	Low	NA	NA	NA	Low	-	Maintain in current condition if to remain in-situ. Remove under controlled SMF conditions as per the Code of Practice for the Safe Use of Synthetic Mineral Fibres [NOHSC: 2006 (1990)].	9 units	-	5120

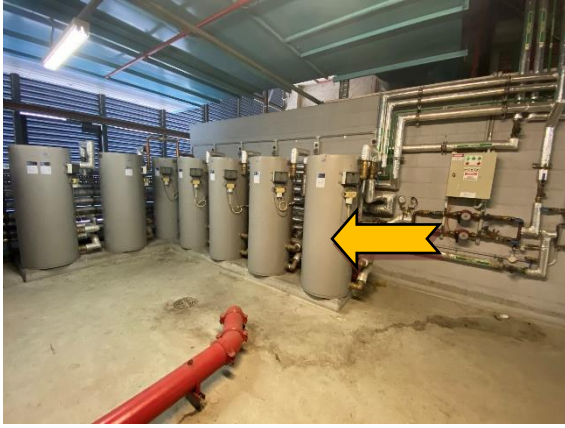
- Interior: level 4, plant room, hot water heater – suspected SMF containing internal insulation material;
- Interior: level 4, plant room, air conditioning ductwork – suspected SMF containing internal insulation material;

Photo 7 Interior: level 4, plant room, hot water heater – suspected SMF containing internal insulation material.
