Asbestos and Hazardous Materials Re-Inspection

3 December 2019

Prepared for
Mirvac Real Estate Pty Ltd

Coffey Services Australia Pty Ltd (Coffey) conducted an Asbestos and Hazardous Materials Re-Inspection of 36 Gow Street, Padstow NSW 2211 on the 5th of September 2019. The survey was undertaken to facilitate the inspection of asbestos and other hazardous materials (HazMat) in accordance with the requirements of the NSW Code of Practice *How to Manage and Control Asbestos in the Workplace (2019)*, and relevant asbestos legislation.

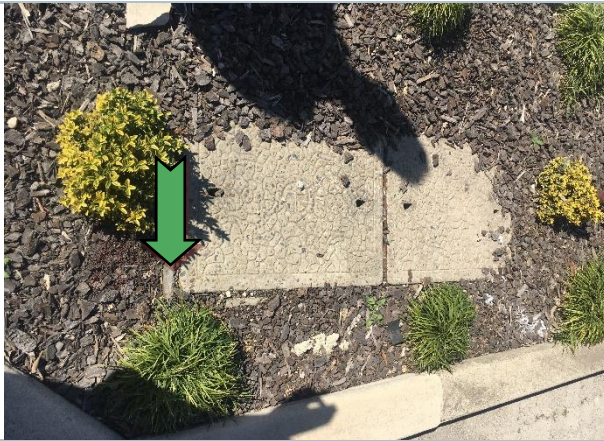
Photo 1 Exterior: carpark in front of office building, adjacent main carpark entrance, pit – non asbestos containing fibre cement pit lining.

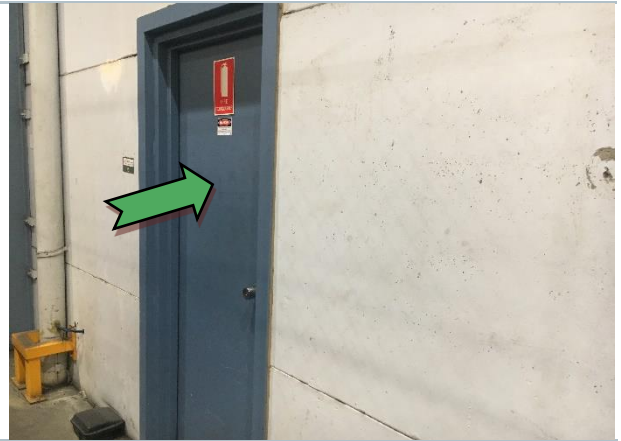
Photo 2 Exterior: Fire doors throughout – no asbestos suspected.

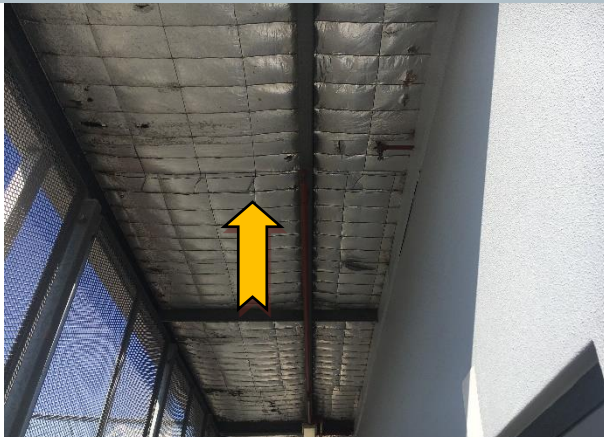
Photo 3 Exterior: substation, eaves – suspected SMF containing insulation.
