Mirvac Real Estate Pty Ltd

**Asbestos and Hazardous Materials
Re-Inspection**

39 Britton Street,
Smithfield NSW 2164

24 January 2020

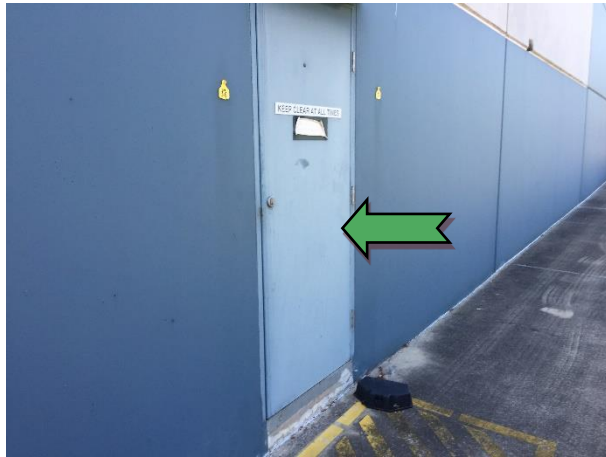
Photo 1 Throughout, fire doors, fire door core – no asbestos suspected.

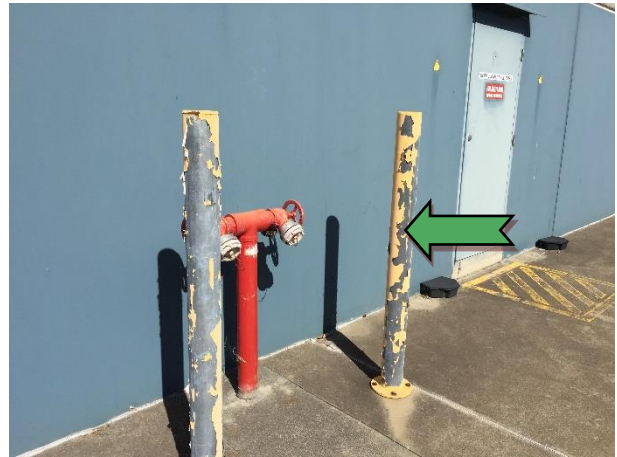
Photo 2 Exterior: throughout, bollards, yellow paint – non lead containing paint.

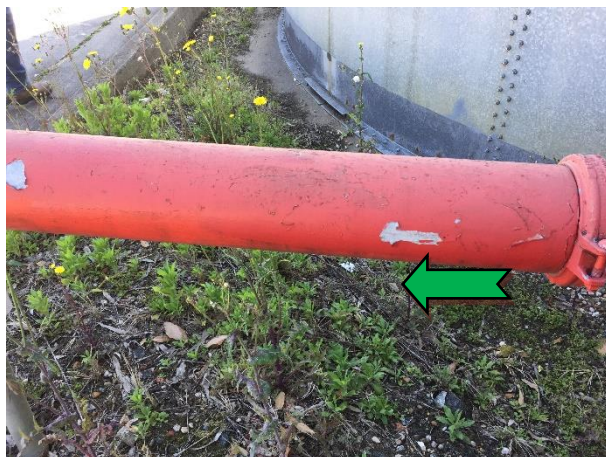
Photo 3 Exterior: throughout, pipework, red paint – non lead containing paint.

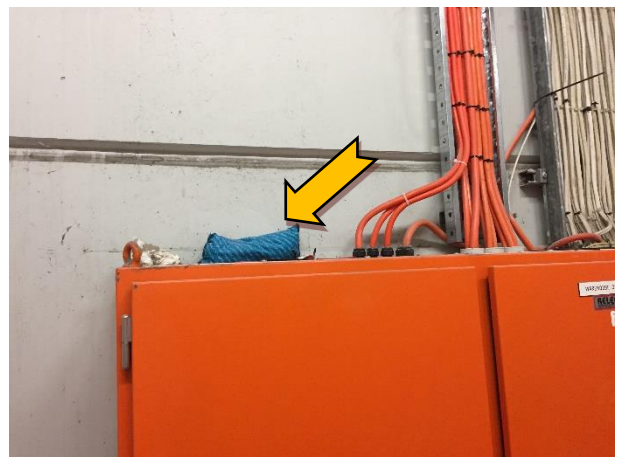
- Interior: switch room – suspected SMF containing pillow insulation.

Photo 4 Interior: switch room SMF pillow insulation.

Interior	Switchroom	Insulation	Pillow insulation	SMF	Visual Observation	Suspected SMF	NA	NA	NA	Good	Sealed	Low	NA	NA	NA	Low	-	Maintain in current condition if to remain in-situ. Remove under controlled SMF conditions as per the Code of Practice for the Safe Use of Synthetic Mineral Fibres [NOHSC: 2006 (1990)].	<1 m²	-	4
