REPORT
**REGISTER OF ASBESTOS
MATERIALS**

75 George Street
PARRAMATTA NSW 2150

PREPARED FOR: **STOCKLAND CORPORATION LIMITED**

DATE: 9 NOVEMBER 2004

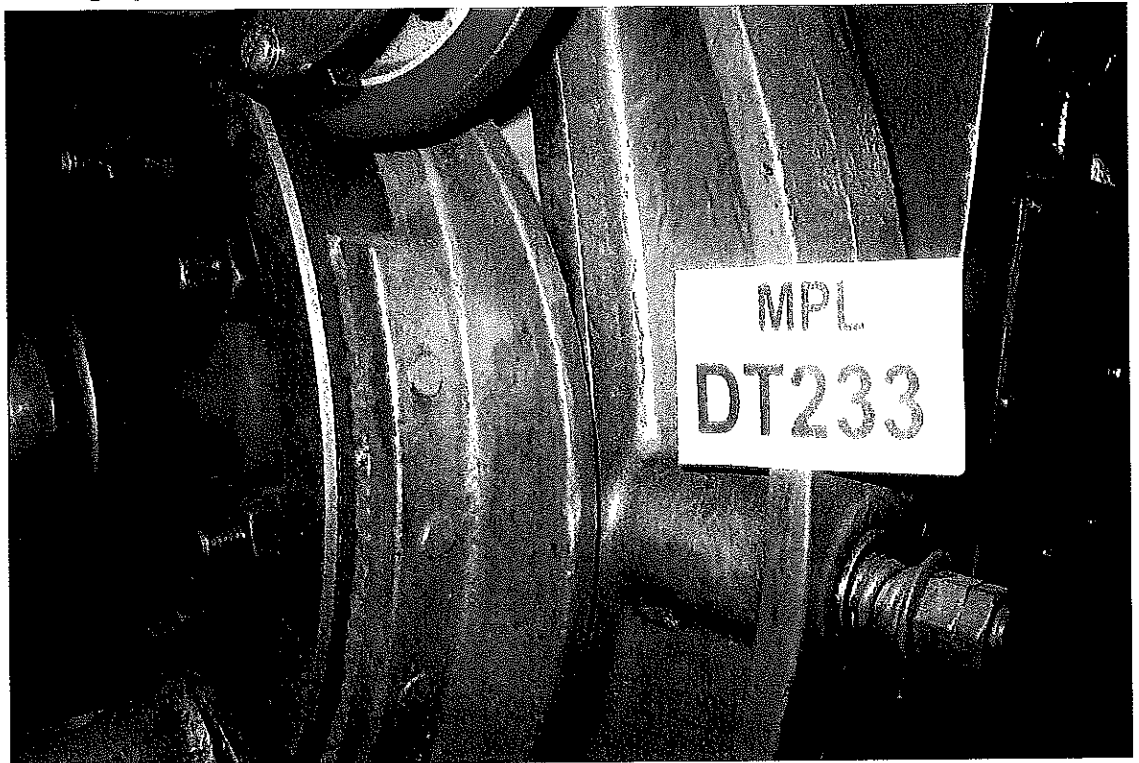
Action	Location	Description	Type of Asbestos	Condition	Status
A3	Lift Motor Room, Roof of Building	Brake linings to the lift motor	CH - White	Good	Sealed - Not Friable
Risk Rating	Sample Reference	Photograph	Area of Asbestos	Recommendation	
Low	Sample DT-233	Photograph 1	0.5m2	Label. Advise service personnel. Replace with non-asbestos product at next service

Asbestos brake linings to the lift motors present a negligible risk to the occupants of the building.

Photograph 1: Brake linings to the lift motors within the Lift Motor Room.

It is recommended to alert service personnel by appropriately labelling the lift motor as containing asbestos and introduce preventative strategies to restrict actions such as cutting, drilling or abrading, which may cause asbestos fibres to become airborne. Brake linings should be replaced with non-asbestos materials at the next service interval.
