# **Hazardous Building Materials Re-inspection**

**75 George Street, Parramatta NSW  
2150**

**CBRE  
June 2022**

**Client No: C0006  
Job No: 105154S**

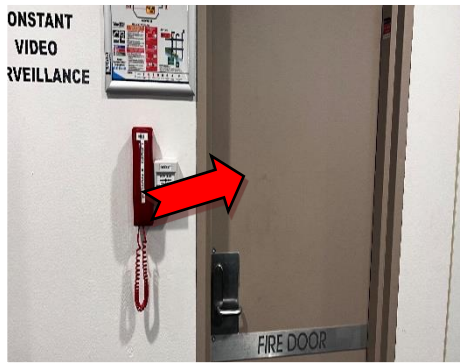
1. Level 4, Fire exit stair well (northern side), fire door – assumed asbestos-containing fire door core.

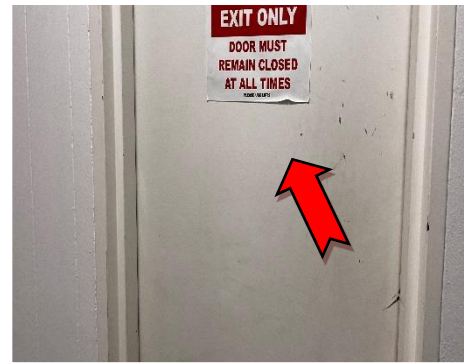
2. Level 3, Fire exit stair well (southern side), fire door – assumed asbestos-containing fire door core.

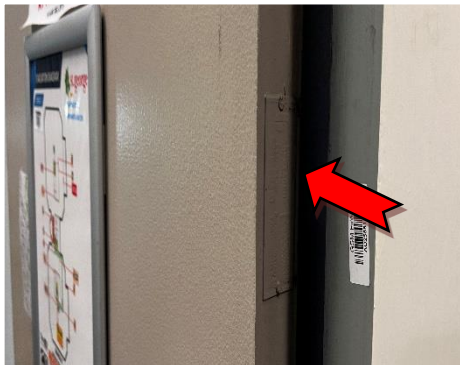
3. Level 2, throughout, fire doors – assumed asbestos-containing fire door cores.

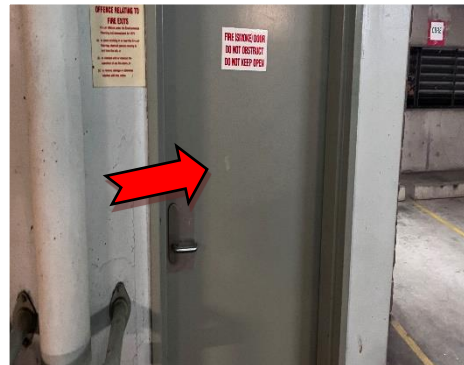
4. Car park upper level, southern side, fire door – assumed asbestos-containing fire door core.

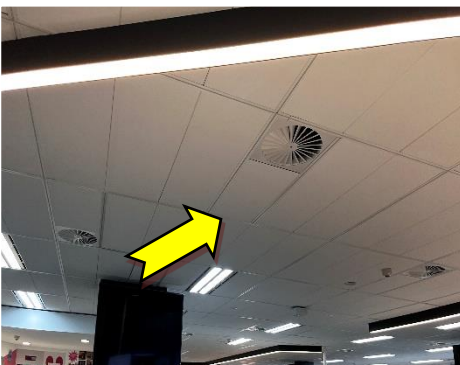
5. Throughout, ceiling – suspected SMF compressed ceiling tiles.

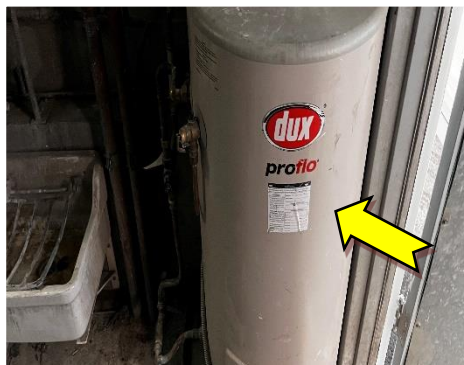
6. Throughout, plant rooms – suspected SMF insulation to hot water heaters.
