Asbestos and Hazardous Materials Reinspection Assessment

8 Chifley Square

05/09/2025

754-SYDEN364426 - 8 Chifley Square - HMRR - 20082025

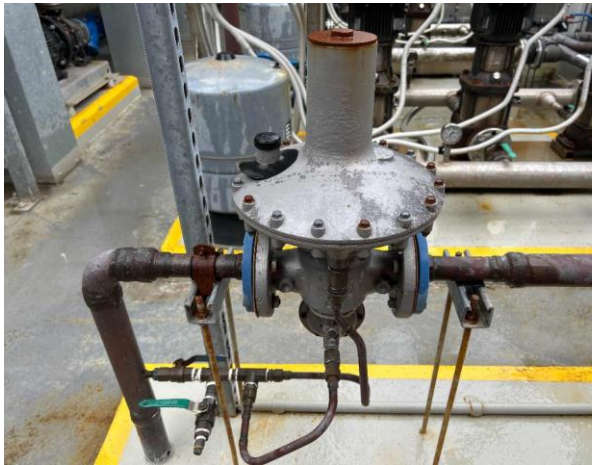
Line ID 1: External, L33, Throughout, Gasket to Gas Supply Valve, Gasket Material - No Asbestos Detected

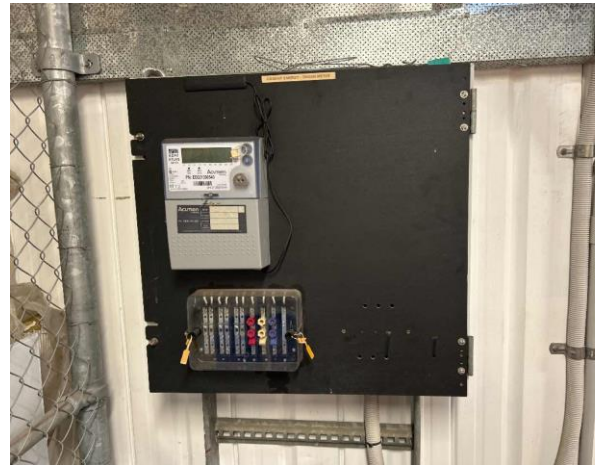
Line ID 2: Internal, All Levels, Throughout, Electrical Switchboards, Bituminous Backing Board - No Asbestos Suspected

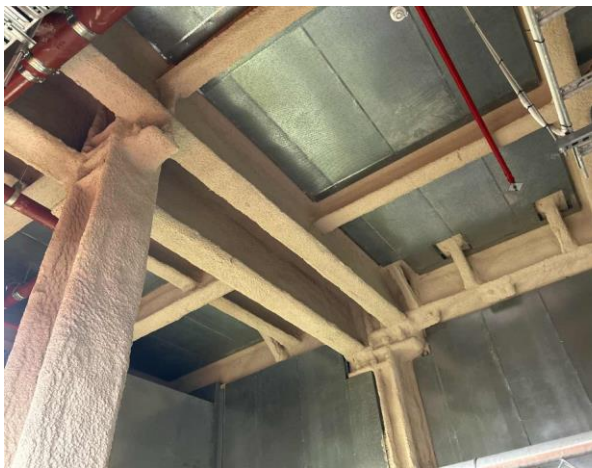
Line ID 3: Internal, All Levels, Throughout, Sprayed Coating to Beams, Ductwork and Pipework., Sprayed Vermiculite - No Asbestos Detected

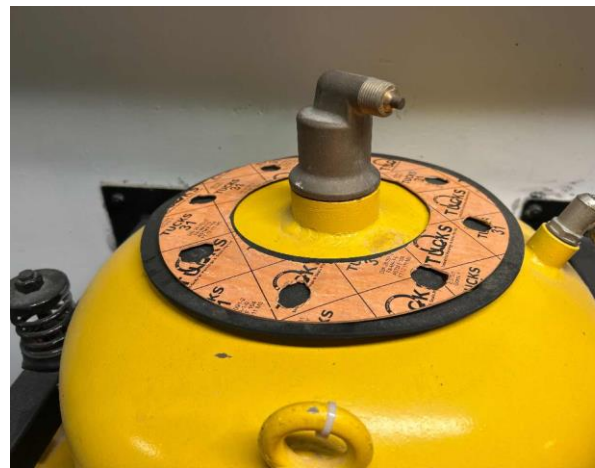
Line ID 4: Internal, L30, Plant Room, Gasket on top of Water Condenser, Gasket Material - No Asbestos Detected

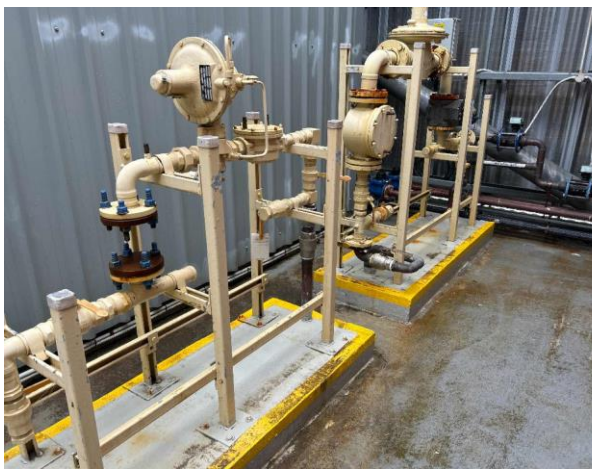
External	L33 / Throughout / Gas Supply Pipework	Beige Paint	Lead Paint	L23415	Lead Detected (0.02% w/w)	-	20 m	-	-	-	<0.1% lead content, not lead-containing paint as described in AS 4361.2, Guide to hazardous paint management - 2017 Part 2: Lead paint in residential, public and commercial buildings.	6

Line ID 6: External, L33, Throughout, Gas Supply Pipework, Beige Paint - Lead Detected (0.02% w/w)

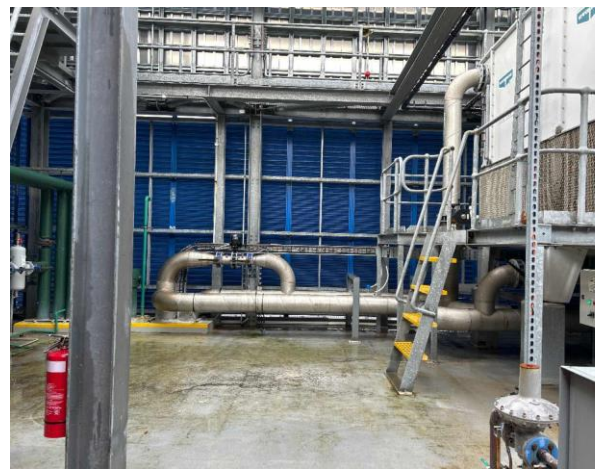
Line ID 7: External, L33, Throughout, Pipework, Internal Insulation - Suspected SMF

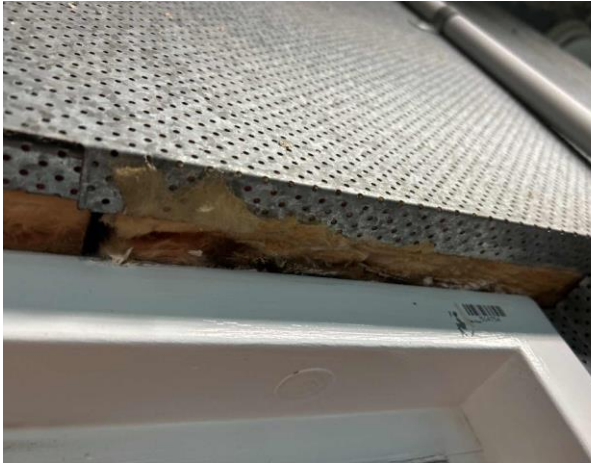
Line ID 8: Internal, All Levels, Throughout, Metal Cased SMF Cladding to Doors, Ceilings & Walls, Insulation Material - Suspected SMF

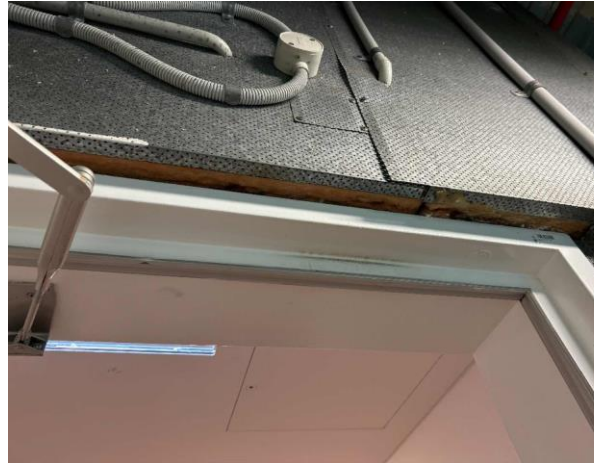
Line ID 8.1: Internal, All Levels, Throughout, Metal Cased SMF Cladding to Doors, Ceilings & Walls, Insulation Material - Suspected SMF

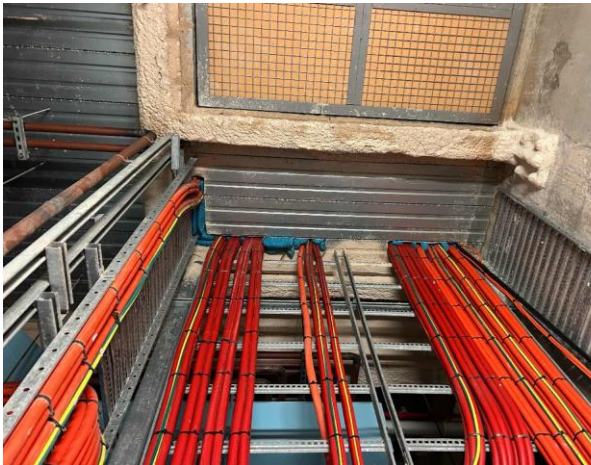
Line ID 9: Internal, All Levels, Throughout, Pipework, Pillow Insulation - Suspected SMF

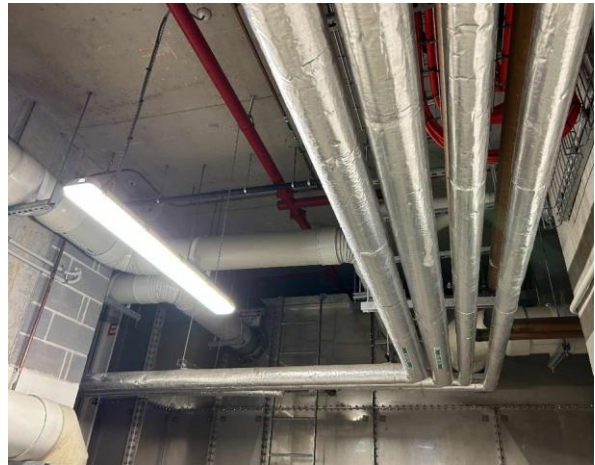
Internal	All Levels / Throughout / Pipework Insulation to Walls and Ceilings	Insulation Material	SMF	754-SYDEN364426 505S5	Suspected SMF	-	1000 m	-	Very Low	-	Maintain in current condition if to remain in-situ. Remove under controlled SMF conditions as per the Code of Practice for the Safe Use of Synthetic Mineral Fibres [NOHSC: 2006 (1990)].	10
Internal	B1 / Loading Dock / Hot Water Heaters	Insulation Material	SMF	754-SYDEN364426 505S8	Suspected SMF	-	4 Units	-	Very Low	-	Maintain in current condition if to remain in-situ. Remove under controlled SMF conditions as per the Code of Practice for the Safe Use of Synthetic Mineral Fibres [NOHSC: 2006 (1990)].	11
Internal	L19 / Plant Room / Hot Water Heater	Insulation Material	SMF	754-SYDEN364426 505S6	Suspected SMF	-	3 Units	-	Very Low	-	Maintain in current condition if to remain in-situ. Remove under controlled SMF conditions as per the Code of Practice for the Safe Use of Synthetic Mineral Fibres [NOHSC: 2006 (1990)].	12

Line ID 10: Internal, All Levels, Throughout, Pipework Insulation to Walls and Ceilings, Insulation Material - Suspected SMF

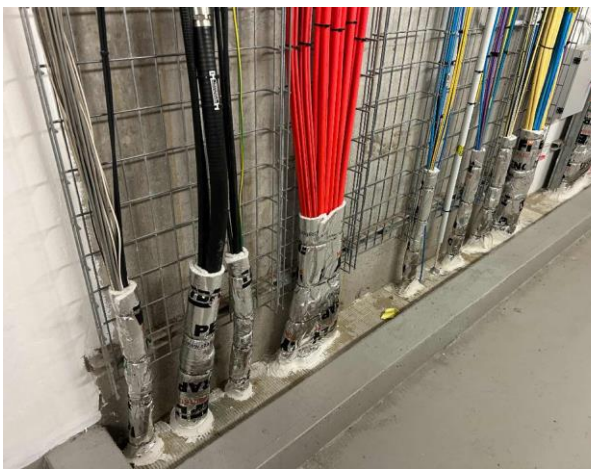
Line ID 10.1: Internal, All Levels, Throughout, Pipework Insulation to Walls and Ceilings, Insulation Material - Suspected SMF

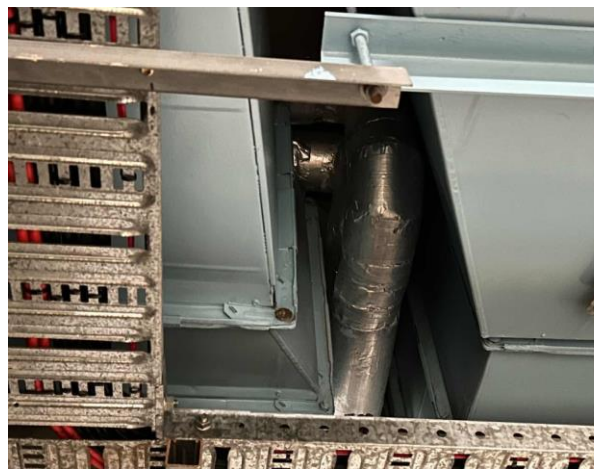
Line ID 10.2: Internal, All Levels, Throughout, Pipework Insulation to Walls and Ceilings, Insulation Material - Suspected SMF

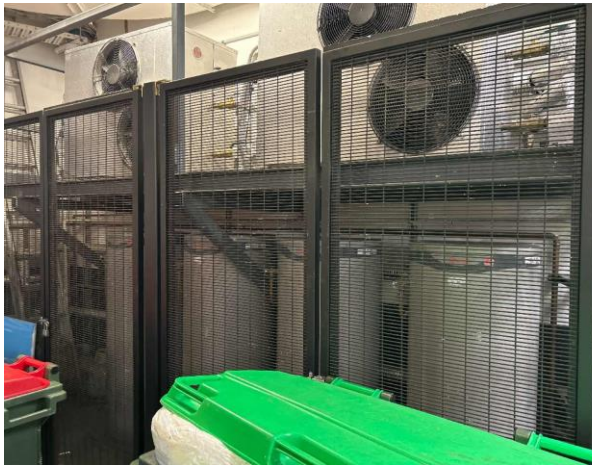
Line ID 11: Internal, B1, Loading Dock, Hot Water Heaters, Insulation Material - Suspected SMF

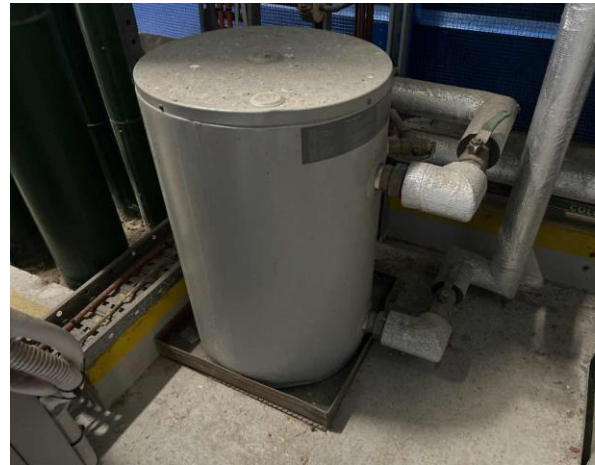
Line ID 12: Internal, L19, Plant Room, Hot Water Heater, Insulation Material - Suspected SMF

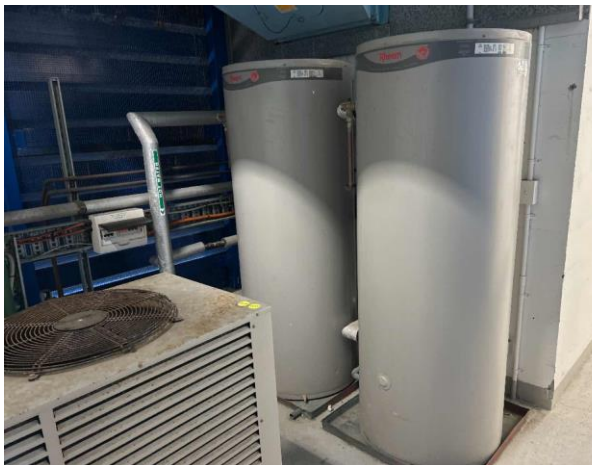
Line ID 12.1: Internal, L19, Plant Room, Hot Water Heater, Insulation Material - Suspected SMF

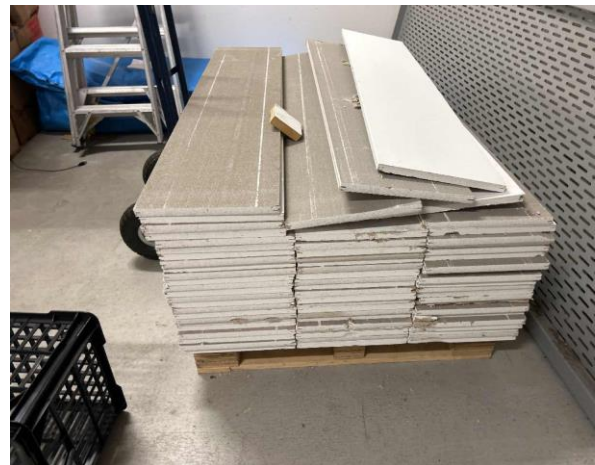
Line ID 13: Internal, L3, Lift Lobby, Stored Ceiling Tiles, Northeast of Lift, Compressed Ceiling Tiles - Suspected SMF

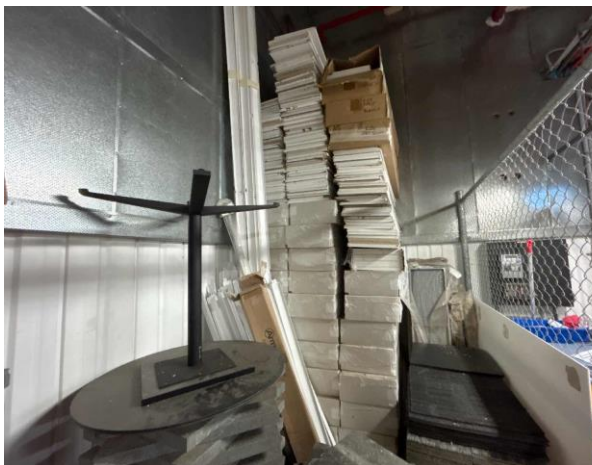
Line ID 14: Internal, L32, Plant Room, Southwest Corner, Storage Cage, Compressed Ceiling Tiles - Suspected SMF

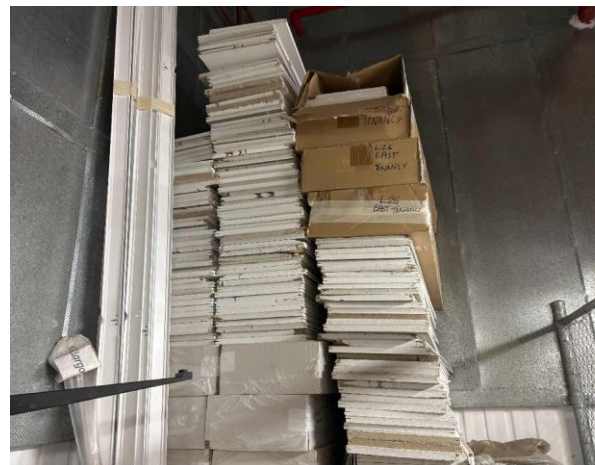
Line ID 14.1: Internal, L32, Plant Room, Southwest Corner, Storage Cage, Compressed Ceiling Tiles - Suspected SMF

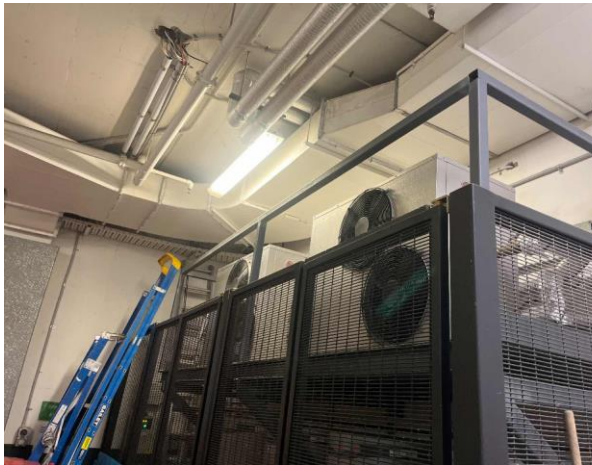
Line ID 15: Internal, B1, Loading Dock, Above Hot Water Heaters, AC Units, Unknown Refrigerant - None Suspected

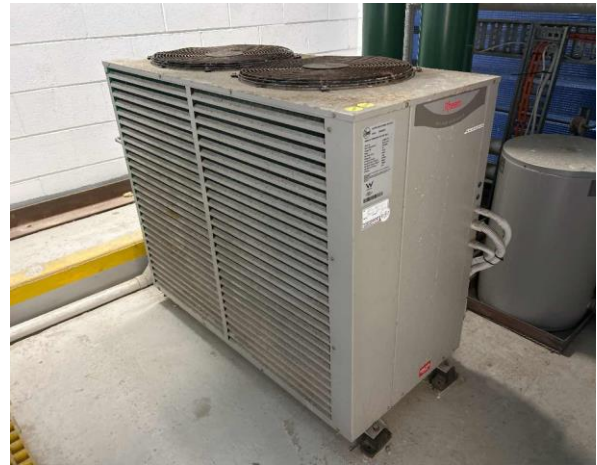
Line ID 16: Internal, L19, Plant Room, Hot Water Heater Pump, R407C Hydrofluorocarbon (HFC) - Non ODS Refrigerant

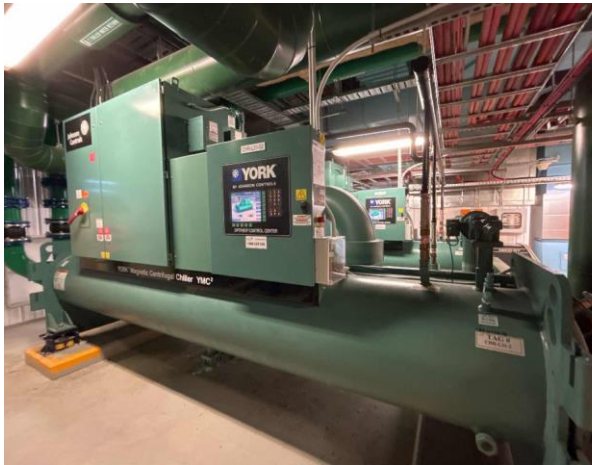
Line ID 17: Internal, L31, Plant Room, Centrifugal Chillers, R134a Hydrofluorocarbon (HFC) - Non ODS Refrigerant

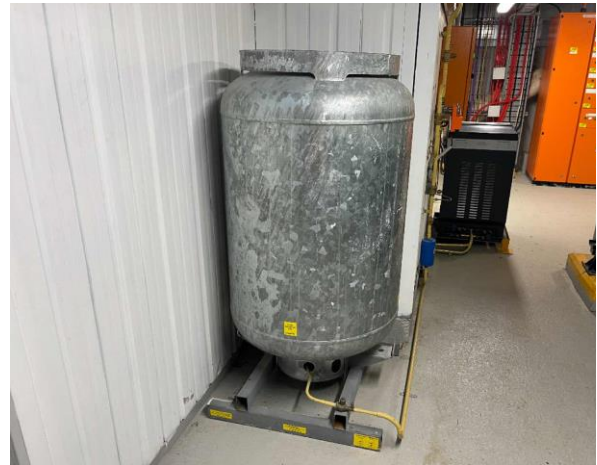
Line ID 18: Internal, L31, Plant Room, Spare Tank, R134a Hydrofluorocarbon (HFC) - Non ODS Refrigerant

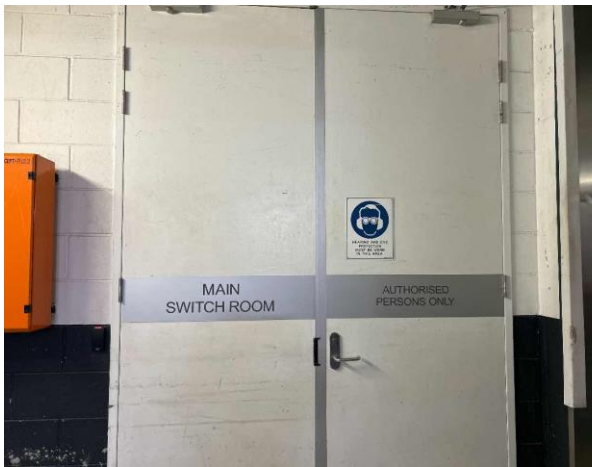
Line ID 20: Internal, B1, Main Switchroom – No Access

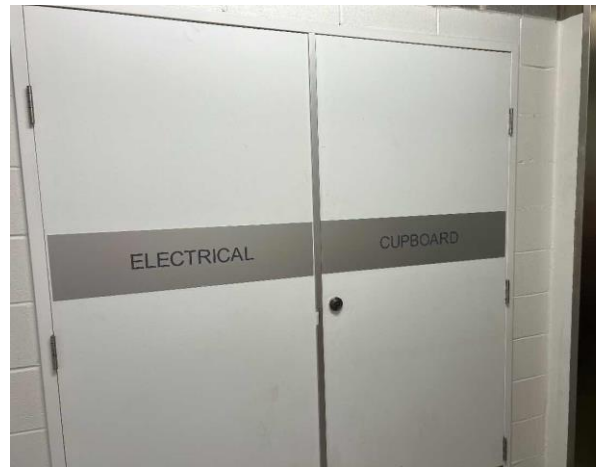
Line ID 21: Internal, L20, Electrical Cupboard – No Access

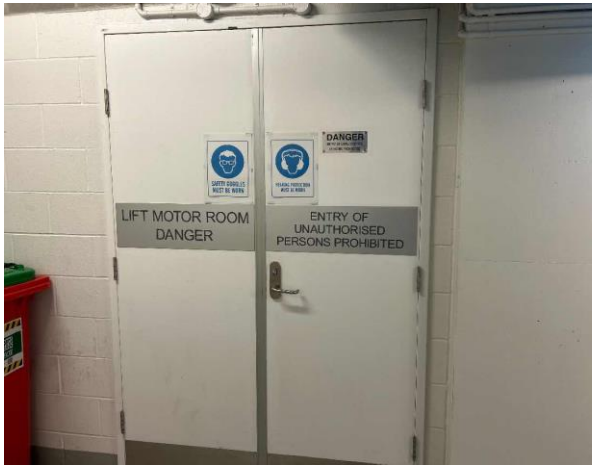
Line ID 22: Internal, L20, Lift Motor Room – No Access
