## COMPLIANCE HAZARDOUS MATERIAL RE-INSPECTION AND RISK ASSESSMENT

JANUARY 2023

J051894

80 Bay Street  
Ultimo NSW  
2007

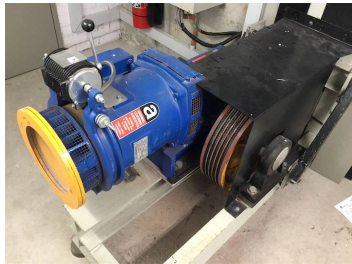
| Location | | 80 Bay Street, Ultimo NSW - Z-Sub Level 1 - Lift Motor Room - Lift Motor - Brake Pads - Friction pads/material - Live Plant | | | | |
| Hazard Type | Asbestos | Material Assessment | | Disturbance Assessment | | |
| Item Number | 5 | Material Score | 3 | Disturbance Score | 1 | |
| | | Priority Score | 4 | Very Low | | |

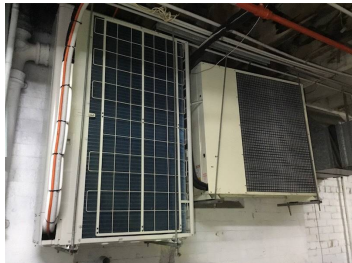
| Location | | 80 Bay Street, Ultimo NSW - Z-Sub Level 1 - Loading Dock - Northeast - A/C Unit - ODS - R22 | | | | |
| Hazard Type | ODS | Material Assessment | | Disturbance Assessment | | |
| Item Number | 10 | Material Score | - | Disturbance Score | - | |

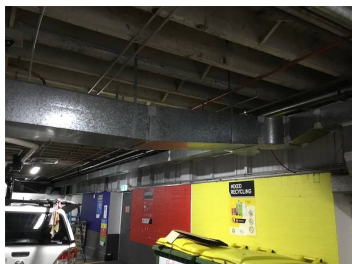
| Location | | 80 Bay Street, Ultimo NSW - Z-Sub Level 1 - Loading Dock - Ceiling - Ductwork - Insulation | | | | |
| Hazard Type | SMF | Material Assessment | | Disturbance Assessment | | |
| Item Number | 11 | Material Score | - | Disturbance Score | - | |

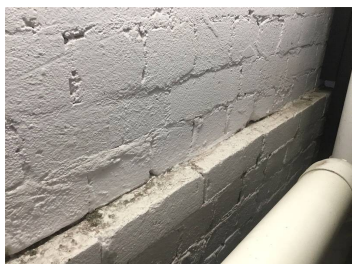
| Location | | 80 Bay Street, Ultimo NSW - Z-Sub Level 1 - Cleaner's Area - All Surfaces - Dust | | | | |
| Hazard Type | Lead Dust | Material Assessment | | Disturbance Assessment | | |
| Item Number | 57 | Material Score | - | Disturbance Score | - | |

| Item No. | Hazard Type | Item Location and Description | Recommendations |
|---|---|---|---|
| Item 57 | Lead Dust | 80 Bay Street, Ultimo NSW, Z-Sub Level 1, Cleaner's Area, All Surfaces, Dust | Restrict Access & Remove Under Suitably Controlled Conditions |

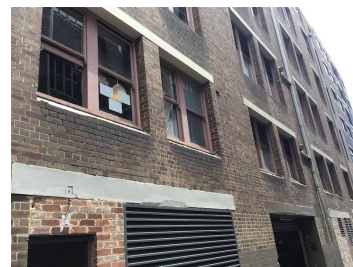
| Location | | 80 Bay Street, Ultimo NSW - Ground Floor - Exterior - East - Window Frame - Pale Pink Paint - Height Restricted | |
| Hazard Type | Lead Paint | Material Assessment | Disturbance Assessment |
| Item Number | 1 | Material Score | Disturbance Score |

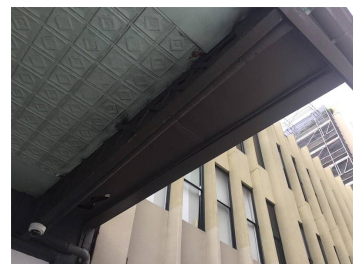
| Location | | 80 Bay Street, Ultimo NSW - Ground Floor - Exterior - Front Entrance Awning - East and West - Fibre Cement Sheetting - Height Restriction | |
| Hazard Type | Asbestos | Material Assessment | Disturbance Assessment |
| Item Number | 58 | Material Score | Disturbance Score |
| | | Priority Score | Low |

| Item No. | Hazard Type | Item Location and Description | Recommendations |
|---|---|---|---|
| Item 58 | Asbestos | 80 Bay Street, Ultimo NSW, Ground Floor, Exterior, Front Entrance Awning - East and West, Fibre Cement Sheeting - Height Restriction | Encapsulate / Repair & Manage In Situ |

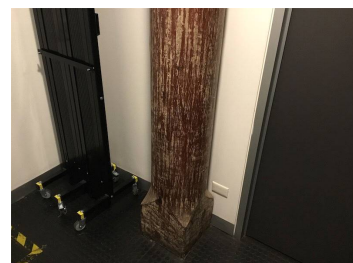
| Location | | 80 Bay Street, Ultimo NSW - Ground Floor - All Tenancy Areas - Throughout Column - White Paint Residues | |
| Hazard Type | Lead Paint | Material Assessment | Disturbance Assessment |
| Item Number | 17 | Material Score | Disturbance Score |

| Item No. | Hazard Type | Item Location and Description | Recommendations |
|---|---|---|---|
| Item 17 | Lead Paint | 80 Bay Street, Ultimo NSW, Ground Floor, All Tenancy Areas, Throughout Column, White Paint Residues | Encapsulate / Repair & Manage In Situ |

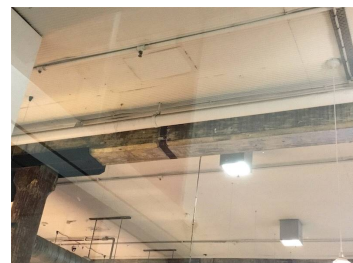
| Location | | 80 Bay Street, Ultimo NSW - Ground Floor - All Tenancy Areas - Ceiling - Timber Beams - White Paint - Height Restricted | |
| Hazard Type | Lead Paint | Material Assessment | Disturbance Assessment |
| Item Number | 18 | Material Score | Disturbance Score |

| Item No. | Hazard Type | Item Location and Description | Recommendations |
|---|---|---|---|
| Item 18 | Lead Paint | 80 Bay Street, Ultimo NSW, Ground Floor, All Tenancy Areas, Ceiling - Timber Beams, White Paint - Height Restricted | Encapsulate / Repair & Manage In Situ |

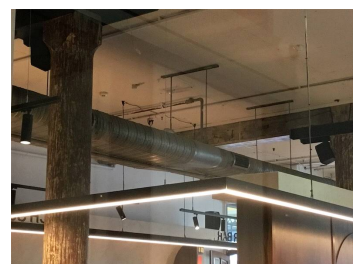
| Location | | 80 Bay Street, Ultimo NSW - Ground Floor - All Tenancy Areas - Throughout Centre of Each Shop - Ductwork - Insulation | |
| Hazard Type | SMF | Material Assessment | Disturbance Assessment |
| Item Number | 22 | Material Score | Disturbance Score |

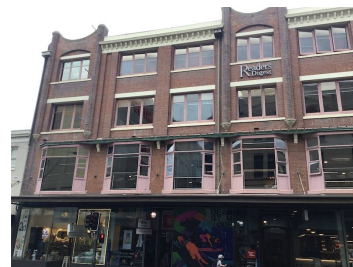
| Location | | 80 Bay Street, Ultimo NSW - 1st Floor - Exterior - East and West - Window Frame - Pale Pink Paint - Height Restricted | |
| Hazard Type | Lead Paint | Material Assessment | Disturbance Assessment |
| Item Number | 2 | Material Score | Disturbance Score |

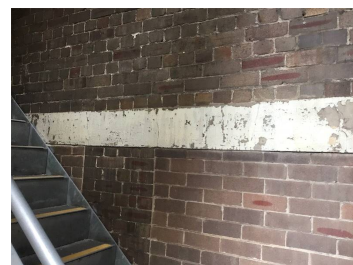
| Location | | 80 Bay Street, Ultimo NSW - 1st Floor - Exterior - Fire Emergency Stairway - Concrete Slab Between Levels - Off White Paint | |
| Hazard Type | Lead Paint | Material Assessment | Disturbance Assessment |
| Item Number | 56 | Material Score | Disturbance Score |

| Item No. | Hazard Type | Item Location and Description | Recommendations |
|---|---|---|---|
| Item 56 | Lead Paint | 80 Bay Street, Ultimo NSW, 1st Floor, Exterior, Fire Emergency Stairway - Concrete Slab Between Levels, Off White Paint | Encapsulate / Repair & Manage In Situ |

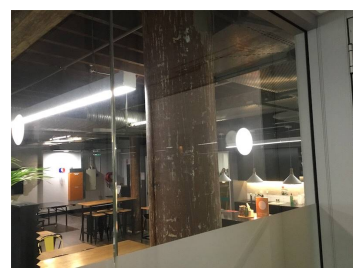
| Location | | 80 Bay Street, Ultimo NSW - 1st Floor - Open Office Area - Throughout Column - White Paint Residues | |
| Hazard Type | Lead Paint | Material Assessment | Disturbance Assessment |
| Item Number | 16 | Priority Score | - |

| Item No. | Hazard Type | Item Location and Description | Recommendations |
|---|---|---|---|
| Item 16 | Lead Paint | 80 Bay Street, Ultimo NSW, 1st Floor, Open Office Area, Throughout Column, White Paint Residues | Encapsulate / Repair & Manage In Situ |

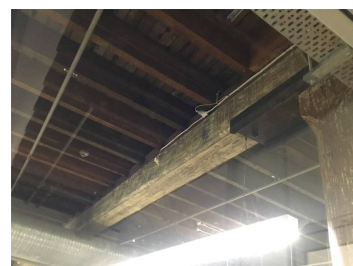
| Location | | 80 Bay Street, Ultimo NSW - 1st Floor - Open Office Area - Ceiling - Timber Beams - White Paint Residues - Height Restricted | |
| Hazard Type | Lead Paint | Material Assessment | Disturbance Assessment |
| Item Number | 19 | Material Score | Disturbance Score |

| Item No. | Hazard Type | Item Location and Description | Recommendations |
|---|---|---|---|
| Item 19 | Lead Paint | 80 Bay Street, Ultimo NSW, 1st Floor, Open Office Area, Ceiling - Timber Beams, White Paint Residues - Height Restricted | Encapsulate / Repair & Manage In Situ |

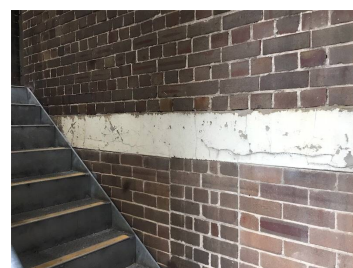
| Location | | 80 Bay Street, Ultimo NSW - 2nd Floor - Exterior - Fire Emergency Stairway - Concrete Slab Between Levels - Off White Paint | |
| Hazard Type | Lead Paint | Material Assessment | Disturbance Assessment |
| Item Number | 54 | Material Score | Disturbance Score |

| Item No. | Hazard Type | Item Location and Description | Recommendations |
|---|---|---|---|
| Item 54 | Lead Paint | 80 Bay Street, Ultimo NSW, 2nd Floor, Exterior, Fire Emergency Stairway - Concrete Slab Between Levels, Off White Paint | Encapsulate / Repair & Manage In Situ |

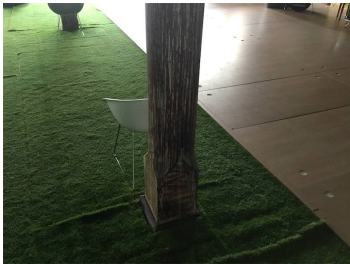
| Location | 80 Bay Street, Ultimo NSW - 2nd Floor - Open Area - Throughout Column - White Paint Residues | | | |
| Hazard Type | Lead Paint | Material Assessment | Disturbance Assessment | |
| Item Number | 31 | Material Score | Disturbance Score | |

| Item No. | Hazard Type | Item Location and Description | Recommendations |
|---|---|---|---|
| Item 31 | Lead Paint | 80 Bay Street, Ultimo NSW, 2nd Floor, Open Area, Throughout Column, White Paint Residues | Encapsulate / Repair & Manage In Situ |

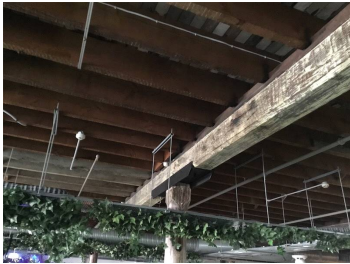
| Location | 80 Bay Street, Ultimo NSW - 2nd Floor - Open Area - Ceiling - Timber Beams - White Paint Residues - Height Restricted | | | |
| Hazard Type | Lead Paint | Material Assessment | Disturbance Assessment | |
| Item Number | 32 | Material Score | Disturbance Score | |

| Item No. | Hazard Type | Item Location and Description | Recommendations |
|---|---|---|---|
| Item 32 | Lead Paint | 80 Bay Street, Ultimo NSW, 2nd Floor, Open Area, Ceiling - Timber Beams, White Paint Residues - Height Restricted | Encapsulate / Repair & Manage In Situ |

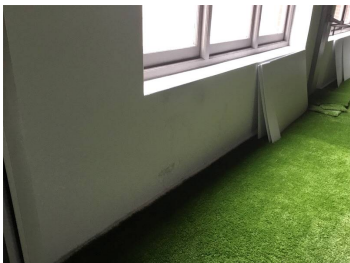
| Location | 80 Bay Street, Ultimo NSW - 2nd Floor - Open Area - Wall - Throughout - White Paint | | | |
| Hazard Type | Lead Paint | Material Assessment | Disturbance Assessment | |
| Item Number | 33 | Material Score | Disturbance Score | |

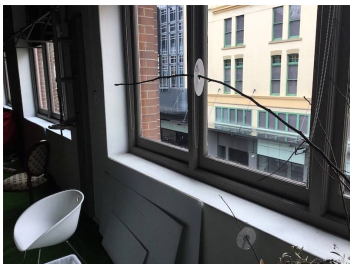
| Location | 80 Bay Street, Ultimo NSW - 2nd Floor - Open Area - Window Frame - Grey Paint | | | |
| Hazard Type | Lead Paint | Material Assessment | Disturbance Assessment | |
| Item Number | 34 | Material Score | Disturbance Score | |

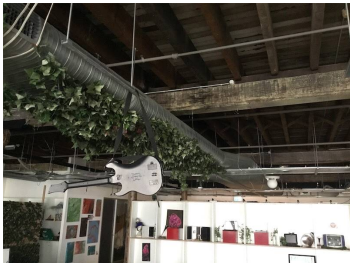
| Location | 80 Bay Street, Ultimo NSW - 2nd Floor - Open Area - Throughout Ceiling - Ductwork - Insulation | | | |
| Hazard Type | SMF | Material Assessment | Disturbance Assessment | |
| Item Number | 35 | Material Score | Disturbance Score | |

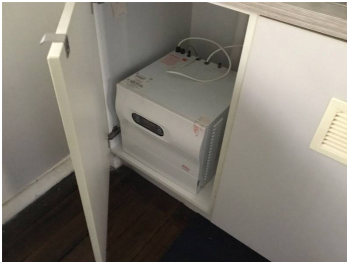
| Location | | 80 Bay Street, Ultimo NSW - 2nd Floor - Kitchenette - Below Sink - Hot Water Unit - Insulation | | | | |
| Hazard Type | | SMF | Material Assessment | | Disturbance Assessment | |
| Item Number | | 49 | Material Score | | - | |

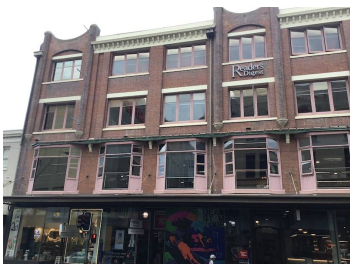
| Location | | 80 Bay Street, Ultimo NSW - 3rd Floor - Exterior - East and West - Window Frame - Pale Pink Paint - Height Restricted | | |
| Hazard Type | Lead Paint | Material Assessment | Disturbance Assessment | |
| Item Number | 4 | Material Score | - | |

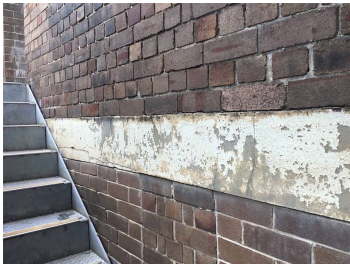
| Location | | 80 Bay Street, Ultimo NSW - 3rd Floor - Exterior - Fire Emergency Stairway - Concrete Slab Between Levels - Off White Paint | | |
| Hazard Type | Lead Paint | Material Assessment | Disturbance Assessment | |
| Item Number | 53 | Material Score | - | |

| Item No. | Hazard Type | Item Location and Description | Recommendations |
|---|---|---|---|
| Item 53 | Lead Paint | 80 Bay Street, Ultimo NSW, 3rd Floor, Exterior, Fire Emergency Stairway - Concrete Slab Between Levels, Off White Paint | Encapsulate / Repair & Manage In Situ |

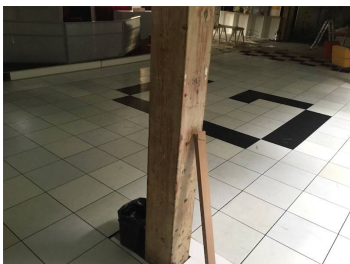
| Location | | 80 Bay Street, Ultimo NSW - 3rd Floor - Open Area - Throughout Column - White Paint Residues | | |
| Hazard Type | Lead Paint | Material Assessment | Disturbance Assessment | |
| Item Number | 36 | Material Score | - | |

| Item No. | Hazard Type | Item Location and Description | Recommendations |
|---|---|---|---|
| Item 36 | Lead Paint | 80 Bay Street, Ultimo NSW, 3rd Floor, Open Area, Throughout Column, White Paint Residues | Encapsulate / Repair & Manage In Situ |

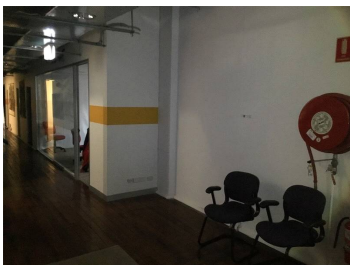
| Location | | 80 Bay Street, Ultimo NSW - 3rd Floor - Open Area - Wall - Throughout - White Paint | | |
| Hazard Type | Lead Paint | Material Assessment | Disturbance Assessment | |
