Asbestos and Hazardous Materials Reinspection Assessment

80 Pacific Highway

North Sydney NSW 2060

05/05/2025

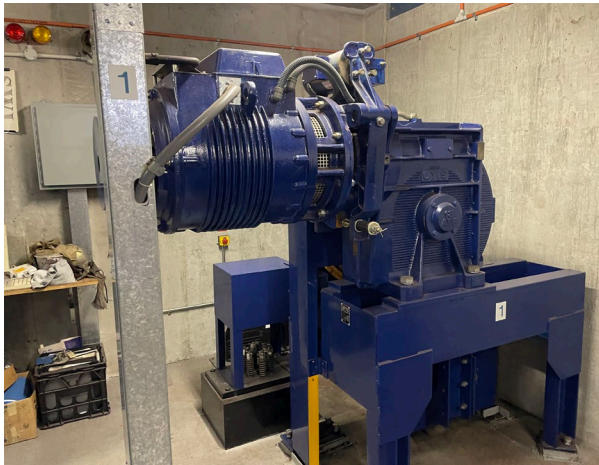
Line ID 1: Internal, L16, Lift Motor Room, 5 x Lift Motors, Friction Pads - No Asbestos Detected

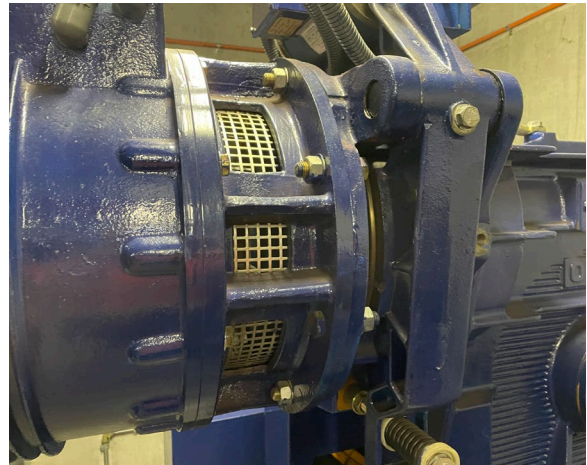
Line ID 1.1: Internal, L16, Lift Motor Room, 5 x Lift Motors, Friction Pads - No Asbestos Detected

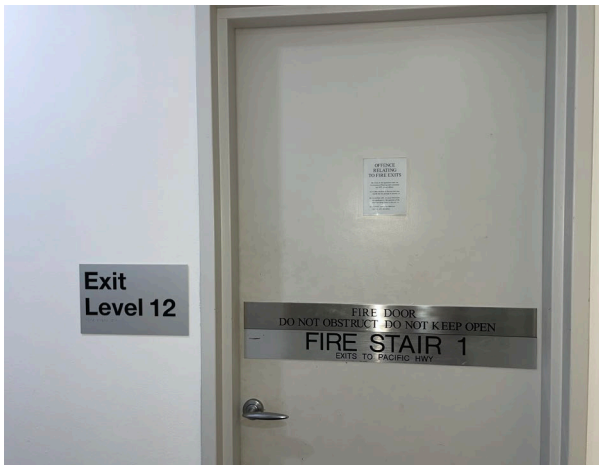
Line ID 2: Internal, All Levels, Stairwells and Plant Rooms, Various Throughout, Fire Door Core - No Asbestos Detected

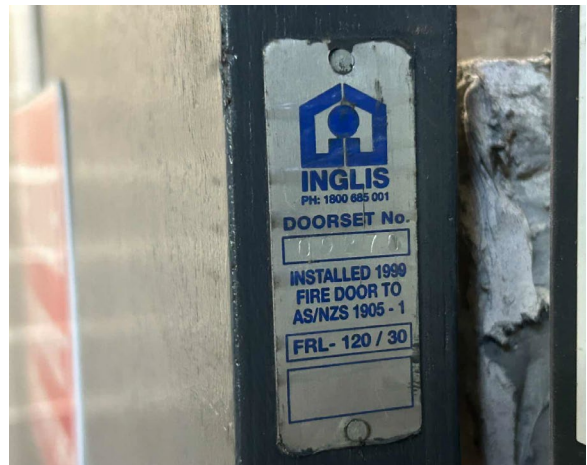
Line ID 2.1: Internal, All Levels, Stairwells and Plant Rooms, Various Throughout, Fire Door Core - No Asbestos Detected

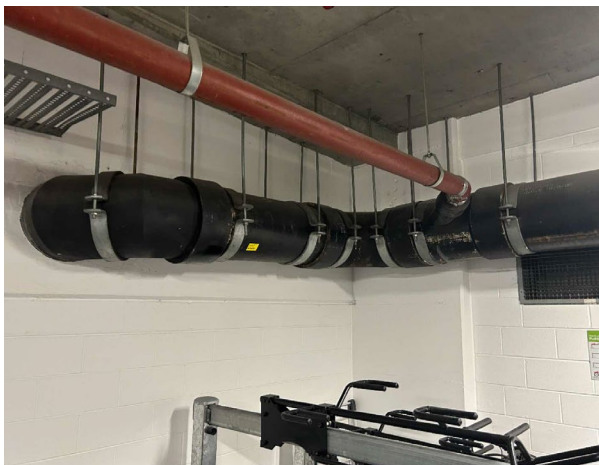
Line ID 3: Internal, B1, Carpark and End of Trip Room, Black Stormwater Pipework, Moulded Fibre Cement - No Asbestos Detected

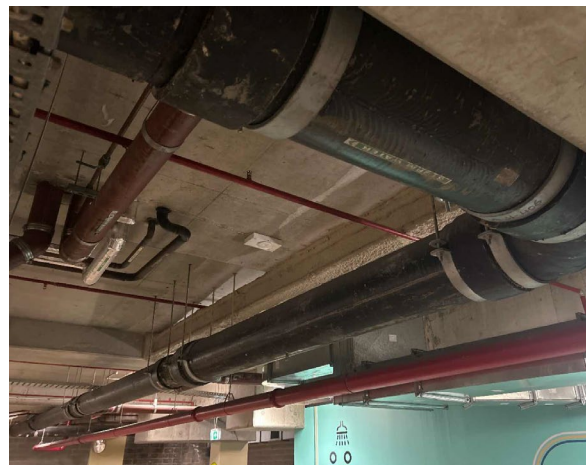
Line ID 3.1: Internal, B1, Carpark and End of Trip Room, Black Stormwater Pipework, Moulded Fibre Cement - No Asbestos Detected

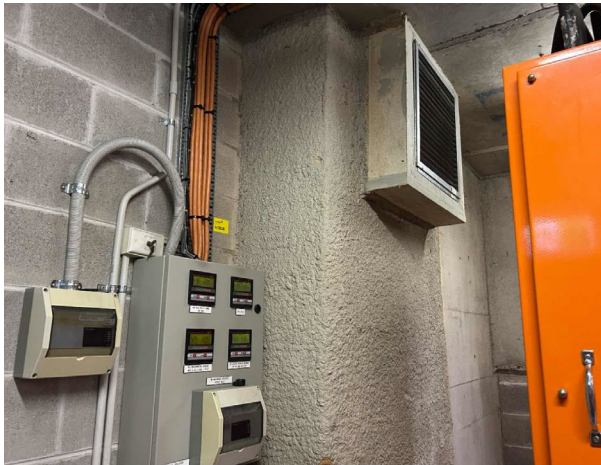
Line ID 6: Internal, B1, Main Switch Room, Ductwork, Sprayed Vermiculite - No Asbestos Detected

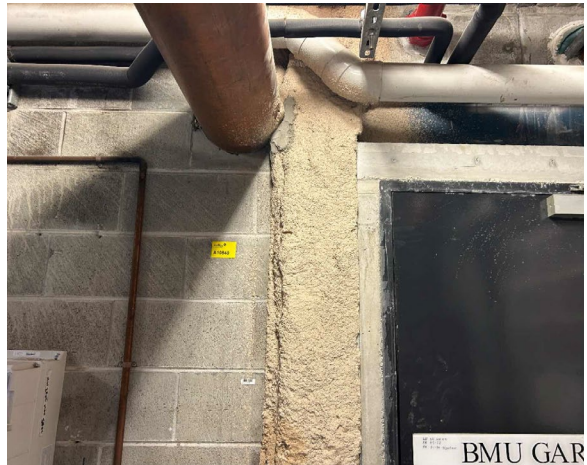
Line ID 7: Internal, L15, Chiller Room, Structural Beams, Sprayed Vermiculite - No Asbestos Detected

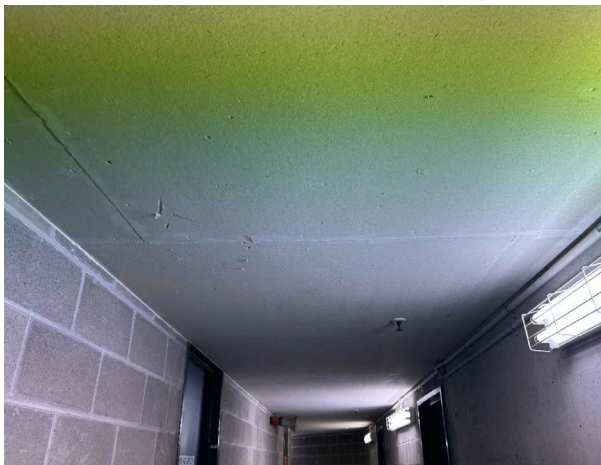
Line ID 8: Internal, L15, Corridors, Ceiling, Insulation Board - No Asbestos Detected

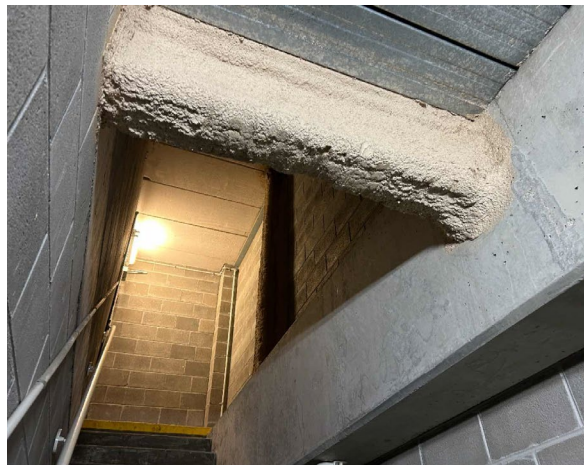
Line ID 9: Internal, L15, Corridors, Structural Beams, Sprayed Vermiculite - No Asbestos Detected

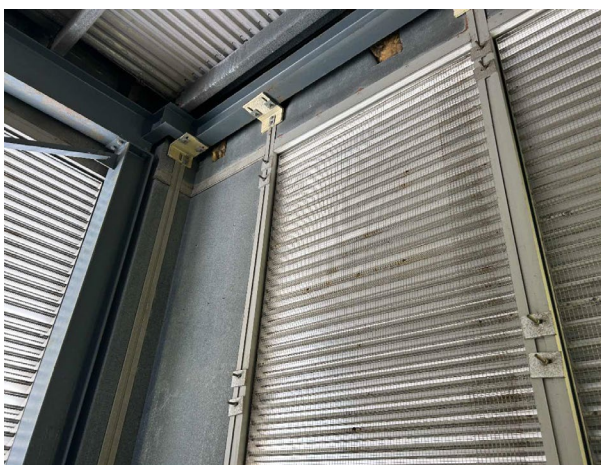
Line ID 11: Internal, L16, Cooling Tower Room, Within Metal Wall Cladding, Insulation Batts - Suspected SMF

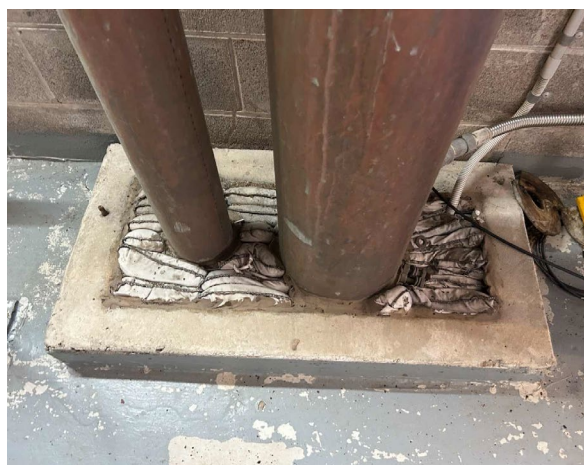
Line ID 12: Internal, All Levels, Plant, Service and Electrical Areas, Penetrations, Pillow Insulation - Suspected SMF

Internal	All Levels / Plant, Service and Electrical Areas / Penetrations	Pillow Insulation	SMF	754-SYDEN364426 80 Pacific Hwy339S2	Suspected SMF	-	1000 Units	-	Very Low	-	Maintain in current condition if to remain in-situ. Remove under controlled SMF conditions as per the Code of Practice for the Safe Use of Synthetic Mineral Fibres [NOHSC: 2006 (1990)].	12

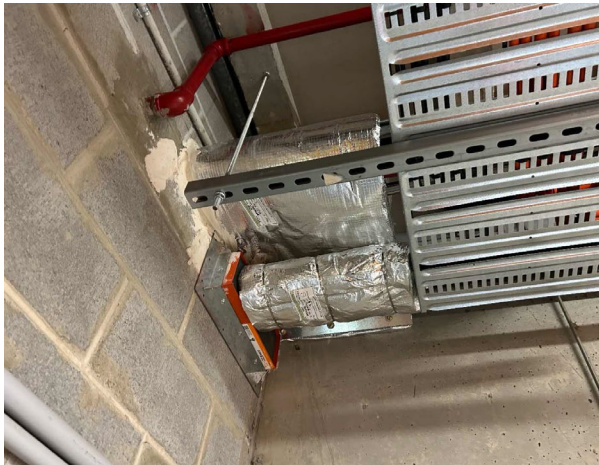
Line ID 13: Internal, All Levels, Plant, Service and Electrical Areas, Various Areas, Foil Lined Insulation to Pipework and Cables, Insulation Material - Suspected SMF

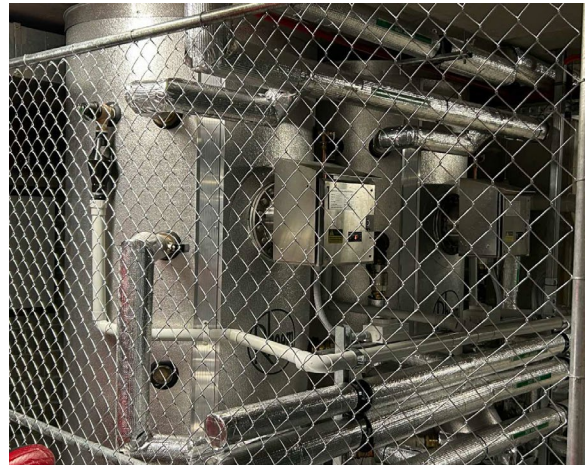
Line ID 14: Internal, B3, Carpark, Caged Area, Water Heaters, Insulation Material - Suspected SMF

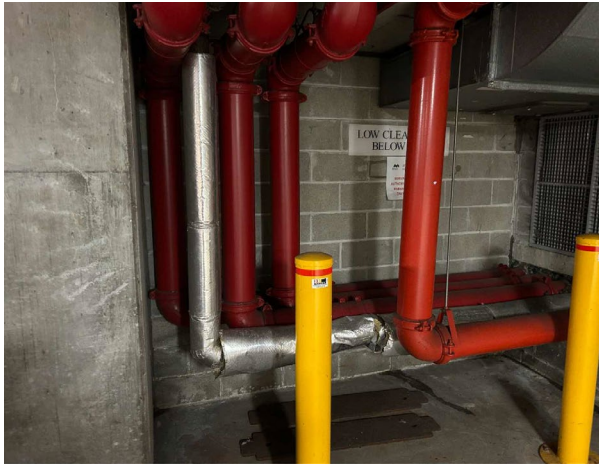
Line ID 15: Internal, B4, Carpark, Parking Space 1, Pipework, Insulation Material - Suspected SMF

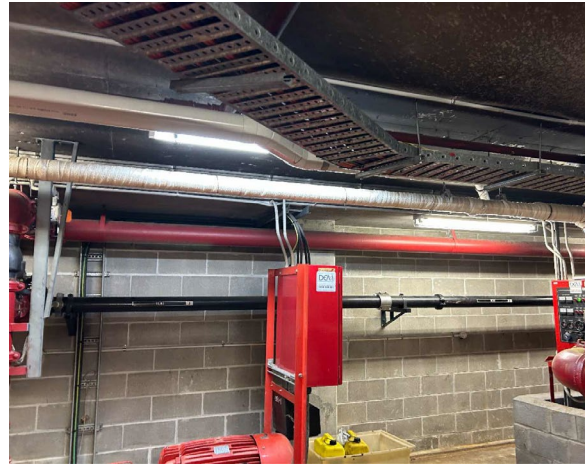
Line ID 16: Internal, B4, Hydrant Pump Room, Pump Exhaust Pipes, Insulation Material - Suspected SMF

Internal	B4 / Hydrant Pump Room / Pump Exhaust Pipes	Insulation Material	SMF	754-SYDEN364426 80 Pacific Hwy339S15	Suspected SMF	-	6 m	-	Very Low	-	Maintain in current condition if to remain in-situ. Remove under controlled SMF conditions as per the Code of Practice for the Safe Use of Synthetic Mineral Fibres [NOHSC: 2006 (1990)].	16
Internal	B4-B1 / Carpark / Ductwork, Internal Lining	Insulation Material	SMF	754-SYDEN364426 80 Pacific Hwy339S12	Suspected SMF	-	400 m ²	-	Very Low	-	Maintain in current condition if to remain in-situ. Remove under controlled SMF conditions as per the Code of Practice for the Safe Use of Synthetic Mineral Fibres [NOHSC: 2006 (1990)].	17

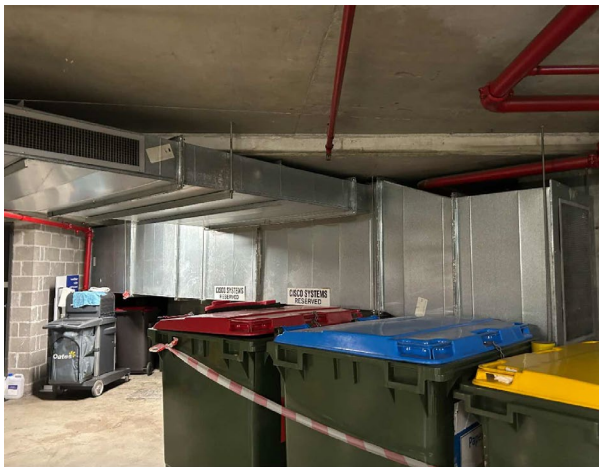
Line ID 17: Internal, B4-B1, Carpark, Ductwork, Internal Lining, Insulation Material - Suspected SMF

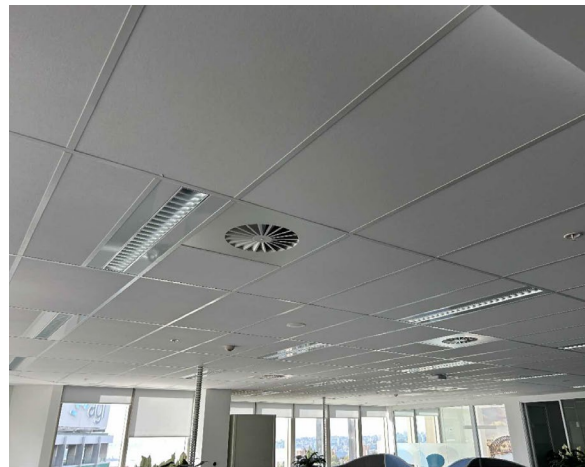
Line ID 18: Internal, L1-14, Office Areas, Ceiling, Compressed Ceiling Tiles - Suspected SMF

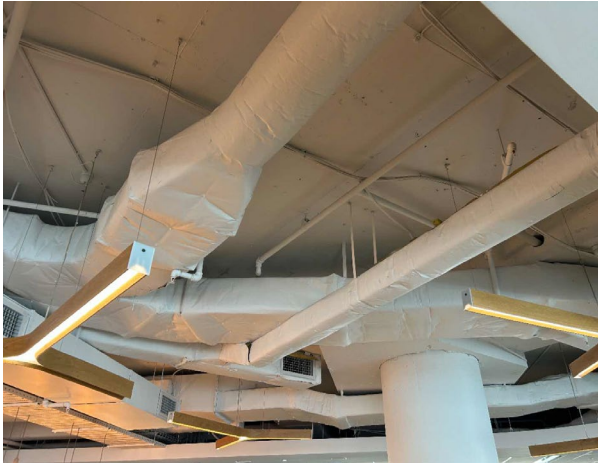
Line ID 19: Internal, L1-14, Office Areas, Ceiling Space, Ductwork, Insulation Material - Suspected SMF

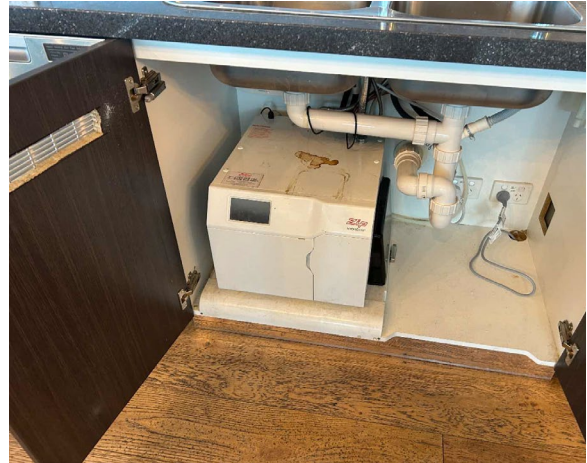
Line ID 20: Internal, L1-14, Office Areas, Kitchenettes, Water Heaters, Insulation Material - Suspected SMF

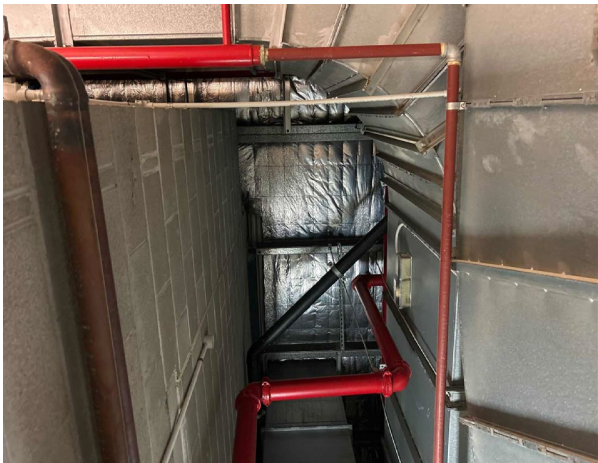
Line ID 21: Internal, L15, AHU Plant Room, Ceiling, Sarking Insulation - Suspected SMF

Internal	L15 / AHU Plant Room / Ceiling	Sarking Insulation	SMF	754-SYDEN364426 80 Pacific Hwy339S8	Suspected SMF	-	100 m ²	-	Very Low	-	Maintain in current condition if to remain in-situ. Remove under controlled SMF conditions as per the Code of Practice for the Safe Use of Synthetic Mineral Fibres [NOHSC: 2006 (1990)].	21
Internal	L15 / Boiler Room / Boiler and Pipework	Insulation Material	SMF	754-SYDEN364426 80 Pacific Hwy339S4	Suspected SMF	-	8 m ²	-	Very Low	-	Maintain in current condition if to remain in-situ. Remove under controlled SMF conditions as per the Code of Practice for the Safe Use of Synthetic Mineral Fibres [NOHSC: 2006 (1990)].	22

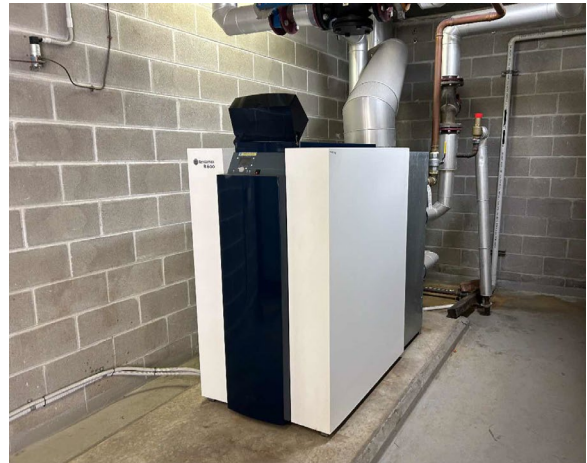
Line ID 22: Internal, L15, Boiler Room, Boiler and Pipework, Insulation Material - Suspected SMF

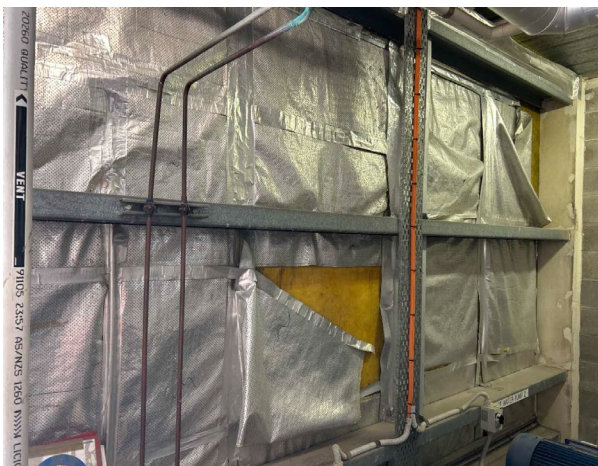
Line ID 23: Internal, L15, Boiler Room, Wall, Sarking Insulation - Suspected SMF

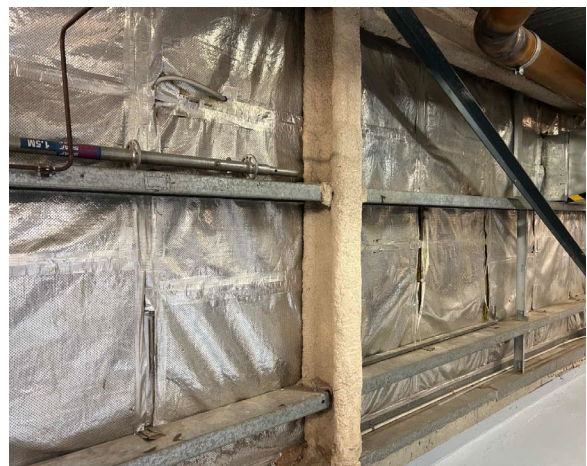
Line ID 24: Internal, L15, Chiller Room, Wall, Sarking Insulation - Suspected SMF

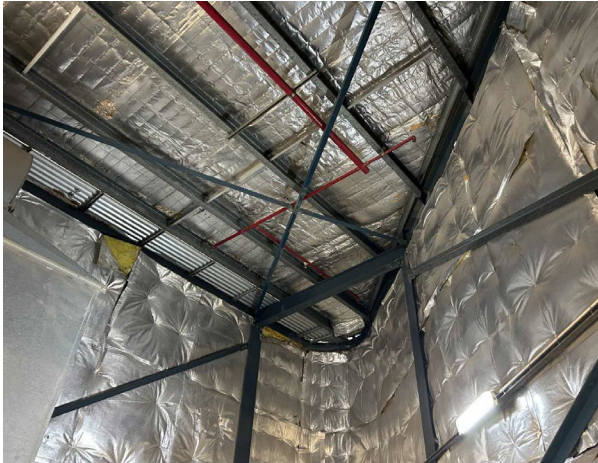
Line ID 25: Internal, L15, Generator Room, Ceiling and Walls, Sarking Insulation - Suspected SMF

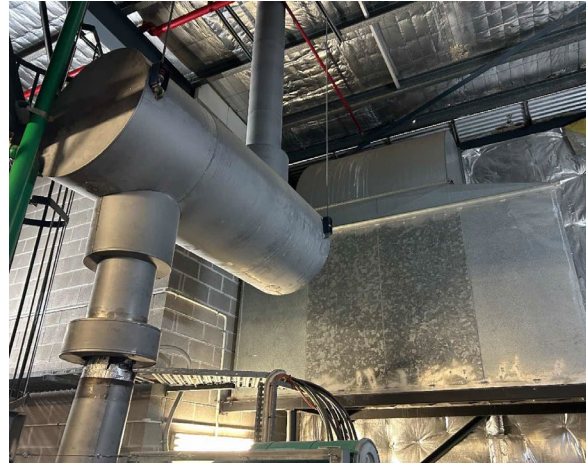
Line ID 26: Internal, L15, Generator Room, Generator Exhaust and Acoustic Baffles, Insulation Material - Suspected SMF

Internal	L15 / Generator Room / Generator Exhaust and Acoustic Baffles	Insulation Material	SMF	754-SYDEN364426 80 Pacific Hwy339S7	Suspected SMF	-	15 m ²	-	Very Low	-	Maintain in current condition if to remain in-situ. Remove under controlled SMF conditions as per the Code of Practice for the Safe Use of Synthetic Mineral Fibres [NOHSC: 2006 (1990)].	26
Internal	B1 / Carpark / Parking Space 13, AC Unit	R410A Hydrofluorocarbon (HFC)	ODS	754-SYDEN364426 80 Pacific Hwy339O2	Non ODS Refrigerant	-	1 Unit	-	-	-	Hydrofluorocarbon (HFC) non ozone depleting substances.	27

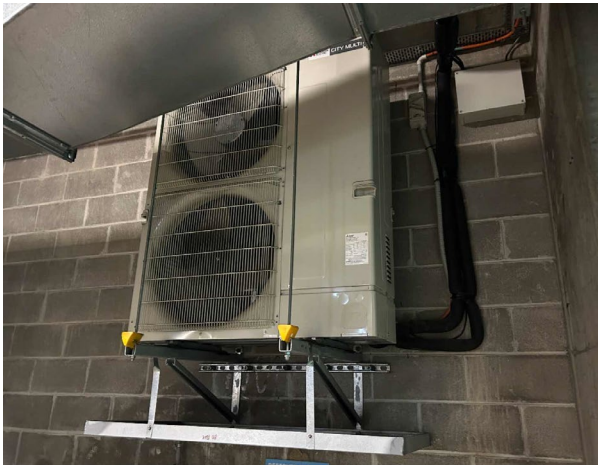
Line ID 27: Internal, B1, Carpark, Parking Space 13, AC Unit, R410A Hydrofluorocarbon (HFC) - Non ODS Refrigerant

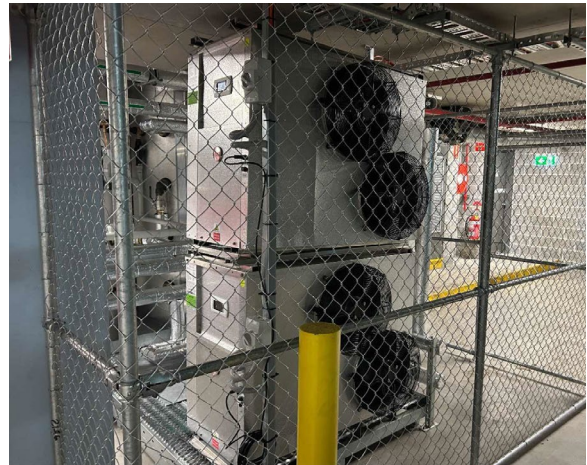
Line ID 28: Internal, B3, Carpark, Caged Area, AC Units, R1234yf - Non ODS Refrigerant

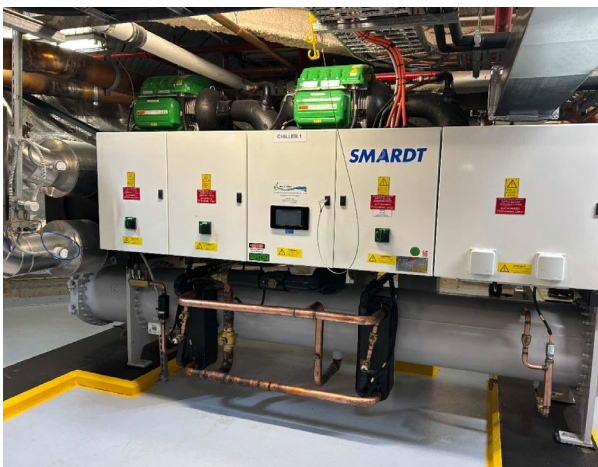
Line ID 29: Internal, L15, Chiller Room, Chillers, R1234ze Refrigerant - Non ODS Refrigerant
