Mirvac, 80 Pacific Highway, North Sydney, Air Shaft Report

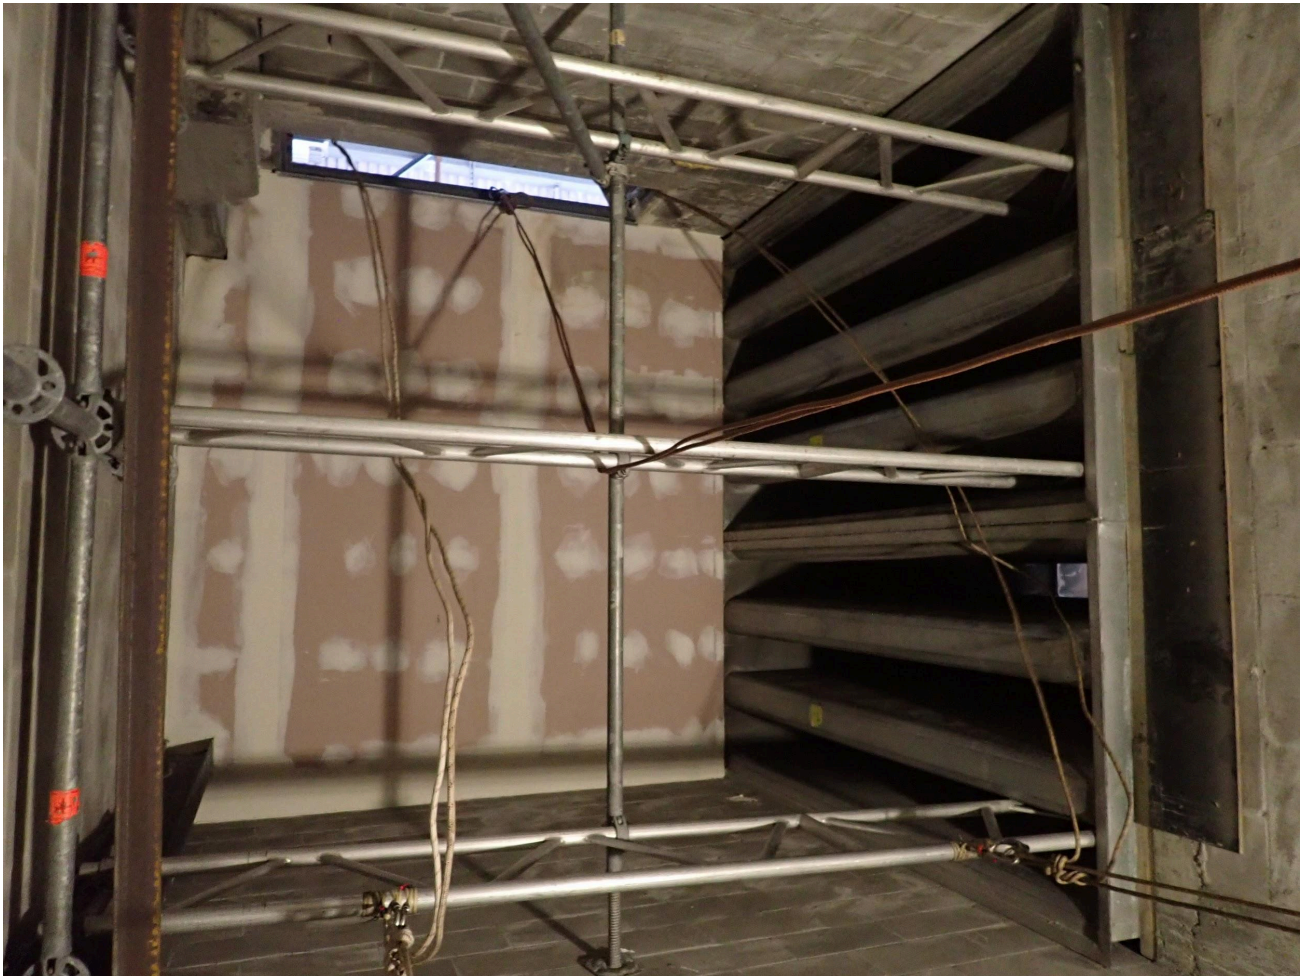
Client: Mirvac	Date: 040424	
Item: Air Shaft West side	Location: Level 13 West side	
Comment: Cat head scaffold inspection complete		
Inspector: JMR, TMN, ECN	Author: JMR

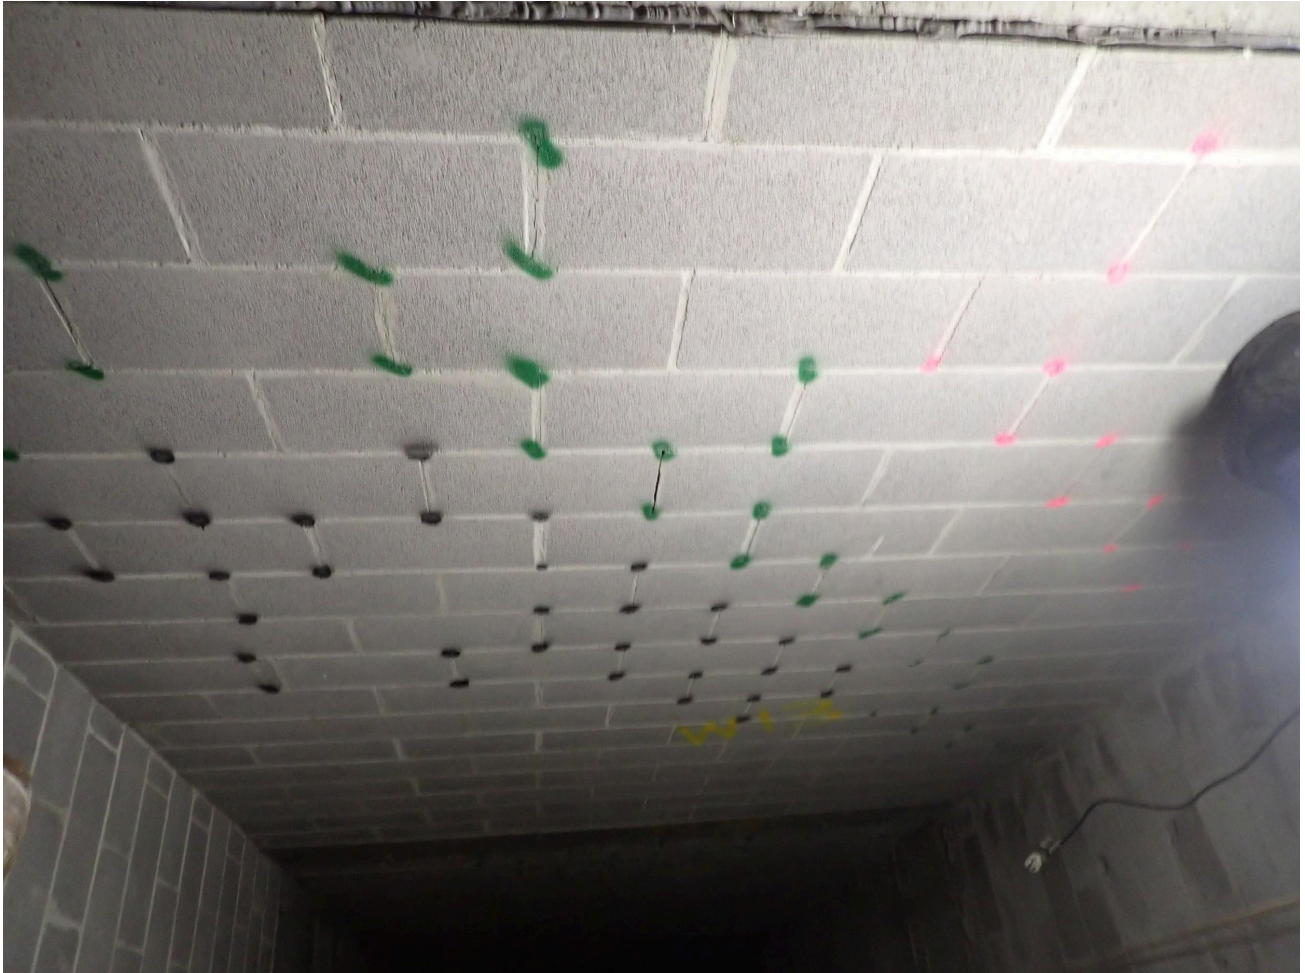
Location: Level 13 West side

Comment: Top view of wall west 13, no change to condition

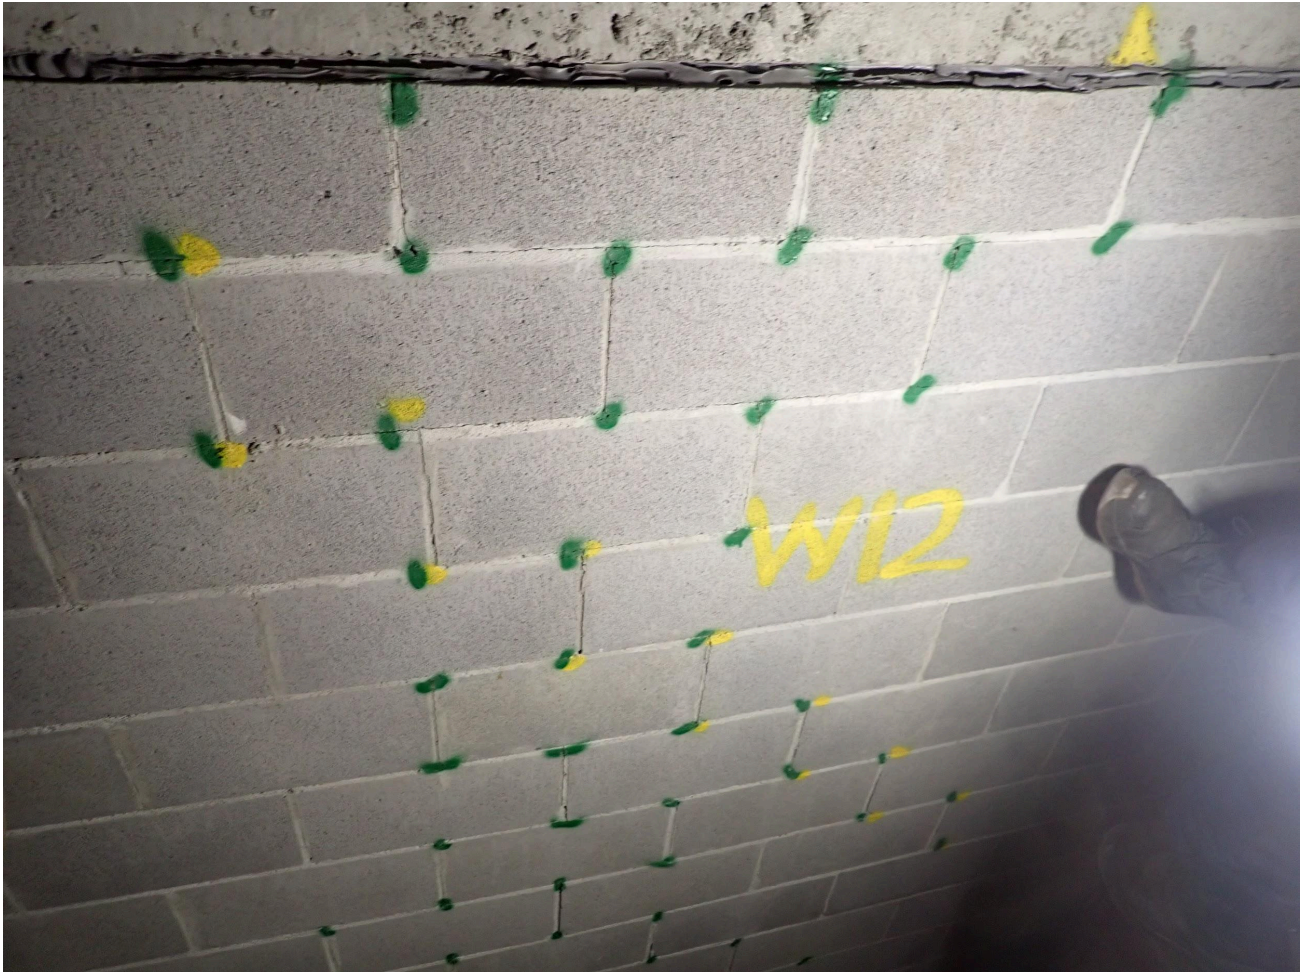
Location: Level 13 West side

Comment: Top view of wall west 12, no change to condition

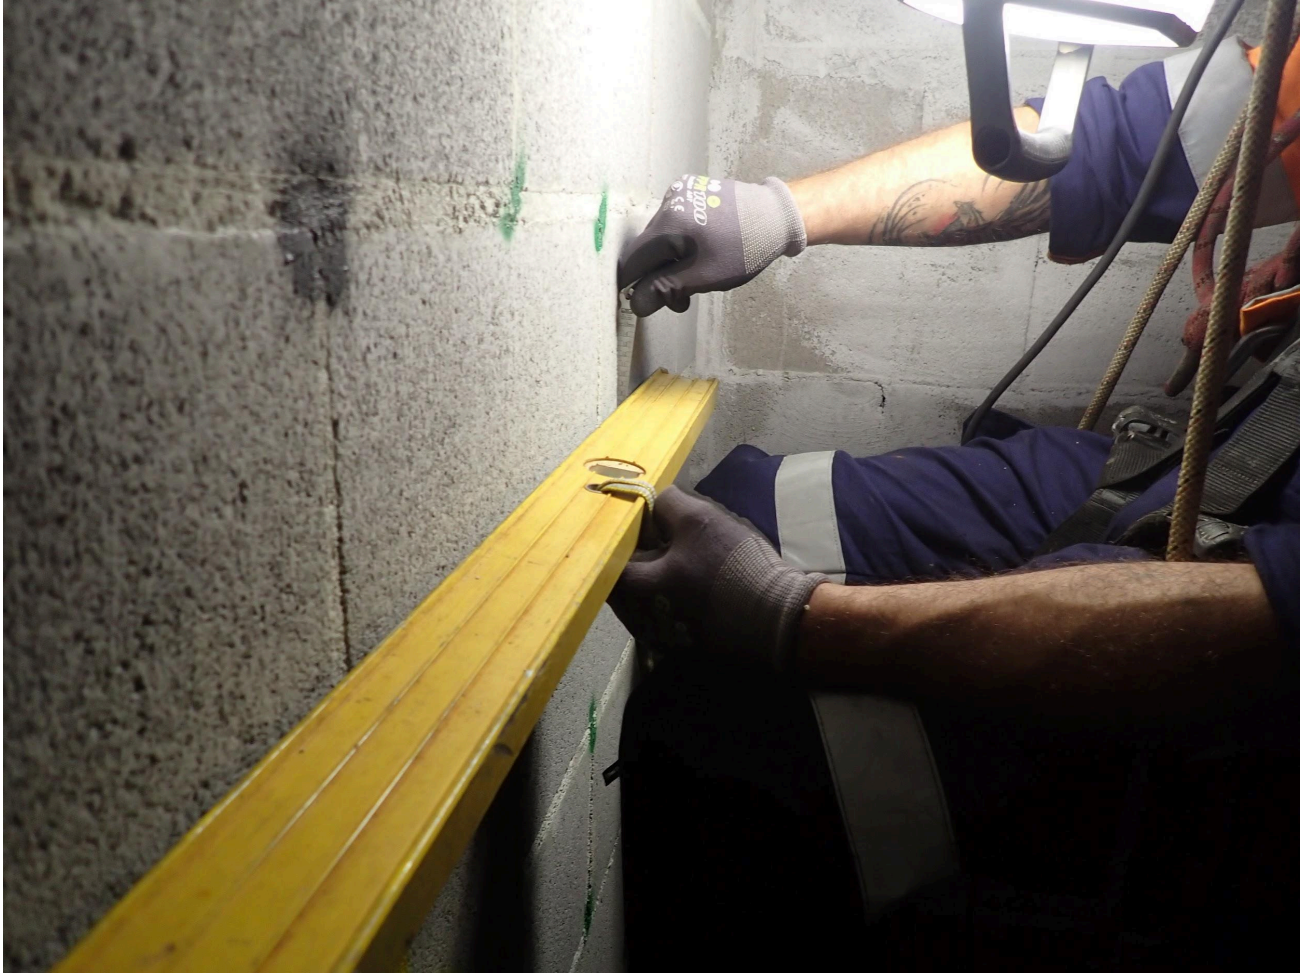
Location: Level 13 West side

Comment: View of wall west 12, no change to condition. Spirit level showing bellying of 12mm

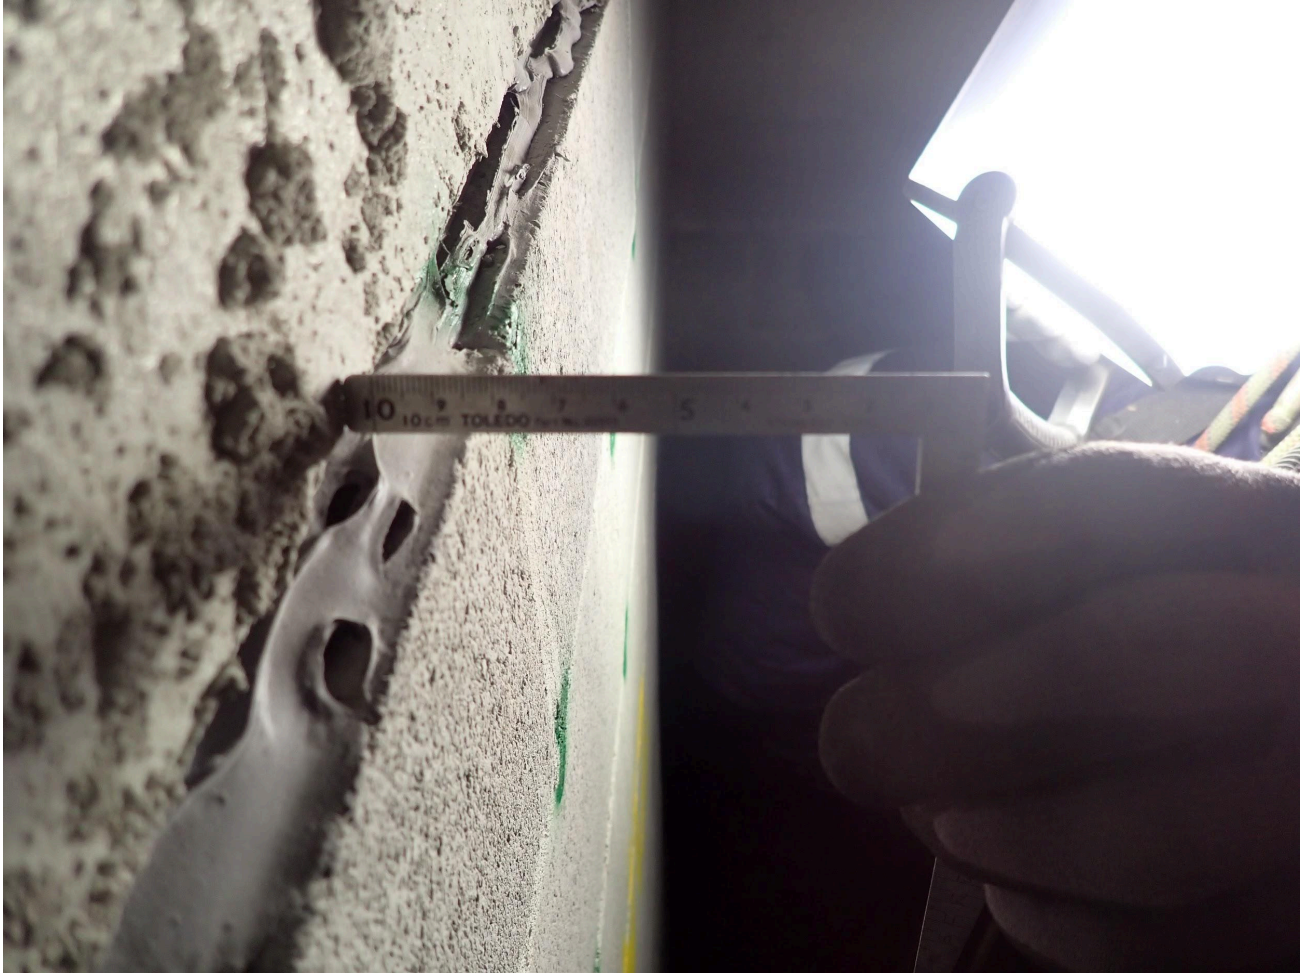
Client: Mirvac	Date: 040424	
Item: Air Shaft West side	Location: Level 13 West side	
Comment: Top of wall 12, misalignment from floor slab of 12mm		
Inspector: JMR, TMN, ECN	Author: JMR

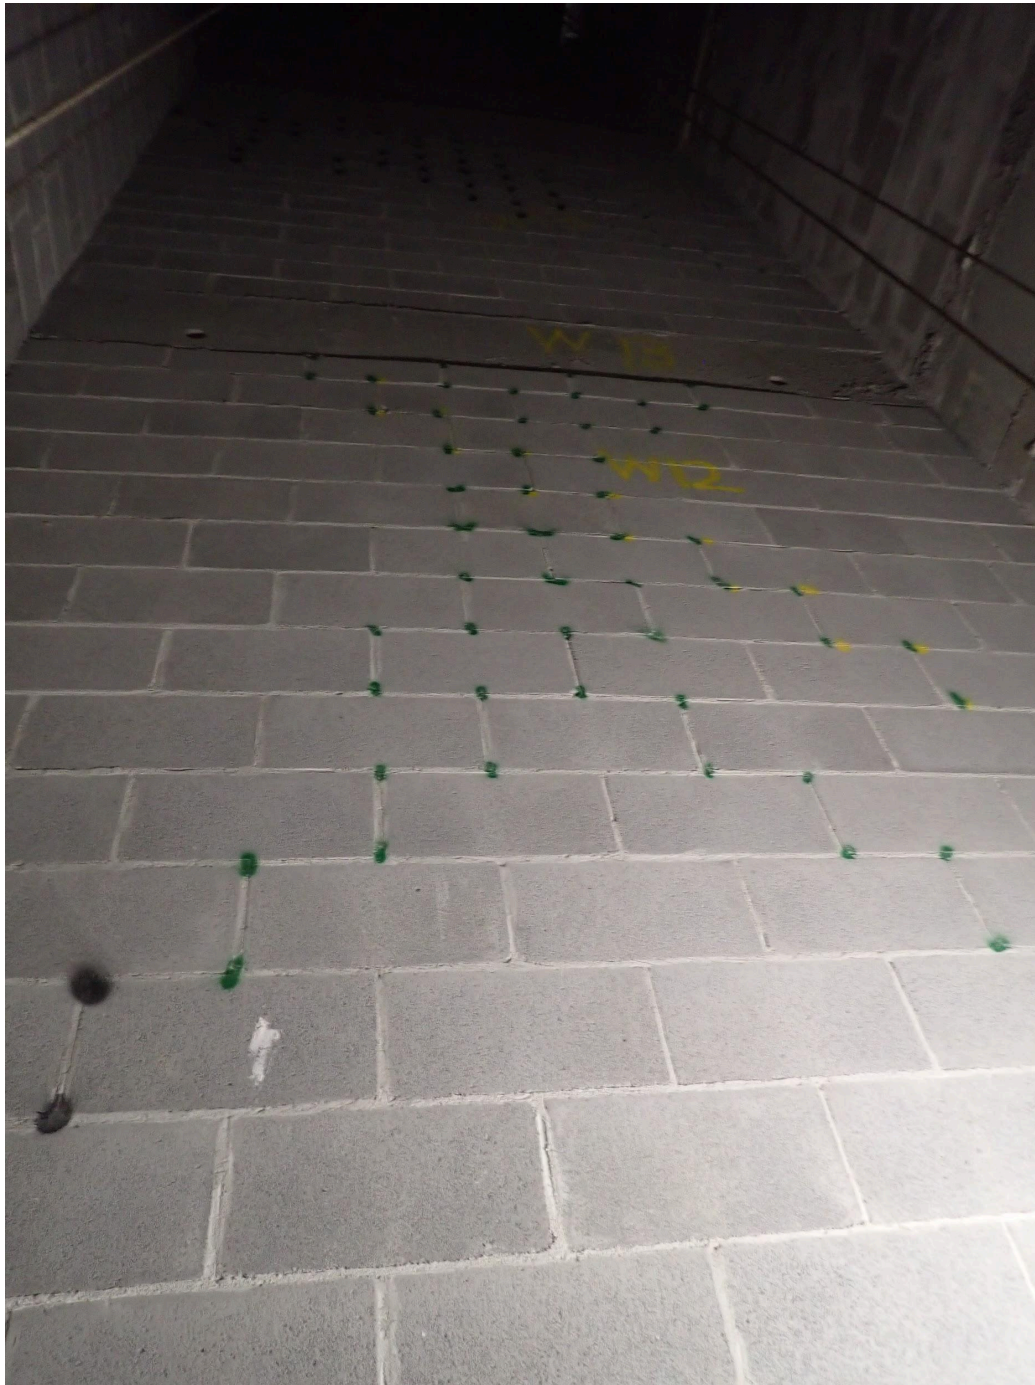
Client: Mirvac	Date: 040424	
Item: Air Shaft West side	Location: Level 13 West side	
Comment: Bottom view of wall 12 showing bellying		
Inspector: JMR, TMN, ECN	Author: JMR

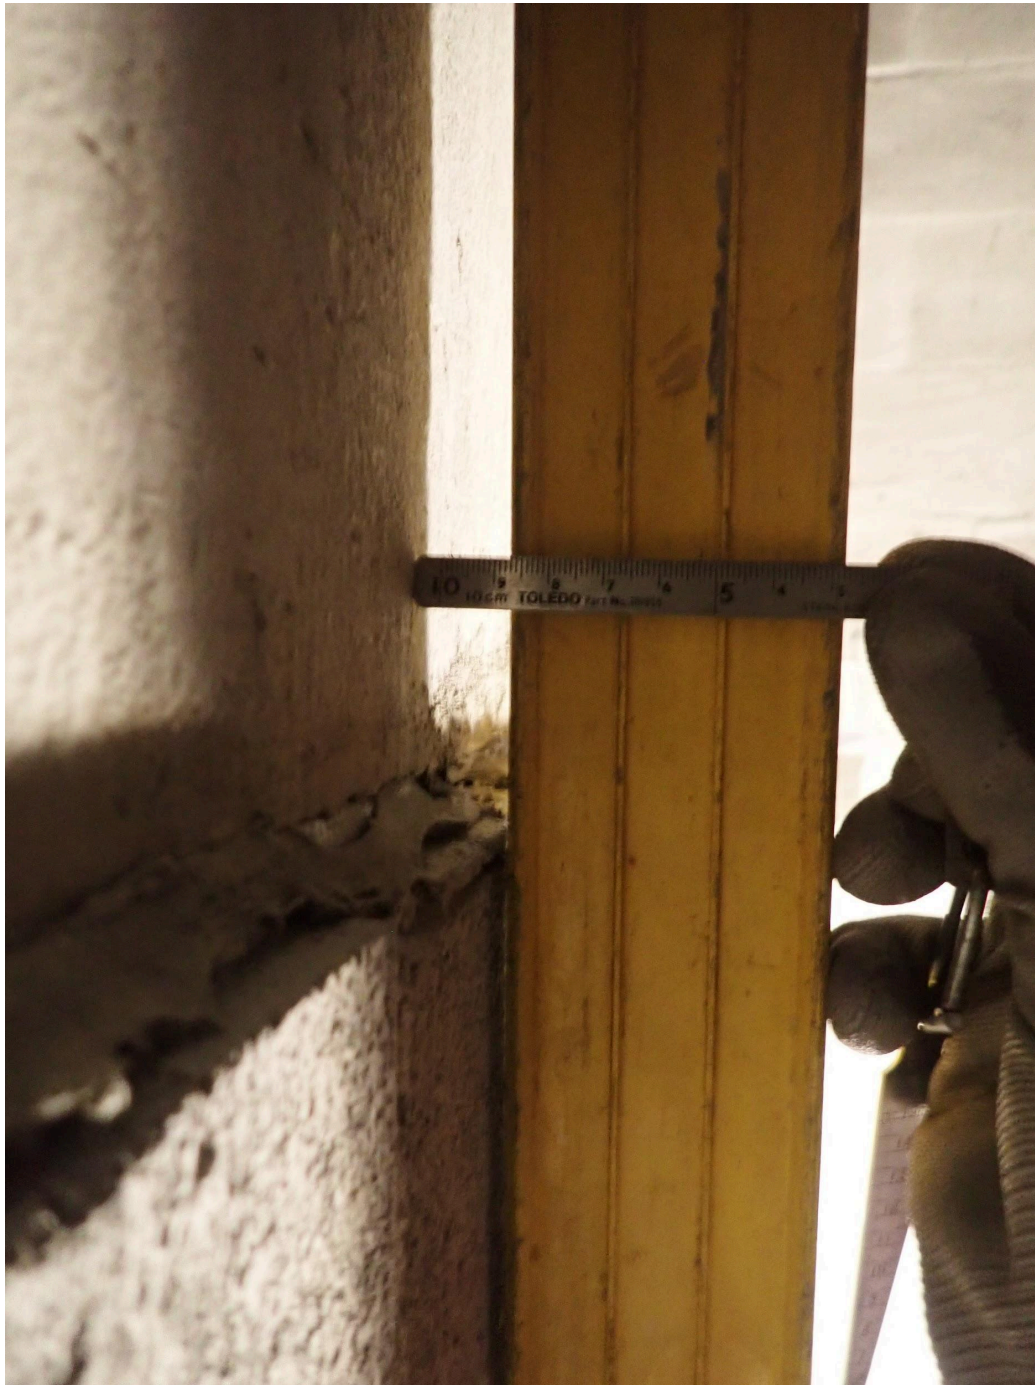
Location: Level 13 West side

Comment: Wall west 6 showing misalignment between slab and wall

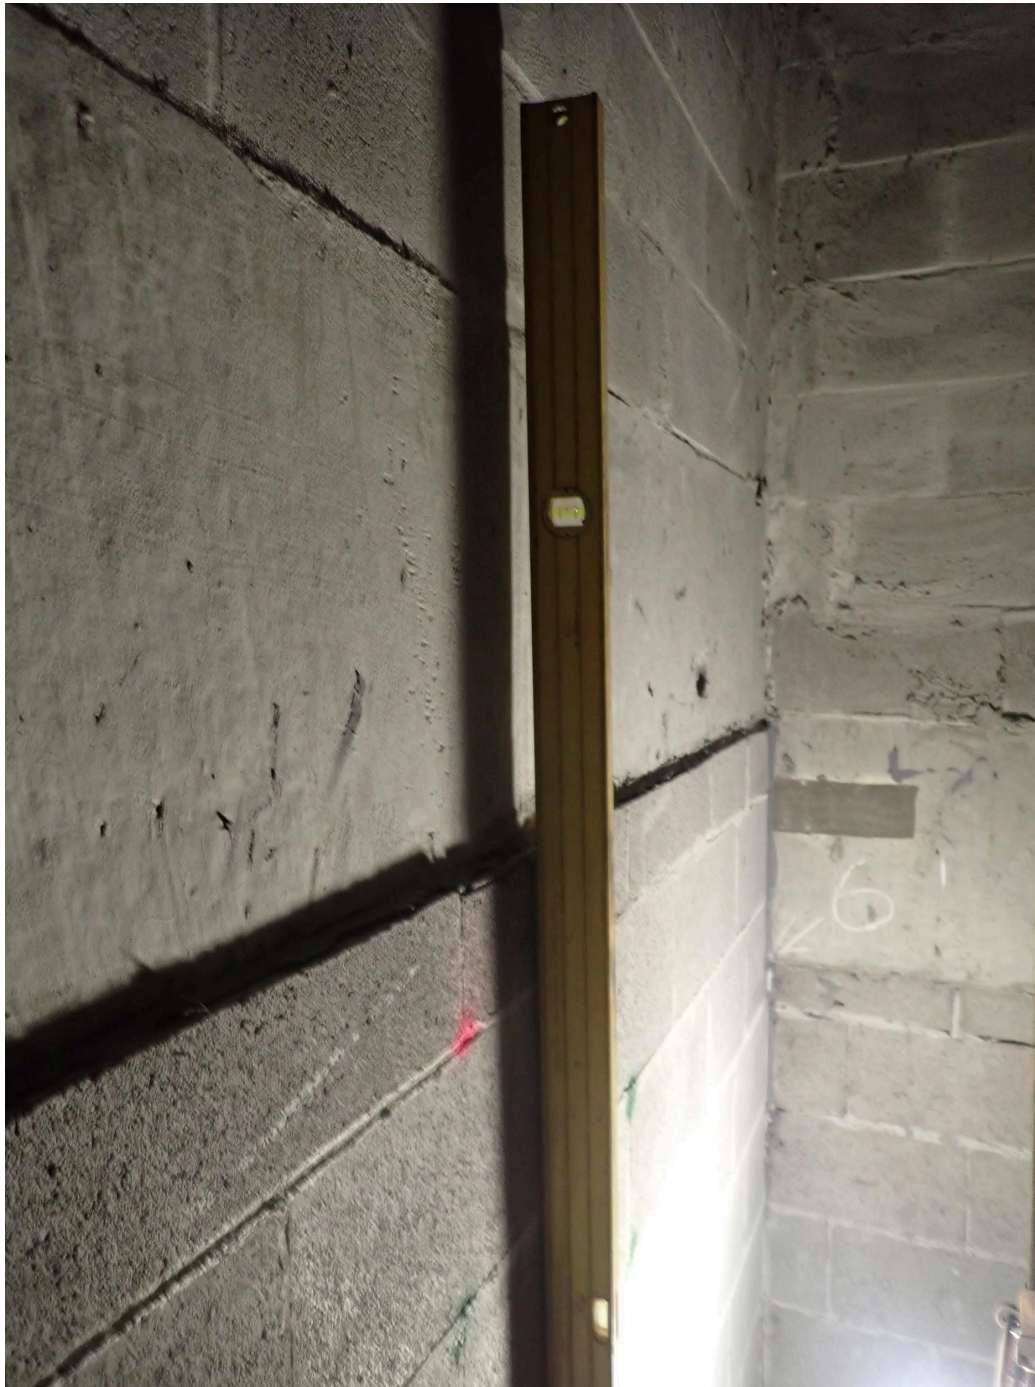
Location: Level 13 West side

Comment: Same as above

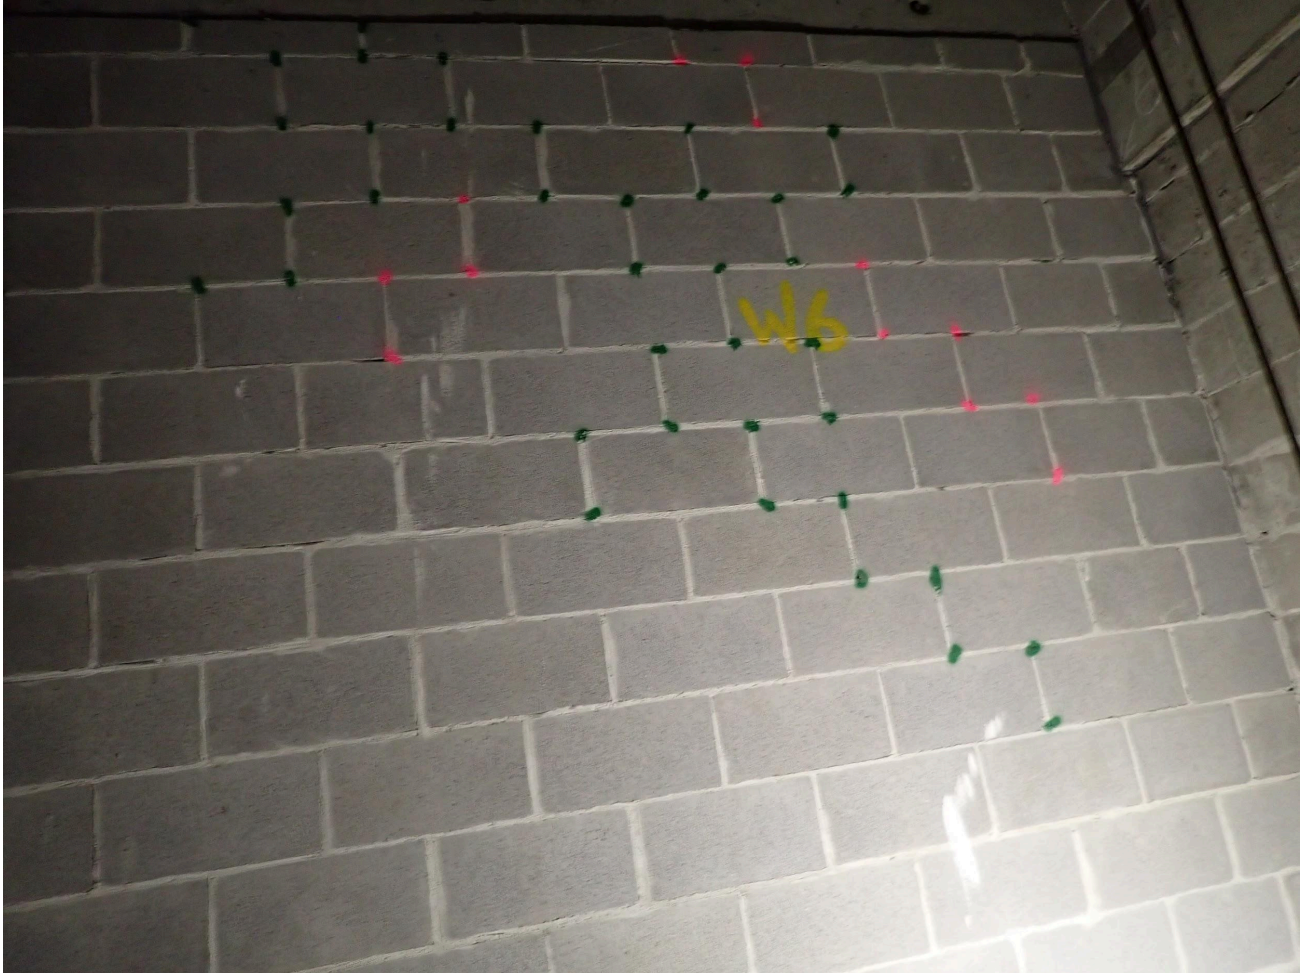
Location: Level 13 West side

Comment: View of wall west 6, no change to condition

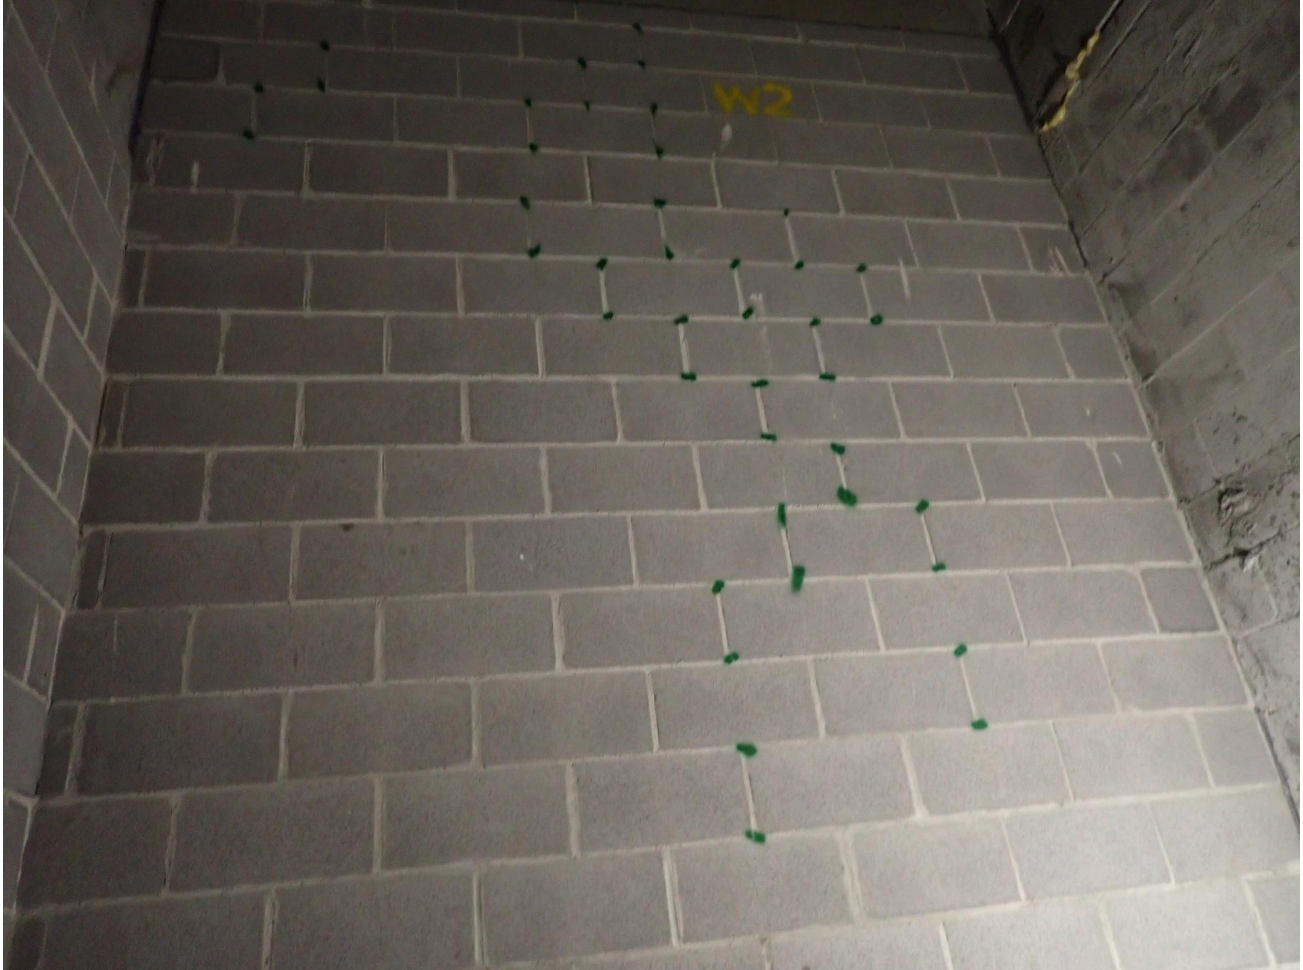
Location: Level 13 West side

Comment: View of wall west 2, no change to condition
