Mirvac Real Estate Pty Ltd

**Asbestos and Hazardous Materials
Re-Inspection**

80 Pacific Highway
North Sydney NSW 2060

18 May 2020

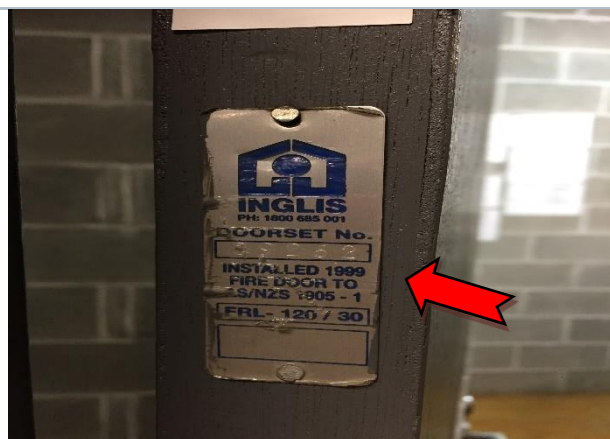
Photo 1 Interior: all levels, fire door – suspected asbestos containing fire door core.

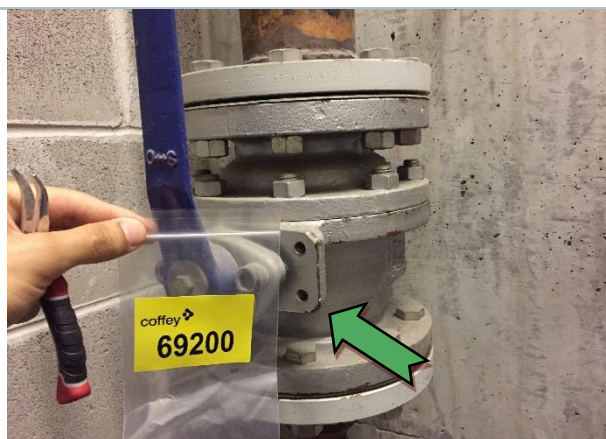
Photo 2 Interior: gas meter room, pipe work, blue gasket – no asbestos detected.

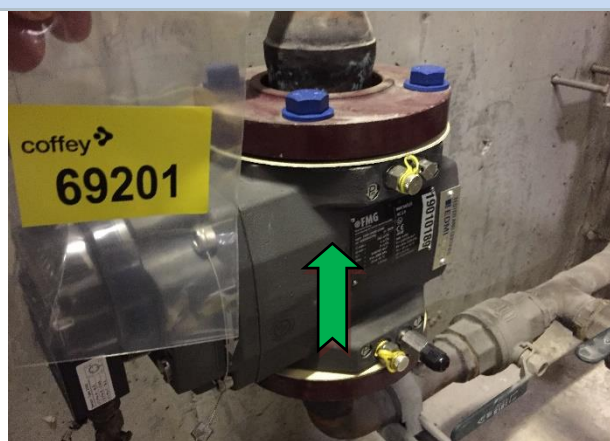
Photo 3 Interior: gas meter room, pipe work, white gasket – no asbestos detected.

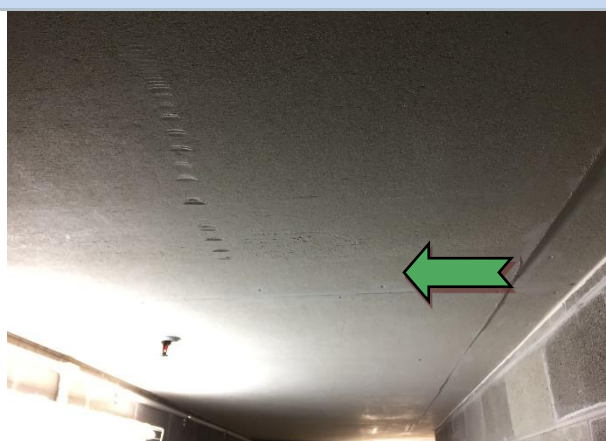
Photo 4 Interior: level 14, access corridor to cooling tower, ceiling insulation board – no asbestos detected.

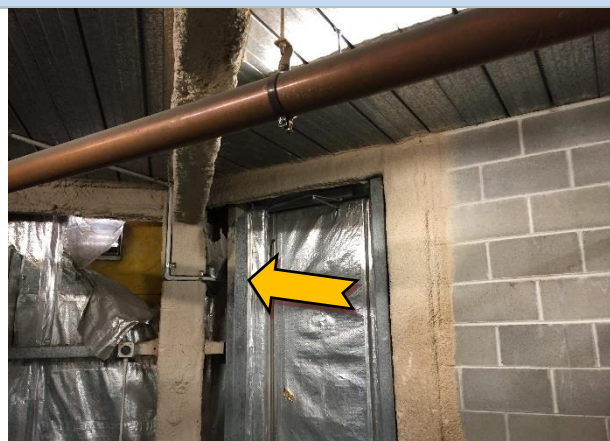
Photo 5 Interior: level 14, plant room, beams, vermiculite – no asbestos detected.

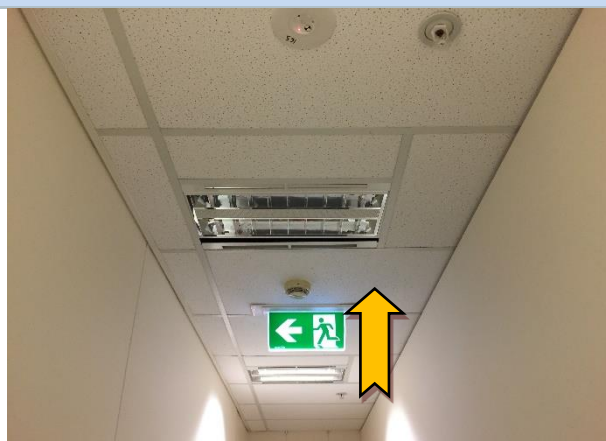
Photo 6 Interior: all levels, throughout, ceiling – suspected SMF containing compressed ceiling tiles.

Interior All levels	Throughout	Ceiling	Compressed Ceiling Tiles	SMF	Visual Observation	Suspected SMF	NA	NA	NA	Good	Sealed	Low	NA	NA	NA	NA	Low	Maintain in current condition if to remain in-situ. Remove under controlled SMF conditions as per the Code of Practice for the Safe Use of Synthetic Mineral Fibres [NOHSC: 2006 (1990)].	Throughout	-	6
Interior All levels	Throughout	Penetrations	Pillow insulation	SMF	Visual Observation	Suspected SMF	NA	NA	NA	Good	Sealed	Low	NA	NA	NA	NA	Low	Maintain in current condition if to remain in-situ. Remove under controlled SMF conditions as per the Code of Practice for the Safe Use of Synthetic Mineral Fibres [NOHSC: 2006 (1990)].	Throughout	-	7
Interior All levels	Throughout	Pipe work	Insulation material - external	SMF	Visual Observation	Suspected SMF	NA	NA	NA	Good	Sealed	Low	NA	NA	NA	NA	Low	Maintain in current condition if to remain in-situ. Remove under controlled SMF conditions as per the Code of Practice for the Safe Use of Synthetic Mineral Fibres [NOHSC: 2006 (1990)].	Throughout	-	8

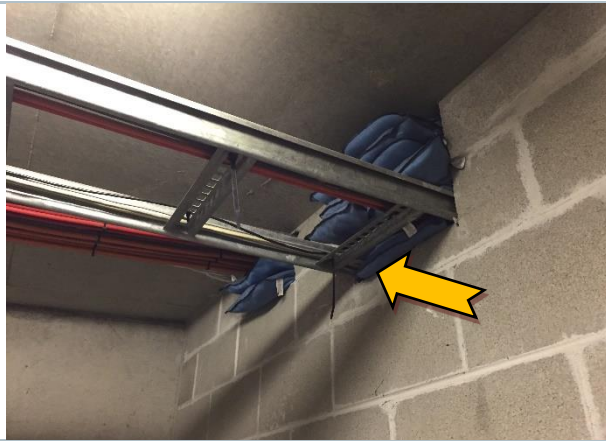
Photo 7 Interior: all levels, throughout, penetrations – suspected SMF containing pillow insulation.

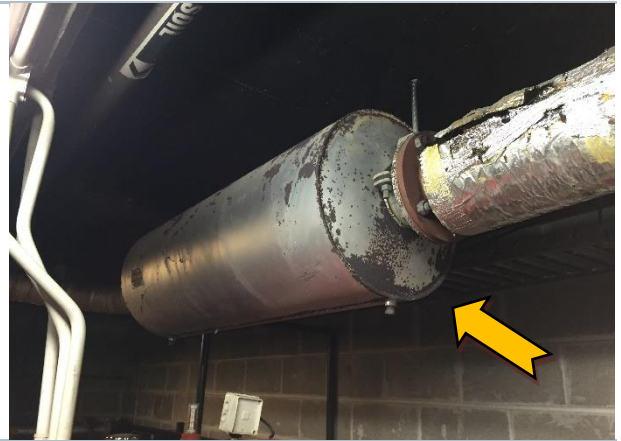
Photo 8 Interior: all levels throughout, pipe work – suspected SFM containing external insulation.

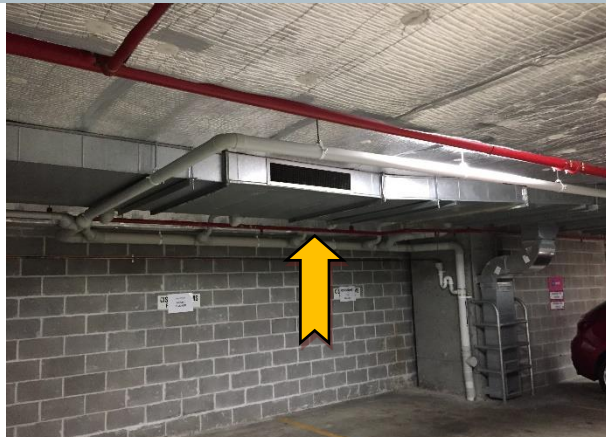
Photo 9 Interior: all levels, throughout, air conditioning ductwork – suspected SMF containing internal insulation.

Interior All levels	Throughout	Air conditioning ductwork	Insulation material - internal	SMF	Visual Observation	Suspected SMF	NA	NA	NA	Good	Sealed	Low	NA	NA	NA	NA	Low	Maintain in current condition if to remain in-situ. Remove under controlled SMF conditions as per the Code of Practice for the Safe Use of Synthetic Mineral Fibres [NOHSC: 2006 (1990)].	Throughout	-	9

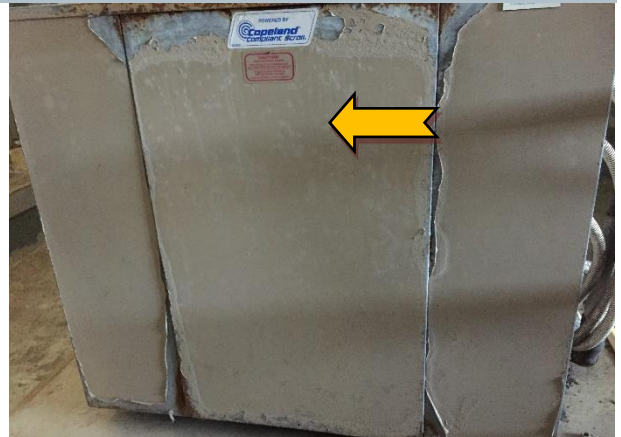
Photo 10 Interior: level 16, cooling tower area, air conditioning ductwork – non lead based grey paint.

Interior Level 16	Cooling tower area	Air conditioning ductwork	Grey - Top coat	Lead Paint - Chip	L07491	Lead Not Detected	-	-	-	-	-	-	-	-	-	-	-	-	-	-	10
No PCB's were identified or suspected top be present at the time of the survey
