# Asbestos & Hazardous Materials Survey

## AMP Capital

123 Pitt Street  
Sydney NSW

September 2021

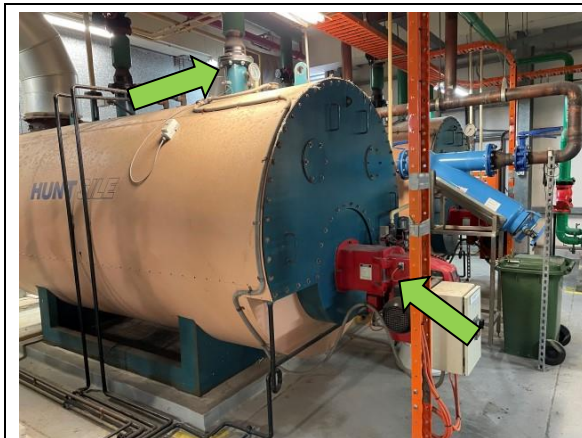
**Photo 1:** Level 34, Boiler Room, Boiler Motor & Pipe Work – Non-asbestos gaskets

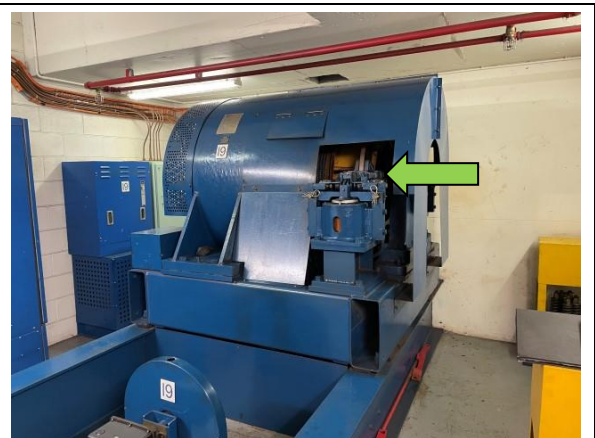
**Photo 2:** Level 32, High Rise Lift Motor Room, Lift Motor – Non-asbestos brake pads

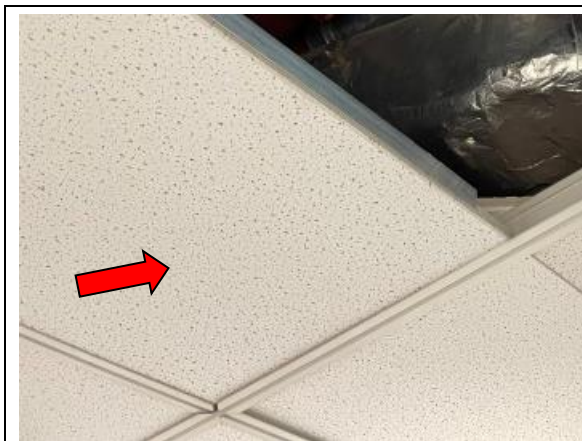
**Photo 7:** All Levels, Office Areas – SMF compressed ceiling tiles

| Location<br>Item Description | Photo No. | Form | Extent | Condition | Risk Status | Control Recommendations |
|---|---|---|---|---|---|---|
| Office areas<br>Ceiling - Compressed ceiling tiles | | Bonded | ~5,000m <sup>2</sup> | Good | Low | Maintain in good condition. Remove under controlled conditions prior to demolition/refurbishments |

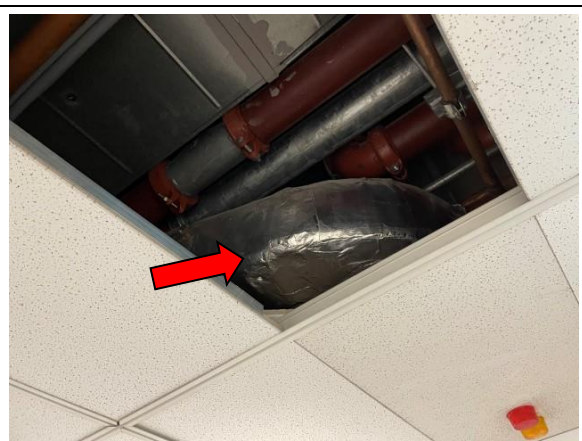
**Photo 8:** All Levels, Ceiling Space, Air Conditioning Duct Work – SMF insulation

| Location<br>Item Description | Photo No. | Form | Extent | Condition | Risk Status | Control Recommendations |
|---|---|---|---|---|---|---|
| Office areas<br>Ceiling Space - Air conditioning duct work | | Bonded | ~200m <sup>2</sup> | Good | Low | Maintain in good condition. Remove under controlled conditions prior to demolition/refurbishments |

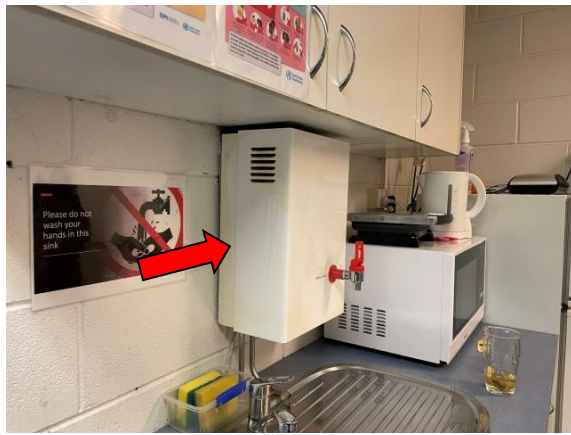
**Photo 9:** All Levels, Kitchenettes, Mini zip boilers – SMF internal insulation

| Location<br>Item Description | Photo No. | Form | Extent | Condition | Risk Status | Control Recommendations |
|---|---|---|---|---|---|---|
| Kitchenettes<br>Mini zip boilers – Internal insulation | | Bonded | ~30 units | Good | Low | Maintain in good condition. Remove under controlled conditions prior to demolition/refurbishments |

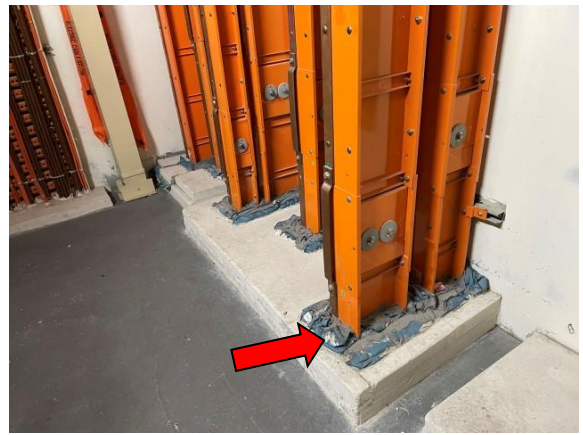
**Photo 10:** All Levels, Electrical penetrations – SMF pillow insulation

| Location<br>Item Description | Photo No. | Form | Extent | Condition | Risk Status | Control Recommendations |
|---|---|---|---|---|---|---|
| Riser Cupboards & Electrical Cupboards<br>Penetrations – Pillow insulation | | Bonded | ~2,000 units | Good | Low | Maintain in good condition. Remove under controlled conditions prior to demolition/refurbishments |

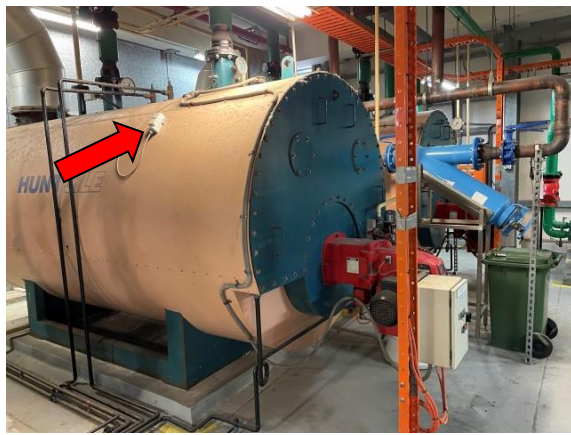
**Photo 11:** Level 34, Plant Room, Boiler – SMF internal insulation

| Location<br>Item Description | Photo No. | Form | Extent | Condition | Risk Status | Control Recommendations |
|---|---|---|---|---|---|---|
| Level 34, Plant Room, Boiler<br>Internal insulation | | Bonded | 2 units | Good | Low | Maintain in good condition. Remove under controlled conditions prior to demolition/refurbishments |

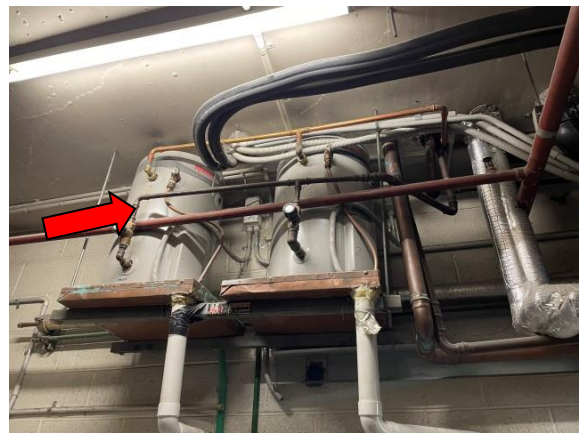
**Photo 12:** Lower Ground Level, Cleaners Store Room, Hot water heaters – SMF internal insulation

| Location<br>Item Description | Photo No. | Form | Extent | Condition | Risk Status | Control Recommendations |
|---|---|---|---|---|---|---|
| Lower Ground Level, Cleaners Store, Hot Water Heaters<br>Internal insulation | | Bonded | 4 units | Good | Low | Maintain in good condition. Remove under controlled conditions prior to demolition/refurbishments |
