COMPLIANCE HAZARDOUS MATERIAL RE-INSPECTION AND RISK ASSESSMENT

JANUARY 2023

Broadway Shopping Centre
1 Bay Street
Glebe NSW
2037

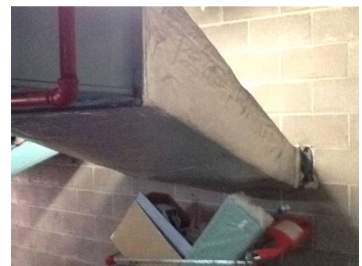
Location		Greek Street - Basement 1 - Air Conditioning Plant Room - Wall Penetration - Pillow Insulation - Insulation						
Hazard Type		SMF	Material Assessment		Disturbance Assessment			
Friability		Bonded	Product Type		-	Occupancy	-	
Sample No.		Visual	Extent of damage		-	Disturbance	-	
Result		Assumed Positive		Surface Treatment		-	Exposure	-
				Asbestos Type		-	Maintenance	-
Item Number		258		Material Score		-	Disturbance Score	-
				Priority Score		-	-

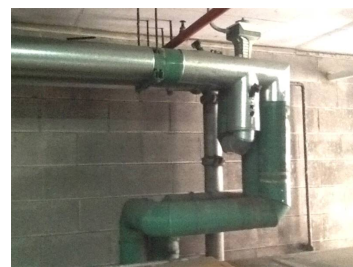
Location Greek Street - Basement 1 - Plant Room - Pipework - Insulation			
Hazard Type	SMF	Material Assessment	Disturbance Assessment
Friability	Bonded	Product Type	Occupancy
Sample No.	Visual	Extent of damage	Disturbance
Result	Assumed Positive	Surface Treatment	Exposure
		Asbestos Type	Maintenance
Item Number	260	Material Score	Disturbance Score
		Priority Score	-

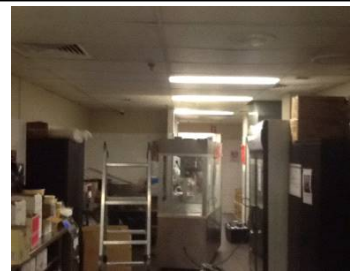
Location	Greek Street - Level 2 - Hoyts - Ceiling Space and Kitchen - Ductwork - Insulation		
Hazard Type	SMF	Material Assessment	Disturbance Assessment
Friability	Bonded	Product Type	Occupancy
Sample No.	Visual	Extent of damage	Disturbance
Result	Assumed Positive	Surface Treatment	Exposure
		Asbestos Type	Maintenance
Item Number	178	Material Score	Disturbance Score
		Priority Score	-

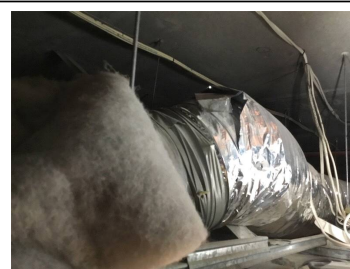
Location	Greek Street - Level 2 - Hoyts - Projection Room - Plant And Equipment - Ductwork - Insulation		
Hazard Type	SMF	Material Assessment	Disturbance Assessment
Friability	Bonded	Product Type	Occupancy
Sample No.	Visual	Extent of damage	Disturbance
Result	Assumed Positive	Surface Treatment	Exposure
		Asbestos Type	Maintenance
Item Number	189	Material Score	Disturbance Score
		Priority Score	-

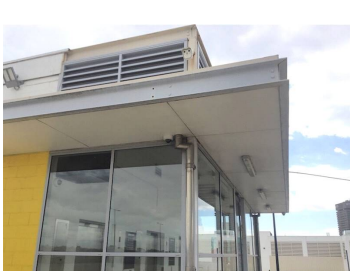
Hazard Type	Lead Paint	Material Assessment	Disturbance Assessment	
Friability	-	Product Type	-	
Sample No.	Greencap J131662-001-BWAY-LP-001 {AQ001516}	Extent of damage	-	
Result	Positive	Surface Treatment	-	
		Asbestos Type	-	
Item Number	199	Material Score	-	
		Priority Score	-

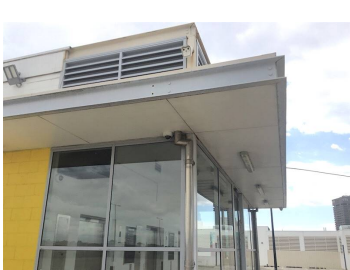
Hazard Type	Asbestos	Material Assessment	Disturbance Assessment	
Friability	Non-friable	Product Type	1	
Sample No.	Visual	Extent of damage	0	
Result	Assumed Positive Unknown or Crocidolite	Surface Treatment	1	
		Asbestos Type	3	
Item Number	200	Material Score	5	
		Priority Score	9

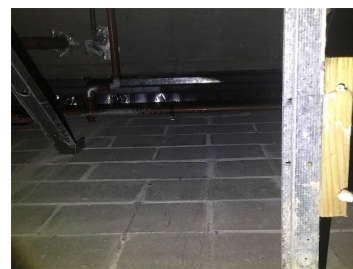
Location Greek Street - Level 4 - Air Handling Unit Plant Room - Pipework - Insulation			
Hazard Type	SMF	Material Assessment	Disturbance Assessment
Friability	Bonded	Product Type	Occupancy -
Sample No.	Visual	Extent of damage	Disturbance -
Result	Assumed Positive	Surface Treatment	Exposure -
		Asbestos Type	Maintenance -
Item Number	202	Material Score	Disturbance Score -
		Priority Score	-

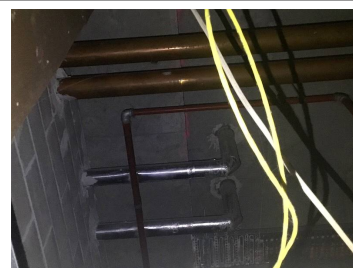
Location Greek Street - Level 4 - Exhaust Fan Room - Roof Lining - Sarking - Insulation			
Hazard Type	SMF	Material Assessment	Disturbance Assessment
Friability	Bonded	Product Type	Occupancy -
Sample No.	Visual	Extent of damage	Disturbance -
Result	Assumed Positive	Surface Treatment	Exposure -
		Asbestos Type	Maintenance -
Item Number	203	Material Score	Disturbance Score -
		Priority Score	-

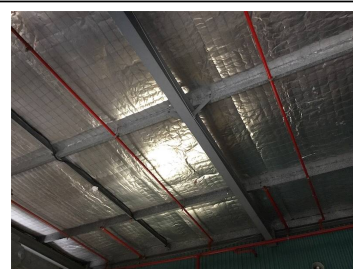
Location Greek Street - Level 4 - Plant Room - Pipework - Insulation			
Hazard Type	SMF	Material Assessment	Disturbance Assessment
Friability	Bonded	Product Type	Occupancy -
Sample No.	Visual	Extent of damage	Disturbance -
Result	Assumed Positive	Surface Treatment	Exposure -
		Asbestos Type	Maintenance -
Item Number	206	Material Score	Disturbance Score -
		Priority Score	-

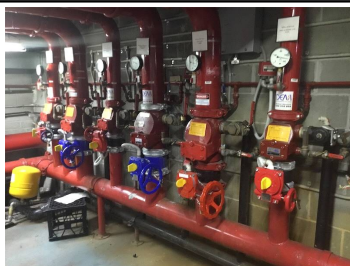
Location		Main Building - 1. Basement Level - Carpark - Hydrant booster sprinkler booster- pipeline - Gasket - Live plant									
Hazard Type		Asbestos		Material Assessment		Disturbance Assessment					
Friability		Non-friable		Product Type		2		Occupancy		0	
Sample No.		Visual		Extent of damage		0		Disturbance		1	
Result		Assumed Positive Amosite		Surface Treatment		0		Exposure		0	
				Asbestos Type		2		Maintenance		0	
Item Number		165		Material Score		4		Disturbance Score		1	
				Priority Score		5		Very Low

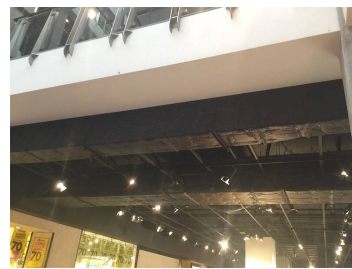
Location		Main Building - 3. Ground Level - All Tenancy Areas - Ceiling Space - Flexible Ductwork - Insulation	
Hazard Type	SMF	Material Assessment	Disturbance Assessment
Friability	Bonded	Product Type	-
Sample No.	Visual	Extent of damage	-
Result	Assumed Positive	Surface Treatment	-
		Asbestos Type	-
Item Number	251	Material Score	-
		Priority Score	-

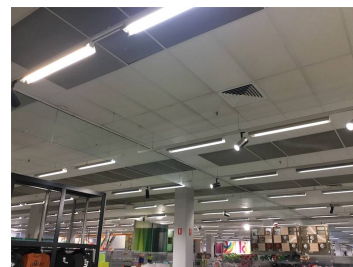
Location		Main Building - 4. Level 1 - Kmart - Back of House - Ceiling Ductwork - Insulation	
Hazard Type	SMF	Material Assessment	Disturbance Assessment
Friability	Bonded	Product Type	-
Sample No.	Visual	Extent of damage	-
Result	Assumed Positive	Surface Treatment	-
		Asbestos Type	-
Item Number	129	Material Score	-
		Priority Score	-

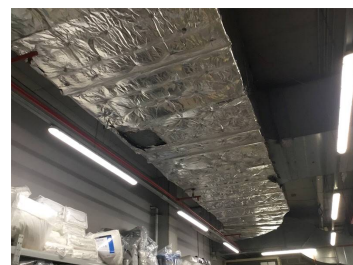
Location		Main Building - 4. Level 1 - Kmart - Back of House - Southwest Plant Room - Ductwork - Insulation	
Hazard Type	SMF	Material Assessment	Disturbance Assessment
Friability	Bonded	Product Type	-
Sample No.	Visual	Extent of damage	-
Result	Assumed Positive	Surface Treatment	-
		Asbestos Type	-
Item Number	134	Material Score	-
		Priority Score	-

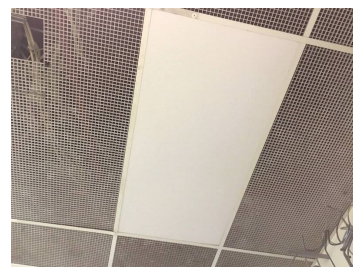
Location		Main Building - 5. Level 2 - Common Area - Ceiling Space - Roof Lining - Sarking Insulation - Insulation Materials	
Hazard Type	SMF	Material Assessment	Disturbance Assessment
Friability	Bonded	Product Type	-
Sample No.	Visual	Extent of damage	-
Result	Assumed Positive	Surface Treatment	-
		Asbestos Type	-
Item Number	272	Material Score	-
		Priority Score	-

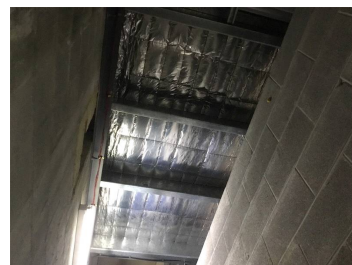
Location	Main Building - 7, Level 3 - Ceiling Space - Ductwork - Insulation		
Hazard Type	SMF	Material Assessment	Disturbance Assessment
Friability	Bonded	Product Type	Occupancy
Sample No.	Visual	Extent of damage	Disturbance
Result	Assumed Positive	Surface Treatment	Exposure
		Asbestos Type	Maintenance
Item Number	254	Material Score	Disturbance Score
		Priority Score	-

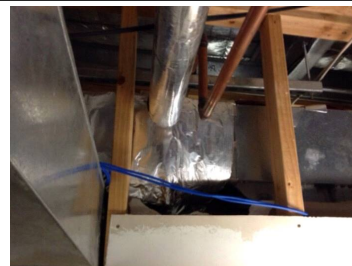
Location	Main Building - 7, Level 3 - Exterior - Perimeter - Wall Cavity - Sarking - Insulation		
Hazard Type	SMF	Material Assessment	Disturbance Assessment
Friability	Bonded	Product Type	Occupancy
Sample No.	Visual	Extent of damage	Disturbance
Result	Assumed Positive	Surface Treatment	Exposure
		Asbestos Type	Maintenance
Item Number	84	Material Score	Disturbance Score
		Priority Score	-

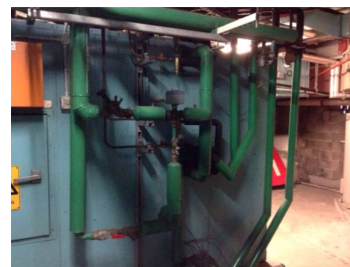
Location		Main Building - 7. Level 3 - Target - Back of House - Staff Room - Plant Room AHU10/2 - Southeast Ductwork - Insulation	
Hazard Type	SMF	Material Assessment	Disturbance Assessment
Friability	Bonded	Product Type	- Occupancy
Sample No.	Visual	Extent of damage	- Disturbance
Result	Assumed Positive	Surface Treatment	- Exposure
		Asbestos Type	- Maintenance
Item Number	101	Material Score	- Disturbance Score
		Priority Score	-

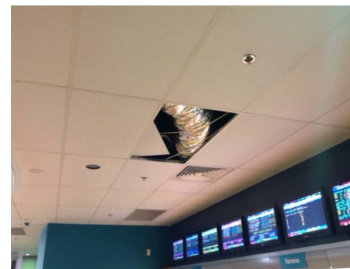
Location		Main Building - 2. Lower Ground Level - Tenancy - TAB - Ceiling - Compressed ceiling tiles - Insulation	
Hazard Type	SMF	Material Assessment	Disturbance Assessment
Friability	Bonded	Product Type	-
Sample No.	Visual	Extent of damage	-
Result	Assumed Positive	Surface Treatment	-
		Asbestos Type	-
Item Number	248	Material Score	-
		Priority Score	-

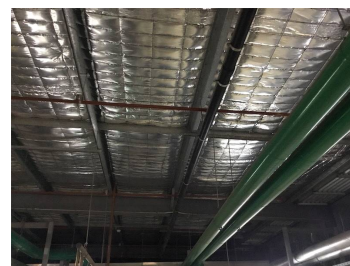
Location	Main Building - 8. Roof - Plant Room - Wall - Sarking - Insulation		
Hazard Type	SMF	Material Assessment	Disturbance Assessment
Friability	Bonded	Product Type -	Occupancy -
Sample No.	Visual	Extent of damage -	Disturbance -
Result	Assumed Positive	Surface Treatment -	Exposure -
		Asbestos Type -	Maintenance -
Item Number	73	Material Score -	Disturbance Score -
		Priority Score -	-

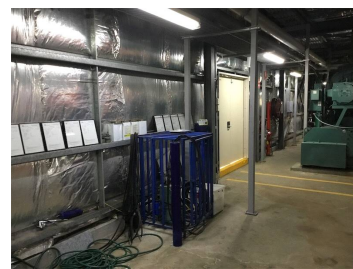
Location		Model & Maxham Building - 2. Ground Level - Common Area - Ceiling - A/C Heater Unit - Millboard Insulation - Live Plant			
Hazard Type	Asbestos	Material Assessment		Disturbance Assessment	
Friability	Friable	Product Type	2	Occupancy	1
Sample No.	Visual	Extent of damage	0	Disturbance	1
Result	Assumed Positive Unknown or Crocidolite	Surface Treatment	1	Exposure	3
		Asbestos Type	3	Maintenance	0
Item Number	1	Material Score	6	Disturbance Score	5
		Priority Score	11	Low

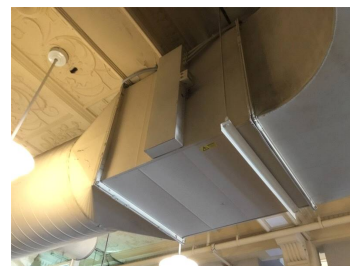
Location		Model & Maxham Building - 2. Ground Level - Common Area - Ceiling - Ductwork - Insulation			
Hazard Type	SMF	Material Assessment		Disturbance Assessment	
Friability	Bonded	Product Type	-	Occupancy	-
Sample No.	Visual	Extent of damage	-	Disturbance	-
Result	Assumed Positive	Surface Treatment	-	Exposure	-
		Asbestos Type	-	Maintenance	-
Item Number	2	Material Score	-	Disturbance Score	-
		Priority Score	-	-
