Asbestos & Hazardous Materials Management Plan

Mirvac

Greenwood Plaza &
101-103 Miller Street
North Sydney NSW

December 2020

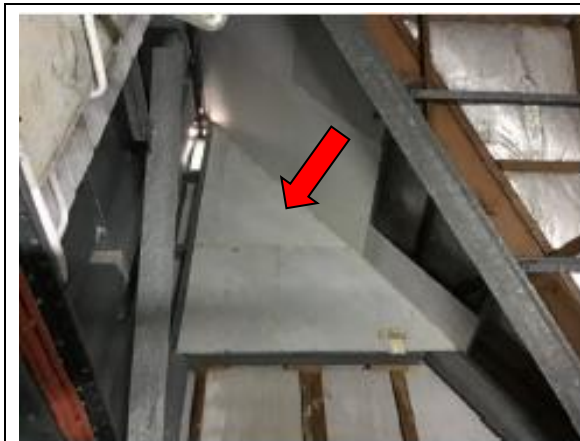
Greenwood Plaza, Level 7, Switch Room – Infill Panels fibre cement suspected to contain asbestos

The asbestos containing fibre cement products identified on site were in a stable condition and do not represent an increased health risk in their current condition and location.

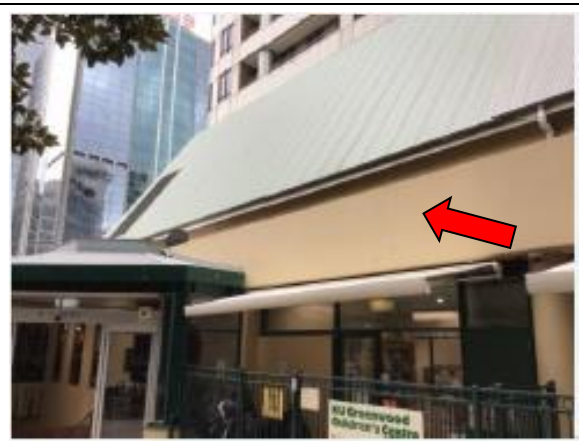
Greenwood Plaza, Roof Level – Fascia fibre cement suspected to contain asbestos

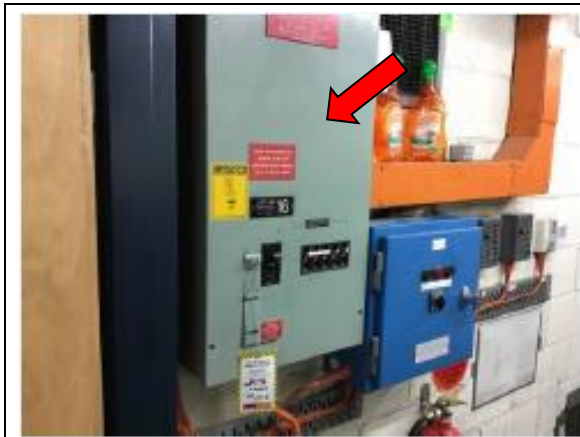
Greenwood Plaza, Level 7, Lift Motor Room – electrical backing board suspected to contain asbestos

The electrical backing boards identified on site do not represent an increased health risk in their current condition and location.

As with all contractors working on site, it is recommended that electricians attending site be made aware of the presence of the backing board.

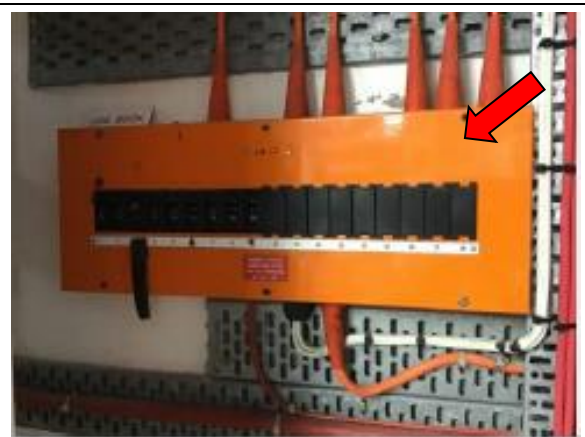
101 Miller Street, Ground Level, Sprinkler Valve Room – electrical backing board suspected to contain asbestos

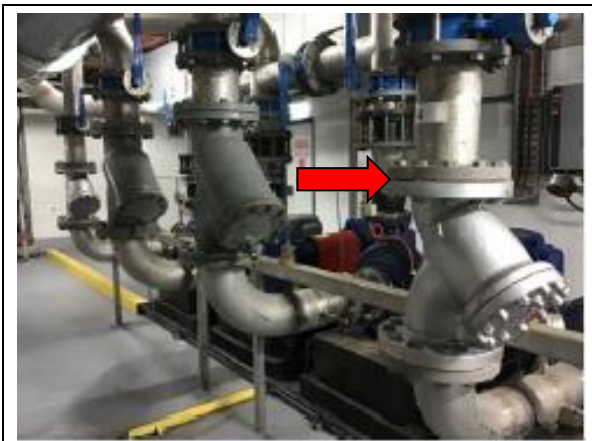
101 Miller Street, Level 8, Chiller Room – pipework gaskets throughout confirmed to contain asbestos

These materials should be replaced with non-asbestos alternatives during regular maintenance if they would be impacted upon. In most cases it is considered safe to leave them in-situ and remove them when decommissioning the item of plant.

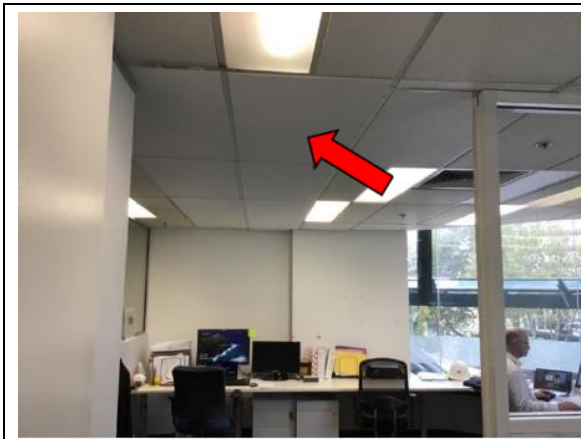
Example of bonded SMF material – compressed SMF ceiling tiles throughout office areas

The SMF material identified on site does not represent an increased risk in their current position and condition.

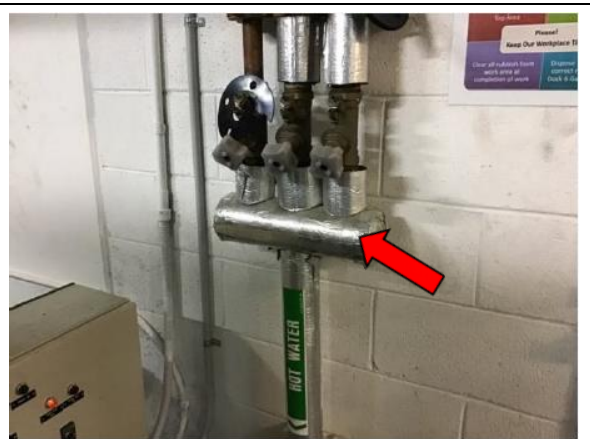
Throughout Building – SMF insulation to pipework

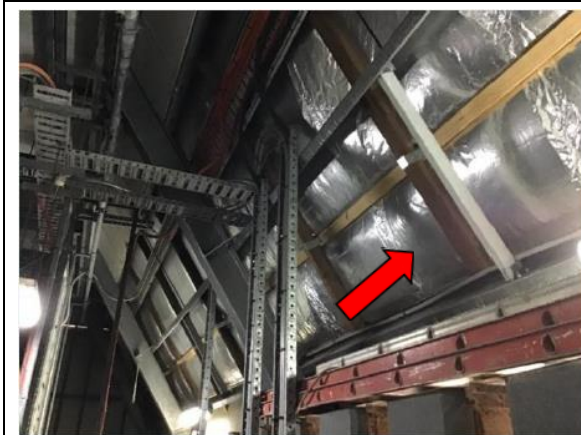
Plant Rooms – SMF insulation to ceiling (behind sarking)

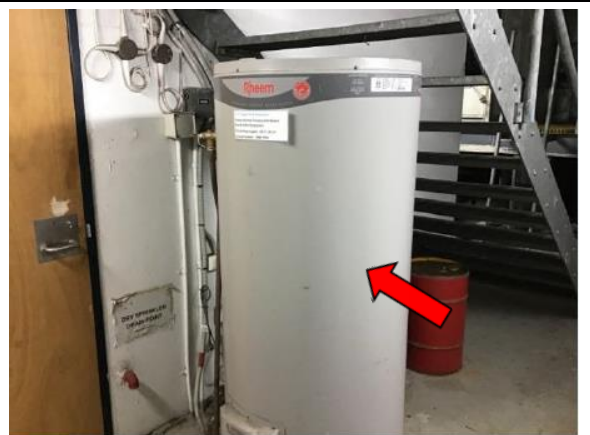
Example of SMF internal insulation in hot water heaters on site
