Asbestos and Hazardous Materials Assessment

Hoxton Park Distribution Centre

40 Blackbird Close

754-SYDEN364426 - Hoxton Park Distribution Centre - HMMR - 12122024

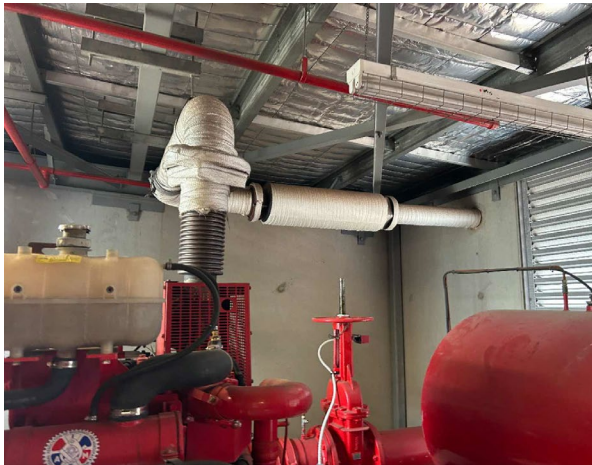
Line ID 1: Internal, GL, Northern Fire Pump Room,
Pump Exhausts, Insulation Material - Suspected SMF

- SMF materials that are likely to be disturbed during any proposed demolition/refurbishment works should be handled in accordance with The National Code of Practice for the Safe Use of Synthetic Mineral Fibres [NOHSC:2006(1990)].

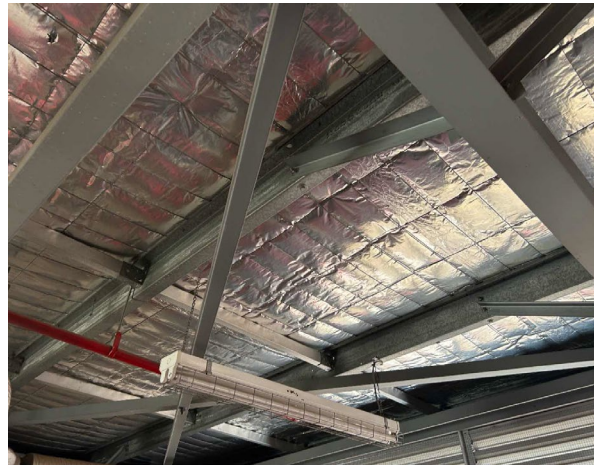
Line ID 2: Internal, GL, Northern Fire Pump Room,
Underside of Ceiling, Sarking Insulation - Suspected SMF

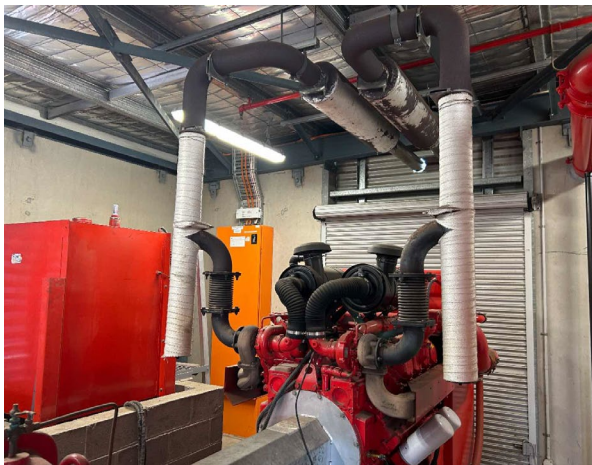
Area	Location	Material Description	Hazard	Reference No.	Result	Friable	Quantity	Condition	Risk Rating	Reinspect Date	Recommendations	Line ID
Internal	GL / Northern Fire Pump Room / Pump Exhausts	Insulation Material	SMF	754-SYDEN364426 Hoxton Park Distribution Centre339S5	Suspected SMF	-	5 m	-	Very Low	-	Maintain in current condition if to remain in-situ. Remove under controlled SMF conditions as per the Code of Practice for the Safe Use of Synthetic Mineral Fibres [NOHSC: 2006 (1990)].	1
Internal	GL / Northern Fire Pump Room / Underside of Ceiling	Sarking Insulation	SMF	754-SYDEN364426 Hoxton Park Distribution Centre339S4	Suspected SMF	-	60 m²	-	Very Low	-	Maintain in current condition if to remain in-situ. Remove under controlled SMF conditions as per the Code of Practice for the Safe Use of Synthetic Mineral Fibres [NOHSC: 2006 (1990)].	2
Internal	GL / Southern Fire Pump Room / Pump Exhausts	Insulation Material	SMF	754-SYDEN364426 Hoxton Park Distribution Centre339S2	Suspected SMF	-	5 m	-	Very Low	-	Maintain in current condition if to remain in-situ. Remove under controlled SMF conditions as per the Code of Practice for the Safe Use of Synthetic Mineral Fibres [NOHSC: 2006 (1990)].	3

Line ID 3: Internal, GL, Southern Fire Pump Room,
Pump Exhausts, Insulation Material - Suspected SMF

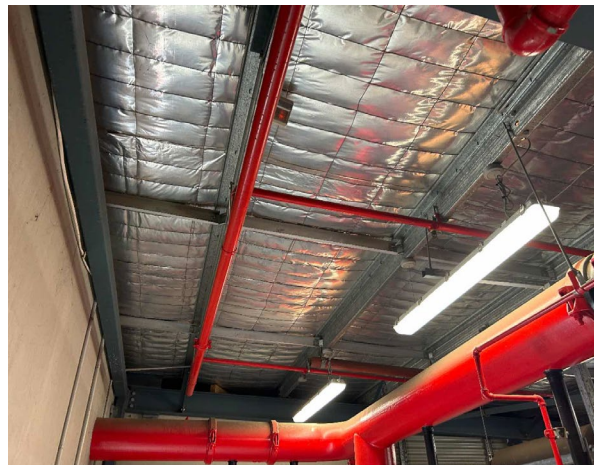
Internal	GL / Southern Fire Pump Room / Underside of Ceiling	Sarking Insulation	SMF	754-SYDEN364426 Hoxton Park Distribution Centre339S1	Suspected SMF	-	80 m²	-	Very Low	-	Maintain in current condition if to remain in-situ. Remove under controlled SMF conditions as per the Code of Practice for the Safe Use of Synthetic Mineral Fibres [NOHSC: 2006 (1990)].	4

Line ID 4: Internal, GL, Southern Fire Pump Room,
Underside of Ceiling, Sarking Insulation - Suspected SMF

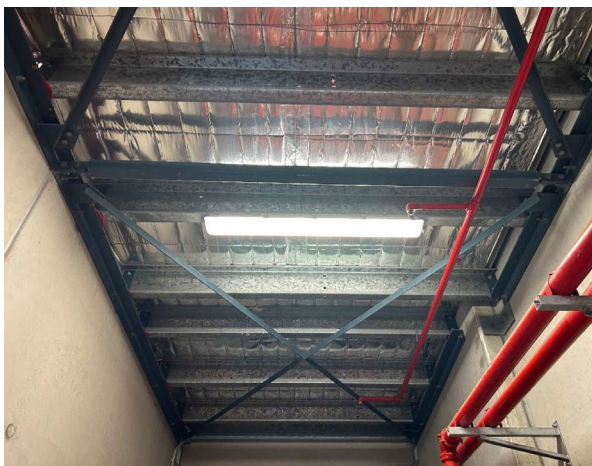
Line ID 5: Internal, GL, Sprinkler Valve Rooms,
Underside of Ceiling, Sarking Insulation - Suspected
SMF

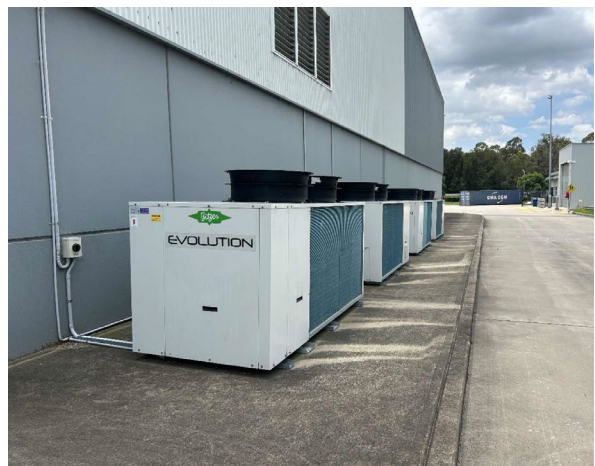
Area	Location	Material Description	Hazard	Reference No.	Result	Friable	Quantity	Condition	Risk Rating	Reinspect Date	Recommendations	Line ID
Internal	GL / Sprinkler Valve Rooms / Underside of Ceiling	Sarking Insulation	SMF	754-SYDEN364426 Hoxton Park Distribution Centre339S3	Suspected SMF	-	250 m²	-	Very Low	-	Maintain in current condition if to remain in-situ. Remove under controlled SMF conditions as per the Code of Practice for the Safe Use of Synthetic Mineral Fibres [NOHSC: 2006 (1990)].	5
External	GL / Northern Building / Perimeter, Various Areas	R134a Hydrofluorocarbon (HFC)	ODS	754-SYDEN364426 Hoxton Park Distribution Centre339O1	Non ODS Refrigerant	-	20 Units	-	-	-	Hydrofluorocarbon (HFC) non ozone depleting substances.	6

Line ID 6: External, GL, Northern Building, Perimeter,
Various Areas, R134a Hydrofluorocarbon (HFC) - Non ODS
Refrigerant
