HAZARDOUS MATERIALS MANAGEMENT PLAN

January 2018
J153823

Mirvac Real Estate Pty Ltd
1 Darling Island Road, Pyrmont

Hazardous Material Risk Assessment Mirvac Operations 1 Darling Island Road, Pyrmont NSW 2009

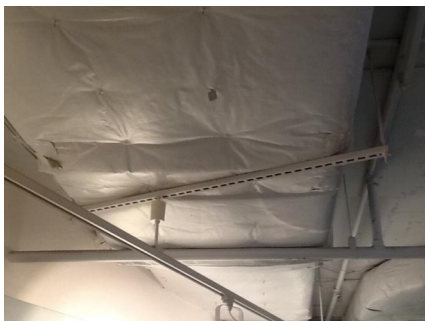
PHOTO NO.: J153823-001-PHOTO003
 RESULT: SMF - PRESUMED POSITIVE
 BUILDING/LEVEL: MAIN BUILDING - ALL LEVELS
 ROOM/LOCATION: ALL ROOMS - VARIOUS THROUGHOUT
 FEATURE/MATERIAL: DUCTWORK INSULATION - INSULATION MATERIAL
 SAMPLE NO.: -

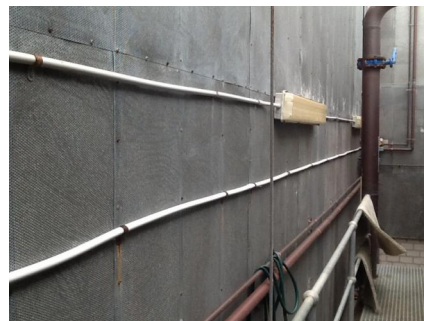
Main Building - Interior - Level Five															
Cooling Towers - Throughout Wall - Insulation Material		SMF		Presumed Positive	J153823-001-P hoto009	200 m²	Good	Bonded (SMF)						Maintain in good condition and incorporate into a HMMP. Remove under controlled conditions prior to demolition or refurbishment.	
Plant Room - South Hot Water Heater - Insulation Material		SMF		Presumed Positive	J153823-001-P hoto005 J153823-001-P hoto004	7 Unit/s	Good	Bonded (SMF)						Maintain in good condition and incorporate into a HMMP. Remove under controlled conditions prior to demolition or refurbishment.	
Plant Room - Throughout Roof Lining - Sarking Insulation		SMF		Presumed Positive	J153823-001-P hoto008	400 m²	Good	Bonded (SMF)						Maintain in good condition and incorporate into a HMMP. Remove under controlled conditions prior to demolition or refurbishment.	
Plant Room - Various Throughout Pipework Insulation - Insulation Material		SMF		Presumed Positive	J153823-001-P hoto006 J153823-001-P hoto007	500 m	Good	Bonded (SMF)						Maintain in good condition and incorporate into a HMMP. Remove under controlled conditions prior to demolition or refurbishment.

PHOTO NO.: J153823-001-PHOTO009
 RESULT: SMF - PRESUMED POSITIVE
 BUILDING/LEVEL: MAIN BUILDING - LEVEL FIVE
 ROOM/LOCATION: COOLING TOWERS - THROUGHOUT
 FEATURE/MATERIAL: WALL - INSULATION MATERIAL
 SAMPLE NO.: -

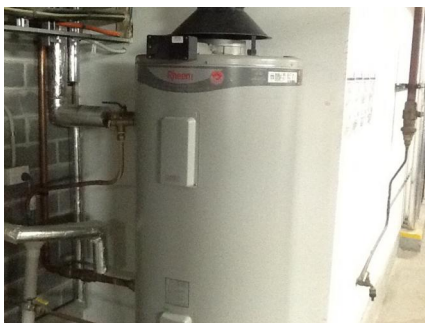
PHOTO NO.: J153823-001-PHOTO005
 RESULT: SMF - PRESUMED POSITIVE
 BUILDING/LEVEL: MAIN BUILDING - LEVEL FIVE
 ROOM/LOCATION: PLANT ROOM - SOUTH
 FEATURE/MATERIAL: HOT WATER HEATER - INSULATION MATERIAL
 SAMPLE NO.: -

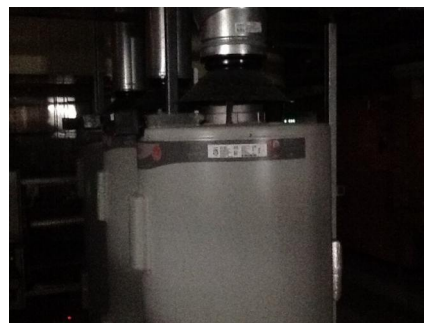
PHOTO NO.: J153823-001-PHOTO004
 RESULT: SMF - PRESUMED POSITIVE
 BUILDING/LEVEL: MAIN BUILDING - LEVEL FIVE
 ROOM/LOCATION: PLANT ROOM - SOUTH
 FEATURE/MATERIAL: HOT WATER HEATER - INSULATION MATERIAL
 SAMPLE NO.: -

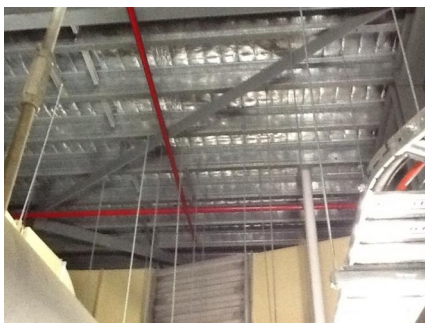
PHOTO NO.: J153823-001-PHOTO008
 RESULT: SMF - PRESUMED POSITIVE
 BUILDING/LEVEL: MAIN BUILDING - LEVEL FIVE
 ROOM/LOCATION: PLANT ROOM - THROUGHOUT
 FEATURE/MATERIAL: ROOF LINING - SARKING INSULATION
 SAMPLE NO.: -

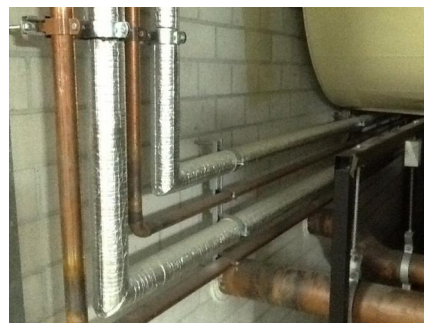
PHOTO NO.: J153823-001-PHOTO006
 RESULT: SMF - PRESUMED POSITIVE
 BUILDING/LEVEL: MAIN BUILDING - LEVEL FIVE
 ROOM/LOCATION: PLANT ROOM - VARIOUS THROUGHOUT
 FEATURE/MATERIAL: PIPEWORK INSULATION - INSULATION MATERIAL
 SAMPLE NO.: -

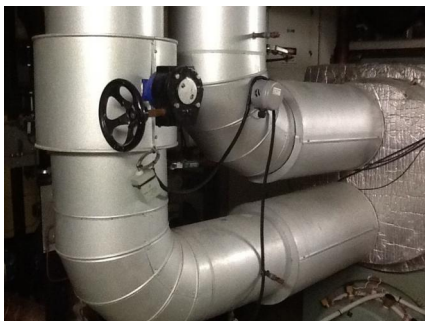
PHOTO NO.: J153823-001-PHOTO007
 RESULT: SMF - PRESUMED POSITIVE
 BUILDING/LEVEL: MAIN BUILDING - LEVEL FIVE
 ROOM/LOCATION: PLANT ROOM - VARIOUS THROUGHOUT
 FEATURE/MATERIAL: PIPEWORK INSULATION - INSULATION MATERIAL
 SAMPLE NO.: -

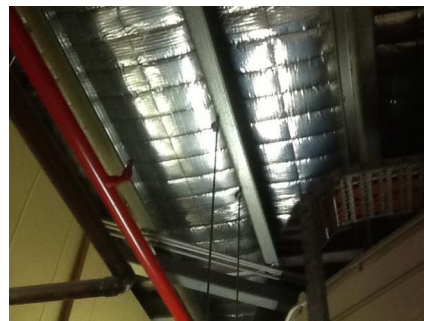
PHOTO NO.: J153823-001-PHOTO010
 RESULT: SMF - PRESUMED POSITIVE
 BUILDING/LEVEL: MAIN BUILDING - LEVEL SIX
 ROOM/LOCATION: PLANT ROOM - THROUGHOUT
 FEATURE/MATERIAL: ROOF LINING - SARKING INSULATION
 SAMPLE NO.: -

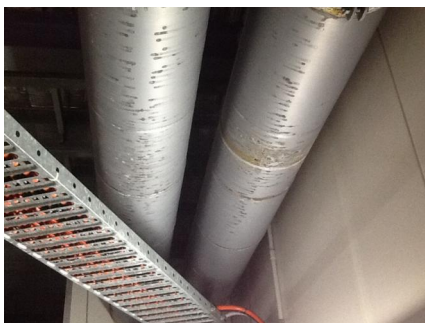
PHOTO NO.: J153823-001-PHOTO012
 RESULT: SMF - PRESUMED POSITIVE
 BUILDING/LEVEL: MAIN BUILDING - LEVEL SIX
 ROOM/LOCATION: PLANT ROOM - VARIOUS THROUGHOUT
 FEATURE/MATERIAL: PIPEWORK INSULATION - INSULATION MATERIAL
 SAMPLE NO.: -

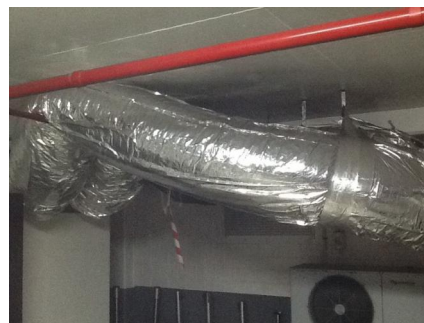
PHOTO NO.: J153823-001-PHOTO001
 RESULT: SMF - PRESUMED POSITIVE
 BUILDING/LEVEL: MAIN BUILDING - PARKING LEVEL P1
 ROOM/LOCATION: CAR PARK - SOUTHEAST
 FEATURE/MATERIAL: FLEXIBLE DUCTWORK INSULATION - INSULATION MATERIAL
 SAMPLE NO.: -

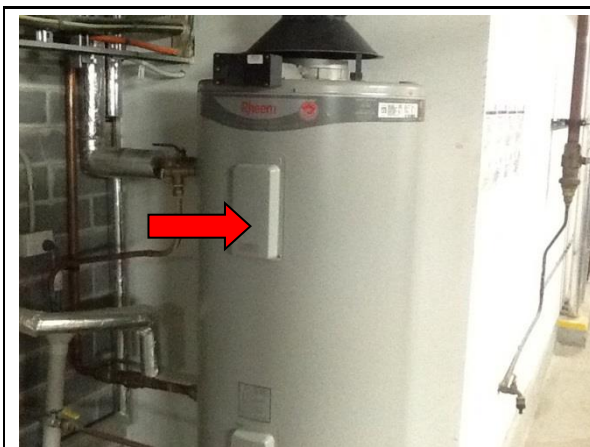
Interior, Level 5, Plant Room, Hot Water Services Tanks – SMF insulation material

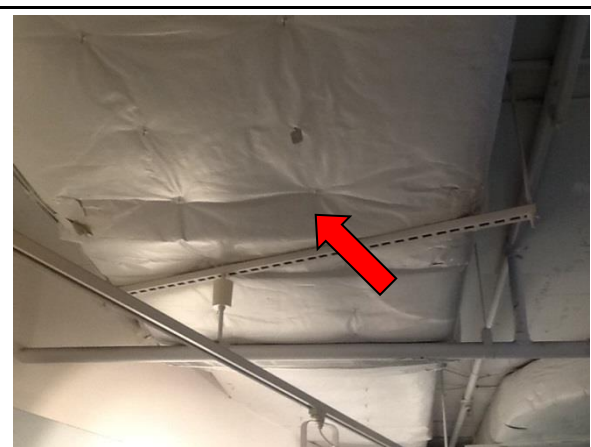
Interior, All Levels, All Rooms, Air-conditioning Ductwork – SMF insulation material (foil-clad)

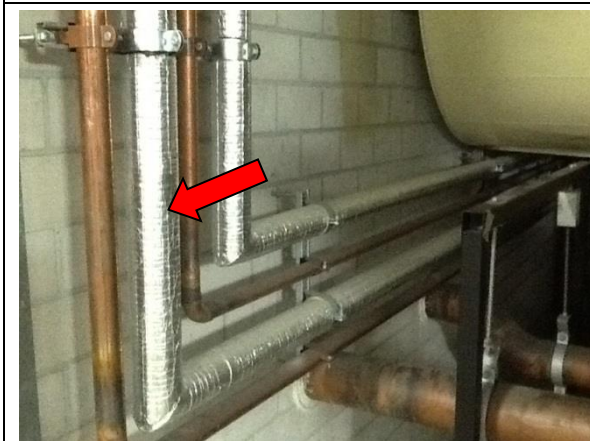
Interior, Levels 5 & 6, Plant Rooms, Pipework insulation – SMF Pipework insulation material

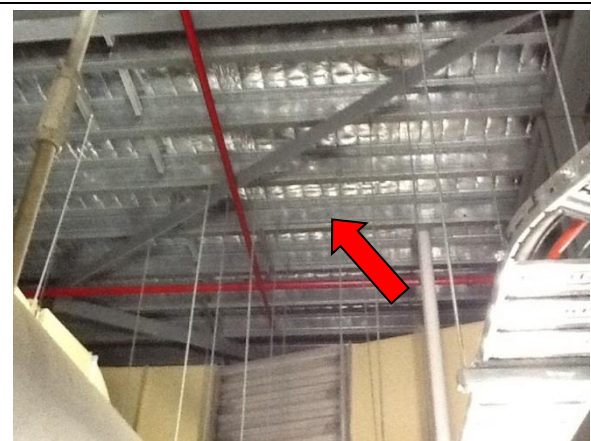
Interior, Levels 5 & 6, Plant Rooms, Roof Lining, – SMF sarking insulation material (foil-clad)
