**Asbestos and Hazardous Materials  
Re-Inspection**

410 Ann Street, Brisbane City QLD 4000

10 December 2019

Prepared for  
Mirvac

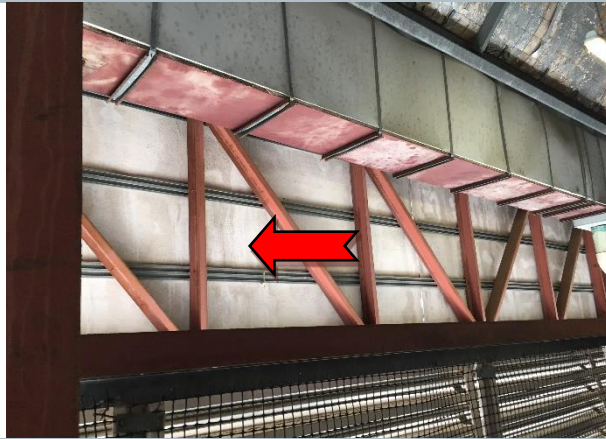
**Photo 1** Exterior: level 13, plant room, external walls – suspected asbestos containing fibre cement sheet.

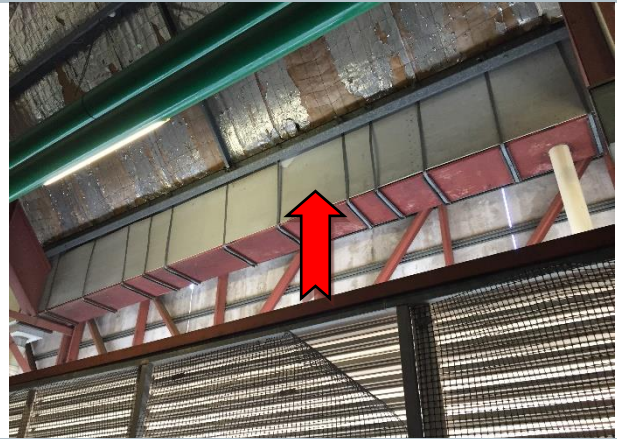
**Photo 2** Exterior: level 13, plant room, soffit – suspected asbestos containing fibre cement sheet.

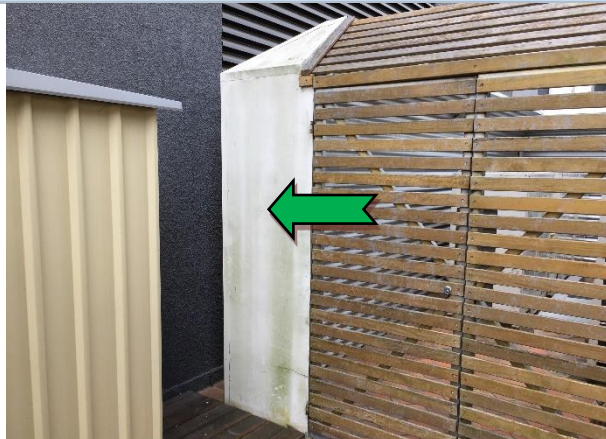
**Photo 3** Exterior: level 3, air conditioning unit enclosure, external walls – non-asbestos containing fibre cement sheet.

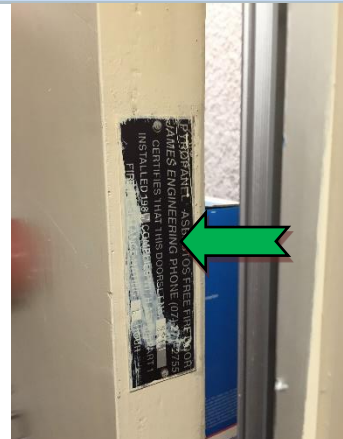
**Photo 4** Interior: all levels, south eastern fire stairwell, fire doors (1987) – non-asbestos containing internal insulation material.

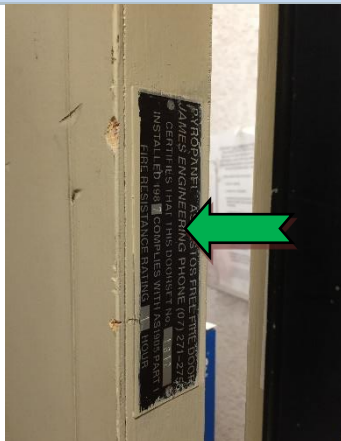
**Photo 5** Interior: all levels, north western fire stairwell, fire doors (1987) – non-asbestos containing internal insulation material.

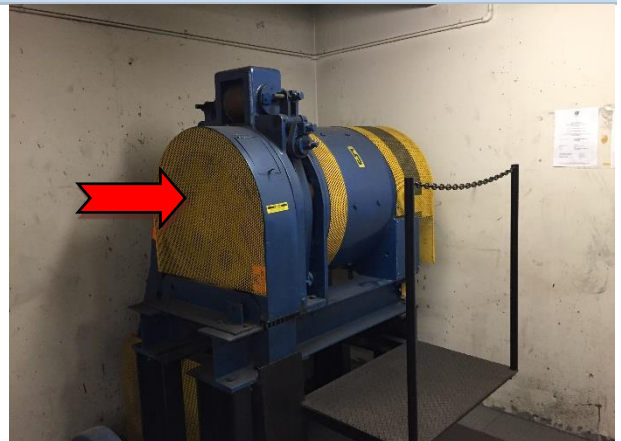
**Photo 6** Interior: level 13, lift motor room, lift motor – asbestos containing friction material.

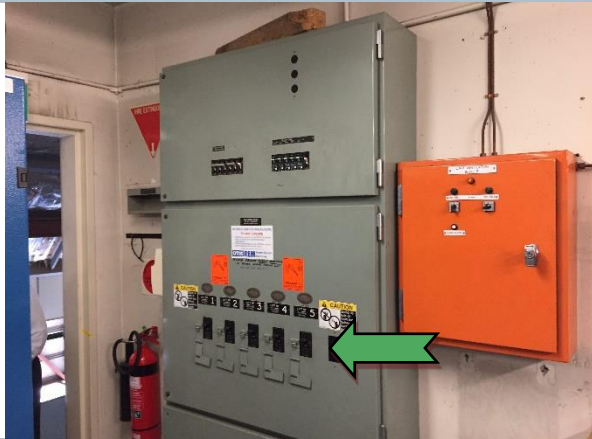
**Photo 7** Interior: level 13, lift motor room, switchboard – non-asbestos containing arc shields.

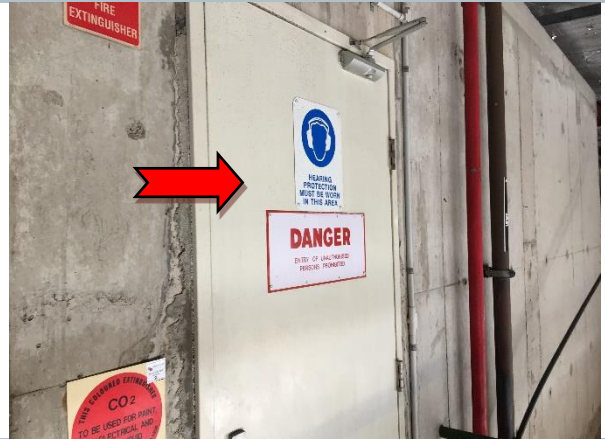
**Photo 8** Interior: level 13, lift motor room, fire door - single (unlabelled) – suspected asbestos containing internal insulation material.

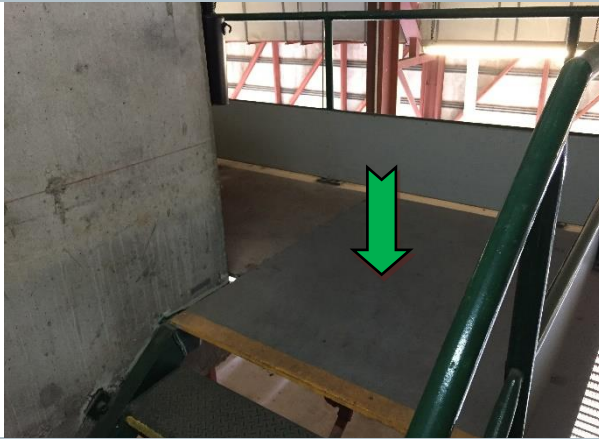
**Photo 9** Interior: level 13, landing adjacent lift motor room, floor – non-asbestos containing compressed cement sheeting.

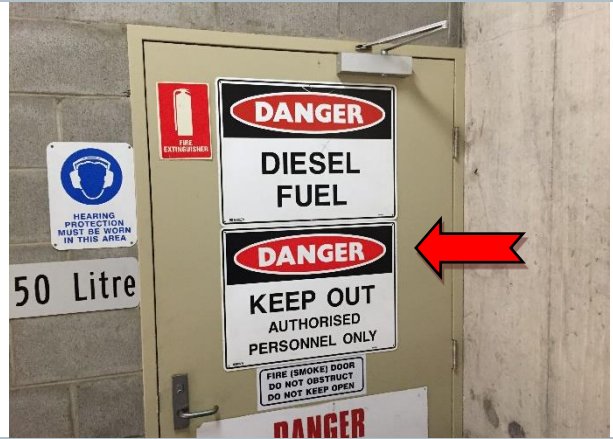
**Photo 10** Interior: level 13, diesel motor room, fire door - single (unlabelled) – suspected asbestos containing internal insulation material.

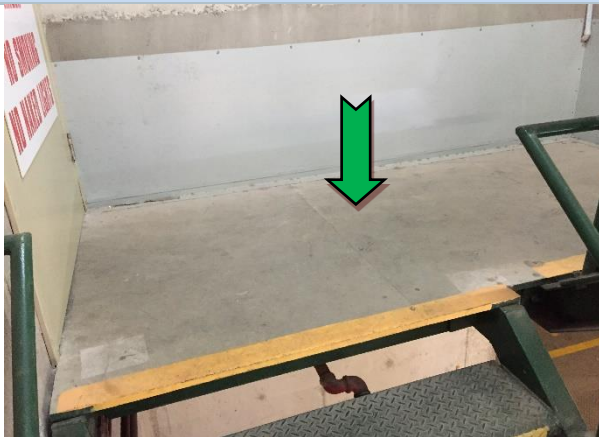
**Photo 11** Interior: level 13, landing adjacent diesel motor room, floor – non-asbestos containing compressed cement sheeting.

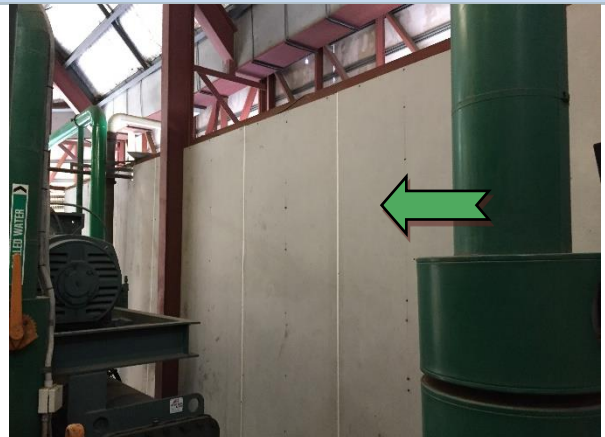
**Photo 12** Interior: level 13, plant room, partition wall – non-asbestos containing fibre cement sheet.

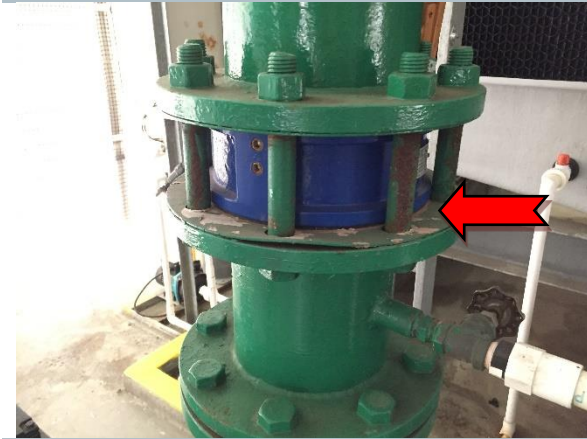
**Photo 13** Interior: level 13, plant room, pipe work – asbestos containing gasket material.

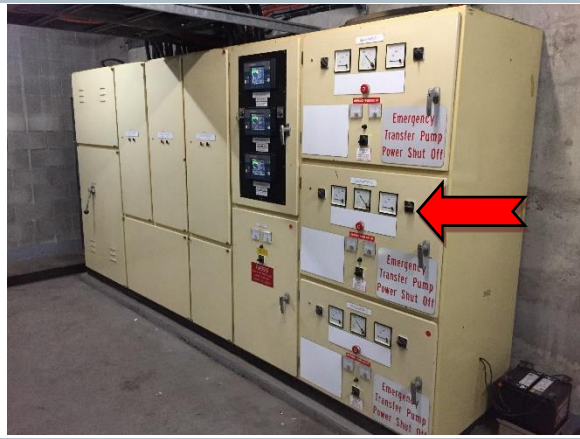
**Photo 14** Interior: level 13, plant room, Emergency Transfer Pump – suspected asbestos containing internal insulation material.

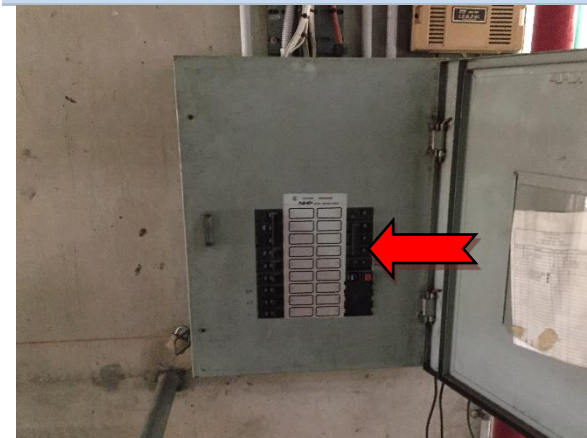
**Photo 15** Interior: level 13, plant room, switchboard – suspected asbestos containing arc shields.

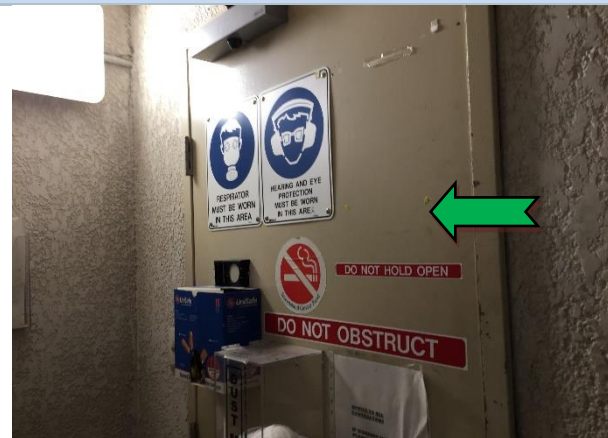
**Photo 16** Interior: level 13, plant room, fire doors (1987) – non-asbestos containing internal insulation material.

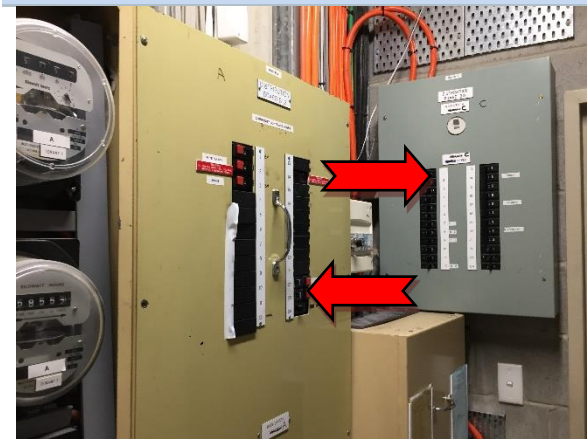
**Photo 17** Interior: ground level to level 12, electrical server room, switchboard – suspected asbestos containing arc shields.

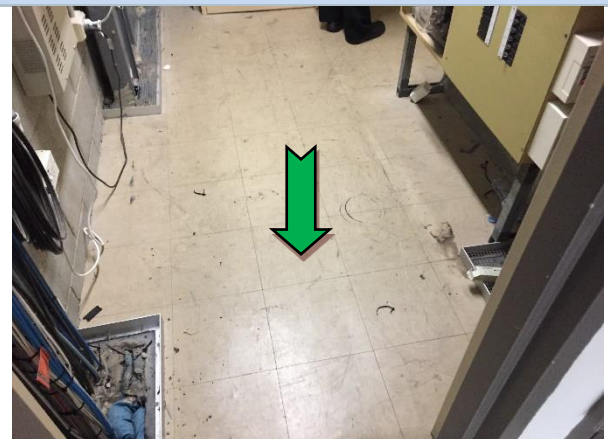
**Photo 18** Interior: ground level to level 12, electrical server rooms, floor coverings (beige) – non-asbestos containing vinyl floor tiles.

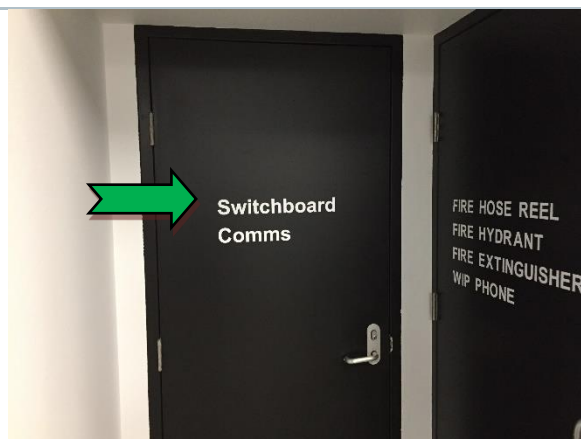
**Photo 19** Interior: ground level to level 12, electrical server rooms, fire doors – non-asbestos containing internal insulation material.

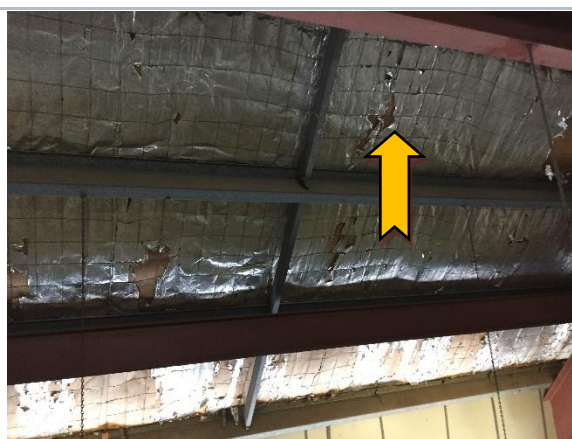
**Photo 20** Interior: level 13, plant room, ceiling – suspected SMF sarking insulation.

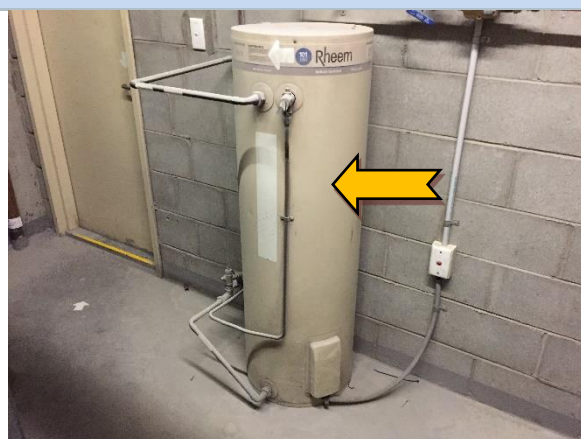
**Photo 21** Interior: level 12, air handling room, 'Rheem' hot water heater – suspected SMF internal insulation material.

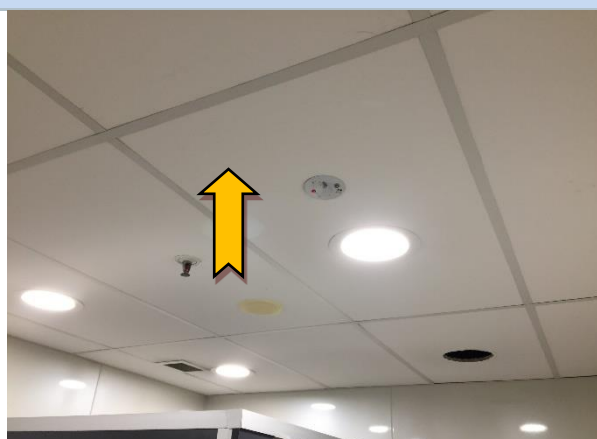
**Photo 22** Interior: ground level to level 12, male amenities, ceiling – suspected SMF compressed ceiling tiles.

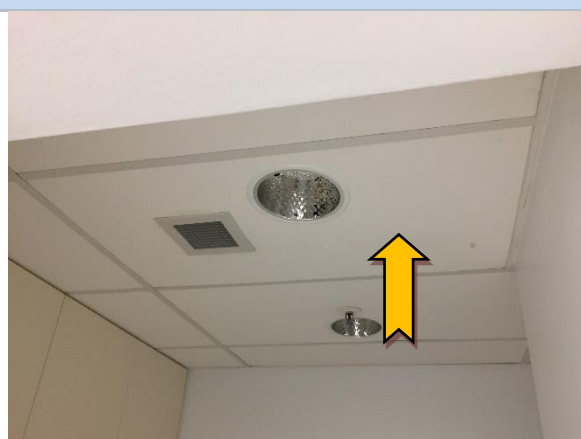
**Photo 23** Interior: ground level to level 12, kitchenette, ceiling – suspected SMF compressed ceiling tiles.

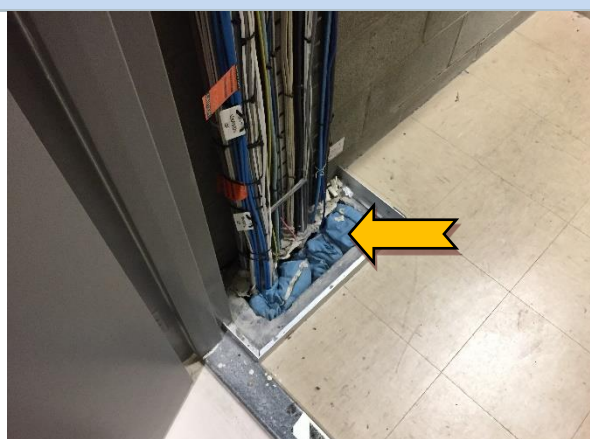
**Photo 24** Interior: ground level to level 12, electrical server room, packer – suspected SMF pillow insulation.

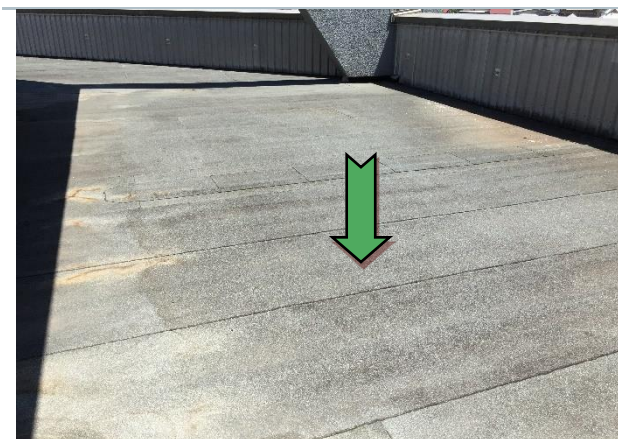
**Photo 25** Exterior: level 7, roof top adjacent to plant room, waterproof membrane – non-asbestos containing bituminous membrane.

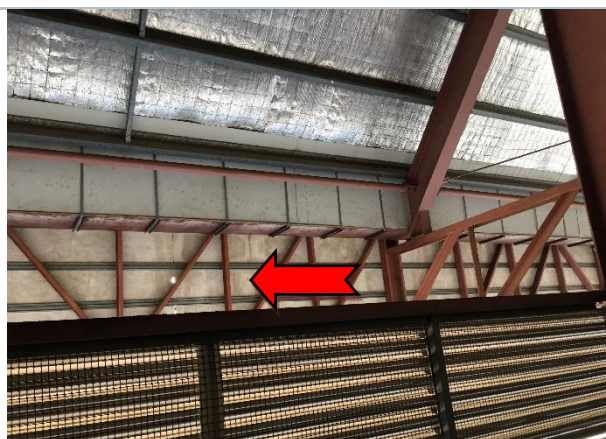
**Photo 26** Exterior: level 7, plant room, external walls – suspected asbestos containing fibre cement sheet.

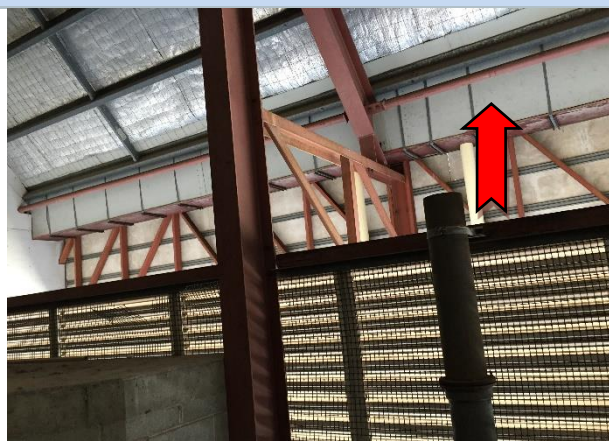
**Photo 27** Exterior: level 7, plant room, soffit – suspected asbestos containing fibre cement sheet.

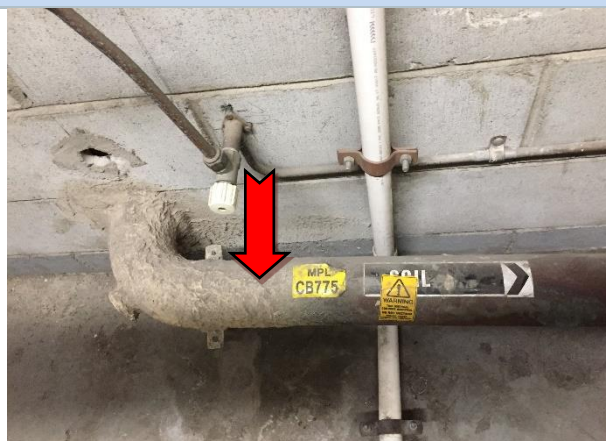
**Photo 28** Interior: all levels, air handling rooms, pipe work – asbestos containing fire stop membrane.

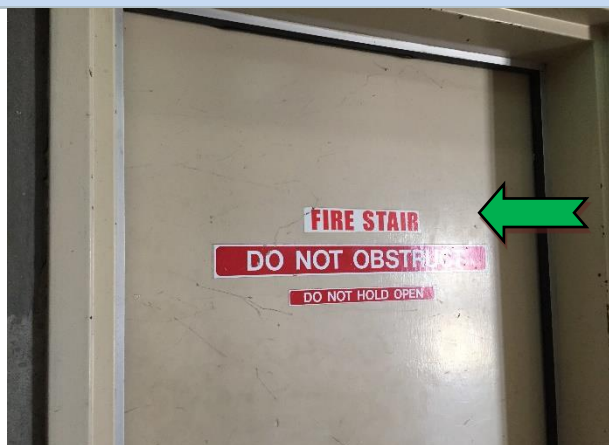
**Photo 29** Interior: all levels, eastern fire stairwell, fire doors (1987) – non-asbestos containing internal insulation material.

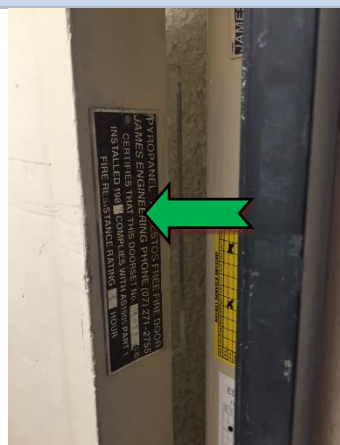
**Photo 30** Interior: all levels, western fire stairwell, fire doors (1987) – non-asbestos containing internal insulation material.

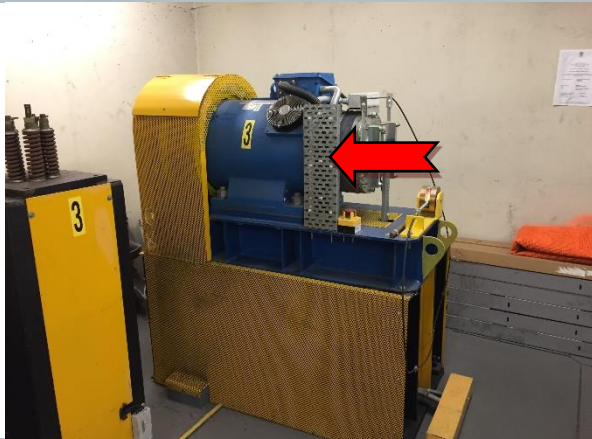
**Photo 31** Interior: level 7, lift motor room, lift motor – suspected asbestos containing friction material.

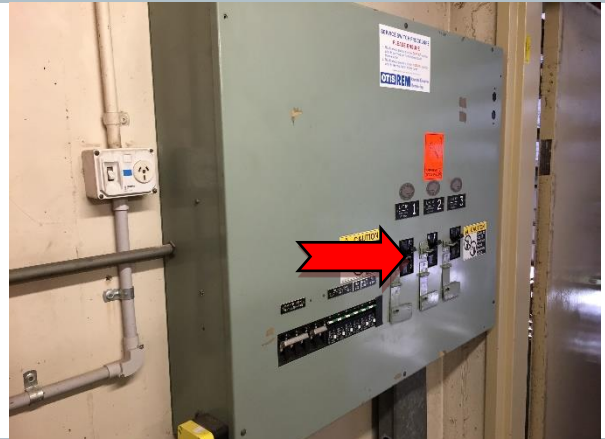
**Photo 32** Interior: level 7, lift motor room, switchboard – suspected asbestos containing arc shields.

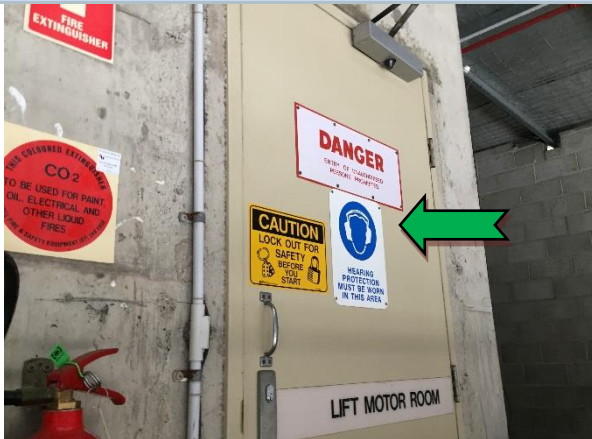
**Photo 33** Interior: level 7, lift motor room, fire doors (1987) – non-asbestos containing internal insulation material.

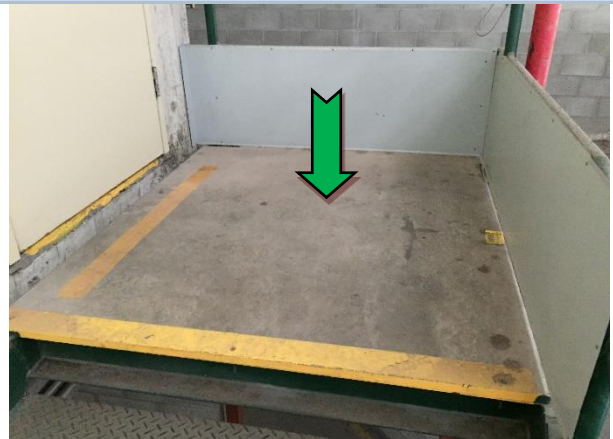
**Photo 34** Interior: level 7, landing adjacent lift motor room, floor – non-asbestos containing compressed cement sheeting.

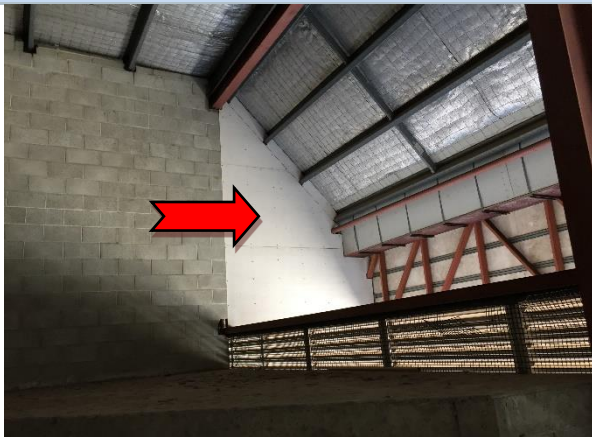
**Photo 35** Interior: level 7, plant room, internal walls – suspected asbestos containing fibre cement sheet.

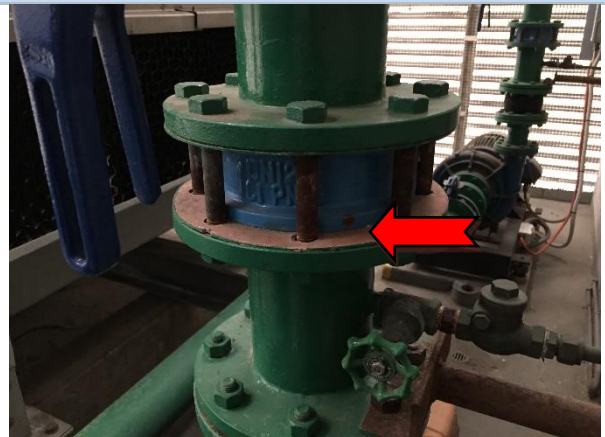
**Photo 36** Interior: level 7, plant room, pipe work – asbestos containing gasket material.

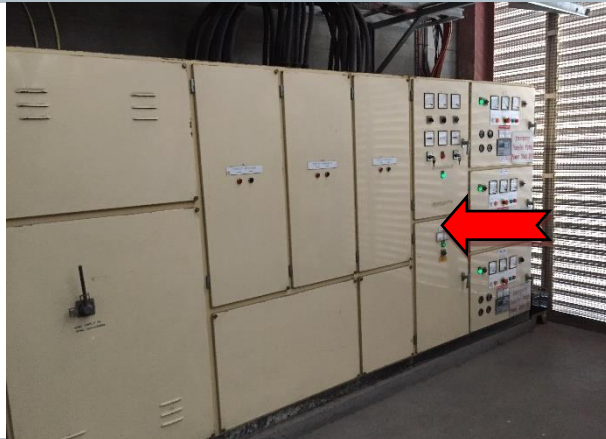
**Photo 37** Interior: level 7, plant room, Emergency Transfer Pump Shut Off – suspected asbestos containing internal insulation material.

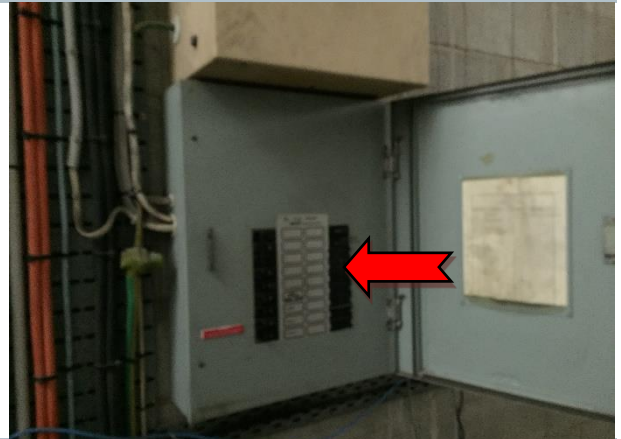
**Photo 38** Interior: level 7, plant room, switchboard – suspected asbestos containing arc shields.

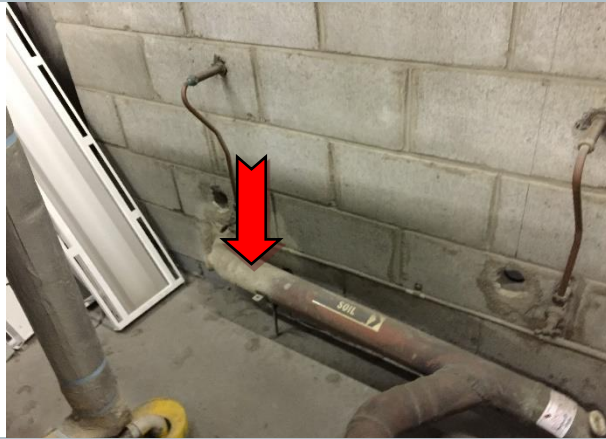
**Photo 39** Interior: levels 1, 3, 5 and 6, plant room, pipe work – asbestos containing fire stop membrane.

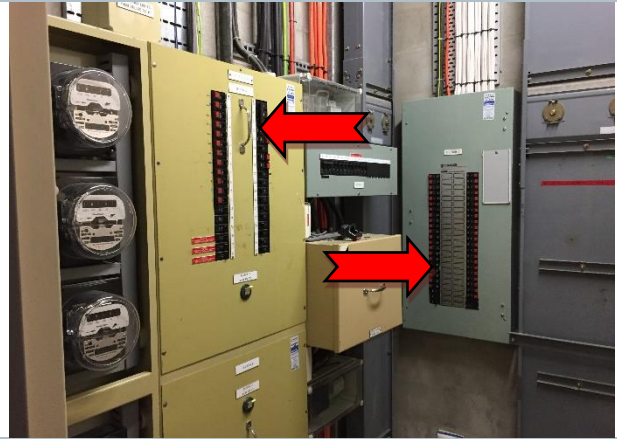
**Photo 40** Interior: levels 1 to 6, electrical server room, switchboard – suspected asbestos containing arc shields.

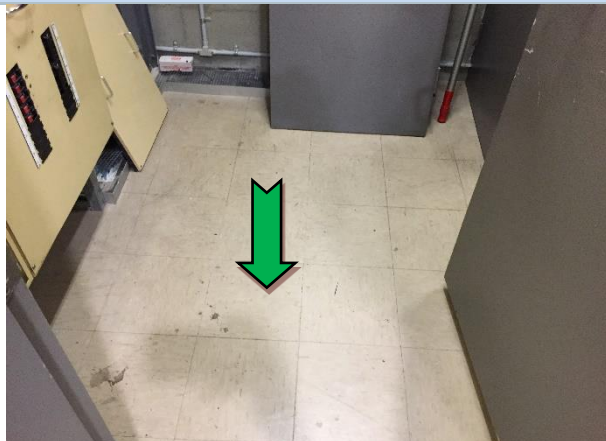
**Photo 41** Interior: levels 1 to 6, electrical server rooms, floor coverings (beige) – non-asbestos containing vinyl floor tiles.

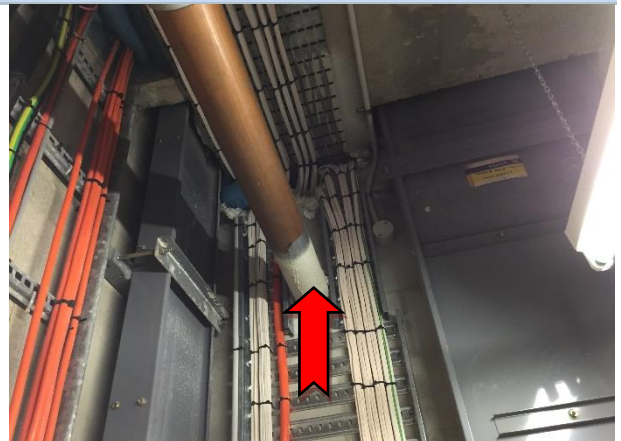
**Photo 42** Interior: levels 1 to 6, electrical server room, pipe work – asbestos containing fire stop membrane.

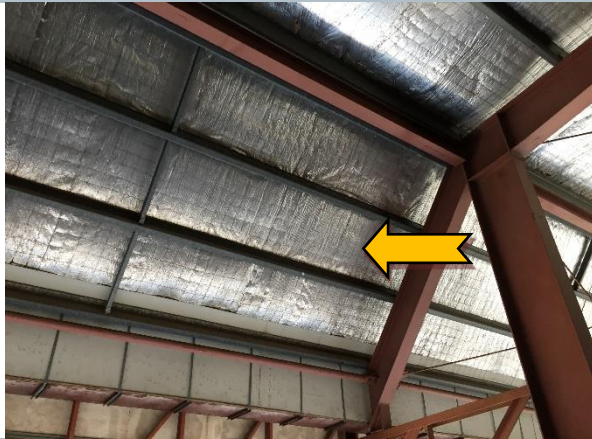
**Photo 43** Interior: level 7, plant room, ceiling – suspected SMF sarking insulation.

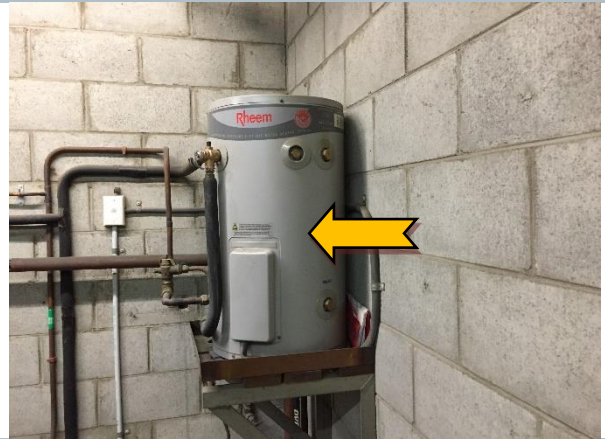
**Photo 44** Interior: ground level to level 6, air handling rooms, 'Rheem' hot water heater – suspected SMF internal insulation material.

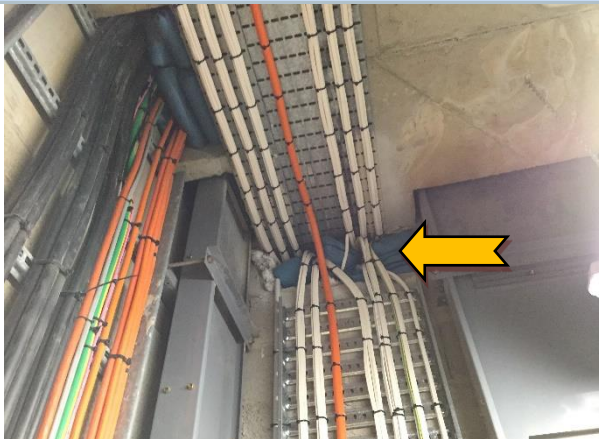
**Photo 45** Interior: ground level to level 6, electrical server room, packer – suspected SMF pillow insulation.

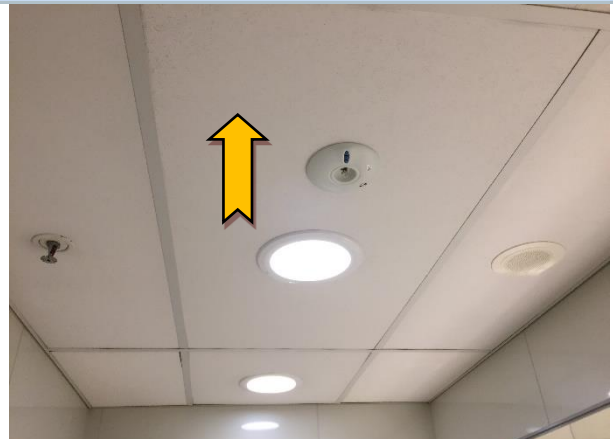
**Photo 46** Interior: ground level, disabled amenities, ceiling – suspected SMF compressed ceiling tiles.

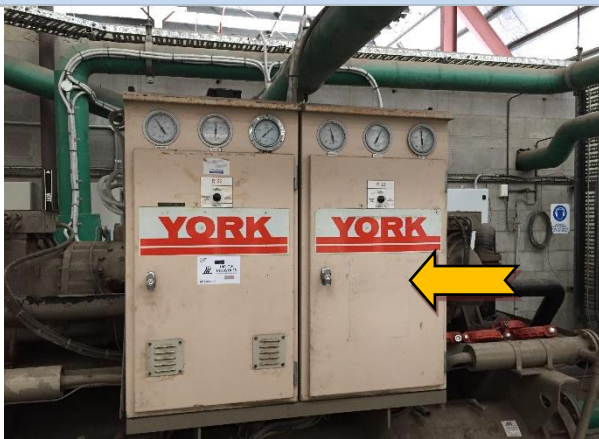
**Photo 47** Interior: level 13, plant room, 'York' air conditioning unit – ozone depleting R22 Hydrochlorofluorocarbon (HCFC) refrigerant.

Removal should be undertaken prior to any demolition. A licensed contractor who will recycle and reuse the refrigerant should decommission the CFC and HCFC based equipment that is being disposed of in accordance with Association of Fluorocarbon Consumers and Manufacturers, *The Australian Refrigeration and Air Conditioning Code of Good Practice* – 1992 and the Australian Commonwealth Government Ozone Protection Act – 1989.

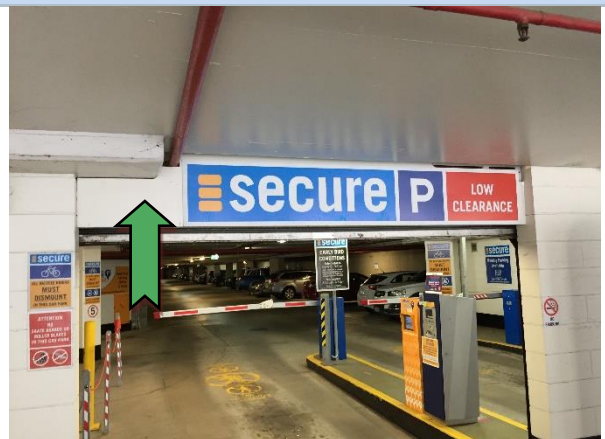
**Photo 48** Exterior: B2, Raff Street entrance, above roller door, cladding – non-asbestos containing fibre cement sheet.

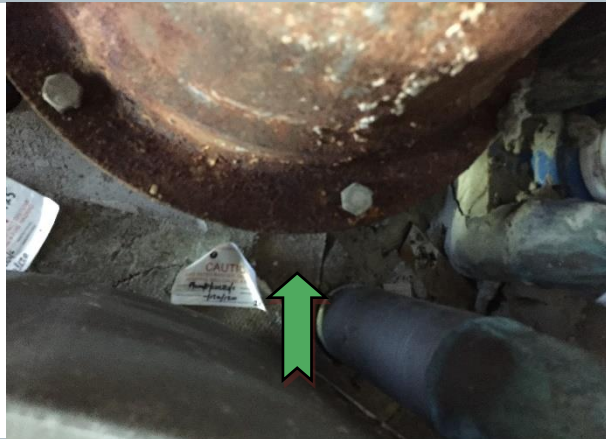
**Photo 49** Interior: B1, West Tower lift foyer, near fire stairs 1, packer to pipework in ceiling – non-asbestos containing fibre cement sheet.

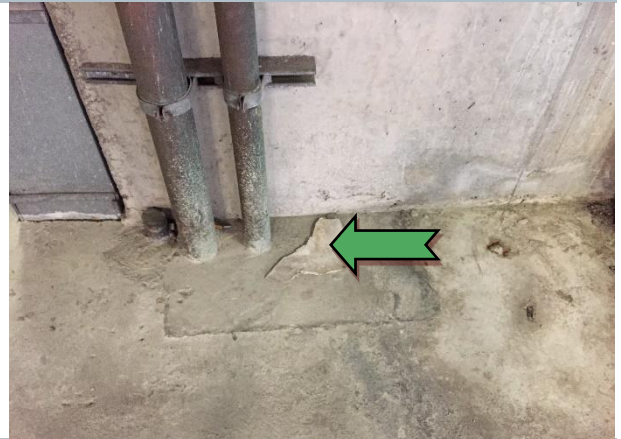
**Photo 50** Interior: B1, West Tower lift foyer, near fire stairs 1, debris – non-asbestos containing fibre cement sheet.

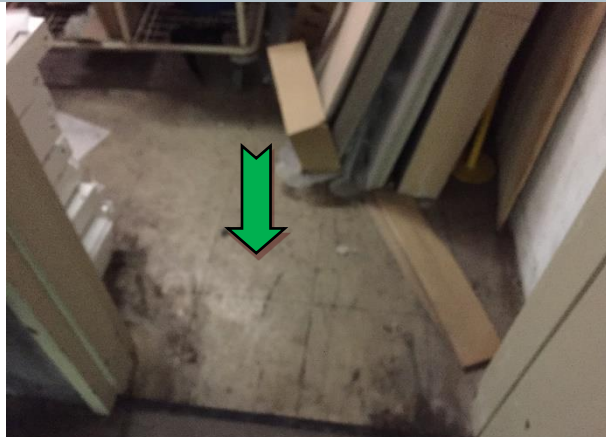
**Photo 51** Interior: B1, West Tower storeroom adjacent switchroom, floor coverings (beige) – non-asbestos containing vinyl floor tiles.

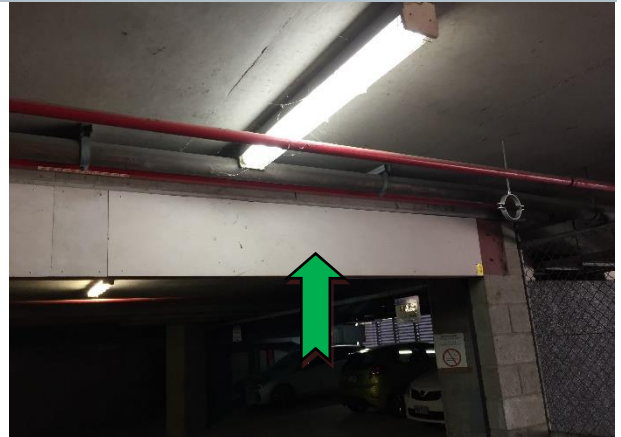
**Photo 52** Interior: B1, West Tower carpark, above roller door, fascia – non-asbestos containing fibre cement sheet.

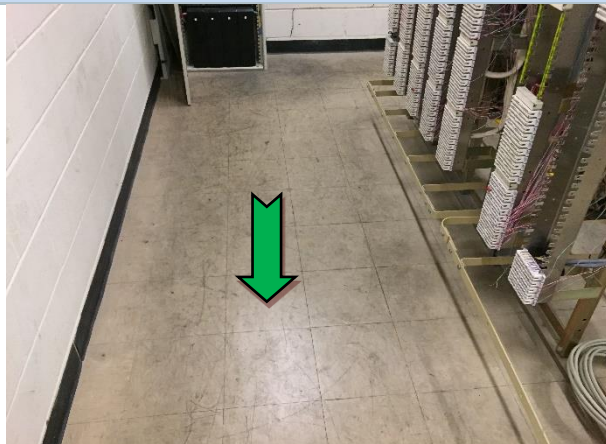
**Photo 53** Interior: B2, MDF room, floor coverings (beige) – non-asbestos containing vinyl floor tiles.

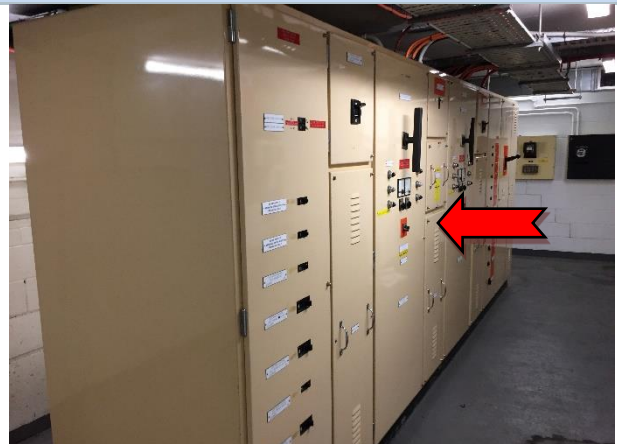
**Photo 54** Interior: B2, MDF and switch rooms throughout, switchboard – suspected asbestos containing arc shields.

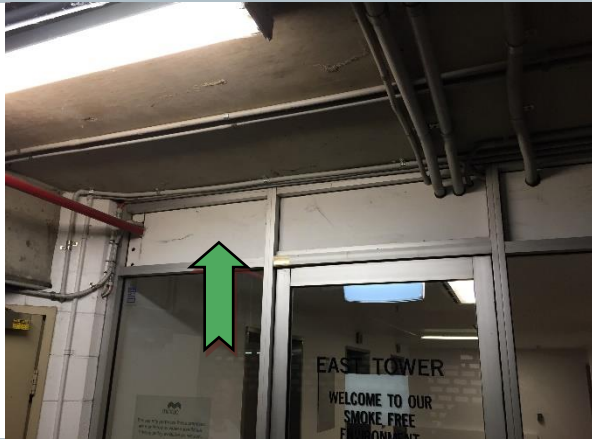
**Photo 55** Interior: B1 and B2 East Tower  
and West Tower lift foyer Infill  
panels Fibre cement sheet

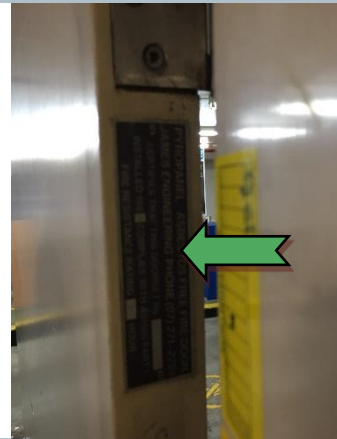
**Photo 56** Interior: B1 and B2 Switch  
rooms throughout Fire door -  
single (1987) Insulation material -  
internal

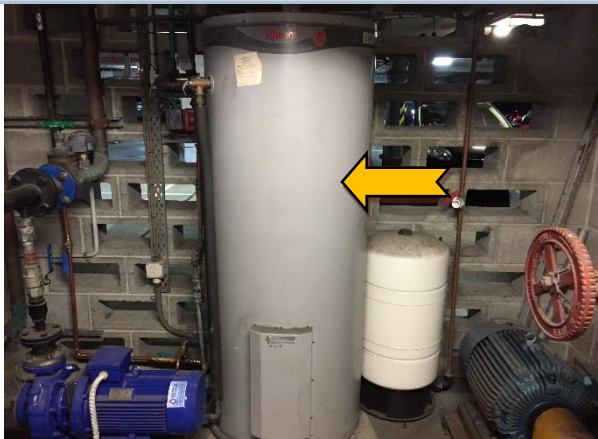
**Photo 57** Interior: B2, Pump and Sprinkler  
rooms, 'Rheem' hot water heater –  
suspected SMF internal insulation  
material.

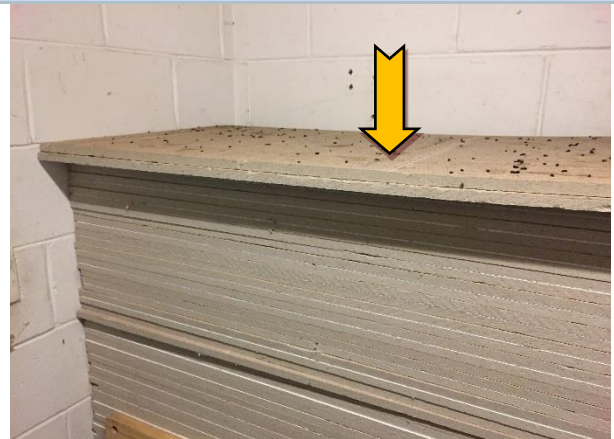
**Photo 58** Interior: B2, storerooms throughout,  
loose ceiling tiles – suspected SMF  
compressed ceiling tiles.
