Asbestos and Hazardous Materials Assessment

80 Ann Street

Brisbane QLD 4000

18/01/2023

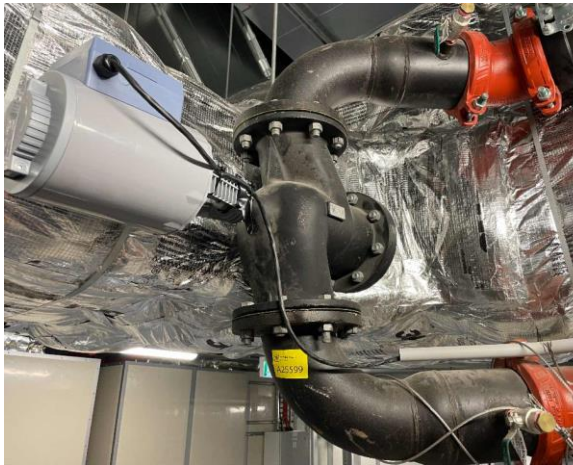
Line ID 2: Internal, Level 15, Plant Room, West Area, Pipework, Gasket Material - No Asbestos Detected

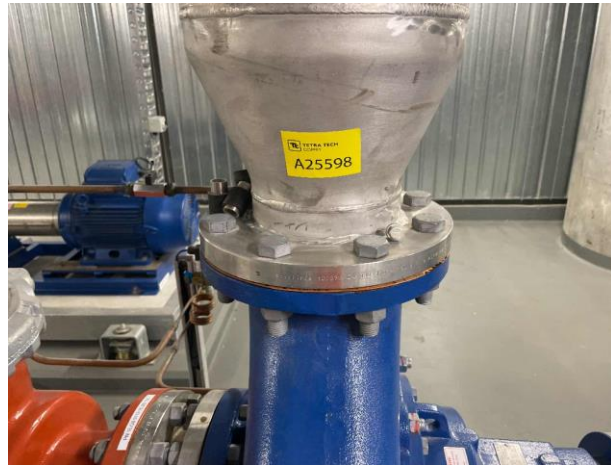
Line ID 3: Internal, Level 6, Chiller Room, to Chilled Water Pump Pipework, Gasket Material - No Asbestos Detected

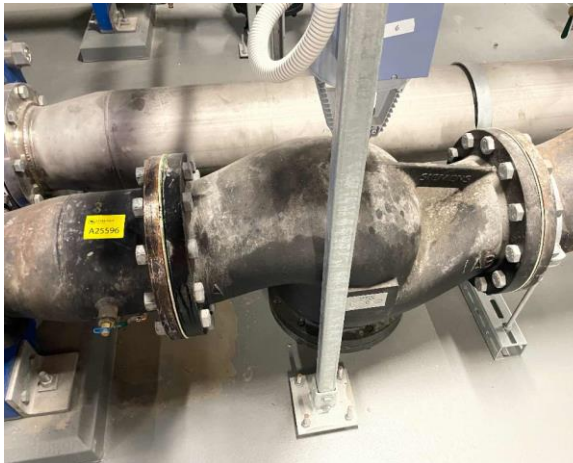
Line ID 4: Internal, Level 6, Chiller Room, to Condenser Water Pipework, Gasket Material - No Asbestos Detected

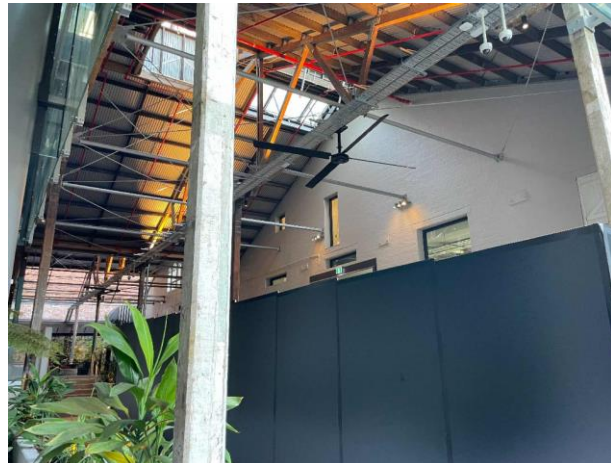
Line ID 5: External, Ground Level, Turbot St Heritage Building, Eastern Undercover Area, Timberwork, White Paint - Lead Detected (3.4% w/w)

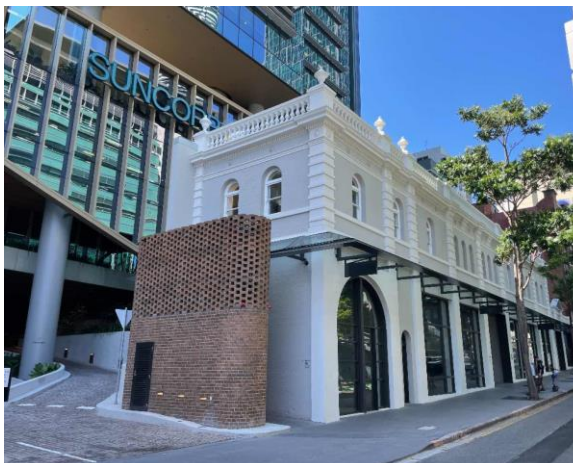
Line ID 6: External, Ground Level and Level 1, Turbot St Heritage Building, Throughout Perimeter, Walls, Beige Paint - Lead Detected (0.072% w/w)

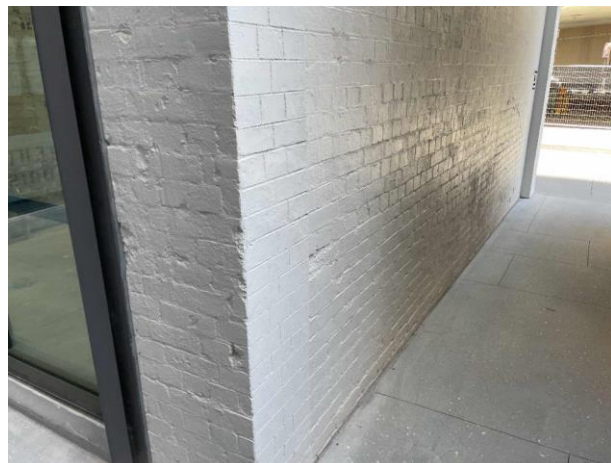
Line ID 6.1: External, Ground Level and Level 1, Turbot St Heritage Building, Throughout Perimeter, Walls, Beige Paint - Lead Detected (0.072% w/w)

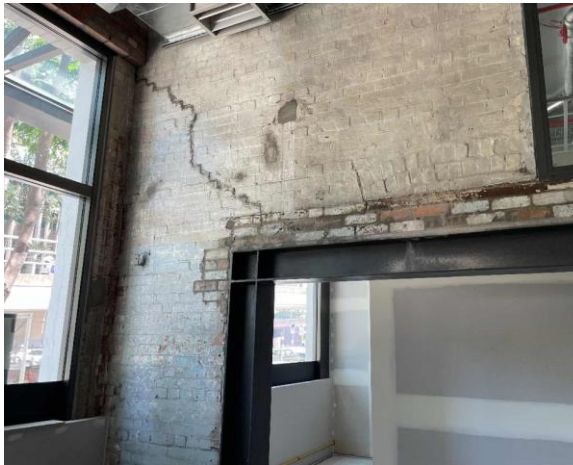
Line ID 7: Internal, Ground Level, Turbot St Heritage Building, North Tenancy, Walls, Green Paint - Lead Detected (0.15% w/w)

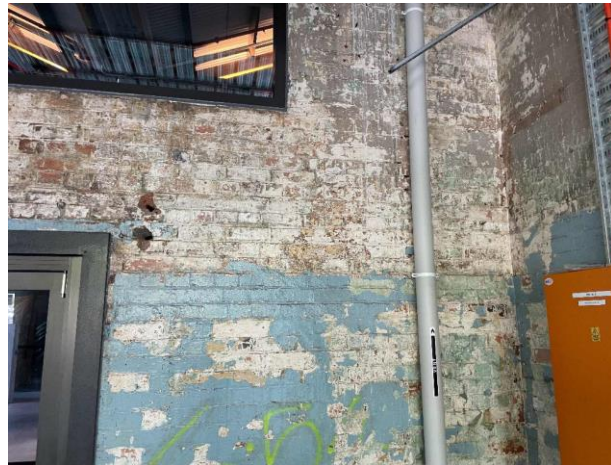
Internal	Ground Level / Turbot St Heritage Building / South Tenancy, Walls	Green Paint	Lead Paint	L16596	Lead Detected (0.22% w/w)	-	150 m²	Low	-	>0.1% lead content, remove flaking sections and over paint with a lead-free paint. Remove under controlled conditions in accordance with AS 4361.2, Guide to hazardous paint management - 2017 Part 2: Lead paint in residential, public and commercial buildings. Conduct a risk assessment to determine the level of remediation controls required.	8
Internal	Ground Level and Level 1 / Turbot St Heritage Building / Northern Stairwell / Throughout, Walls	White Paint	Lead Paint	L16594	Lead Detected (0.90% w/w)	-	100 m²	Very Low	-	>0.1% lead content, maintain in current condition, over paint with a lead-free paint as part of ongoing maintenance. Remove under controlled conditions in accordance with AS 4361.2, Guide to hazardous paint management - 2017 Part 2: Lead paint in residential, public and commercial buildings prior to renovation or demolition works. Conduct a risk assessment to determine the level of remediation controls required.	9

Line ID 8: Internal, Ground Level, Turbot St Heritage Building, South Tenancy, Walls, Green Paint - Lead Detected (0.22% w/w)

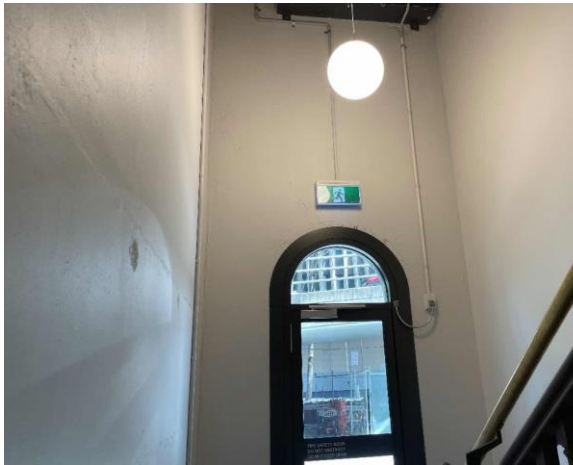
Line ID 9: Internal, Ground Level and Level 1, Turbot St Heritage Building, Northern Stairwell, Throughout, Walls, White Paint - Lead Detected (0.90% w/w)

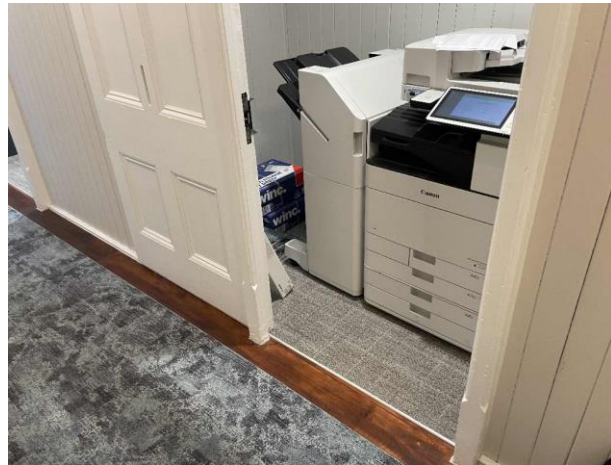
Line ID 10: Internal, Level 1, Turbot St Heritage Building, Throughout, Original Timberwork, White Paint - Lead Detected (4.5% w/w)

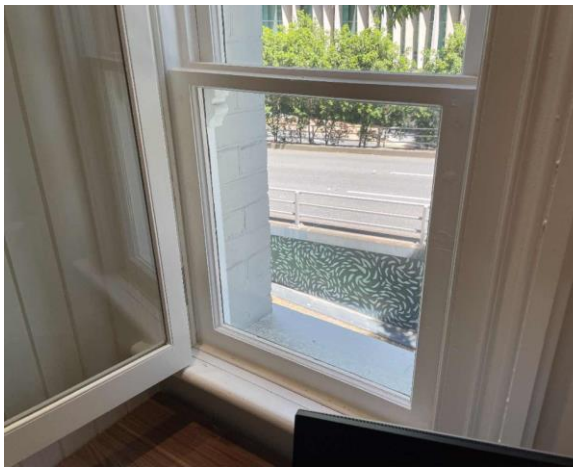
Line ID 11: Internal, Level 1, Turbot St Heritage Building, Throughout, Original Window Frames, White Paint - Lead Detected (13% w/w)

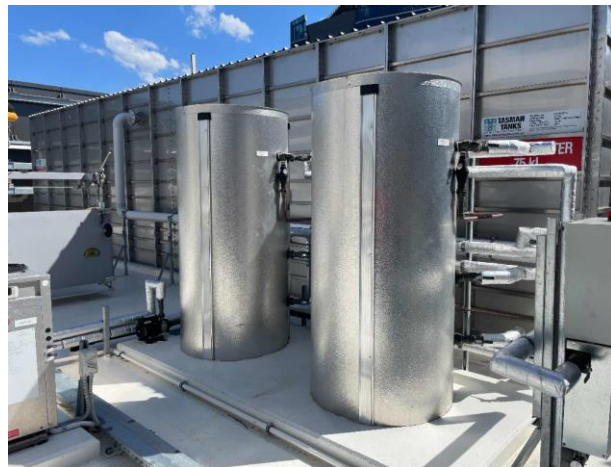
External	Level 32 / Roof Plant Area / Adjacent to Water Tank / Hot Water Units	Internal Insulation	SMF	754-SYDEN228268 339S5	Suspected SMF	-	2 Units	Very Low	-	Maintain in current condition if to remain in-situ. Remove under controlled SMF conditions as per the Code of Practice for the Safe Use of Synthetic Mineral Fibres [NOHSC: 2006 (1990)].	12
Internal	All Levels / Electrical Room / Throughout / Cable Conduits	Insulation Material	SMF	754-SYDEN228268 339S4	Suspected SMF	-	20 m	Very Low	-	Maintain in current condition if to remain in-situ. Remove under controlled SMF conditions as per the Code of Practice for the Safe Use of Synthetic Mineral Fibres [NOHSC: 2006 (1990)].	13

Line ID 12: External, Level 32, Roof Plant Area, Adjacent to Water Tank, Hot Water Units, Internal Insulation - Suspected SMF

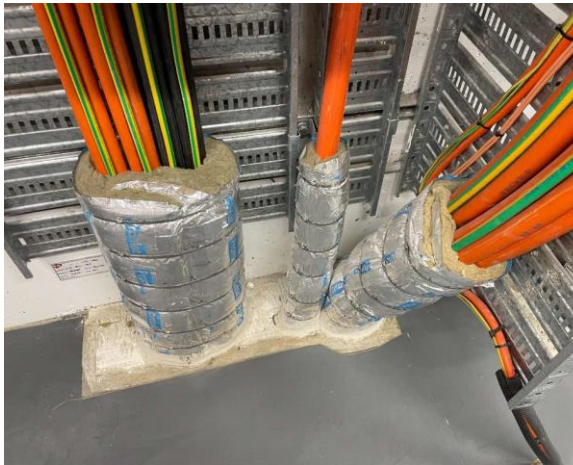
Line ID 13: Internal, All Levels, Electrical Room Throughout, Cable Conduits, Insulation Material - Suspected SMF

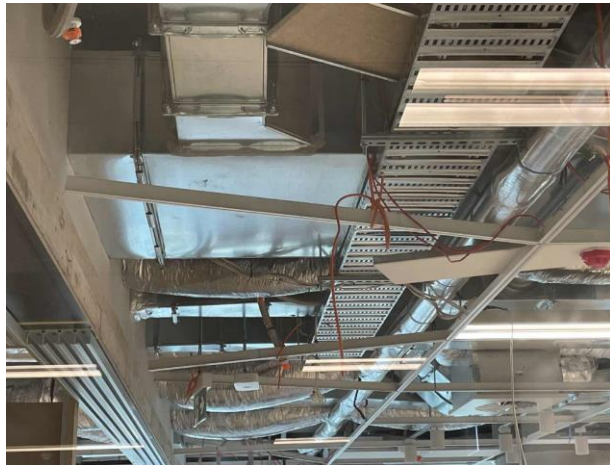
Line ID 14: Internal, All Levels, Office Areas, Ceiling Space, Ductwork and Pipework, Insulation Material - Suspected SMF

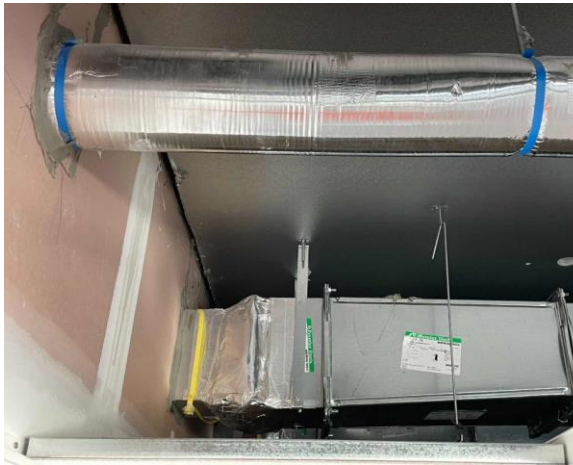
Line ID 14.1: Internal, All Levels, Office Areas, Ceiling Space, Ductwork and Pipework, Insulation Material - Suspected SMF

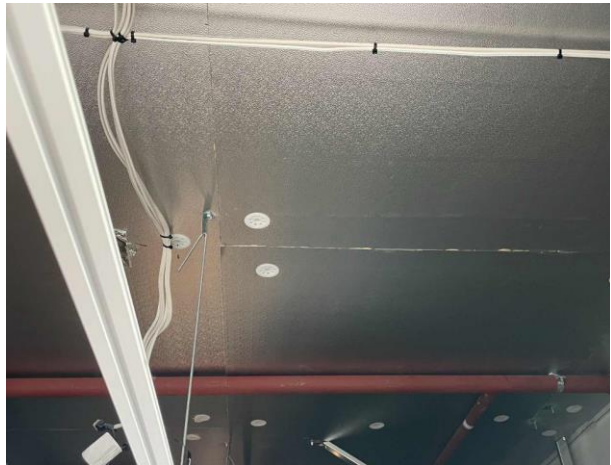
Line ID 15: Internal, All Levels, Office Areas, Ceiling Space, Lining, Insulation Material - Suspected SMF

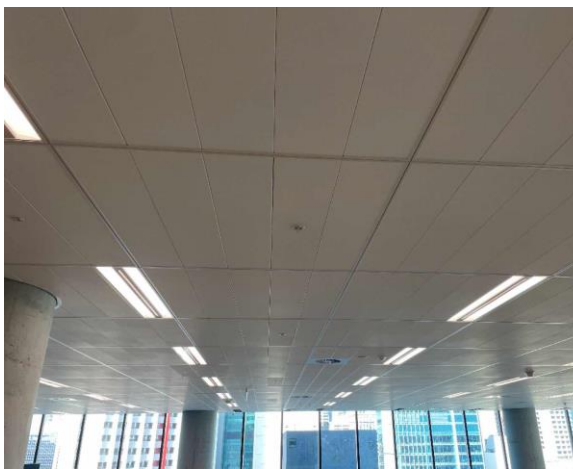
Line ID 16: Internal, All Levels, Office Areas, Throughout, Compressed Ceiling Tiles - Suspected SMF

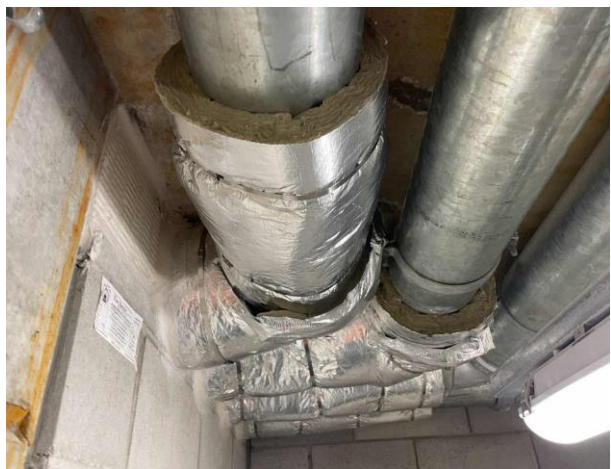
Internal	All Levels / Service Areas and Risers / Throughout / Pipework	Insulation Material	SMF	754-SYDEN228268339S2	Suspected SMF	-	500 m	Very Low	-	Maintain in current condition if to remain in-situ. Remove under controlled SMF conditions as per the Code of Practice for the Safe Use of Synthetic Mineral Fibres [NOHSC: 2006 (1990)].	17
Internal	All Levels / Stairwells / Hydrant Pipework	Insulation Material	SMF	754-SYDEN228268339S1	Suspected SMF	-	50 m	Very Low	-	Maintain in current condition if to remain in-situ. Remove under controlled SMF conditions as per the Code of Practice for the Safe Use of Synthetic Mineral Fibres [NOHSC: 2006 (1990)].	18
Internal	Ground Level / Turbot St Heritage Building / Underside of Ceiling, Air Conditioning Ductwork	Insulation Material	SMF	754-SYDEN228268339S21	Suspected SMF	-	30 m²	Very Low	-	Maintain in current condition if to remain in-situ. Remove under controlled SMF conditions as per the Code of Practice for the Safe Use of Synthetic Mineral Fibres [NOHSC: 2006 (1990)].	19

Line ID 17: Internal, All Levels, Service Areas and Risers Throughout, Pipework, Insulation Material - Suspected SMF

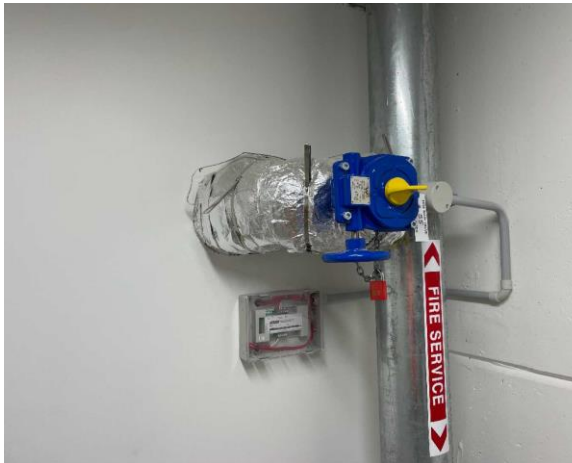
Line ID 18: Internal, All Levels, Stairwells, Hydrant
Pipework, Insulation Material - Suspected SMF

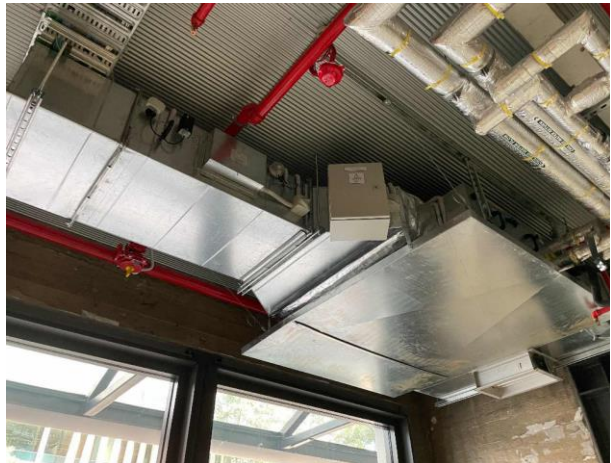
Line ID 19: Internal, Ground Level, Turbot St Heritage
Building, Underside of Ceiling, Air Conditioning Ductwork,
Insulation Material - Suspected SMF

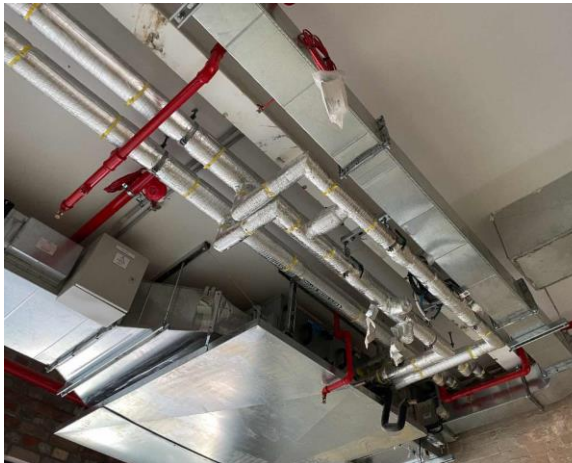
Line ID 20: Internal, Ground Level, Turbot St Heritage
Building, Underside of Ceiling, Pipework, Insulation
Material - Suspected SMF

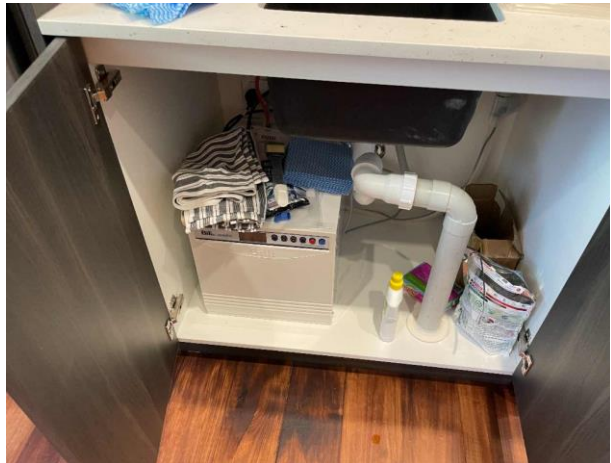
Line ID 21: Internal, Level 1, Turbot St Heritage Building, Staff
Room, Below Sink, Hot Water Unit, Internal Insulation -
Suspected SMF

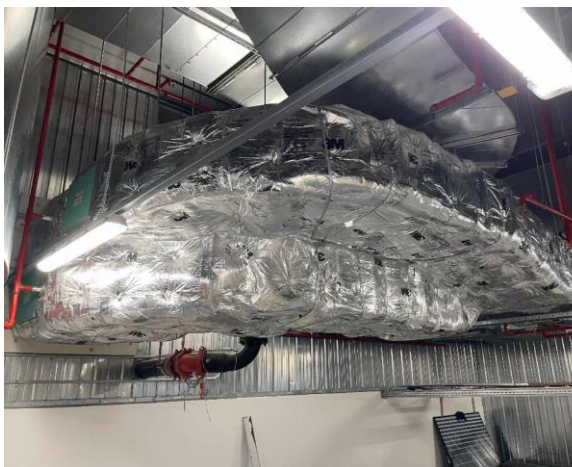
Line ID 22: Internal, Level 15, Plant Room, Air
Conditioning Ductwork, Insulation Material -
Suspected SMF

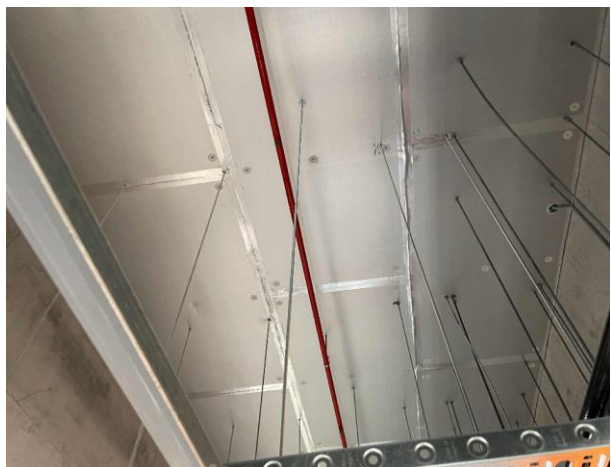
Internal	Level 15 / Plant Room / Ceiling Lining	Insulation Material	SMF	754-SYDEN228268339S17	Suspected SMF	-	500 m²	Very Low	-	Maintain in current condition if to remain in-situ. Remove under controlled SMF conditions as per the Code of Practice for the Safe Use of Synthetic Mineral Fibres [NOHSC: 2006 (1990)].	23
Internal	Level 15 / Plant Room / Pipework	Insulation Material	SMF	754-SYDEN228268339S18	Suspected SMF	-	100 m	Very Low	-	Maintain in current condition if to remain in-situ. Remove under controlled SMF conditions as per the Code of Practice for the Safe Use of Synthetic Mineral Fibres [NOHSC: 2006 (1990)].	24
Internal	Level 31 / Plant Room / Air Conditioning Ductwork	Insulation Material	SMF	754-SYDEN228268339S14	Suspected SMF	-	80 m	Very Low	-	Maintain in current condition if to remain in-situ. Remove under controlled SMF conditions as per the Code of Practice for the Safe Use of Synthetic Mineral Fibres [NOHSC: 2006 (1990)].	25

Line ID 23: Internal, Level 15, Plant Room, Ceiling Lining,
Insulation Material - Suspected SMF

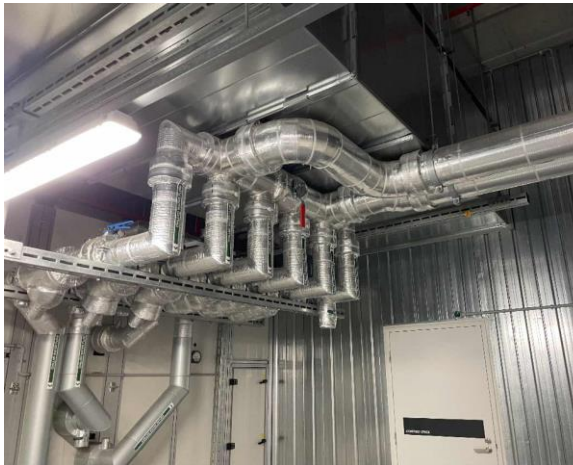
Line ID 24: Internal, Level 15, Plant Room, Pipework, Insulation Material - Suspected SMF

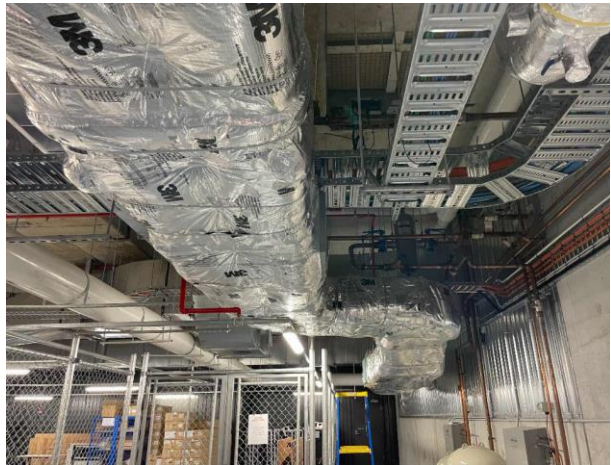
Line ID 25: Internal, Level 31, Plant Room, Air Conditioning Ductwork, Insulation Material - Suspected SMF

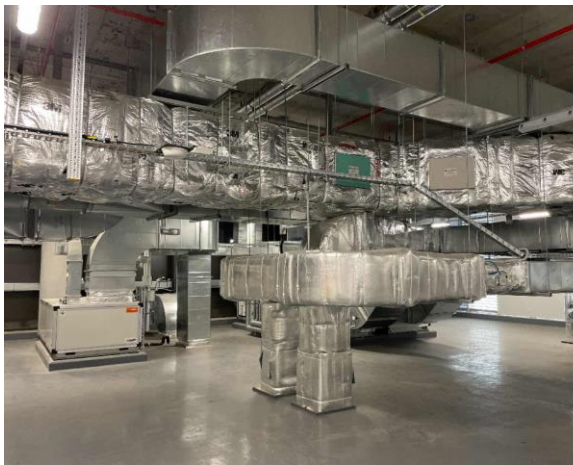
Line ID 26: Internal, Level 32, Plant Room Throughout, Air Conditioning Ductwork, Insulation Material - Suspected SMF

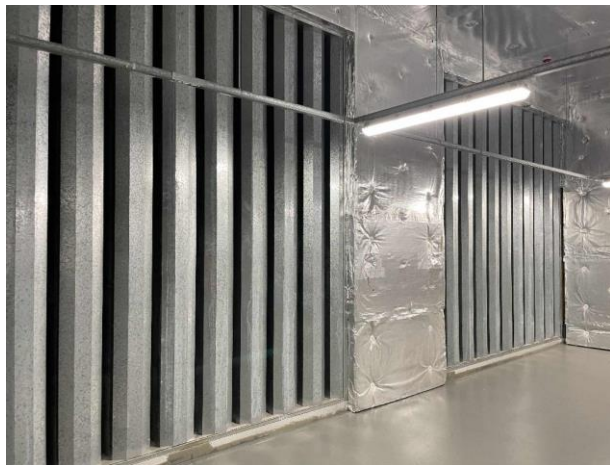
Line ID 27: Internal, Level 6, Generator Room, Sound Attenuators, Insulation Material - Suspected SMF

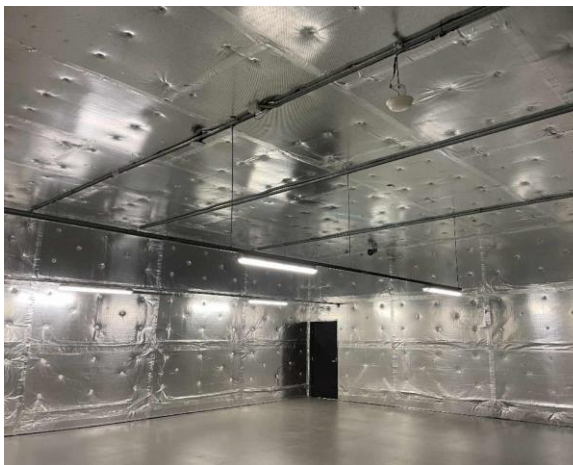
Line ID 28: Internal, Level 6, Generator Room, Throughout Wall and Ceiling Lining, Insulation Material - Suspected SMF

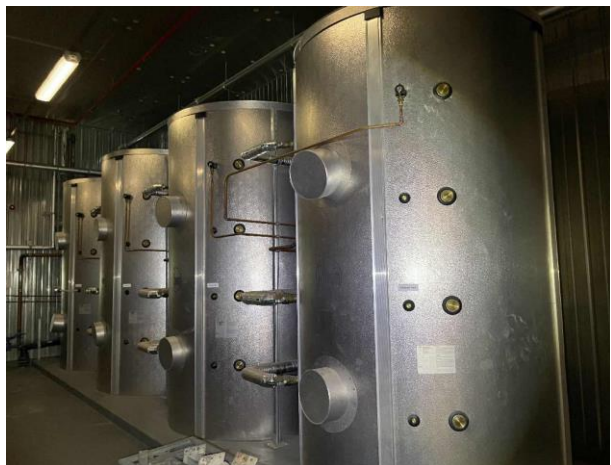
Internal	Level 6 / HWP Room / Large Rheem Hot Water Units	Internal Insulation	SMF	754-SYDEN228268339S3	Suspected SMF	-	4 Units	Very Low	-	Maintain in current condition if to remain in-situ. Remove under controlled SMF conditions as per the Code of Practice for the Safe Use of Synthetic Mineral Fibres [NOHSC: 2006 (1990)].	29
Internal	Level 6 / Plant Room / Throughout / Air Conditioning Ductwork	Insulation Material	SMF	754-SYDEN228268339S15	Suspected SMF	-	200 m²	Very Low	-	Maintain in current condition if to remain in-situ. Remove under controlled SMF conditions as per the Code of Practice for the Safe Use of Synthetic Mineral Fibres [NOHSC: 2006 (1990)].	30
Internal	Level 6 / Plant Room / Throughout / Pipework	Insulation Material	SMF	754-SYDEN228268339S16	Suspected SMF	-	100 m	Very Low	-	Maintain in current condition if to remain in-situ. Remove under controlled SMF conditions as per the Code of Practice for the Safe Use of Synthetic Mineral Fibres [NOHSC: 2006 (1990)].	31

Line ID 29: Internal, Level 6, HWP Room, Large Rheem Hot Water Units, Internal Insulation - Suspected SMF

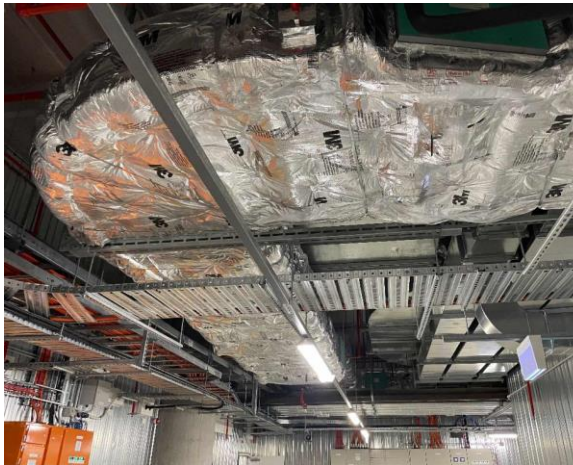
Line ID 30: Internal, Level 6, Plant Room Throughout, Air Conditioning Ductwork, Insulation Material - Suspected SMF

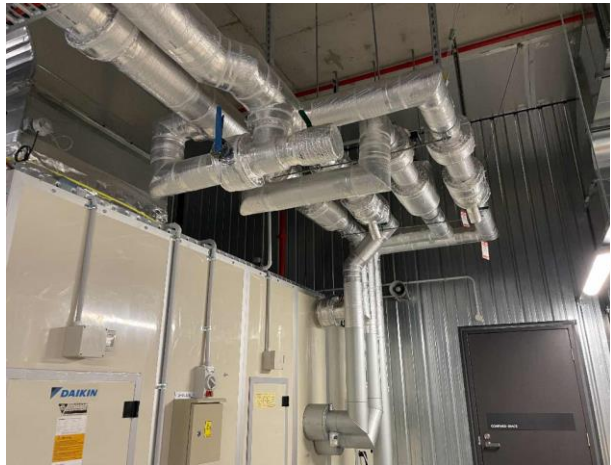
Line ID 31: Internal, Level 6, Plant Room Throughout, Pipework, Insulation Material - Suspected SMF

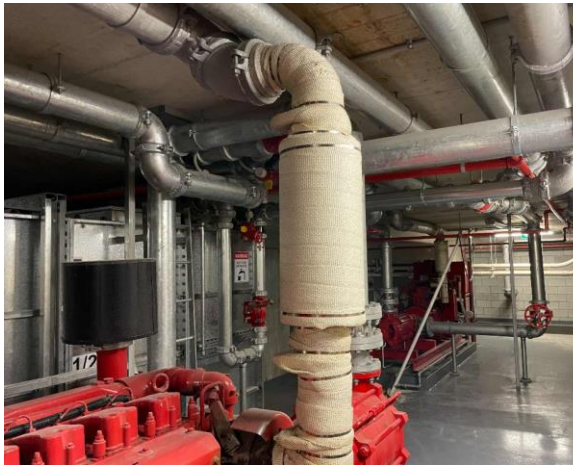
Line ID 32: Internal, Level B1, Fire Pump Room, 3x Pumps, Exhaust Pipes, Insulation Material - Suspected SMF

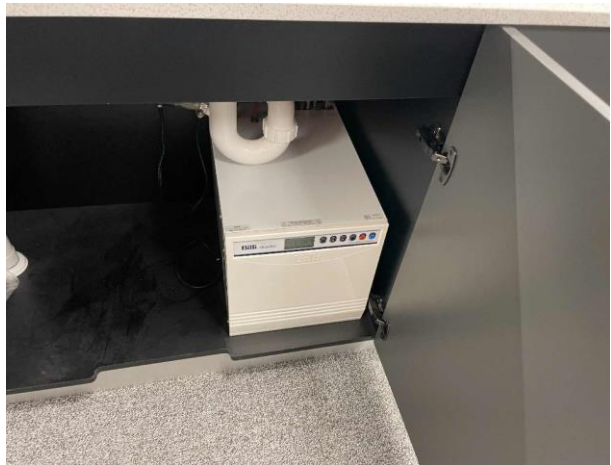
Line ID 33: Internal, Level B1, Security Room Adjacent Entrance Driveway, Below Sink, Zip Boiler, Internal Insulation - Suspected SMF

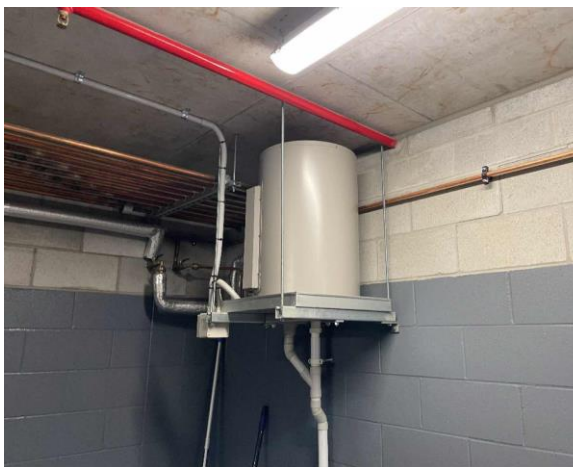
Line ID 34: Internal, Level B1, Waste Room, South Side, Hot Water Heater, Internal Insulation - Suspected SMF

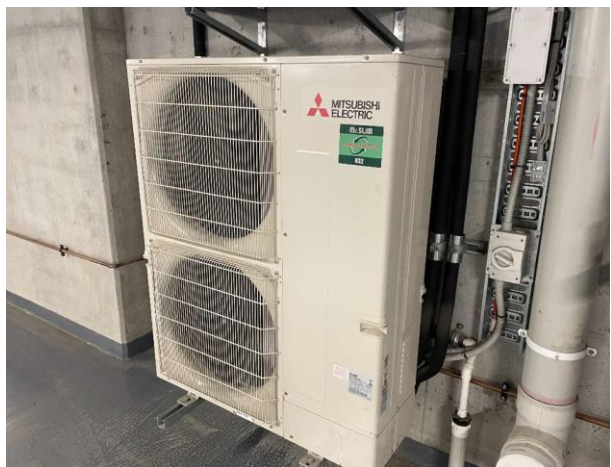
Line ID 35: Internal, All Levels, Plant Areas, Various Areas, Air Conditioning Units, R32 Refrigerant - Non ODS Refrigerant

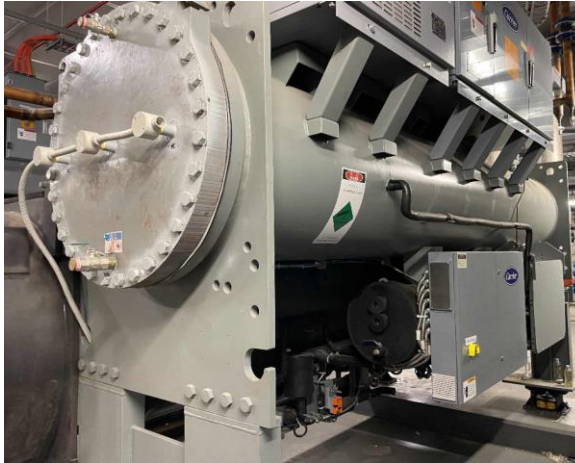
Line ID 36: Internal, Level 6, Chiller Room, Chillers,
R1233ZD Refrigerant - Non ODS Refrigerant
