**Mirvac Real Estate Pty Ltd**

**Asbestos and Hazardous Materials  
Re-Inspection**

380 St Kilda Road, Melbourne VIC 3000

4 February 2020

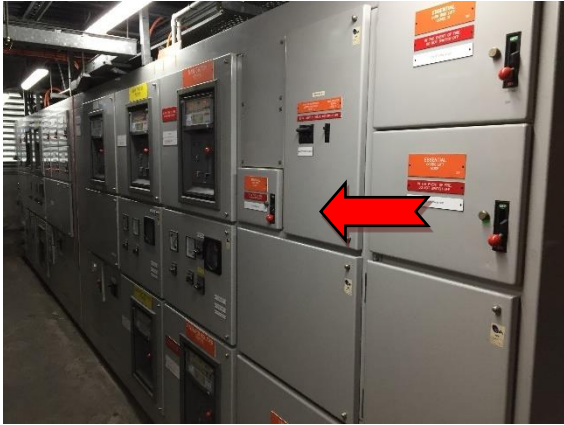
**Photo 1** Interior: carpark level 8, main switch room, switchboard – suspected asbestos containing fuses.

| Area / Level | Room & Location | Feature | Item Description | Hazard Type | Sample No. | Sample Status | Friable | Asbestos Type | Product Type | Extent of Damage | Surface Treatment | Occupant Activity | Likelihood of Disturbance | Exposure Potential | Maintenance Activity | Risk Score | Action | Recommendations & Comments | Quantity | Reinspect Date | Photo No. |
|---|---|---|---|---|---|---|---|---|---|---|---|---|---|---|---|---|---|---|---|---|---|
| Interior: Carpark level 8 | Main switch room | Switchboard | Fuses | Asbestos | Visual Observation | Suspected Asbestos | Y | 3 | 1 | 0 | 0 | 0 | 0 | 0 | 1 | 5 | A4 | Confirm status, label as containing asbestos and maintain in current condition if to remain in-situ. Remove under controlled friable asbestos removal conditions prior to refurbishment or demolition works by a Class A (friable) licensed asbestos removal contractor. | Unknown | Nov-24 | 1 |

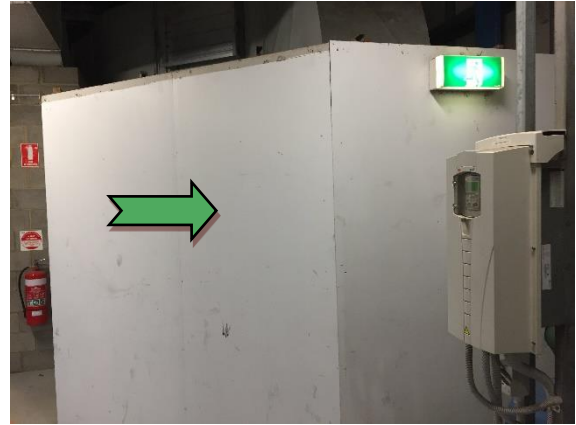
**Photo 2** Interior: level 16, plant room, partition walls to diesel room – non-asbestos containing fibre cement sheet.

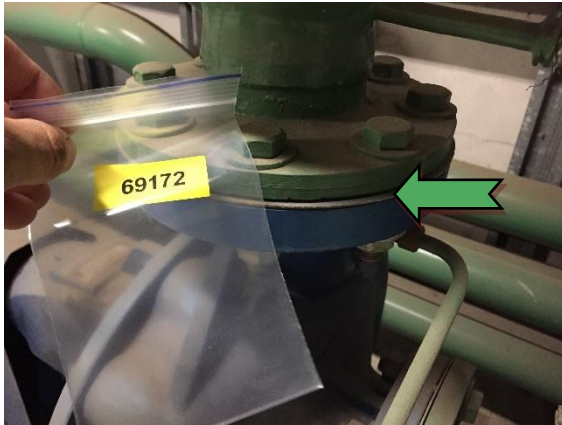
**Photo 3** Interior: level 16, plant room, pump machinery – non-asbestos containing gasket material.

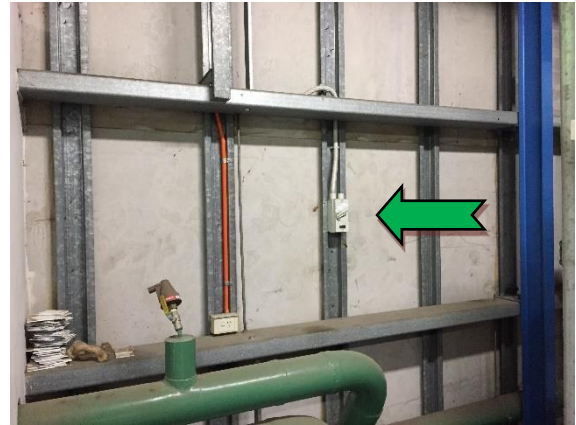
**Photo 4** Interior: level 16, plant room, internal walls – non-asbestos containing fibre cement sheet.

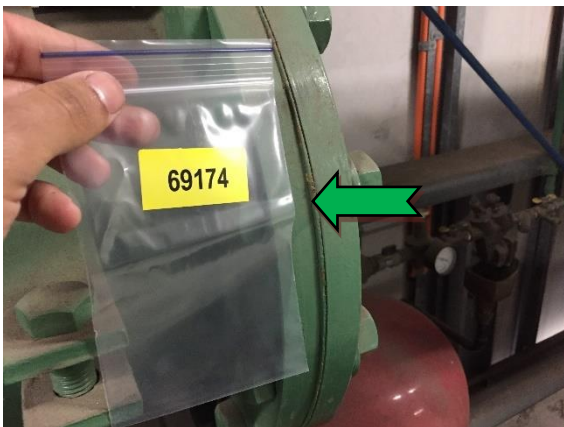
**Photo 5** Interior: level 16, plant room, pump machinery – non-asbestos containing gasket material.

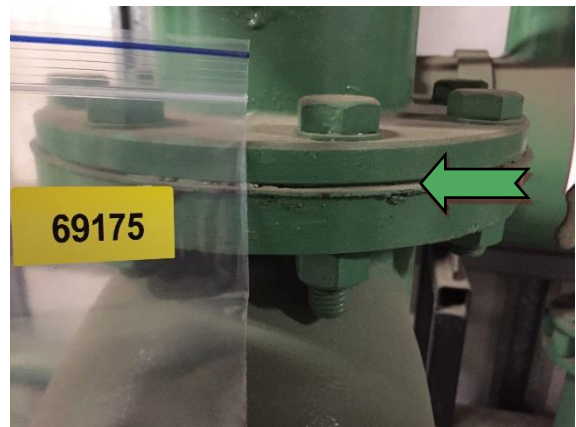
**Photo 6** Interior: level 16, plant room, pump machinery – non-asbestos containing gasket material.

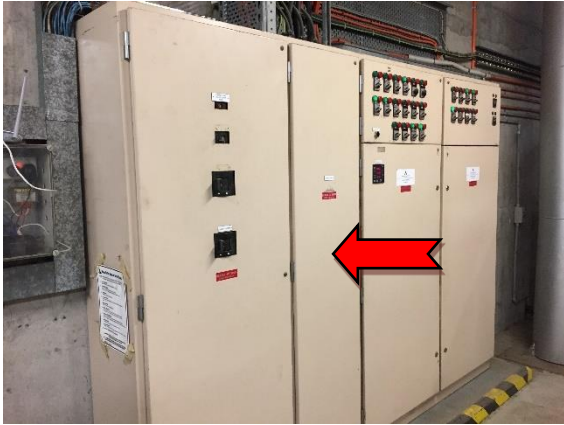
**Photo 7** Interior: level 16, plant room, switchboard – suspected asbestos containing fuses.

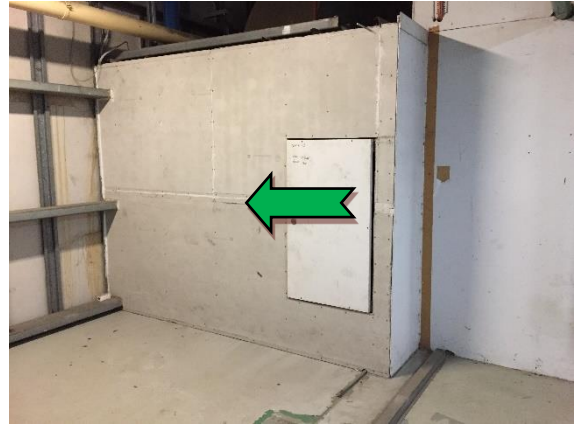
**Photo 8** Interior: level 16, plant room, partition walls to diesel storage area – non-asbestos containing fibre cement sheet.

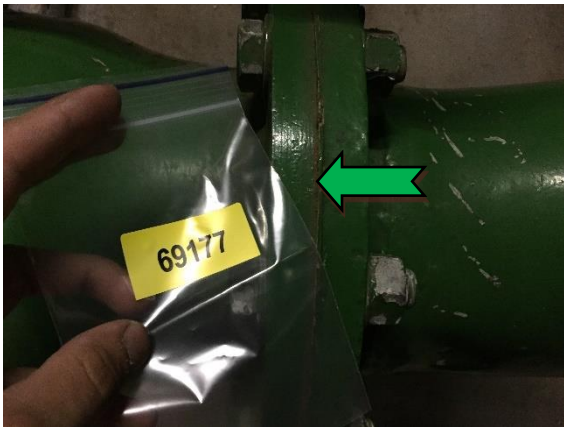
**Photo 9** Interior: level 16, plant room, York chiller – non-asbestos containing gasket material.

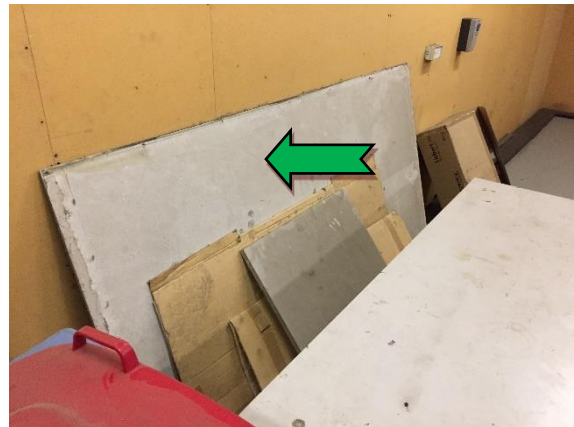
**Photo 10** Interior: level 16, plant room, diesel storage area, stored panel – non-asbestos containing fibre cement sheet.

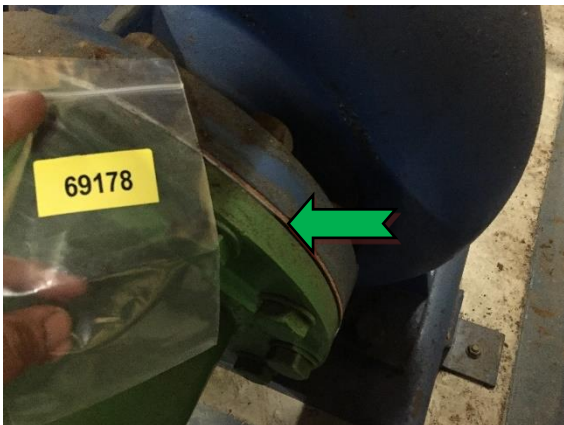
**Photo 11** Interior: level 16, plant room, pump adjacent York chiller – non-asbestos containing gasket material.

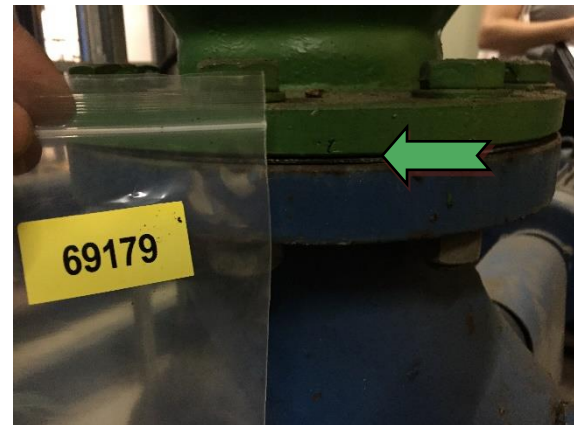
**Photo 12** Interior: level 16, plant room, pump adjacent York chiller – non-asbestos containing gasket material.

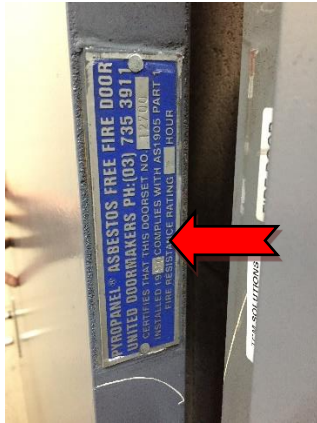
**Photo 13** Interior: all levels, throughout, fire doors – suspected asbestos containing fire door core.

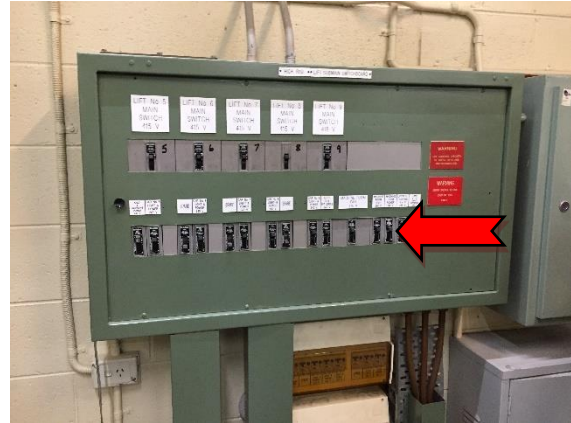
**Photo 14** Interior: lift motor room, switchboard – suspected asbestos containing fuses.

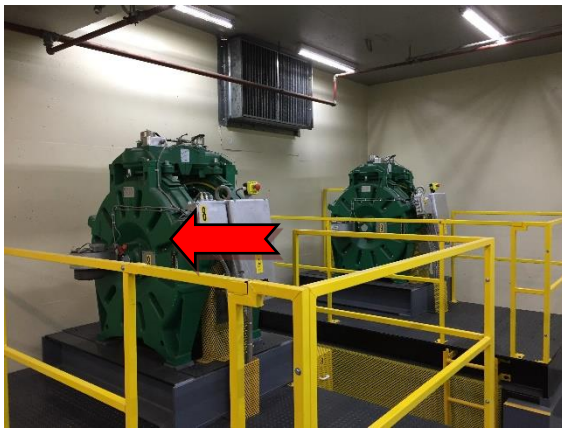
**Photo 15** Interior: lift motor room, lift motor – suspected asbestos containing friction pads.

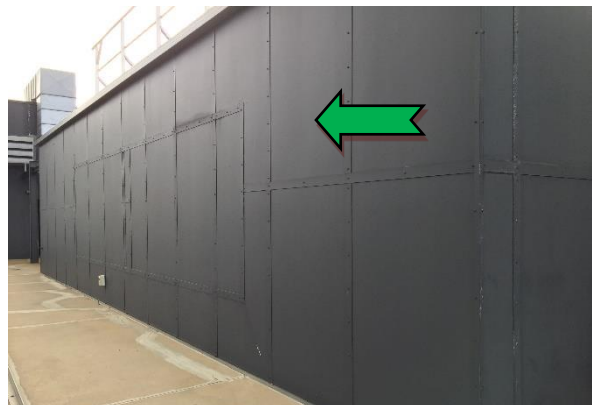
**Photo 16** Exterior: roof, external walls – non-asbestos containing fibre cement sheet.

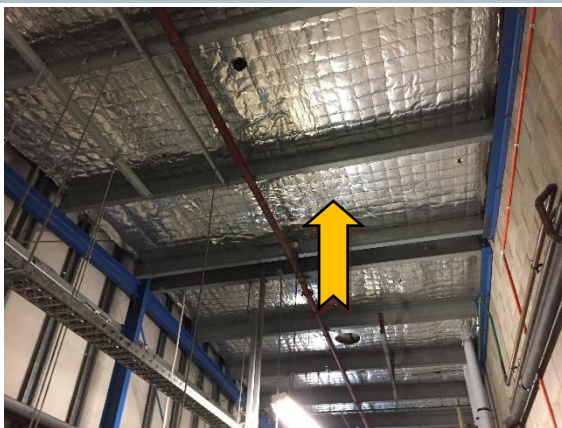
**Photo 17** Interior: level 16, plant room, ceiling – suspected SMF containing sarking insulation.

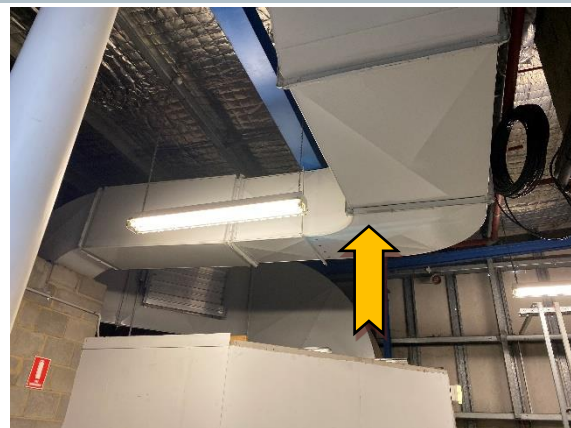
**Photo 18** Interior: level 16, plant room, throughout, air conditioning ductwork – suspected SMF containing internal insulation material.

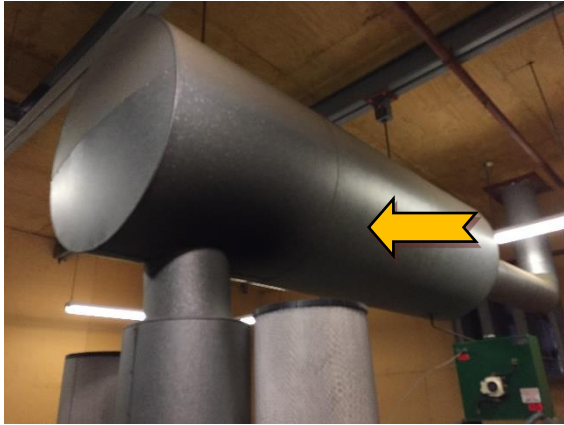
**Photo 19** Interior: level 16, plant room, diesel storage area, diesel pump – suspected SMF containing internal insulation material.

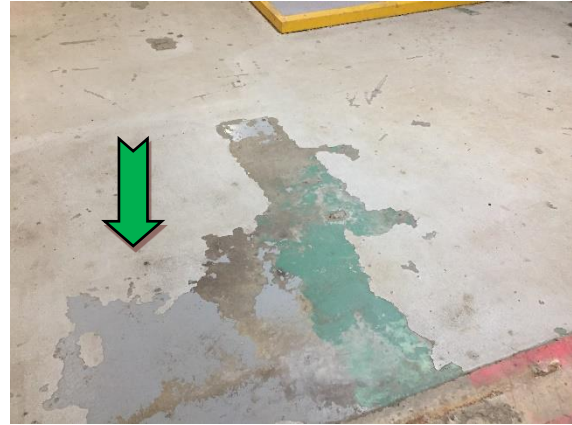
**Photo 20** Interior: level 16, plant room, floor throughout, non-lead based blue paint.

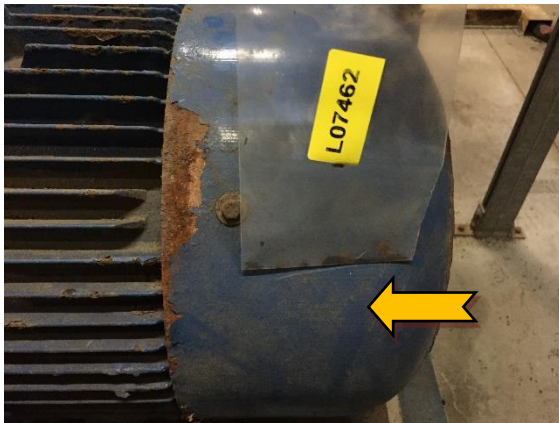
**Photo 21** Interior: level 16, throughout plant room, machinery – lead based blue paint (0.96%w/w).

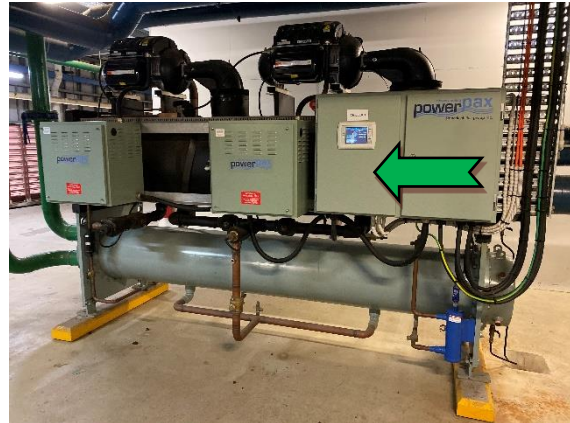
**Photo 22** Interior: level 16, plant room, Power Pax chiller – non-ODS containing R134a hydrofluorocarbon refrigerant.

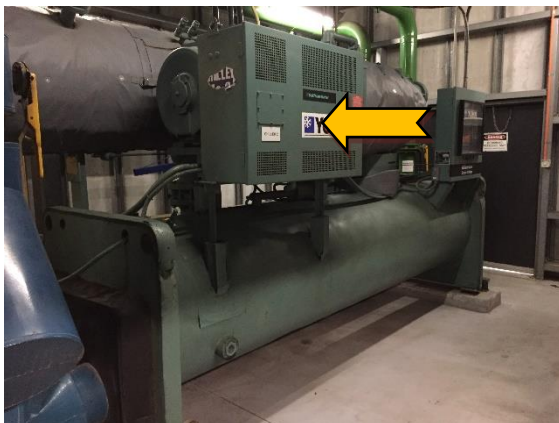
**Photo 23** Interior: level 16, plant room, York chiller – ODS containing R22 Hydrochlorofluorocarbon (HCFC) refrigerant.

Removal should be undertaken prior to any demolition. A licensed contractor who will recycle and reuse the refrigerant should decommission the CFC and HCFC based equipment that is being disposed of in accordance with Association of Fluorocarbon Consumers and Manufacturers, *The Australian Refrigeration and Air Conditioning Code of Good Practice* – 1992 and the Australian Commonwealth Government Ozone Protection Act – 1989.
