# Asbestos & Hazardous Materials Survey

## AMP Capital

700 Bourke Street  
Docklands VIC 3000

December 2020

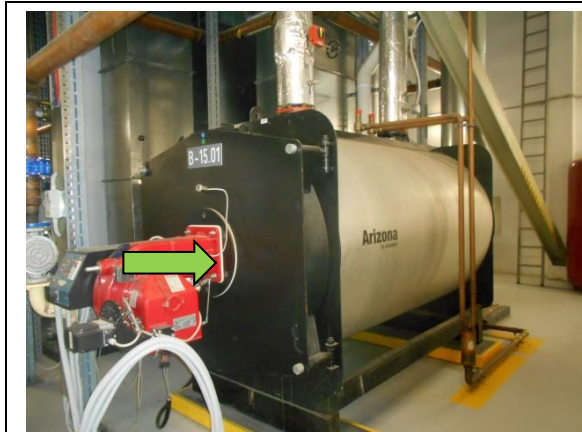
**Photo 1:** Level 15, Plant Room, Boiler Room, Motor to Boiler – Non-asbestos containing gaskets

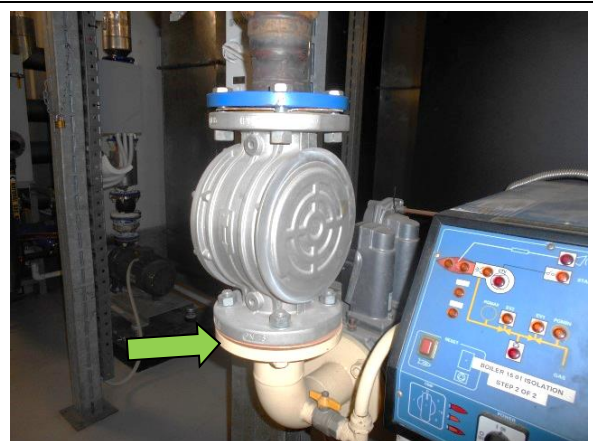
**Photo 2:** Level 15, Plant Room, Boiler Room, Pipework to Boiler – Non-asbestos containing gaskets

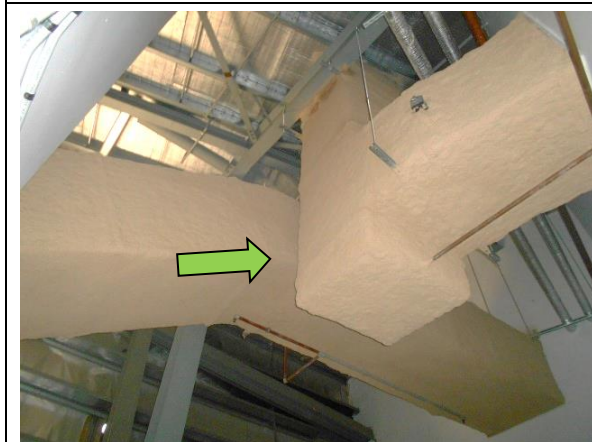
**Photo 3:** Level 15, Plant Room, Ductwork, Sprayed Insulation – Non-asbestos insulation material

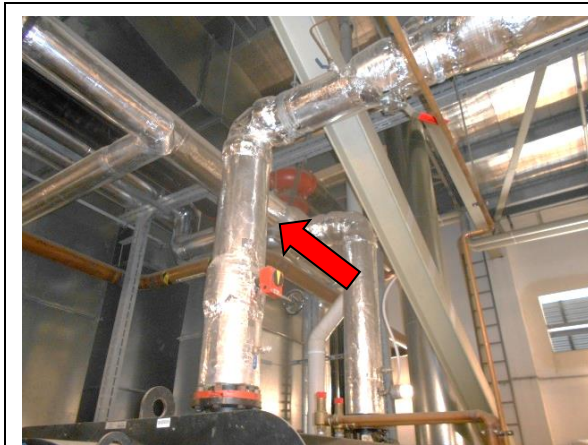
**Photo 4:** Roof Level, Boiler Room – SMF to pipework insulation

Location Item Description	Photo No.	Form	Extent	Condition	Risk Status	Control Recommendations
<b>Roof Level</b>						
No SMF materials identified	-	-	-	-	-	-
<b>Level 15 Plant Room</b>						
Boiler Plant Room Hot Water Pipework - Insulation	4	Bonded	~40 m	Good	Low	Maintain in good condition. Remove under controlled conditions prior to demolition/refurbishments.
Boiler Room, Boiler - Insulation	5	Bonded	2 units	Good	Low	Maintain in good condition. Remove under controlled conditions prior to demolition/refurbishments.
Plant Room Adjacent Potable Water Tank Internal Insulation to Hot Water Units	6	Bonded	~6 units	Good	Low	Maintain in good condition. Remove under controlled conditions prior to demolition/refurbishments.
<b>Office Levels 1-14</b>						
Electrical/Communications Rooms Fire Stopping Insulation	7	Bonded	~40m <sup>2</sup>	Good	Low	Maintain in good condition. Remove under controlled conditions prior to demolition/refurbishments.

- No asbestos materials were identified on site therefore an Asbestos Management Plan is not required to be developed for the site.
- Maintain identified SMF containing materials in good condition. Remove under controlled conditions prior to demolition/refurbishment.

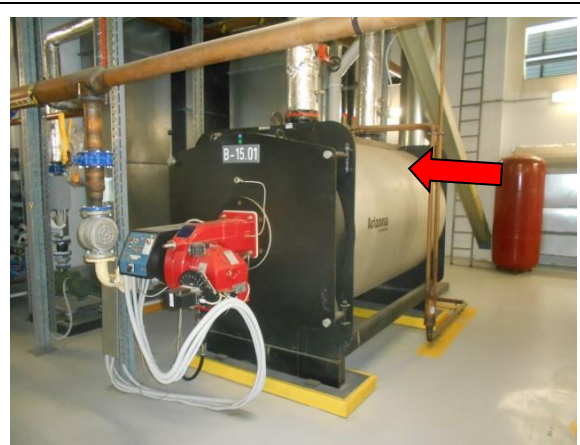
**Photo 5:** Roof Level, Boiler Room – SMF to internal areas of boiler

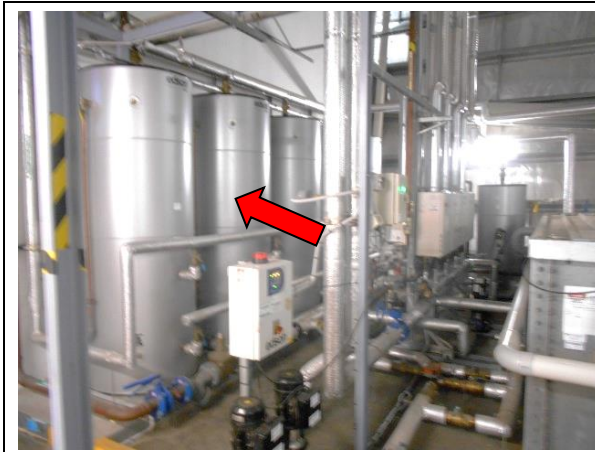
**Photo 6:** Level 15, Plant Room– SMF internal insulation to hot water units

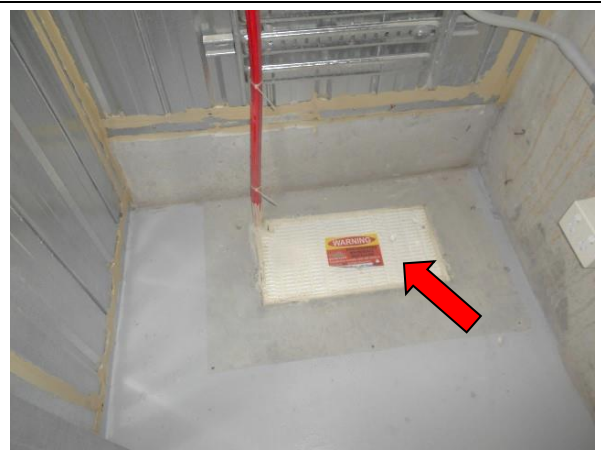
**Photo 7:** Office Levels, Electrical and Communications Cupboards – Fire stopping insulation to floor/ceiling penetrations

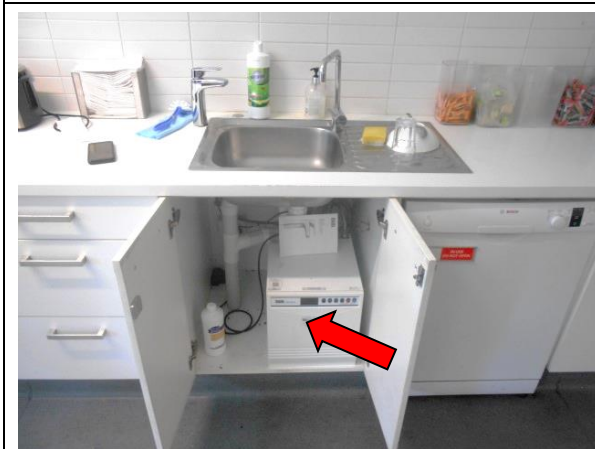
**Photo 8:** Office Levels, Kitchenettes– SMF internal insulation to hot water units

Kitchens Internal Insulation to Hot Water Units	8	Bonded	~14 units	Good	Low	Maintain in good condition. Remove under controlled conditions prior to demolition/refurbishments.
Ceiling Space Rigid Ductwork Insulation	-	Bonded	~800 m	Good	Low	Maintain in good condition. Remove under controlled conditions prior to demolition/refurbishments.
Ceiling Space Flexible Ductwork Insulation	9	Bonded	~800 m	Good	Low	Maintain in good condition. Remove under controlled conditions prior to demolition/refurbishments.
Ceiling Space Pipework Insulation	-	Bonded	~1000 m	Good	Low	Maintain in good condition. Remove under controlled conditions prior to demolition/refurbishments.
<b>Levels P1 &amp; P2</b>						
Main Switch Room Fire Stopping Insulation	-	Bonded	2 m <sup>2</sup>	Good	Low	Maintain in good condition. Remove under controlled conditions prior to demolition/refurbishments.

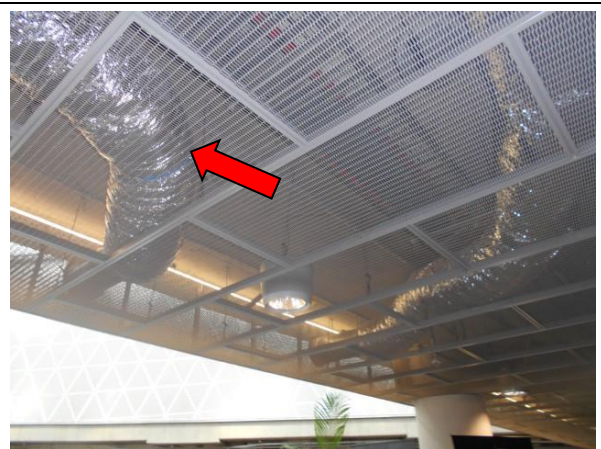
**Photo 9:** Office Levels, Ceiling Space– SMF to flexible ductwork insulation
