Asbestos & Hazardous Materials Survey

700 Bourke Street,
Melbourne VIC

February 2026

Report For	Mirvac
Address	700 Bourke Street, Melbourne VIC
Site Inspection By	Rehan Akram Consultant, RiskTech Compliance
Date of Inspection	2 February 2026
Conferred With	Ross Petousis Facility Supervisor, Mirvac

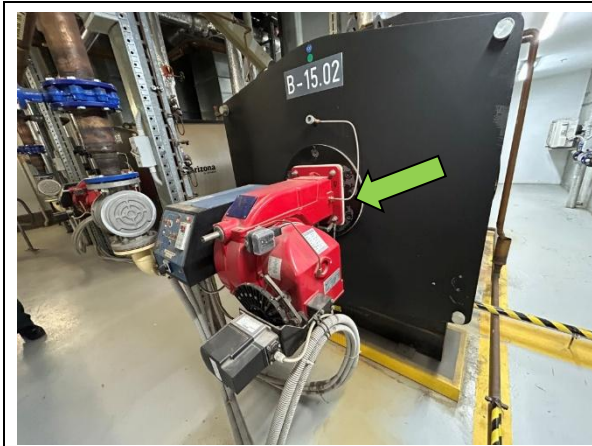
Photo 1: Level 15, Plant Room, Boiler Room, Motor to Boiler – Non-asbestos containing gaskets

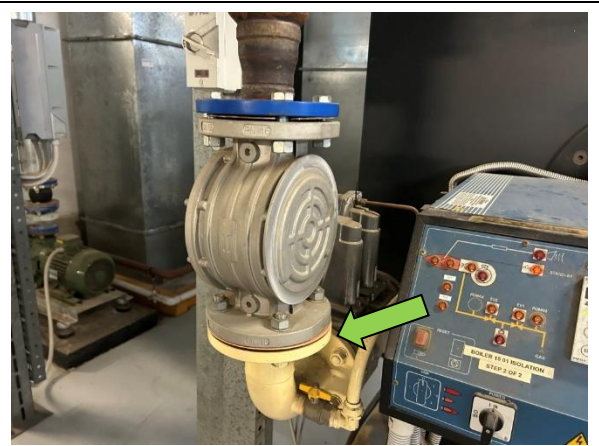
Photo 2: Level 15, Plant Room, Boiler Room, Pipework to Boiler – Non-asbestos containing gaskets

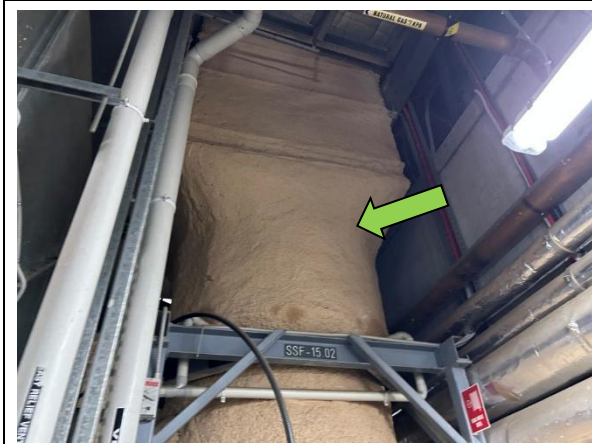
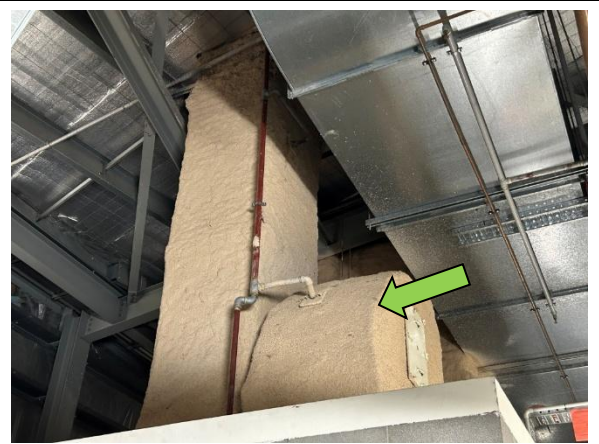
Photo 3 & 4: Level 15, Plant Room, Ductwork, Sprayed Insulation – Non-asbestos insulation material

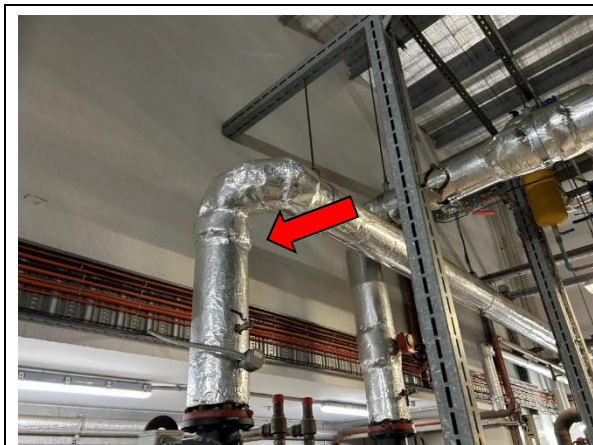
The SMF materials identified on site were generally in a good condition and installed to industry standards. These materials do not represent an increased health risk in their current condition.

Photo 5: Roof Level, Boiler Room – SMF to pipework insulation

- No asbestos materials were identified on site therefore an Asbestos Management Plan is not required to be developed for the site.
- Maintain identified SMF containing materials in good condition. Remove under controlled conditions prior to demolition/refurbishment.

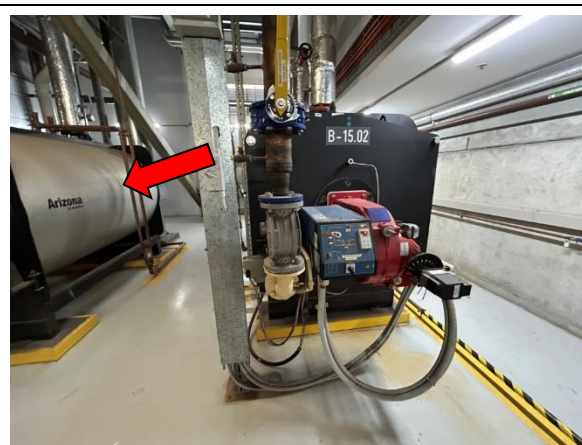
Photo 6: Roof Level, Boiler Room – SMF to internal areas of boiler

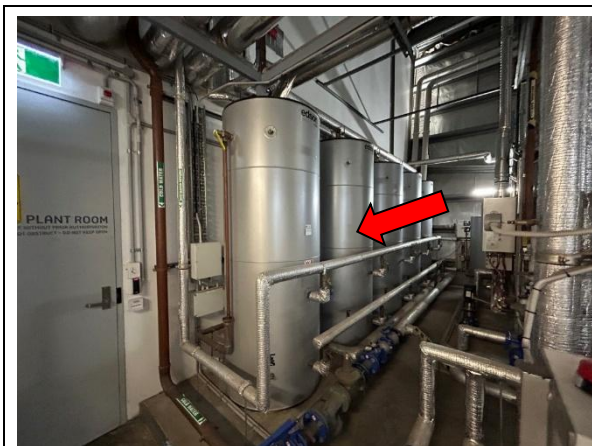
Photo 7: Level 15, Plant Room- SMF internal insulation to hot water units

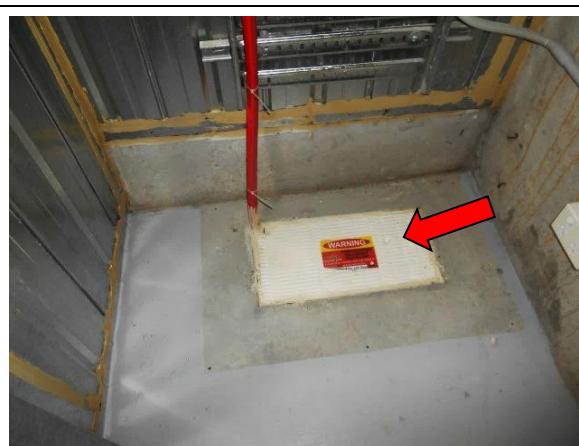
Photo 8: Office Levels, Electrical and Communications Cupboards – Fire stopping insulation to floor/ceiling penetrations

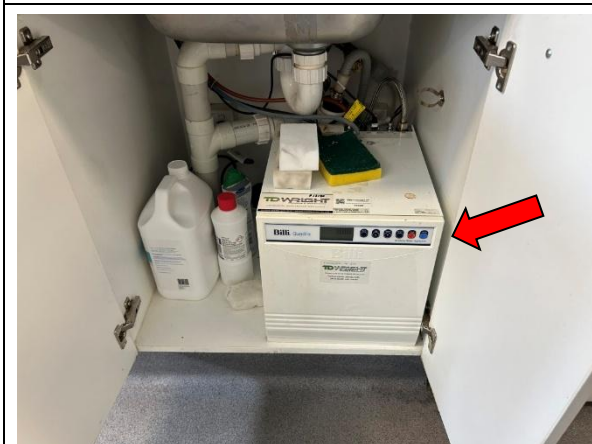
Photo 9: Office Levels, Kitchenettes- SMF internal insulation to hot water units

Kitchens Internal Insulation to Hot Water Units	9	Bonded	~14 units	Good	Low	Maintain in good condition. Remove under controlled conditions prior to demolition/refurbishments.
Ceiling Space Rigid Ductwork Insulation	-	Bonded	~800 m	Good	Low	Maintain in good condition. Remove under controlled conditions prior to demolition/refurbishments.
Ceiling Space Flexible Ductwork Insulation	10	Bonded	~800 m	Good	Low	Maintain in good condition. Remove under controlled conditions prior to demolition/refurbishments.
Ceiling Space Pipework Insulation	-	Bonded	~1000 m	Good	Low	Maintain in good condition. Remove under controlled conditions prior to demolition/refurbishments.
Interior – Level P1 & P2						
Main Switch Room Fire Stopping Insulation	-	Bonded	2 m ²	Good	Low	Maintain in good condition. Remove under controlled conditions prior to demolition/refurbishments.

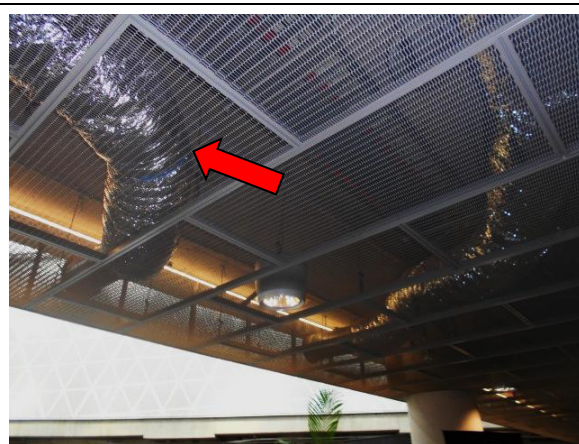
Photo 10: Office Levels, Ceiling Space- SMF to flexible ductwork insulation
