Asbestos and Hazardous Materials Pre-Demolition Assessment

90 Collins St

Melbourne CBD Vic 3000

17/03/2023

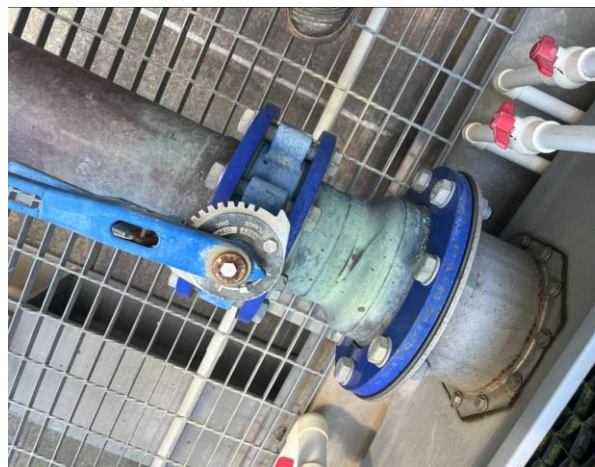
Line ID 5.1: External, Roof, West Plant Area, Cooling Tower Pipe , Gaskets - None Suspected

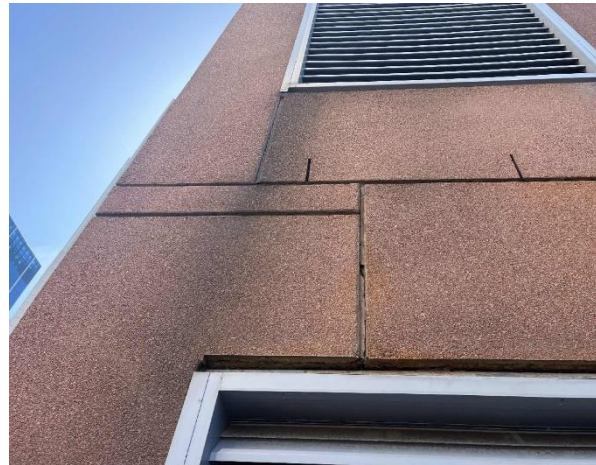
Line ID 6.1: External, Roof, West Plant Area, Expansion Joint Render to Concrete Wall Panels, Render - Chrysotile Asbestos Detected

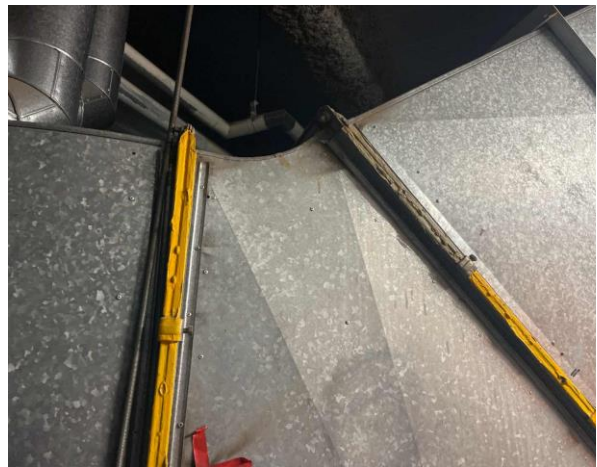
Line ID 48: Internal, L14, Plant Room, Around the Heater Core to the Ductwork, Heater Bank Insulation - Suspected Asbestos

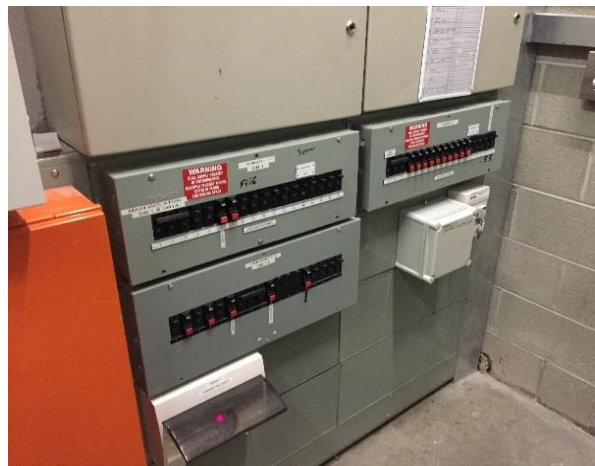
Line ID 68: Internal, L21, Plant Room, Electrical Services Cupboard, Arc Shields - Suspected Asbestos

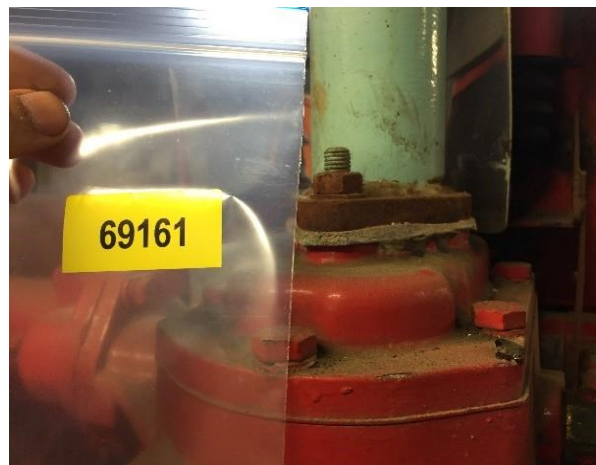
Line ID 86: Internal, L23, Plant Room, To Machinery, Grey Gasket Material - Chrysotile Asbestos Detected

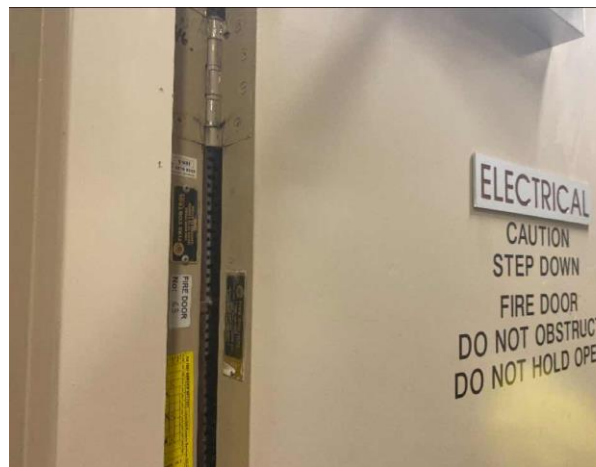
Line ID 94.2: Internal, L2-3, L5-13 and 15-21, Lift Lobby and Electrical Service Room, Fire Entry Door, Fire Door Core - Suspected Asbestos

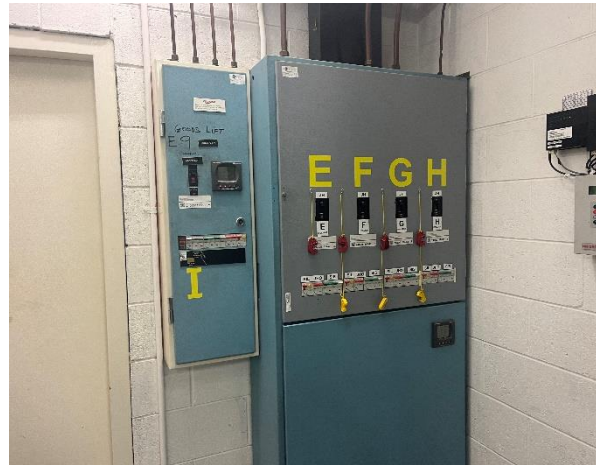
Line ID 95: Internal, L2-3, L5-13 and 15-21, Lift Lobby and Electrical Service Room, Grey Switchboards, HRC Fuses - Suspected Asbestos

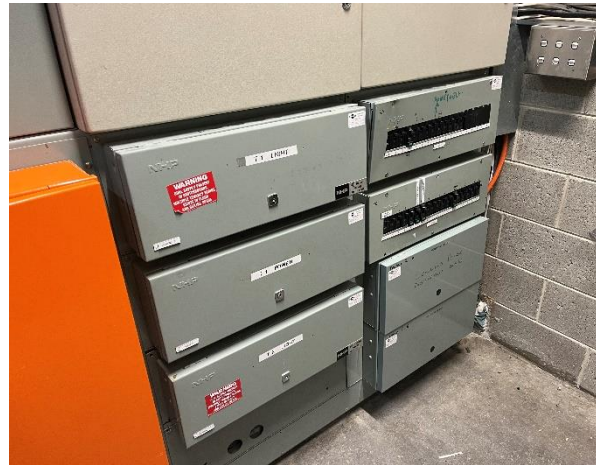
Line ID 95.2: Internal, L2-3, L5-13 and 15-21, Lift Lobby and Electrical Service Room, Grey Switchboards, HRC Fuses - Suspected Asbestos

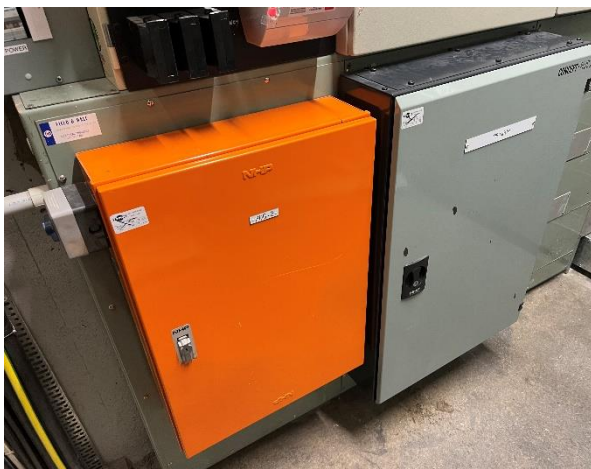
Line ID 95.3: Internal, L2-3, L5-13 and 15-21, Lift Lobby and Electrical Service Room, Grey Switchboards, HRC Fuses - Suspected Asbestos

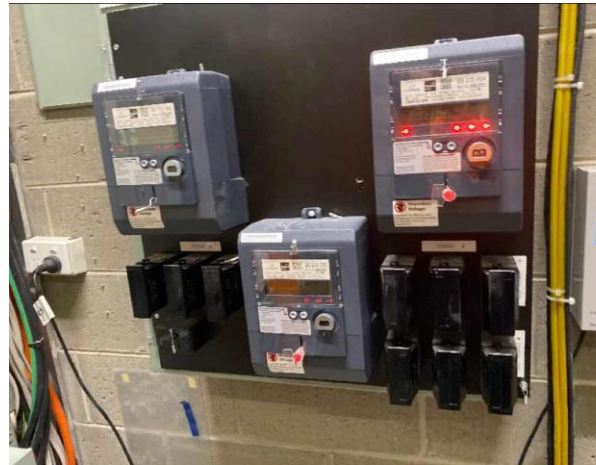
Line ID 102: Internal, L6, Lift Lobby Electrical Services Room, Black Switchboards, HRC Fuses - Suspected Asbestos

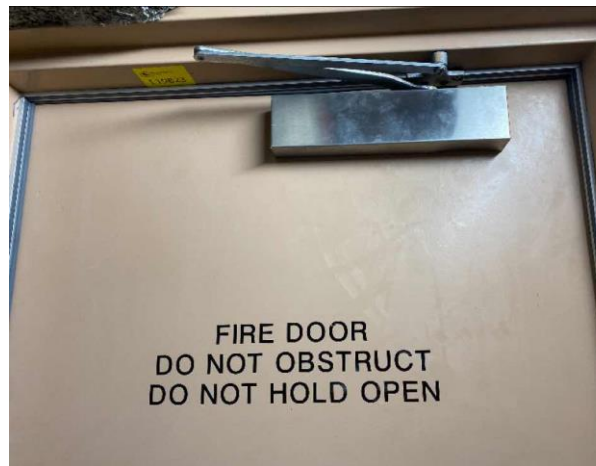
Line ID 110: Internal, L14, Plant Room, Fire Doors Throughout, Brown (Light) Paint - Lead Detected (0.15% w/w)

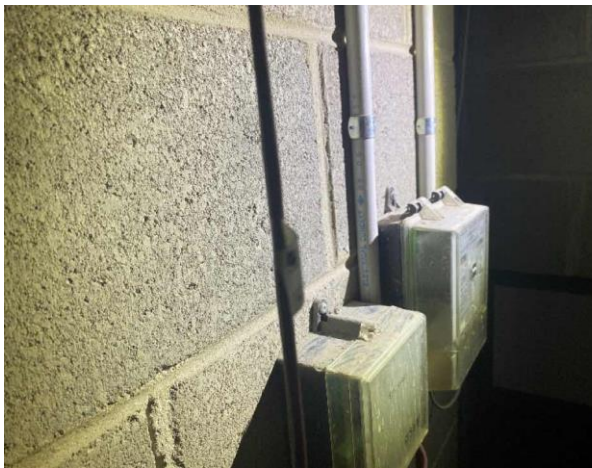
Line ID 116: Internal, L11, Pipe Riser, Pipe Riser Switchbanks, Dust - Lead Detected (180mg/kg)

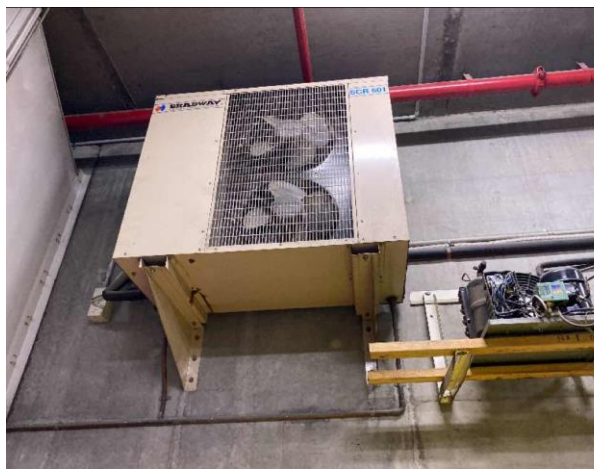
Line ID 171: Internal, GF, Car Park Plant Room, South Wall, Unknown Refrigerant - Suspected ODS

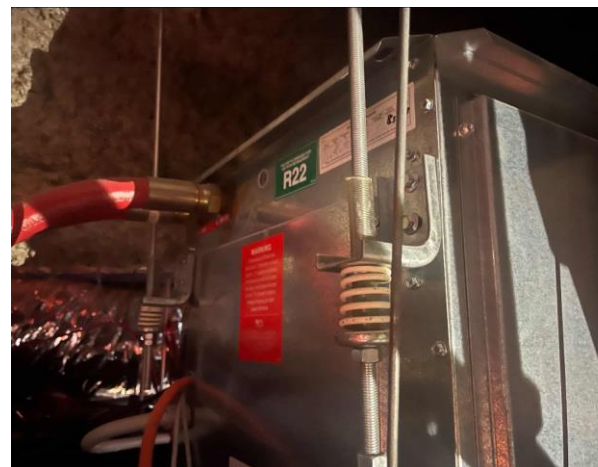
Line ID 174.3: Internal, L2-3, L5-13 and 15-21, Main Office, Ceiling Void Ductwork, R22 Hydrochlorofluorocarbon (HCFC) - ODS Refrigerant
