Asbestos & Hazardous Materials Survey

558 Little Bourke Street,
Melbourne VIC

October 2019

Report For:	AMP Capital
Address:	558 Little Bourke Street, Melbourne VIC
Prepared By:	Matthew Hyde, Senior Consultant (RiskTech Compliance)
Date of Inspection:	16 October 2019
Conferred With:	Darren Hynes, Senior Facilities Manager

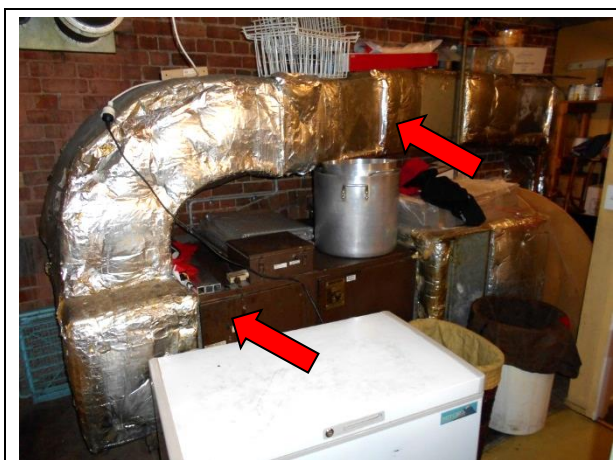
Asbestos Material	Location	Posed Risk	Extent
Mastic Sealant	Level 1, Restaurant Plant Room – Suspected mastic sealant attached to ductwork and exhaust fan	Low	~10 Joints

The asbestos containing materials (ACMs) suspected on site were generally found to be in a good/stable condition and do not represent an increased risk in their current condition.

Photo 1: Level 1, Restaurant Plant Room – Suspected mastic sealant attached to ductwork and exhaust fan

Level 1, Restaurant, Plant Room Exhaust Fan & Ductwork, Expansion Joints - Mastic sealant material *no access to joints (covered by insulation)	.*	Suspected Positive	1	~10 Joints	Good	Non Friable	Low	Low	June 2021	No	P4	Confirm status of material. If positive, label & maintain item in good condition. Remove by a Class A/B licensed asbestos contractor prior to refurbishment / demolition.
Level 1, Restaurant, Plant Room Floor Covering – Yellow sheet vinyl	Greencap J132800-AMP-003-001	Negative	-	-	-	-	-	-	-	-	-	-

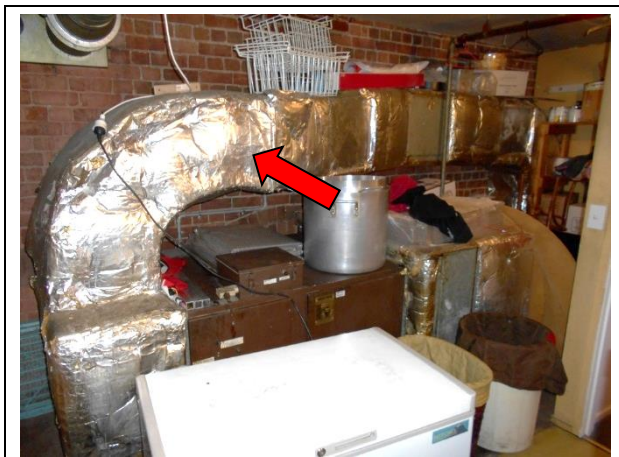
SMF Item	Location/Comments
Internal insulation to hot water heaters	Ground Level, Restaurant, Kitchen
Insulation material to air conditioning duct work	Level 1, Restaurant Plant Room

The SMF materials identified on site were generally in a good condition and installed to industry standards. These materials do not represent an increased health risk in their current condition.

Photo 2: Level 1, Restaurant Plant Room, Ductwork – SMF insulation

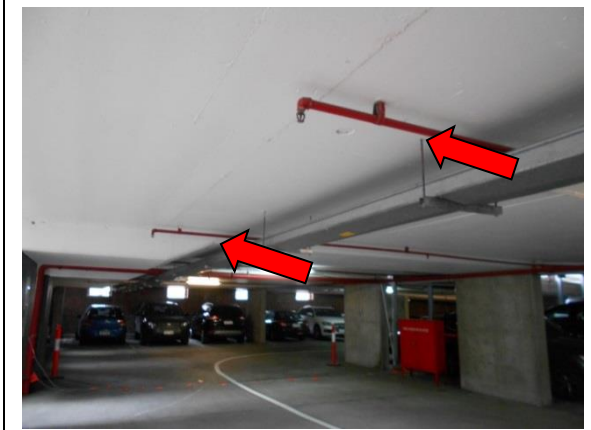
Lead Paint	Location/Comments	Extent
Red colour paint	All Levels, Fire Sprinkler Pipework	~1000m

The lead paint systems identified on site were observed to be in a good to fair condition at the time of inspection. It is recommended to remove flaking paint under controlled conditions and overpaint within non-lead containing paint.

Photo 3: All Levels, Fire Sprinkler Pipework – Positive lead paint sample (red colour paint)
