Asbestos & Hazardous Materials Survey

577 Little Bourke Street,
Melbourne VIC

October 2019

Report For:	AMP Capital
Address:	577 Little Bourke Street, Melbourne VIC
Prepared By:	Matthew Hyde, Senior Consultant (RiskTech Compliance)
Date of Inspection:	16 October 2019
Conferred With:	Darren Hynes, Senior Facilities Manager

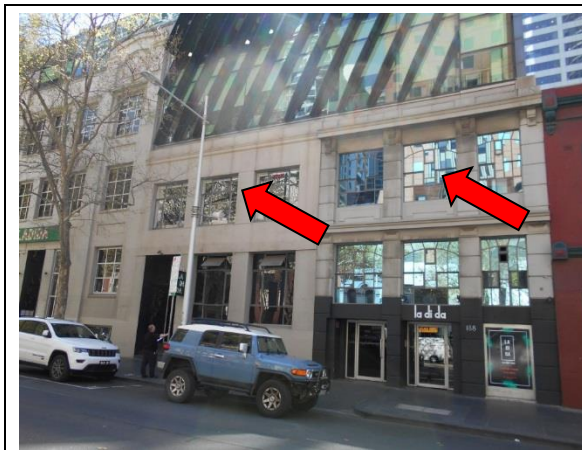
Asbestos Material	Location	Posed Risk	Extent
Mastic Sealant	Exterior, Original Façade (west side), Windows	Low	~10 Windows

The asbestos containing materials (ACMs) suspected on site were generally found to be in a good/stable condition and do not represent an increased risk in their current condition.

Photo 1: Exterior, Original Façade, Windows – Asbestos containing mastic sealant

- Asbestos materials identified on site should be managed through the Asbestos Management Plan developed by RiskTech Compliance for this site in conjunction with this report (Ref. AMP 577 Little Bourke St ASBMANPLAN Oct19).
- Label asbestos-containing materials (ACM) to warn of the dangers of disturbing these materials as per the *VIC Occupational Health and Safety Regulations 2017* and *Managing Asbestos in Workplaces* Victorian Compliance Code 2018.
- Schedule periodic reassessment (minimum every 5 years) of the ACM remaining on-site to monitor their aging/deterioration - as per *Managing Asbestos in Workplaces – Victorian Compliance Code 2018*.
- Maintain identified SMF materials in good condition. Remove under controlled conditions prior to demolition/refurbishments.

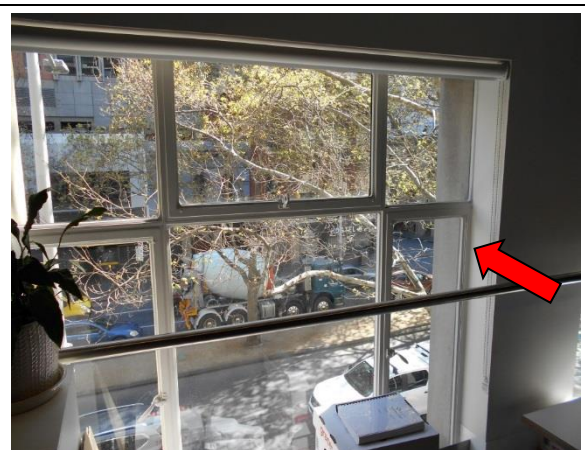
Photo 2: Interior, Original Façade, Windows – Asbestos containing mastic sealant (Photo taken from Level 2)

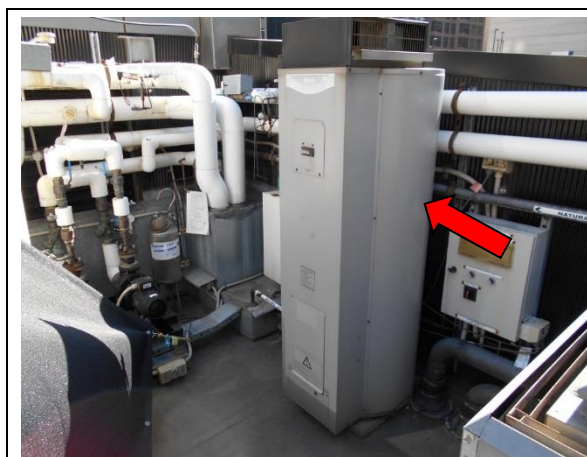
The SMF materials identified on site were generally in a good condition and installed to industry standards. These materials do not represent an increased health risk in their current condition.

Photo 3: Level 4, Roof Area, Adjacent Chiller – SMF internal insulation to hot water heater

- Remove identified SMF materials under controlled conditions prior to demolition.
- Remove flaking damaged paint prior to accessing the Level 1 roof area of the Lord of the Fries tenancy. When demolition or refurbishment works are to involve the disturbance of confirmed lead-containing paint, dust suppression techniques should be utilised. Any works, which may disturb potential lead-based paint systems, should be conducted in accordance with the requirements of *Australian Standard AS 4361.2 2017 Guide to lead paint management, Part 2: Residential and commercial buildings*.

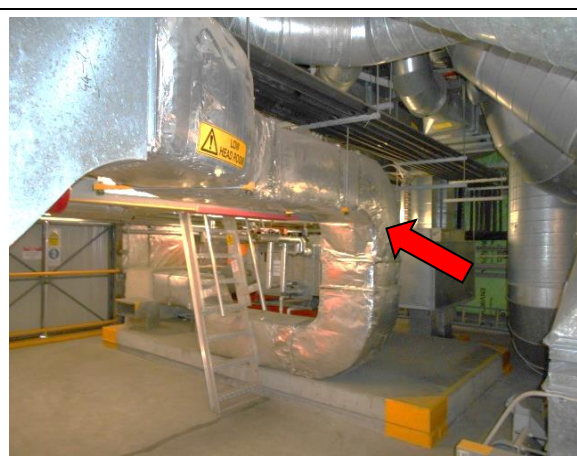
Photo 4: Level 4, Plant Room, Ductwork – SMF insulation

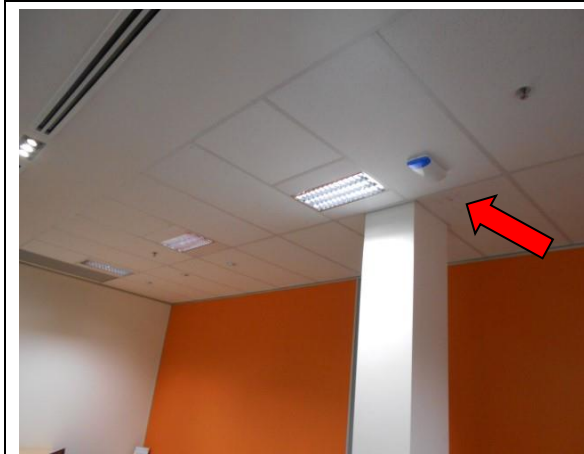
Photo 5: Level 2, Office Area, Ceiling – SMF compressed ceiling tiles

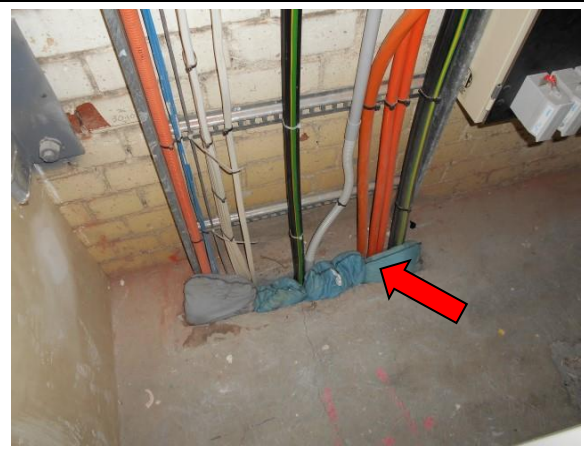
Photo 6: All Levels, Electrical Cupboards, Penetrations – SMF pillow insulation

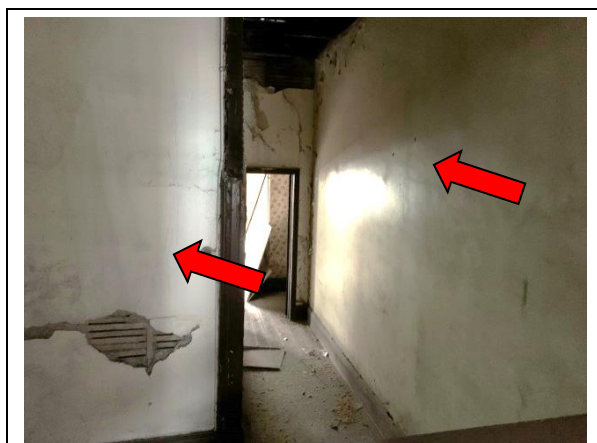
Lead Paint	Location/Comments	Extent
White colour paint	Lord of the Fries Building – Level 1, Walls	~30m ²

The lead paint systems identified on site were observed to be in a fair condition at the time of inspection. It is noted that this area has been secured and access is not currently possible. It is recommended to remove flaking paint under controlled conditions and overpaint within non-lead containing paint prior to access being required in the area.

Photo 7: Lord of the Fries Building – Level 1, Walls
(positive lead paint sample on the white paint)
