Asbestos & Hazardous Materials Survey

Bourke Place
600 Bourke Street,
Melbourne VIC

October 2019

Report For:	AMP Capital
Address:	600 Bourke Street, Melbourne VIC
Prepared By:	Matthew Hyde, Senior Consultant (RiskTech Compliance)
Date of Inspection:	16 & 17 October 2019
Conferred With:	Darren Hynes, Senior Facilities Manager

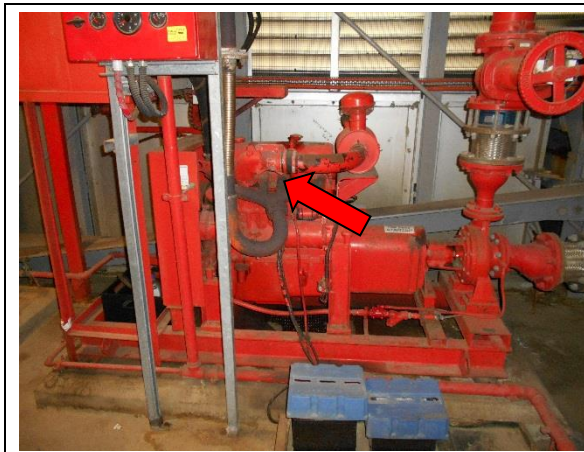
Photo 1: Level 53, Plant Room, Large Diesel Fire Pump, Manifold – Asbestos containing gasket

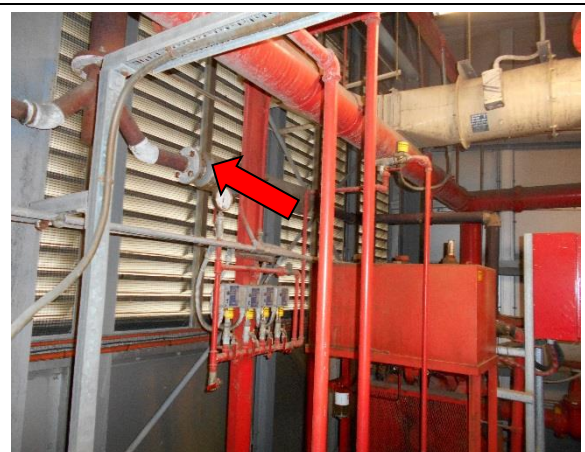
Photo 2: Level 53, Plant Room, Large Diesel Fire Pump, Vent Pipe, Flange Joint – Asbestos containing gasket

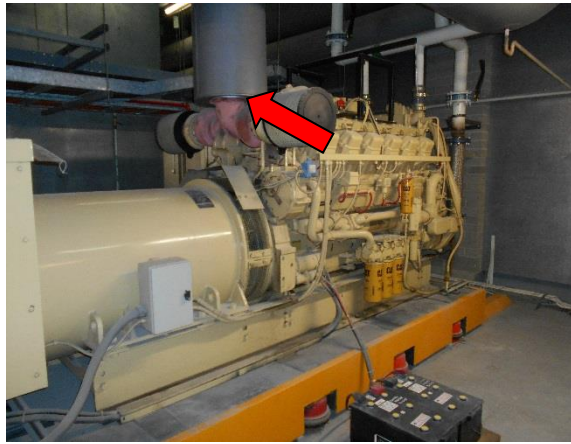
Photo 3: Level 52, Plant Room, Generator Room
Diesel Generator, Vent Pipe, Flange Joint –
Asbestos containing gasket

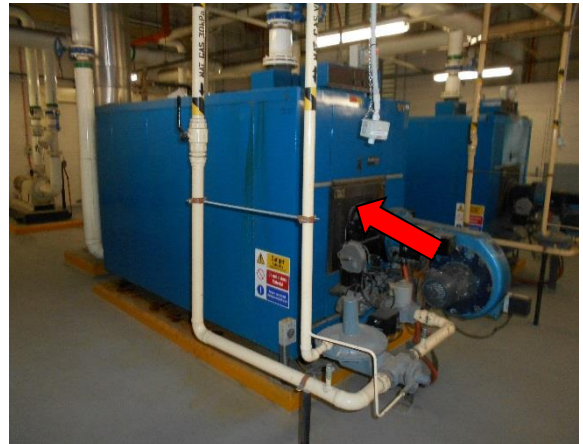
Photo 4: Level 51, Plant Room, Boiler Room
Boiler, Inlet Manifold – Asbestos containing
gasket

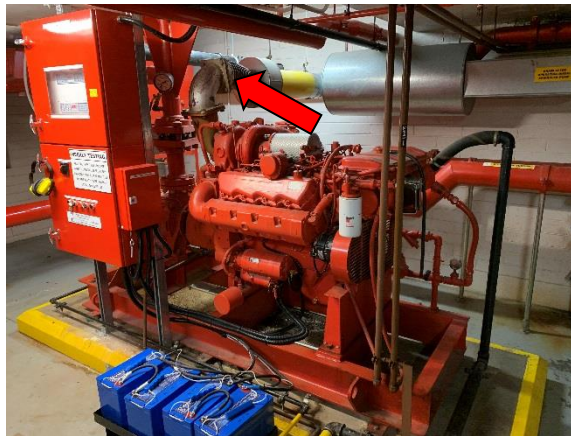
Photo 5: Level B3, Sprinkler Pump Room, Large
Diesel Fire Pump, Vent Pipe, Flange Joint –
Asbestos containing gasket

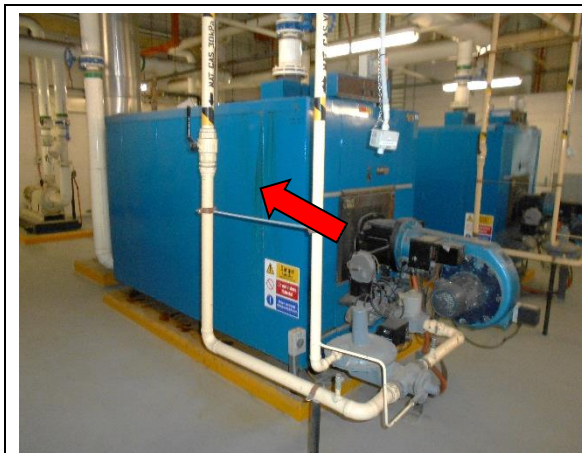
Photo 6: Level 51, Plant Room, Boiler Room – SMF internal insulation to boilers

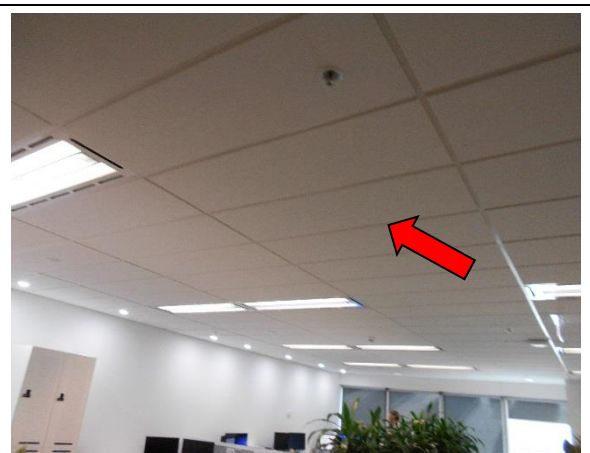
Photo 7: All Levels, Office Areas, Ceilings – SMF compressed ceiling tiles

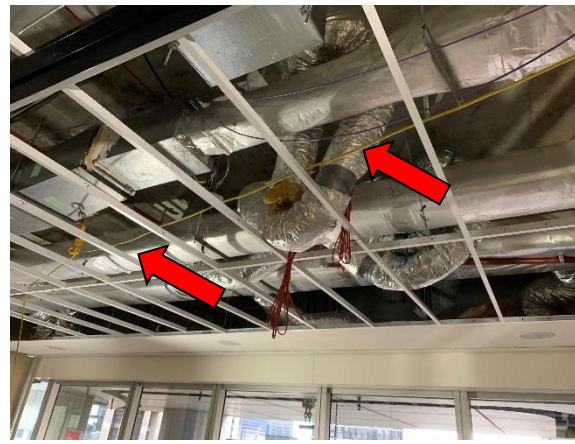
Photo 8: All Levels, Office Areas, Ceiling Spaces, Ductwork – SMF insulation

Office areas, Ceiling Space Ductwork - Insulation material	8	Bonded	~30m ²	Good	Low	Maintain in good condition. Remove under controlled conditions prior to demolition/refurbishments
Electrical Cupboards Penetrations – Pillow Insulation material	9	Bonded	~50 units	Good	Low	Maintain in good condition. Remove under controlled conditions prior to demolition/refurbishments

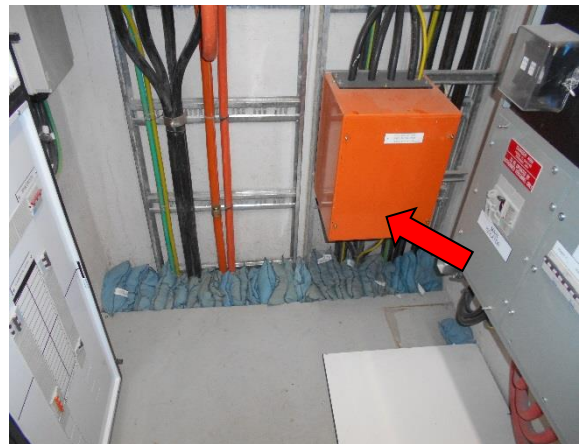
Photo 9: All Levels, Electrical Riser Cupboards – SMF pillow insulation

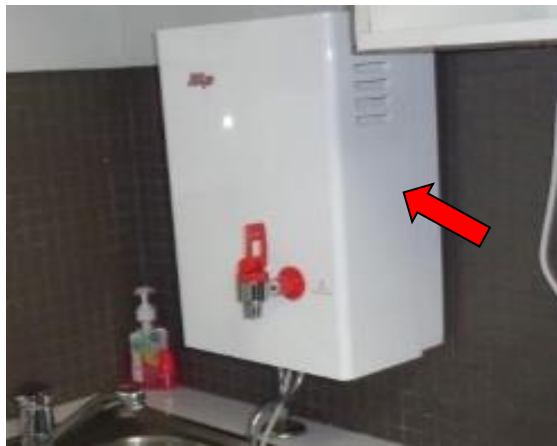
Photo 10: All Levels, Office Areas, Kitchenettes– SMF internal insulation to min zip boilers

Location Item Description	Photo No.	Form	Extent	Condition	Risk Status	Control Recommendations
Kitchenettes, Mini Zip Boilers Internal SMF insulation	10	Bonded	3 units	Good	Low	Maintain in good condition. Remove under controlled conditions prior to demolition/refurbishments
Pipework (metal encased) Internal SMF insulation	-	Bonded	~100m	Good	Low	Maintain in good condition. Remove under controlled conditions prior to demolition/refurbishments
Interior – Level 37 Plant Room						
Calorifier Internal SMF insulation	11	Bonded	1 unit	Good	Low	Maintain in good condition. Remove under controlled conditions prior to demolition/refurbishments
Pipework (metal encased) Internal SMF insulation	-	Bonded	~100m	Good	Low	Maintain in good condition. Remove under controlled conditions prior to demolition/refurbishments
Penetrations SMF Pillow Insulation material	-	Bonded	~50 units	Good	Low	Maintain in good condition. Remove under controlled conditions prior to demolition/refurbishments

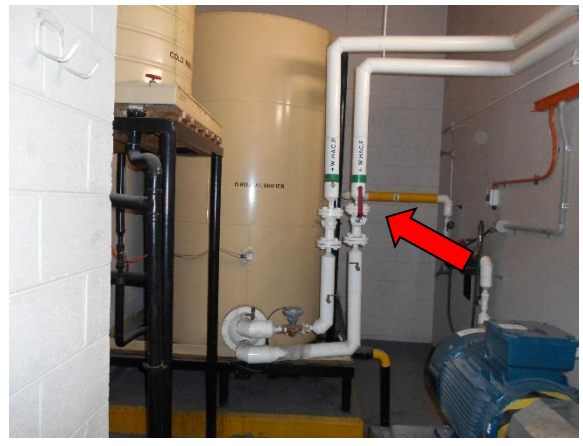
Photo 11: Level 37, Plant Room, Calorifier – SMF internal insulation

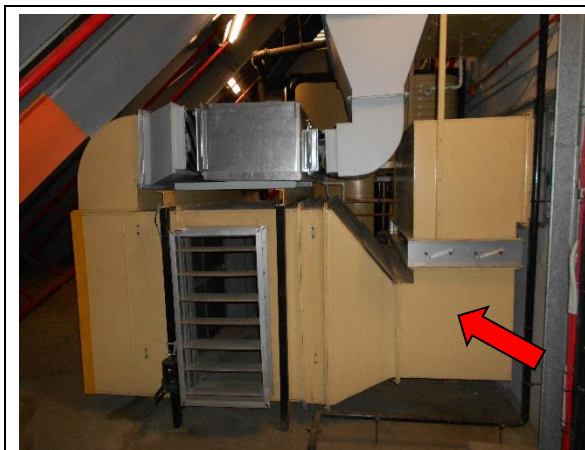
Lead Paint	Location/Comments	Extent
Yellow colour paint	Levels 53, 51, 37, 13 & 2 Plant Rooms – Air conditioning duct work and air handling units	~1000m ²

Photo 12: Level 53, Throughout, Ductwork (positive lead paint sample on the yellow paint)

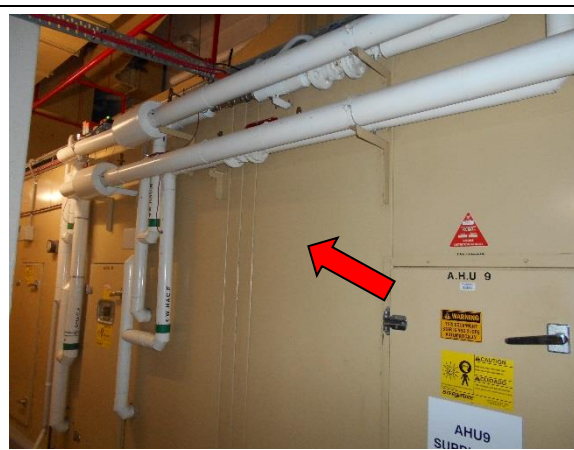
Photo 13: Level 37, Air Handling Units (positive lead paint sample on the yellow paint)
