Mirvac Real Estate Pty Ltd

**Asbestos and Hazardous Materials
Re-Inspection**

477 Collins Street, Melbourne VIC 3000

9 April 2021

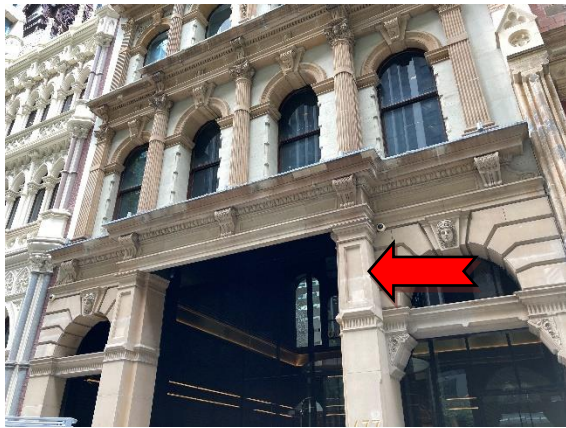
Photo 1 Exterior: throughout façade – suspected asbestos containing mastic.

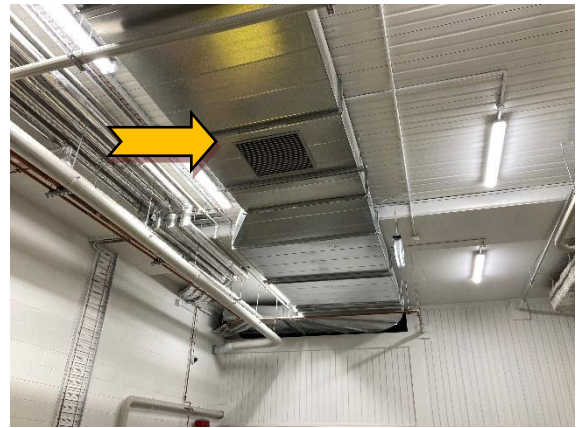
Photo 2 Interior: throughout, air conditioning ductwork – suspected SMF containing internal insulation material.

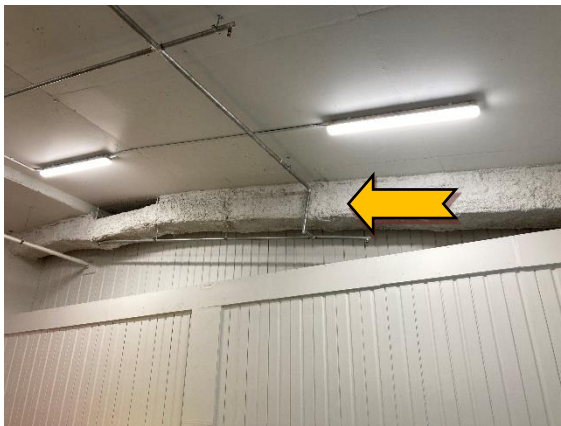
Photo 3 Interior: throughout, air conditioning ductwork – suspected SMF external insulation material.

Interior	Throughout	Air conditioning ductwork	Insulation material - external	SMF	Visual Observation	Suspected SMF	-	-	-	Good	Sealed	Low	-	-	-	Low	-	Maintain in current condition if to remain in-situ. Remove under controlled SMF conditions as per the Code of Practice for the Safe Use of Synthetic Mineral Fibres [NOHSC: 2006 (1990)].	Throughout	-	3
Interior	Loading dock	Hot water heater	Insulation material - internal	SMF	Visual Observation	Suspected SMF	-	-	-	Good	Sealed	Low	-	-	-	Low	-	Maintain in current condition if to remain in-situ. Remove under controlled SMF conditions as per the Code of Practice for the Safe Use of Synthetic Mineral Fibres [NOHSC: 2006 (1990)].	1 unit	-	4
Interior	Fire control room	Pipe work	Insulation material - external	SMF	Visual Observation	Suspected SMF	-	-	-	Good	Sealed	Low	-	-	-	Low	-	Maintain in current condition if to remain in-situ. Remove under controlled SMF conditions as per the Code of Practice for the Safe Use of Synthetic Mineral Fibres [NOHSC: 2006 (1990)].	Throughout	-	5

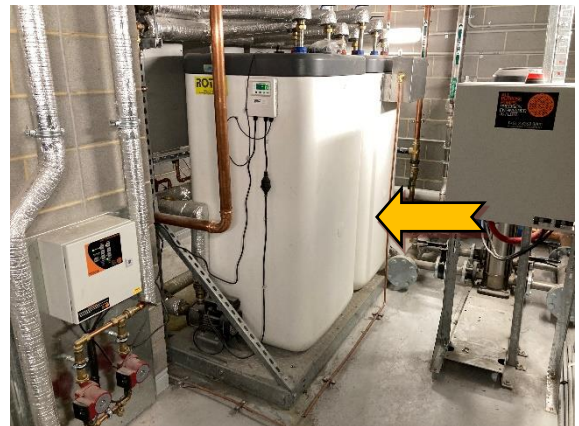
Photo 4 Interior: loading dock, hot water heater – suspected SMF internal insulation material.

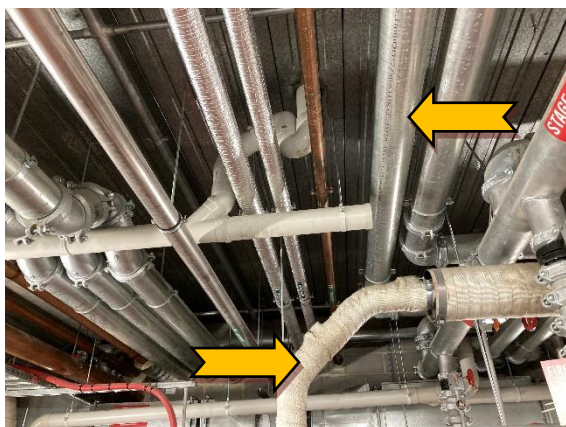
Photo 5 Interior: fire control room, pipework – suspected SMF external insulation material.

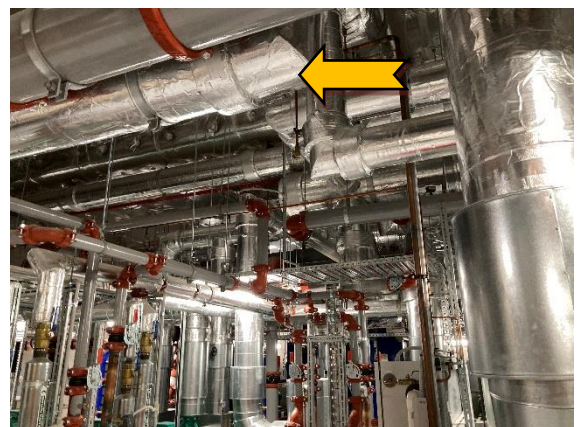
Photo 6 Interior: level 8, chiller room, pipework – suspected SMF external insulation material

Interior	Level 8, Chiller room	Pipe work	Insulation material - external	SMF	Visual Observation	Suspected SMF	-	-	-	Good	Sealed	Low	-	-	-	Low	-	Maintain in current condition if to remain in-situ. Remove under controlled SMF conditions as per the Code of Practice for the Safe Use of Synthetic Mineral Fibres [NOHSC: 2006 (1990)].	Throughout	-	6
Interior	Loading dock	Air conditioning units	R32 Hydrofluorocarbon (HFC)	Ozone Depleting Substances	Visual Observation	Non ODS Refrigerant	-	-	-	-	-	-	-	-	-	-	-	-	-	-	7
Interior	Level 8, Chiller room	Chillers	R134a Hydrofluorocarbon (HFC)	Ozone Depleting Substances	Visual Observation	Non ODS Refrigerant	-	-	-	-	-	-	-	-	-	-	-	-	-	-	8

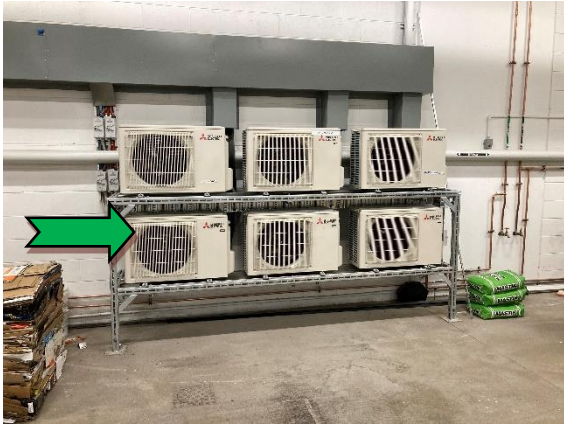
Photo 7 Interior: loading dock, air conditioning units – non ODS refrigerant.

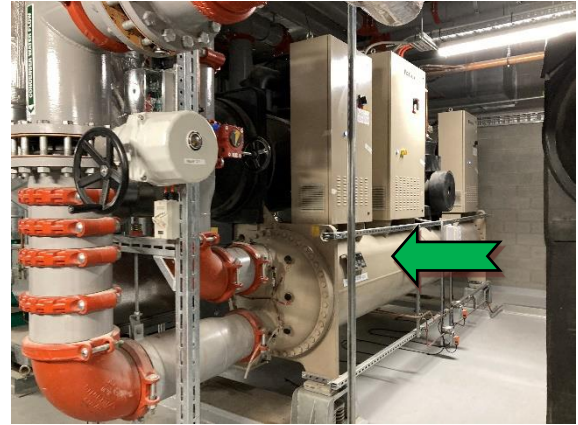
Photo 8 Interior: level 8 chiller room, chillers – non ODS refrigerant.
