Telecommunications Installation Audit Report  
(Physical Review)

**Mirvac Funds Limited**

**4 Riverside Quay, Southbank**

**27 May 2017**

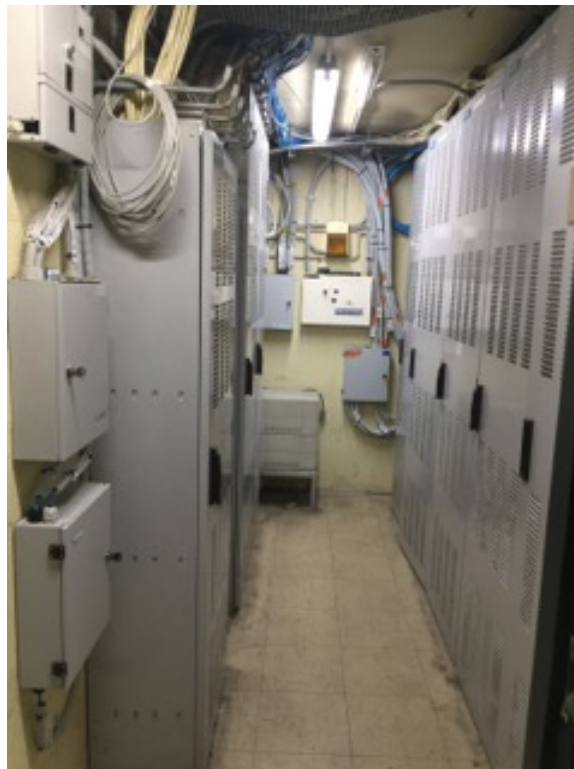
MDF Room - Telstra racks

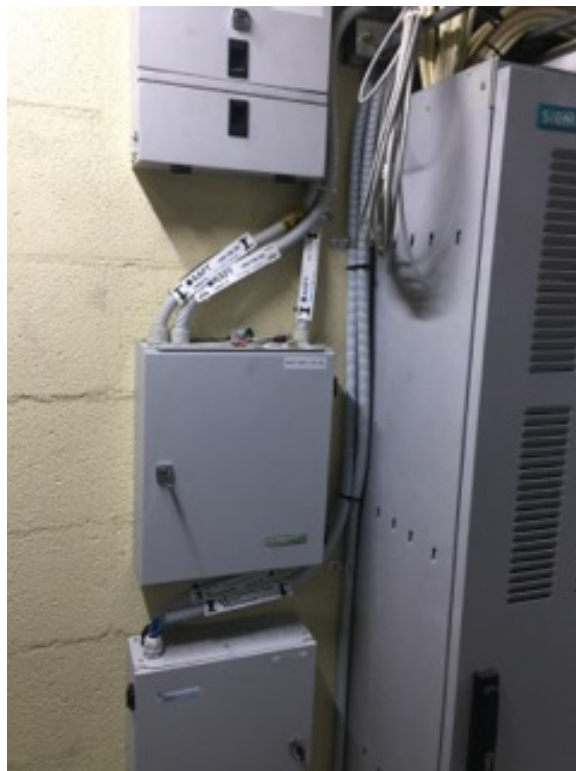
MDF Room – AMP, AAPT, Pipe Networks cabinets

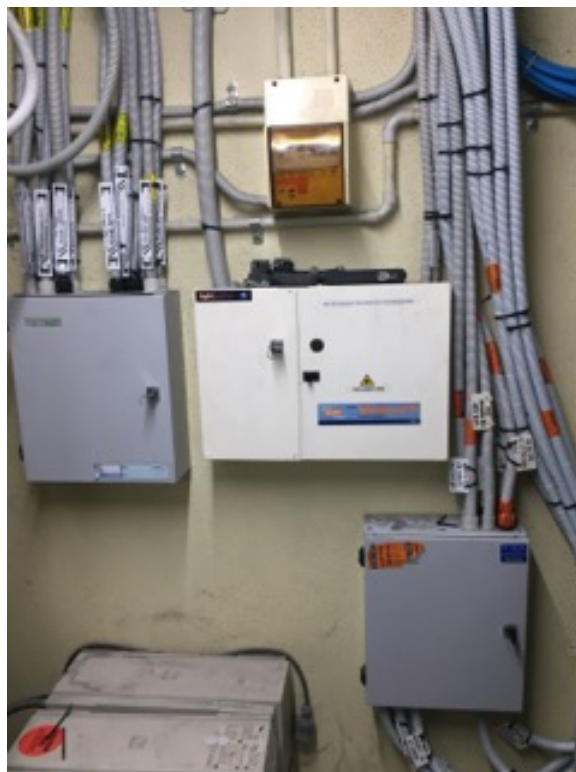
MDF Room – Pipe Networks, Telstra, Vocus cabinets

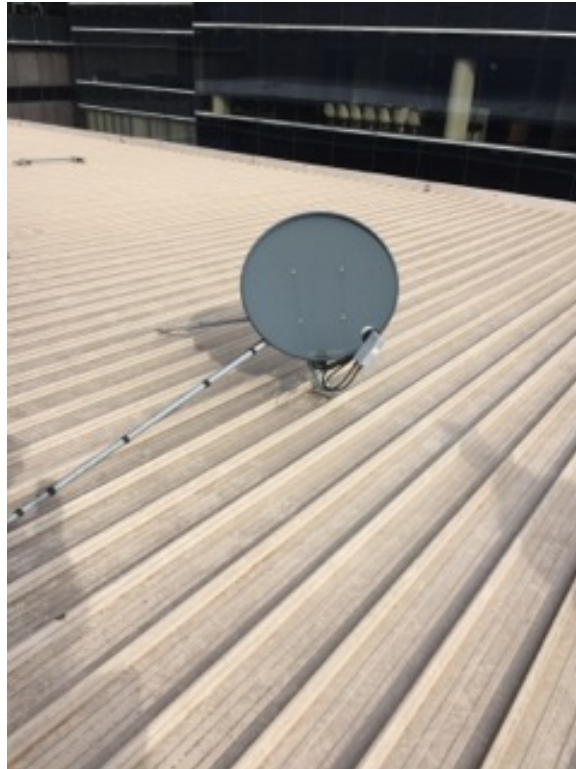
Roof – Foxtel satellite dish

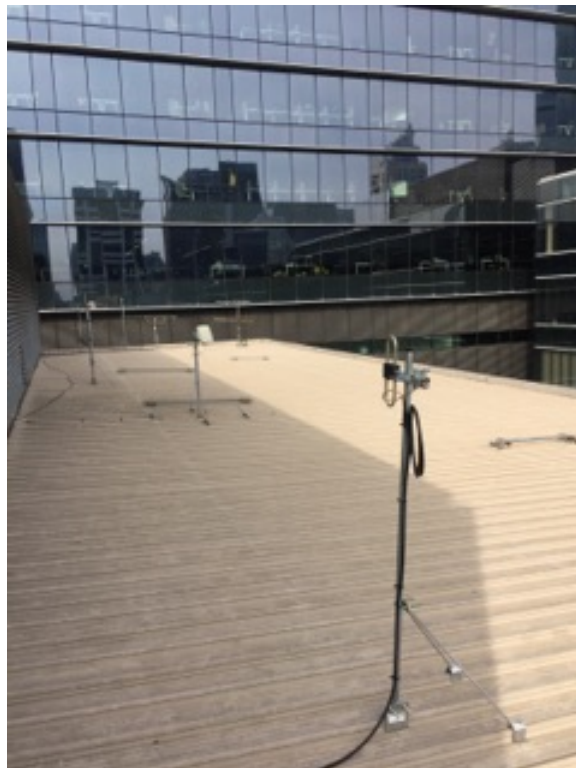
Roof – unknown antennas

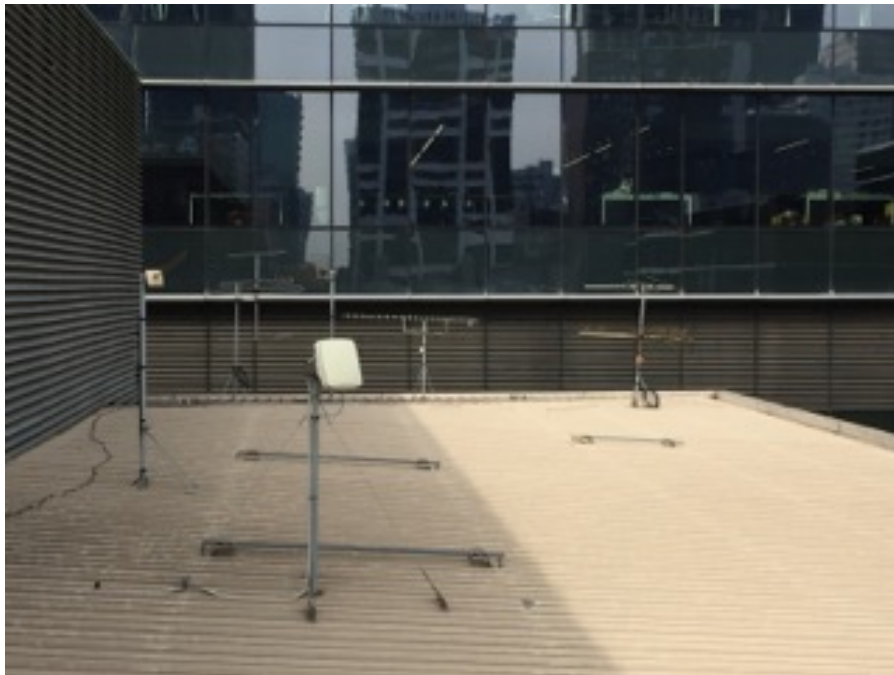
Roof – unknown antennas

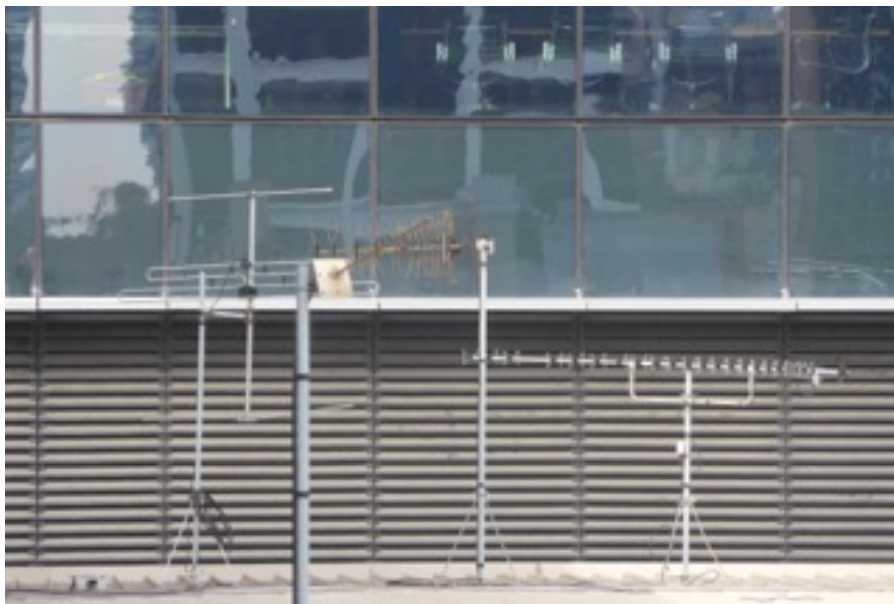
Roof – unknown digital TV and yagi antennas

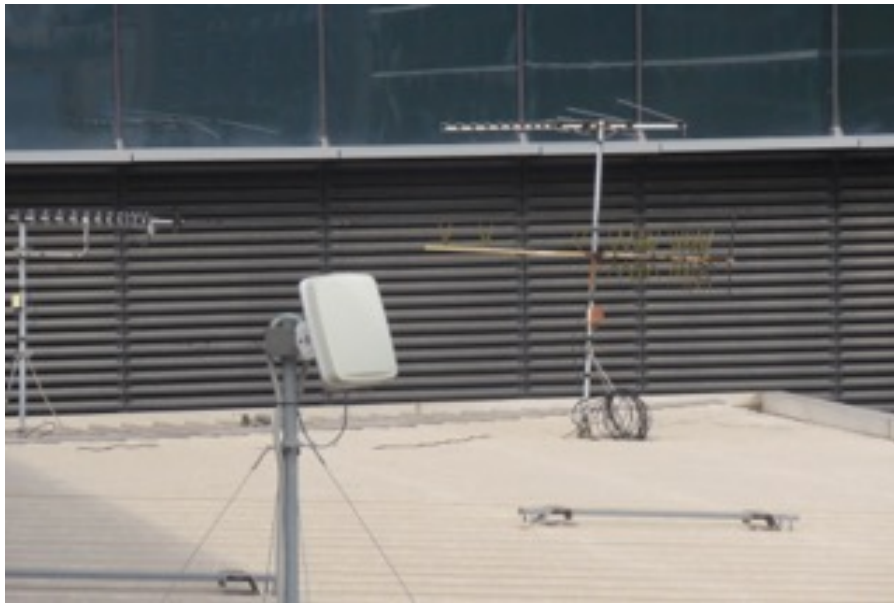
Roof – unknown flat microwave antenna

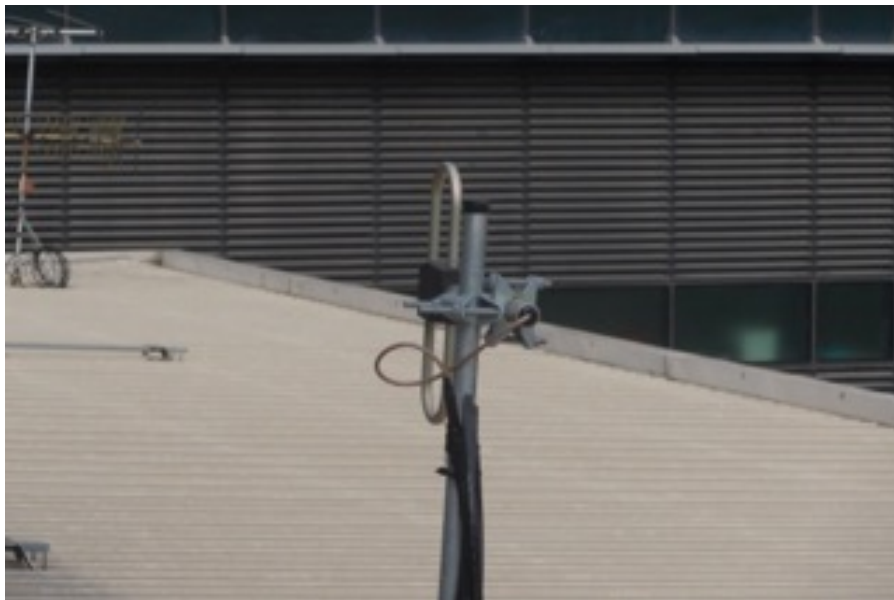
Roof – unknown dipole antenna

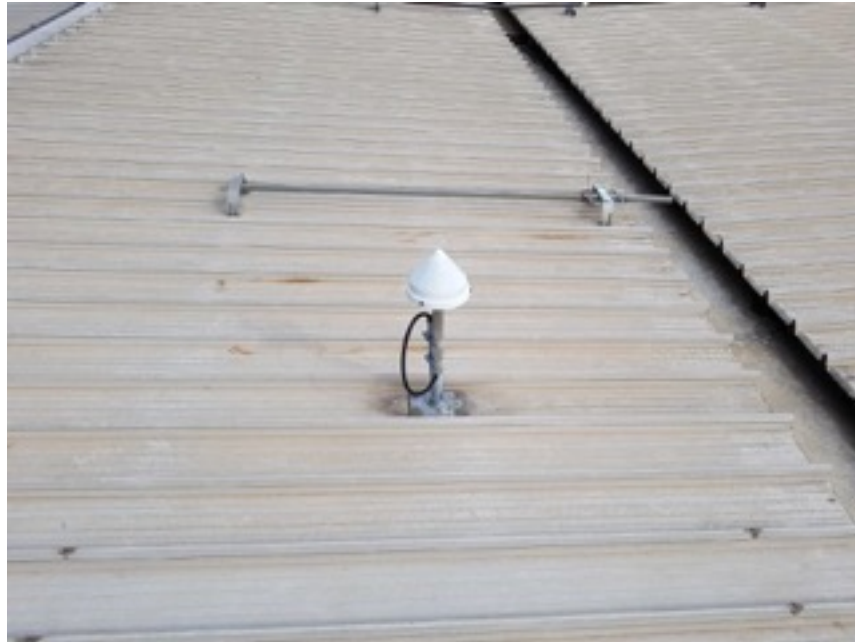
Upper Roof – unknown GPS antenna

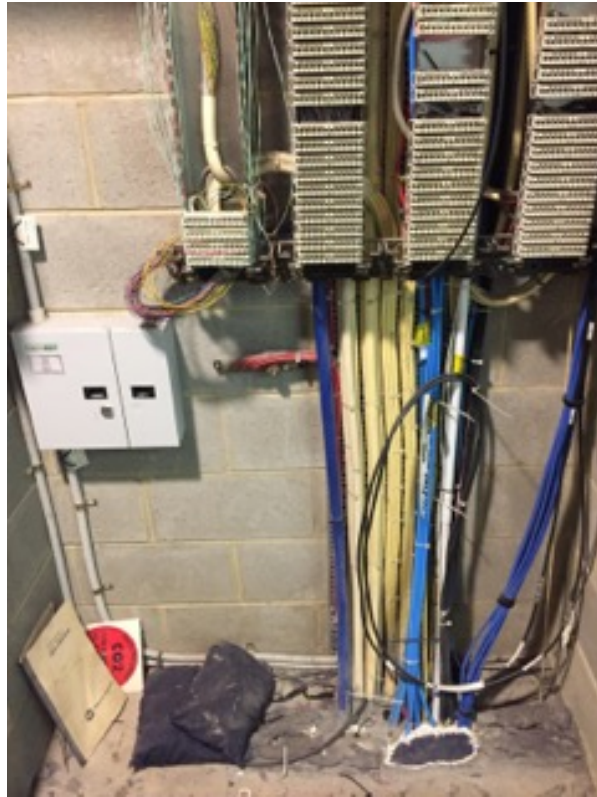
Riser L4 – rubbish, redundant cables

- (v) **riser review** - a review of all risers and their condition is undertaken by management as our limited riser cabinet review indicated firestopping measures out of position or totally missing.

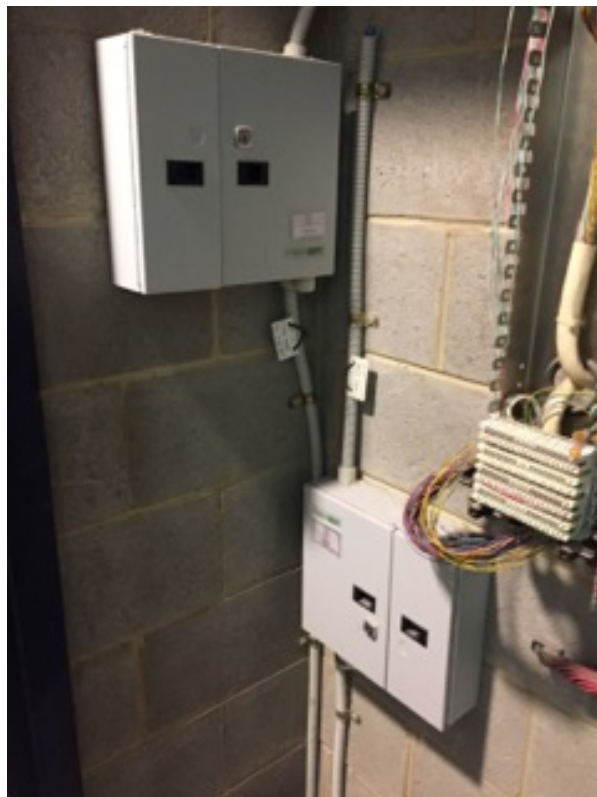
Riser L4 – Telstra cabinets

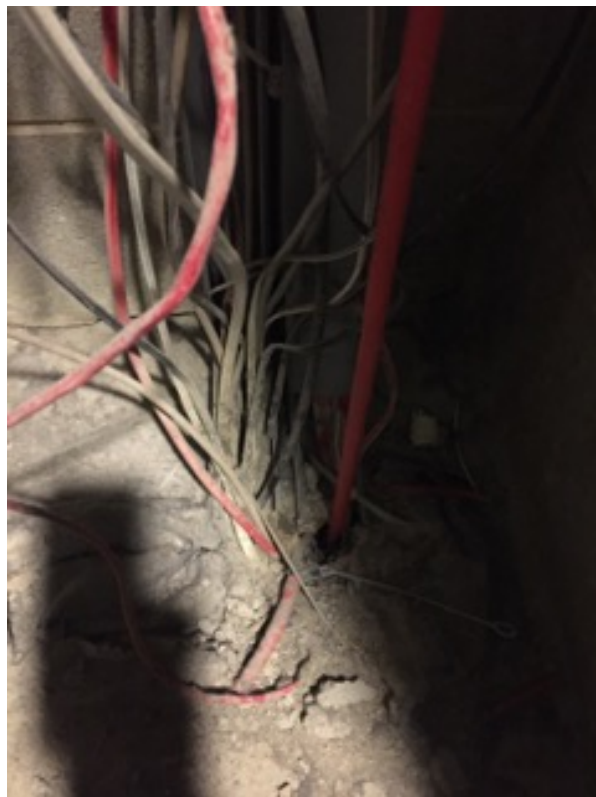
Riser L4 – missing fire stopping, redundant cables

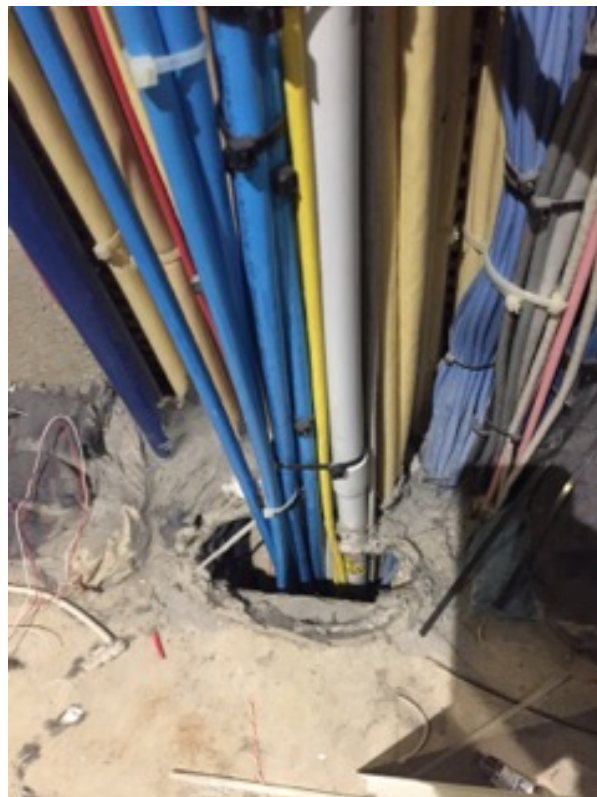
Riser L2 – rubbish, missing fire stopping

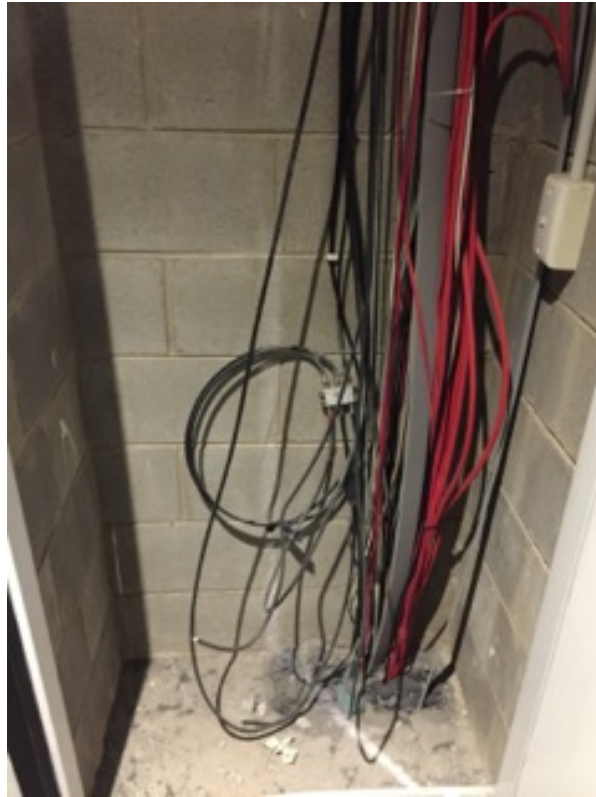
Riser L2 - missing fire stopping, redundant cables

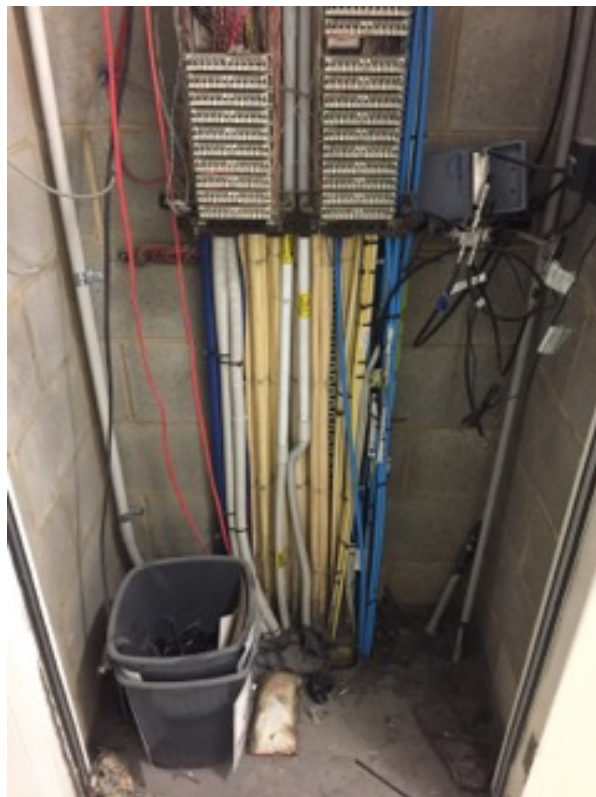
Riser G - missing fire stopping, rubbish

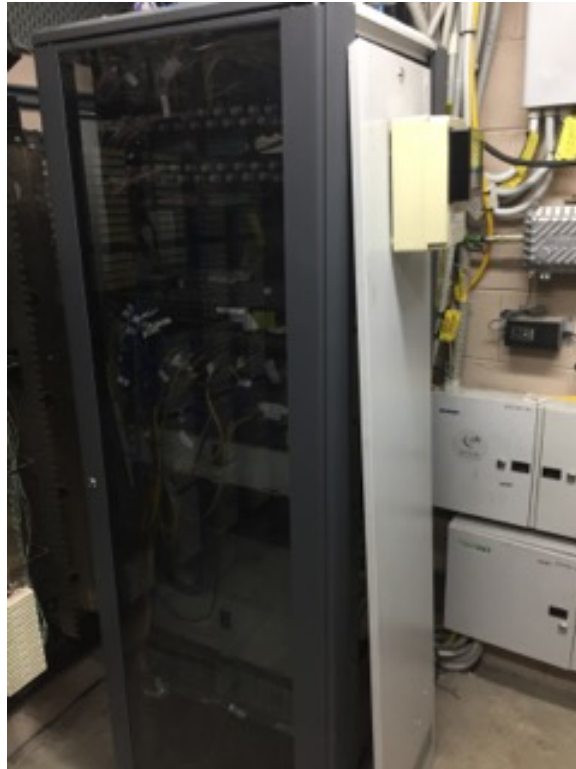
MDF Room – UeComm rack

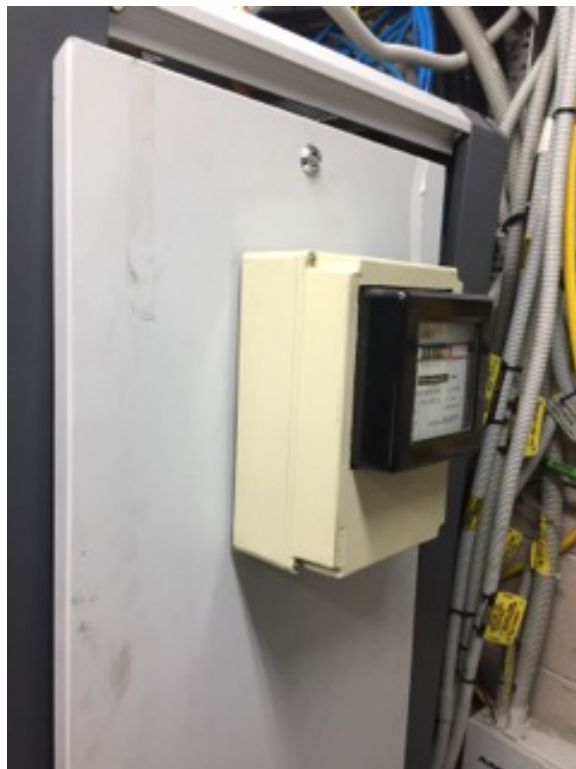
<b>Major Findings</b>	<b>Recommendations</b>
	requirement that any new fibre Carriers proposing to occupy the Site must utilise any vacant and available riser space to ensure the available space is maximised should be imposed.
<b>Unsafe equipment:</b> In the MDF Room, the side panel of the UeComm wall cabinet, on which the power supply is mounted, is not fixed to the cabinet, so that the exposed internal mains power supply is accessible.	UeComm should be requested to return to the Site to rectify the exposed power supply and ensure the installation complies with all building and electrical standards.
<b>Risers, Rooftops and Other Areas</b>	
<b>Full riser:</b> The Ground Level communications riser is at capacity.	Particular care ought to be taken when authorising any future Carriers using this riser.
<b>Terminated or Abandoned cabling:</b> Terminated or abandoned cabling appears to have been left in place in the risers with the effect that in addition to taking up valuable riser space, the excess cabling is reducing overall riser capacity.  For details refer to the riser review prepared based on our Inspection set out in Schedule 5.	Although not currently stipulated in Tenure Documents, consideration should be given to introducing a provision in all new or renewed tenancies requiring the payment of a bond or other protection covering cabling make good in the telecommunications risers.  In the absence of such a requirement, it may be difficult for the Owner to recover costs associated with the costly and time consuming exercise of determining if abandoned cabling is live or terminated.

MDF Room – UeComm rack, unsafe power supply

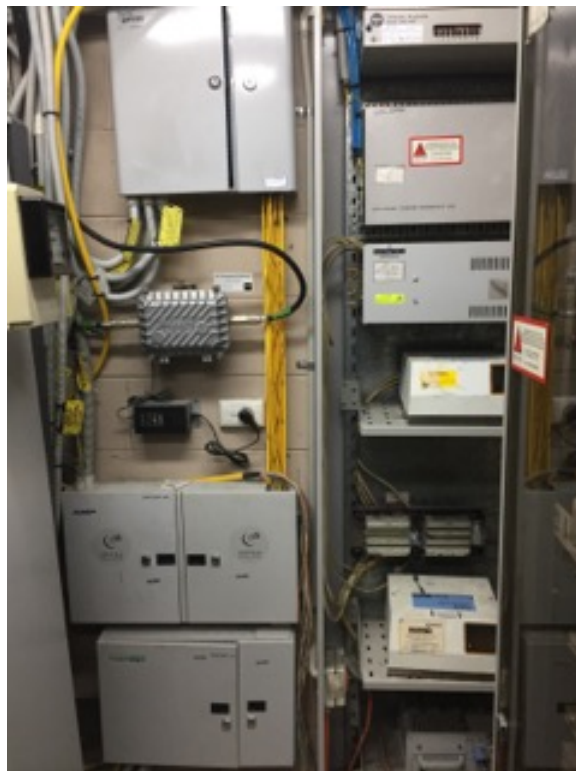
MDF Room – Optus Networks cabinets, Telstra racks

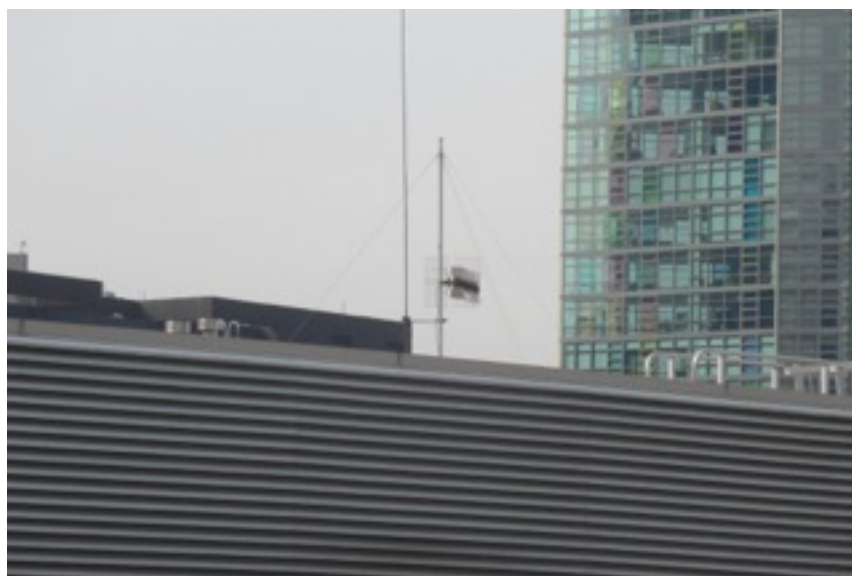
Roof – Unknown omni and yagi/grid antennas

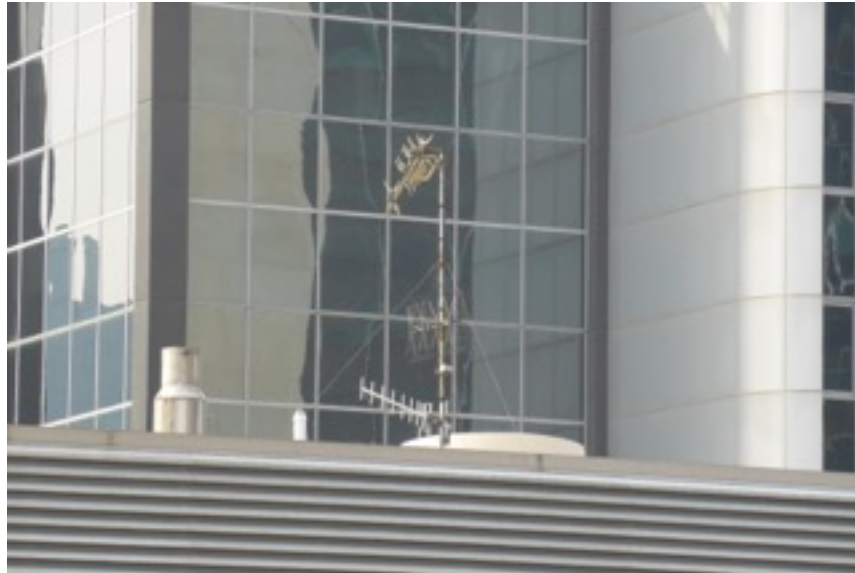
Roof – Unknown digital TV yagi antennas

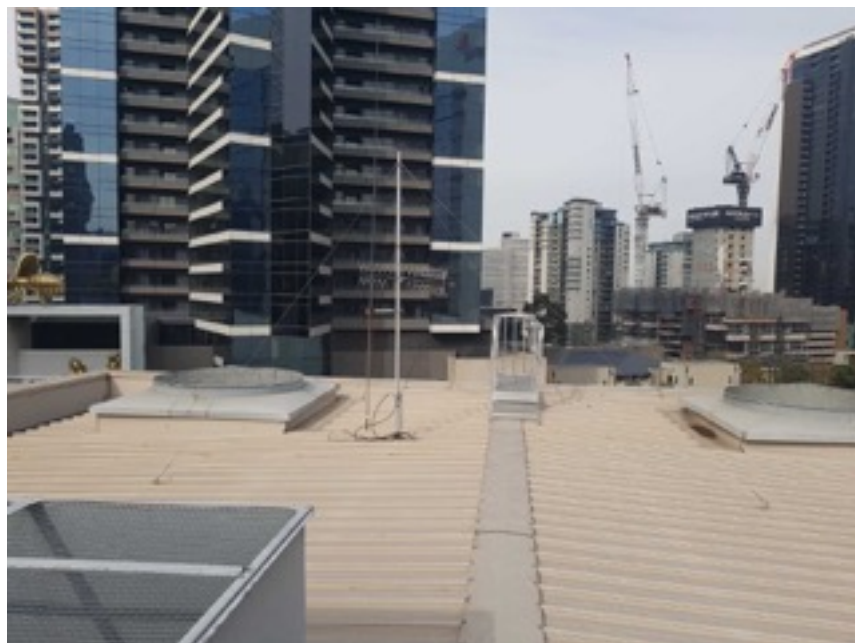
Roof – Unknown omni and yagi/grid antennas

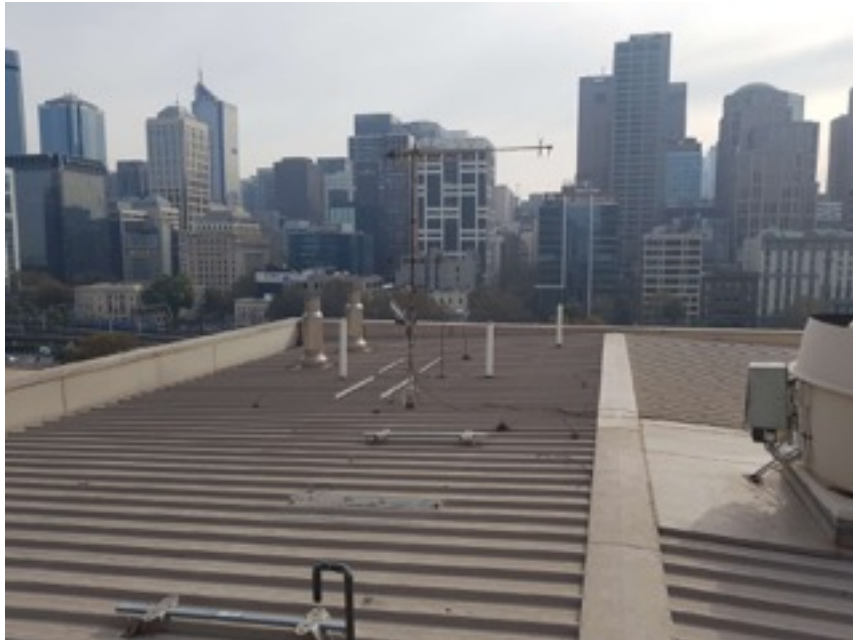
Roof – Unknown digital TV yagi antennas

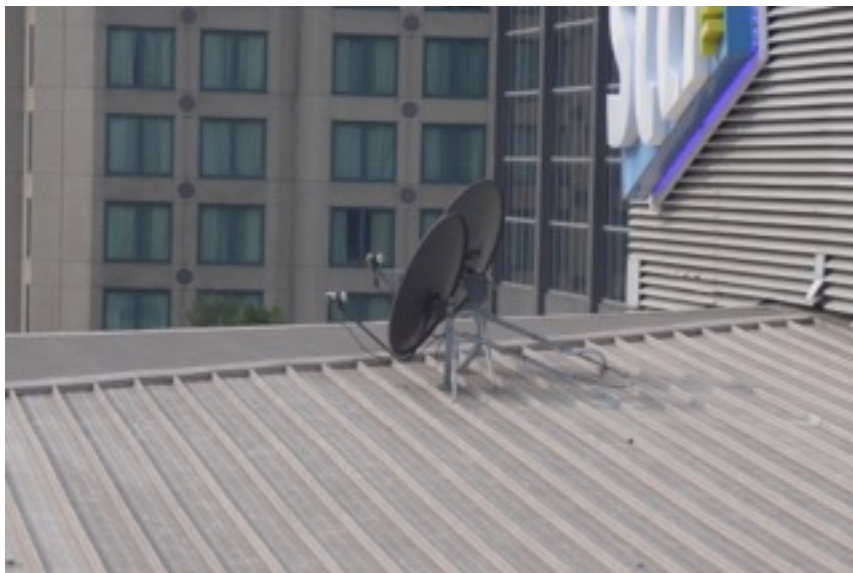
Roof – Foxtel satellite dishes

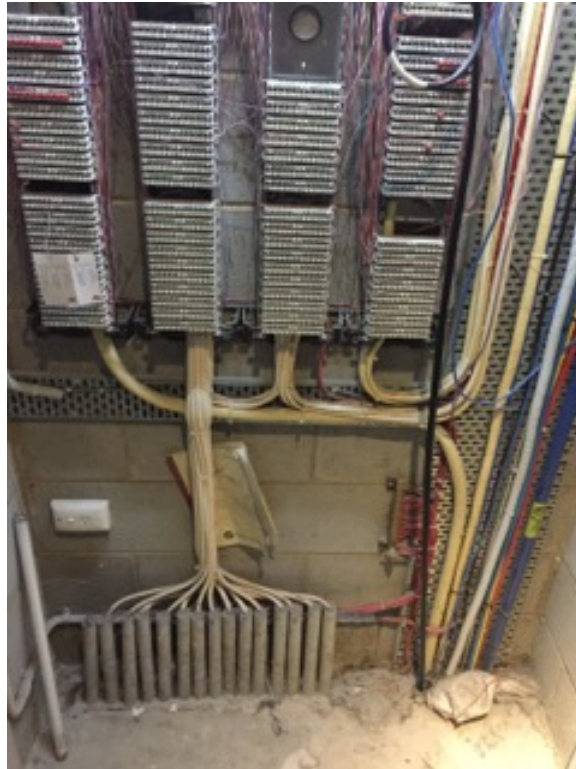
<b>Major Findings</b>	<b>Recommendations</b>
telecommunications equipment and installations asset register prepared based on our Inspection set out in Schedule 4.	
<b>Firestopping:</b> The firestopping is not properly installed in the risers.	The Carriers must be requested to rectify the installation of the firestopping.
<b>Rubbish / waste:</b> Rubbish / waste was found to have been left in a number of the risers inspected which constitutes both a WH&S concern and possibly indicates the areas may have been accessed by unauthorised persons.	The Carriers in these areas must be requested to remove all rubbish/waste and any concerns regarding unauthorised access need to be dealt with as a priority.
<p><b>Redundant / terminated cabling:</b> Redundant cabling appears to have been left in place in the Ground Level riser.</p> <p>For details refer to the telecommunications equipment and installations asset register prepared based on our Inspection set out in Schedule 4.</p>	<p>Given that it may be difficult and potentially hazardous to know with certainty if the cabling is "live" or simply abandoned, any abandoned or 'terminated' equipment or cabling should be carefully dealt with and only by those qualified to do so.</p> <p>Abandoned equipment, may, depending of the terms of the applicable Tenure Documents, also constitute a failure by the Carrier to make good and where this applies the Carrier should be requested to return, at its cost, to the Site to remove all abandoned equipment.</p>

Riser L6 – firestopping missing

- (v) **riser review** - a review of all risers and their condition is undertaken by management as our limited riser cabinet review indicated firestopping measures out of position or totally missing.

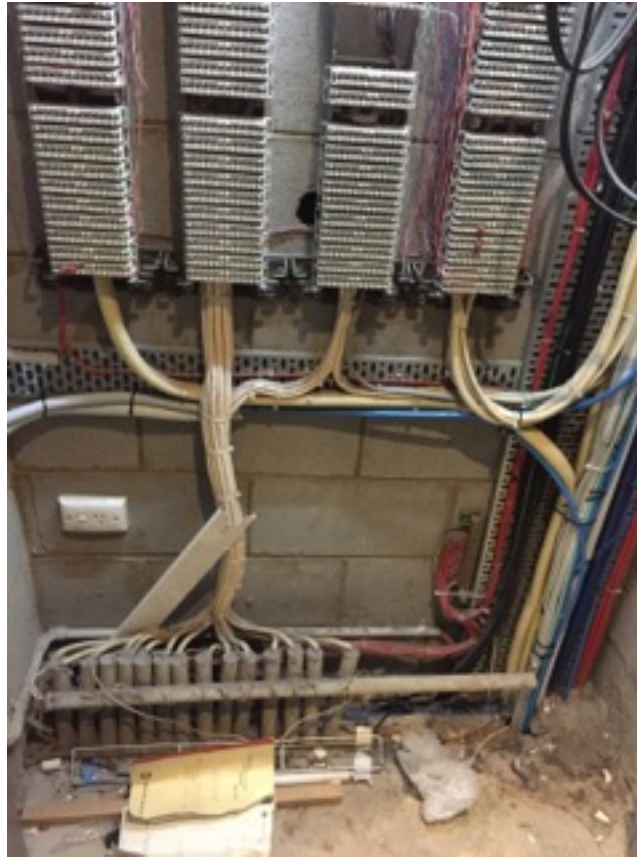
Riser L4 – rubbish, fire stopping missing

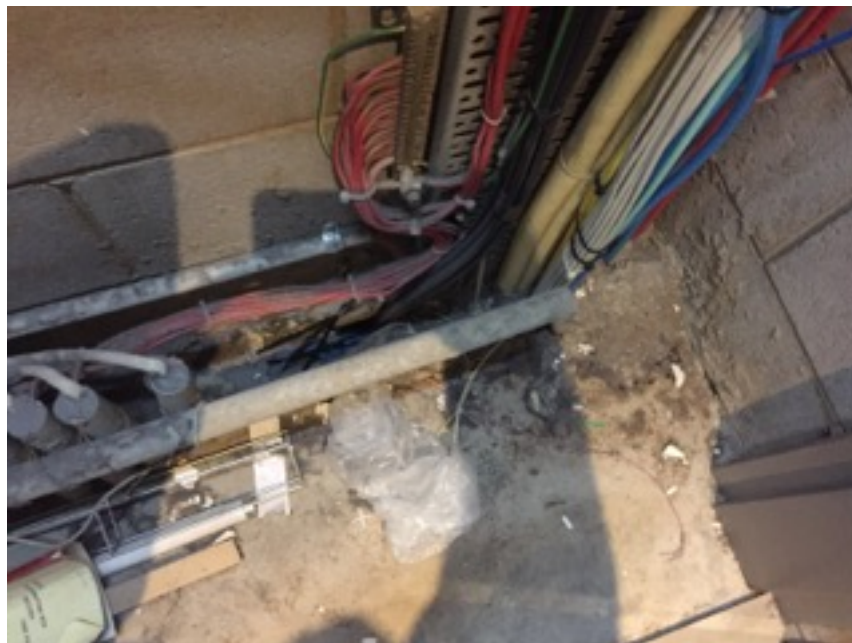
Riser L4 - rubbish, fire stopping missing

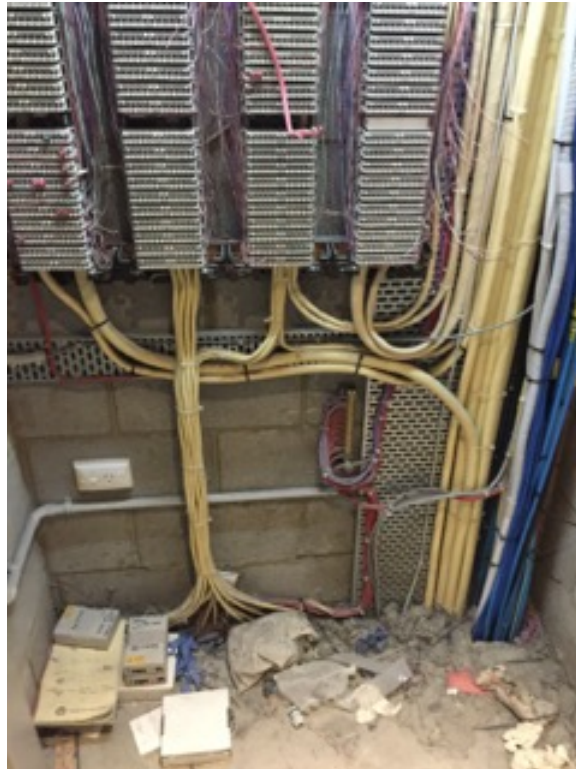
Riser L2 - rubbish, fire stopping missing

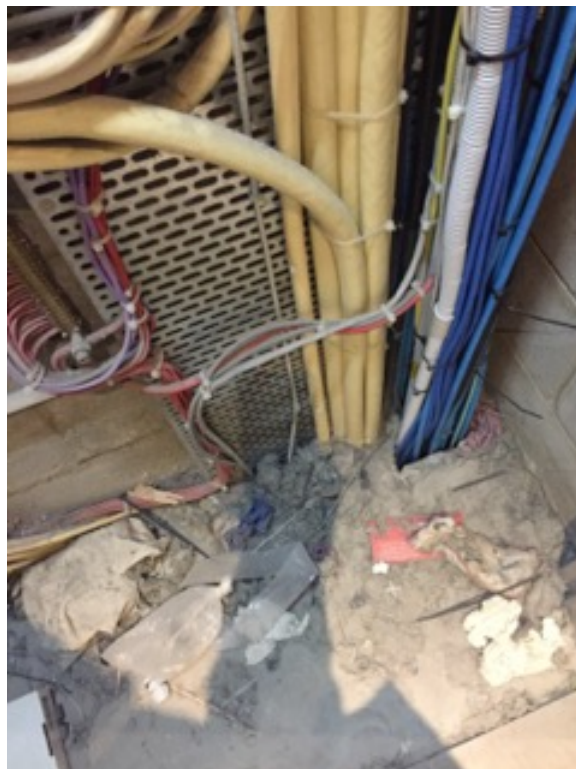
Riser L2 - rubbish, fire stopping missing

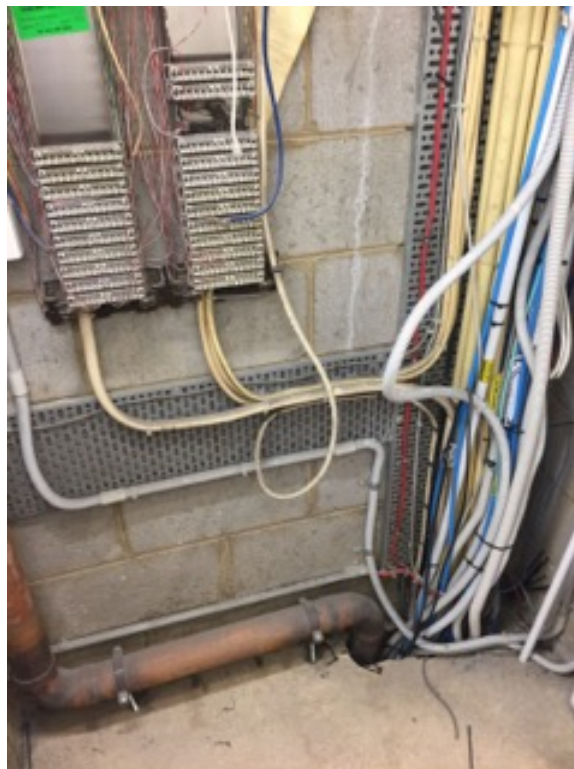
Riser G - fire stopping missing

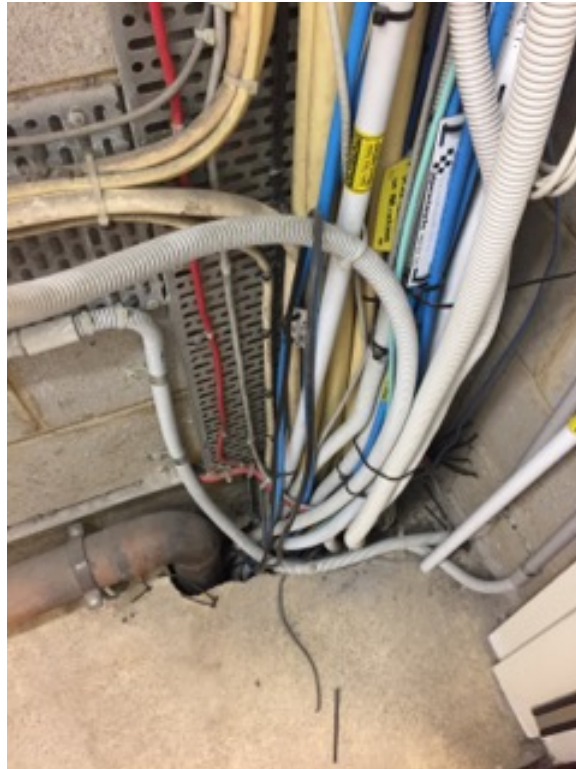
Riser G - fire stopping missing

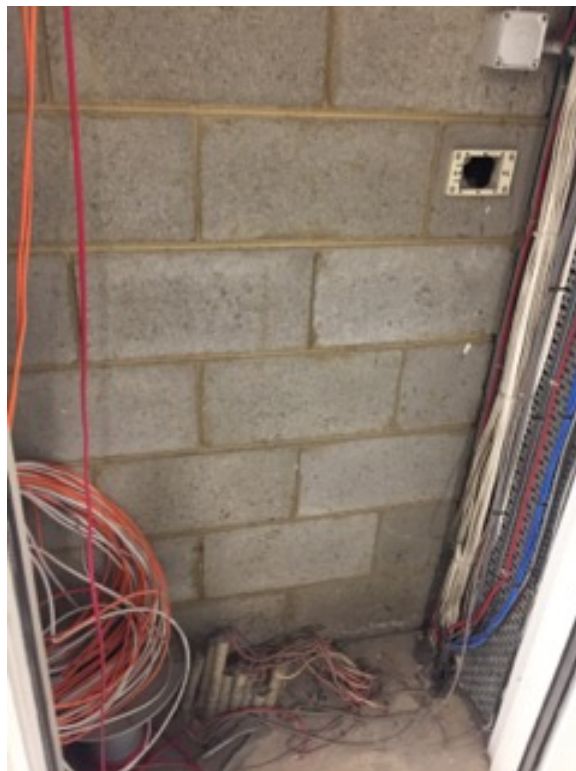
Riser G – redundant cabling, fire stopping missing

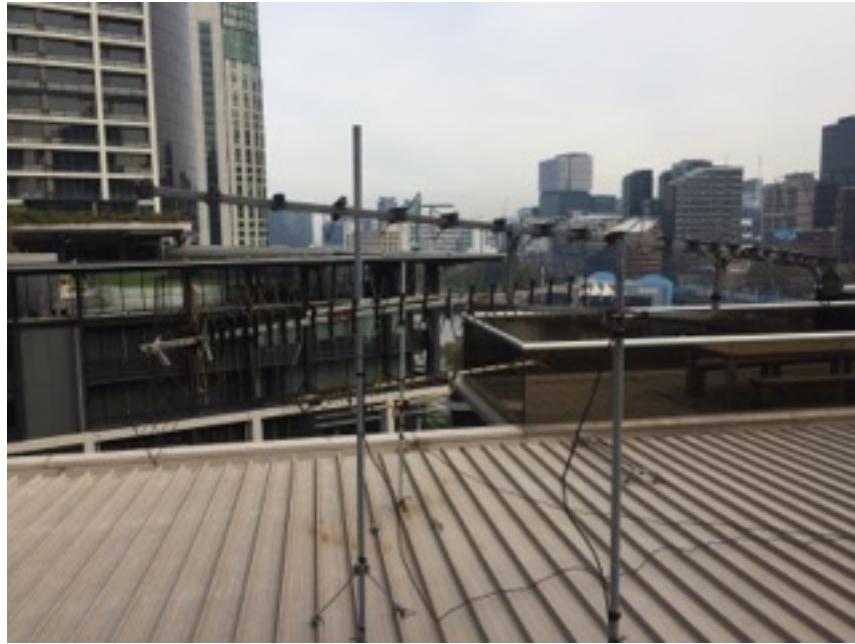
Roof – unknown digital TV yagi antennas

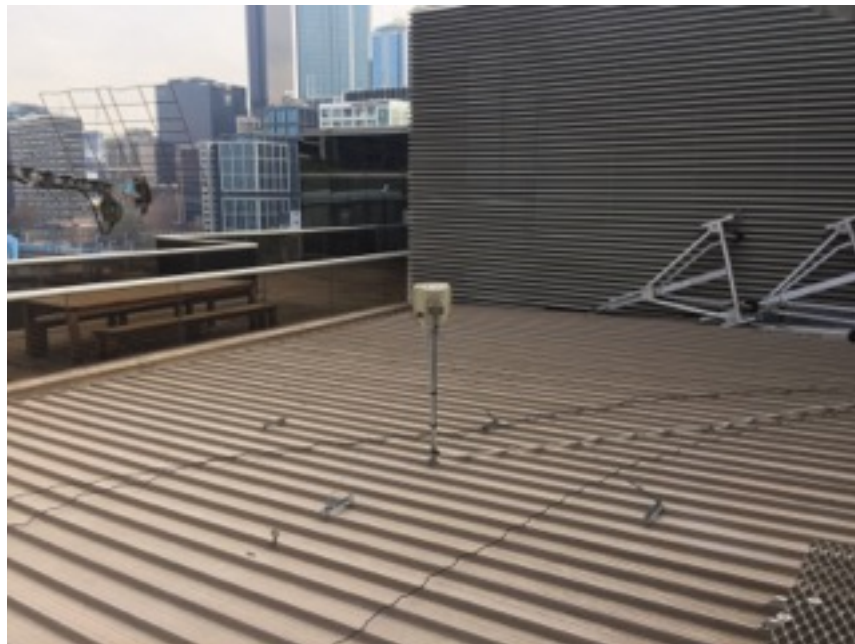
Roof – unknown flat microwave antenna

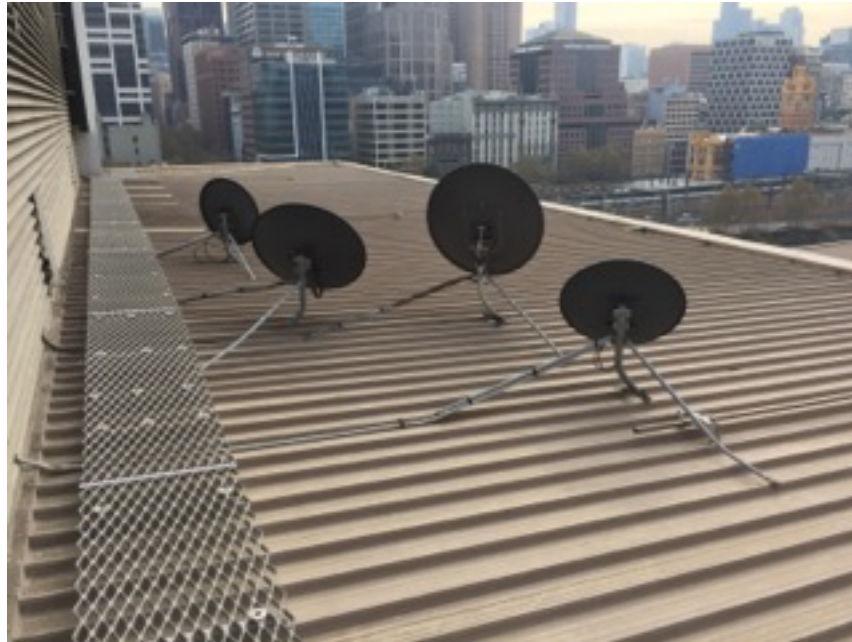
Roof – Foxtel satellite dishes

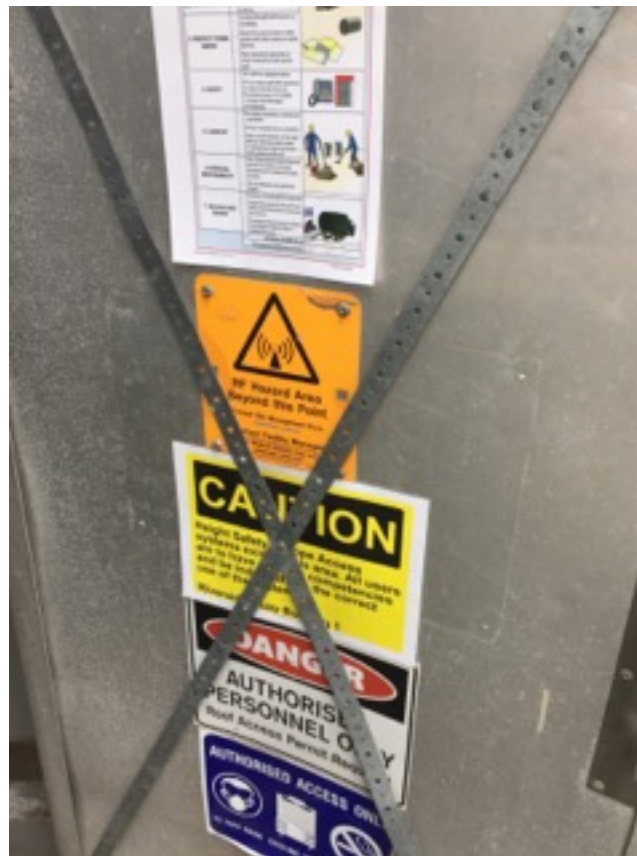
Roof – access door signage

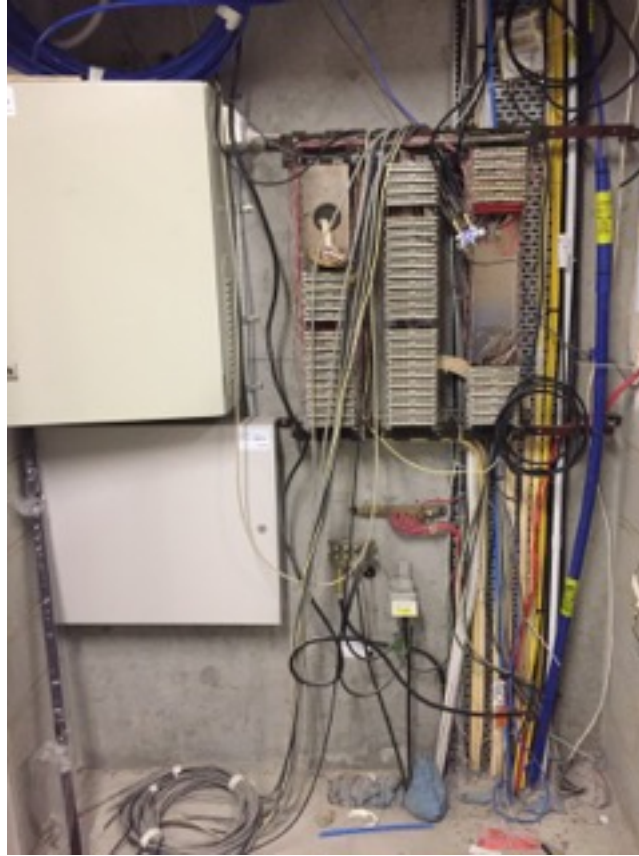
Riser L8 – redundant cabling

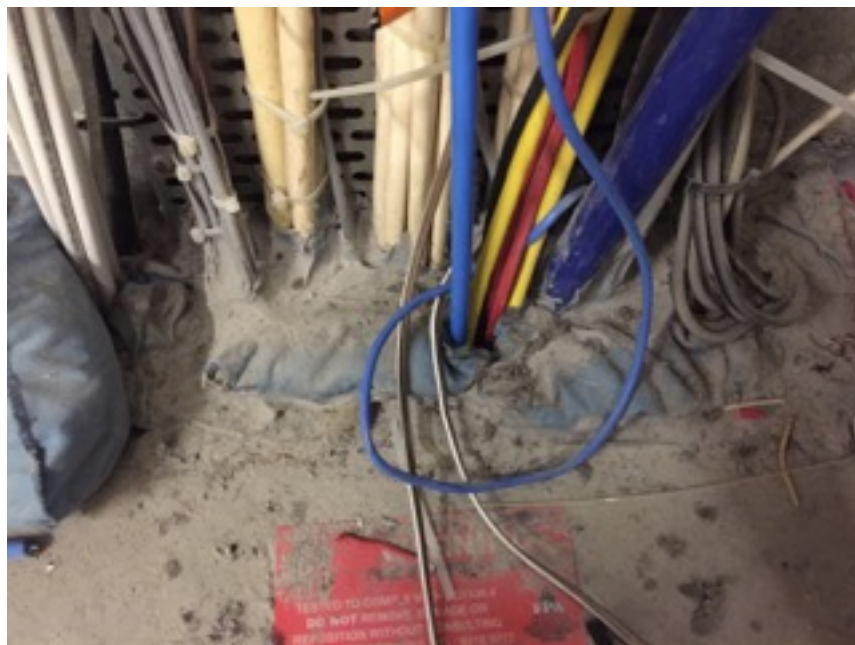
Riser L8 – missing fire stopping

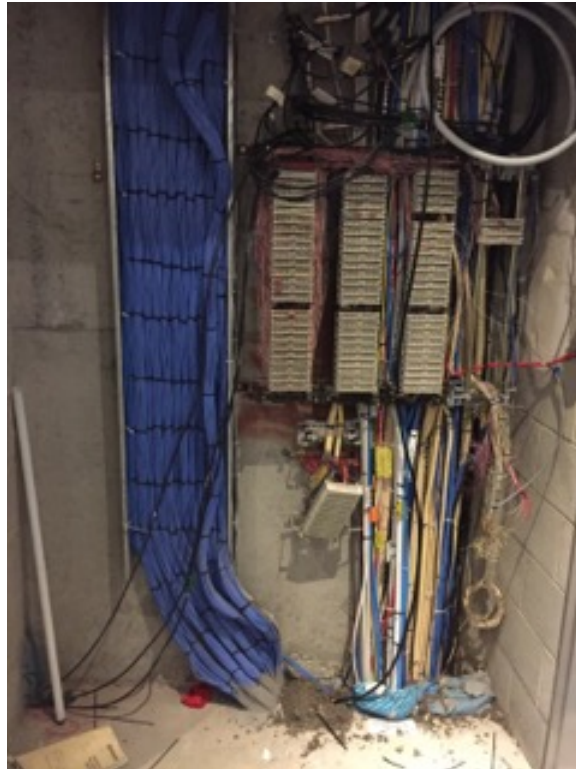
Riser L6 – redundant cabling

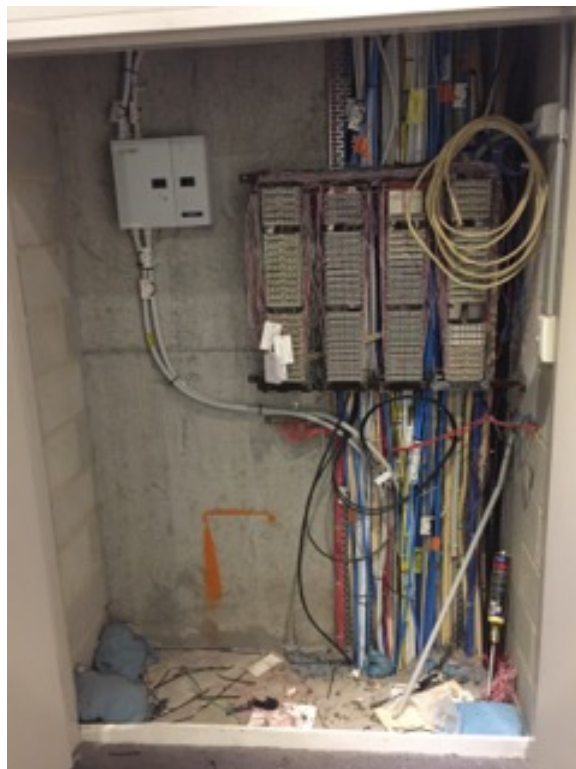
Riser L4 – rubbish, redundant cabling, missing fire stopping

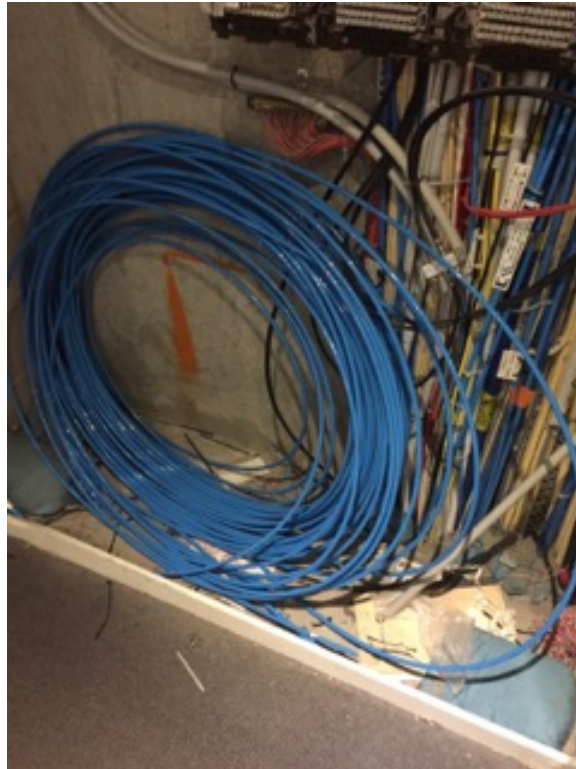
Riser L4 – redundant cabling

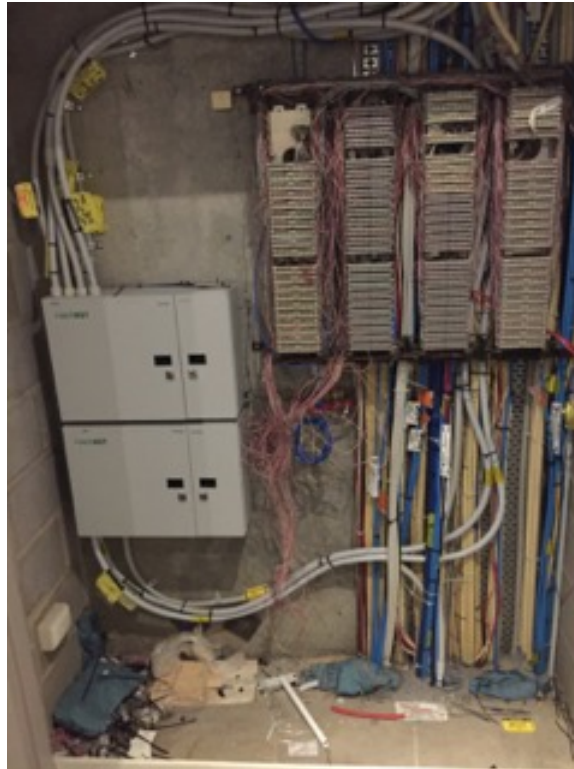
Riser L2 – rubbish, redundant cabling

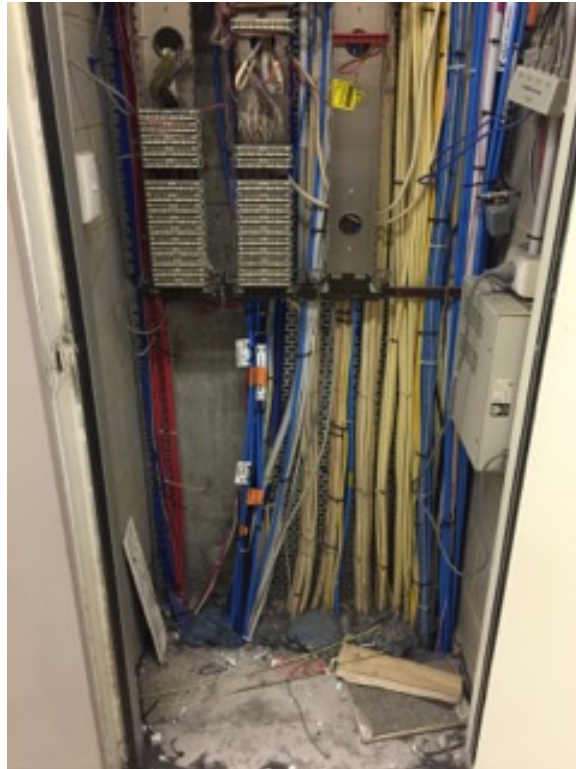
Riser G - rubbish

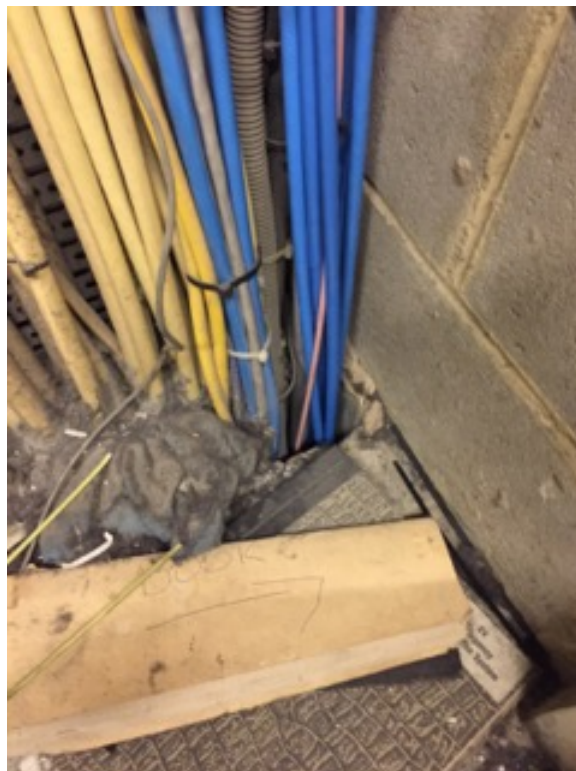
Riser G – missing fire stopping
