Mirvac Real Estate Pty Ltd
Asbestos and Hazardous Materials Assessment

David Malcolm Justice Centre

28 Barrack Street

754-SYDEN364426 - 28 Barrack Street - HMMR - 18122024

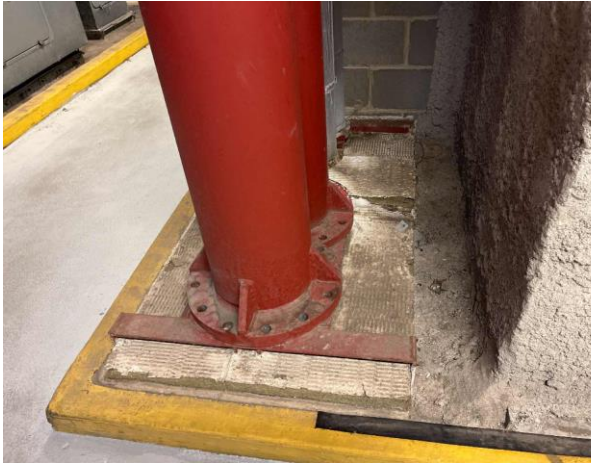
Line ID 1: Internal, L32, Plant Room, Base of Pipes, Around Insulation, Mastic Sealant - No Asbestos Detected

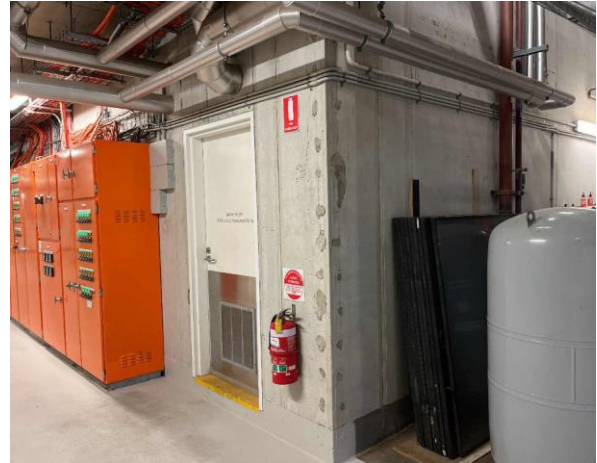
Line ID 2: Internal, L32, Plant Room, Boiler Room Walls, Fibre Cement Sheet - No Asbestos Detected

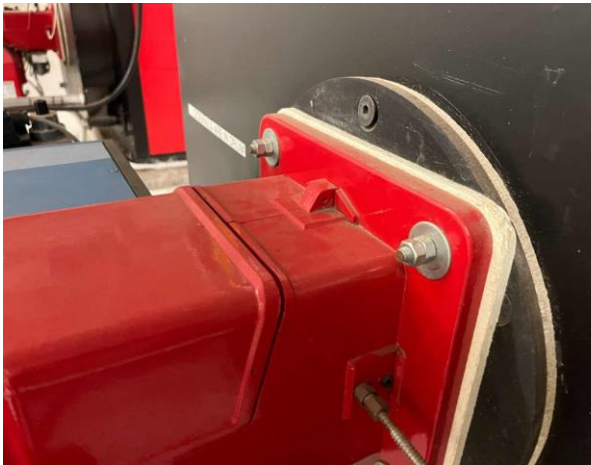
Line ID 3: Internal, L32, Plant Room, Boiler Room, Square Gasket to Boiler, Gasket Material - No Asbestos Detected

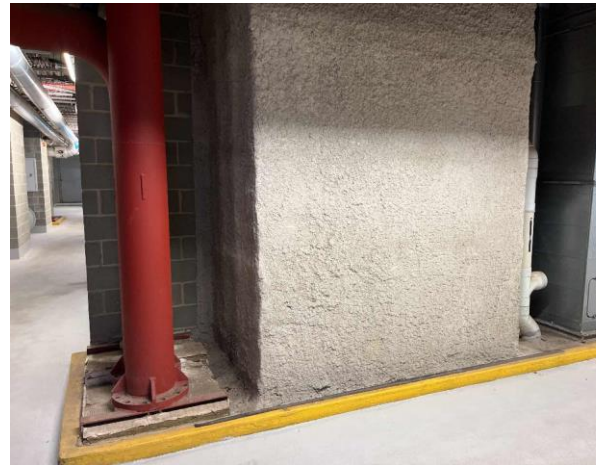
Line ID 4: Internal, L32, Plant Room, Throughout, Sprayed Vermiculite - No Asbestos Detected

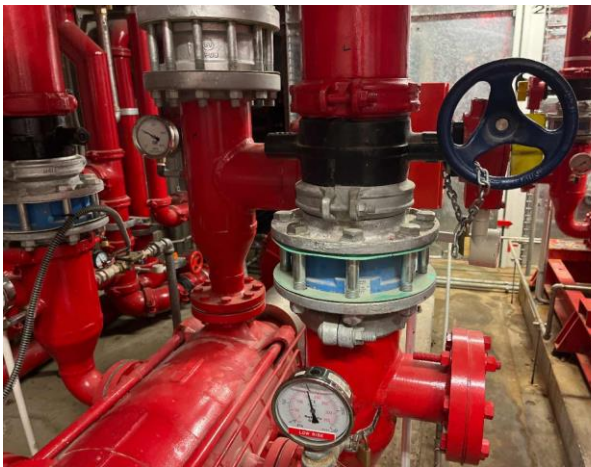
Line ID 5: Internal, Basement, Sprinkler Pump Room, Green Gaskets to Pipework, Gasket Material - No Asbestos Detected

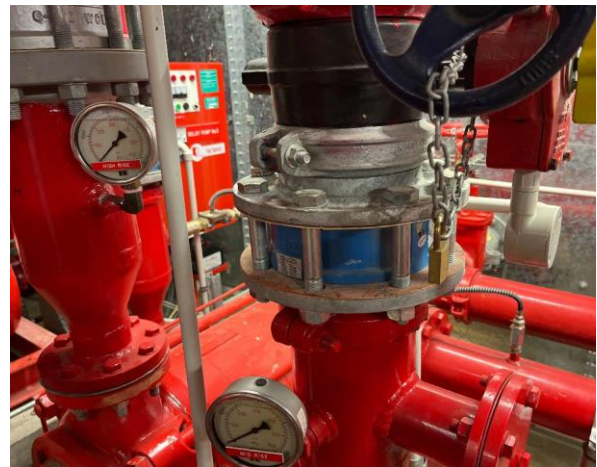
Line ID 6: Internal, Basement, Sprinkler Pump Room, Orange Gasket to Pipework, Gasket Material - No Asbestos Detected

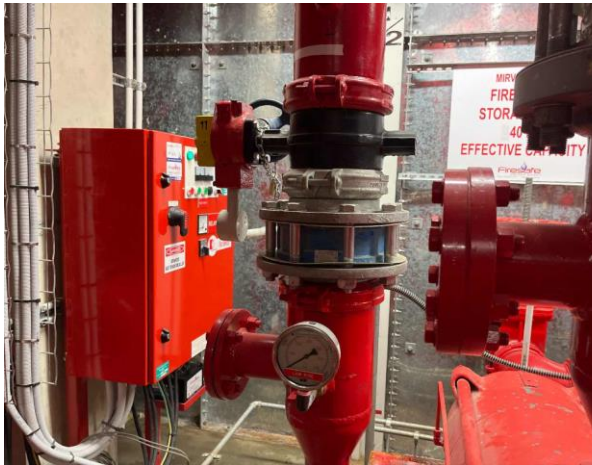
Line ID 7: Internal, Basement, Sprinkler Pump Room, White Gasket to Pumps, Gasket Material - No Asbestos Detected

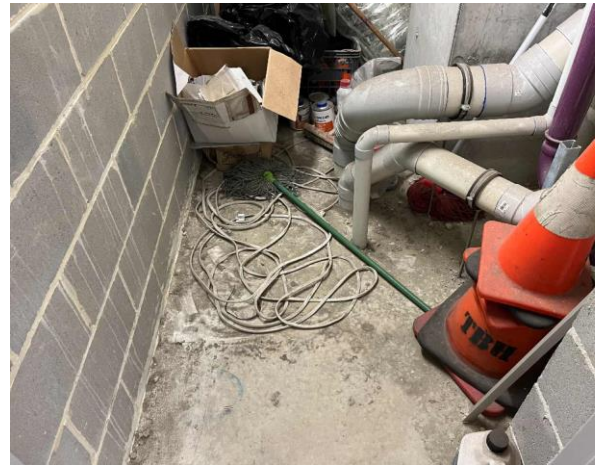
Line ID 8: Internal, L1, Small Plant Room, Floor throughout, Dust - Lead Detected (56mg/kg)

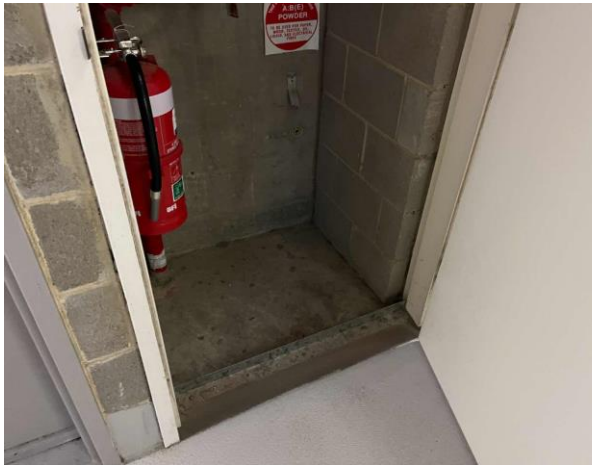
Line ID 9: Internal, L32, Plant Room, Fire Hose Reel Cupboard, to Floor, Dust - Lead Detected (10mg/kg)

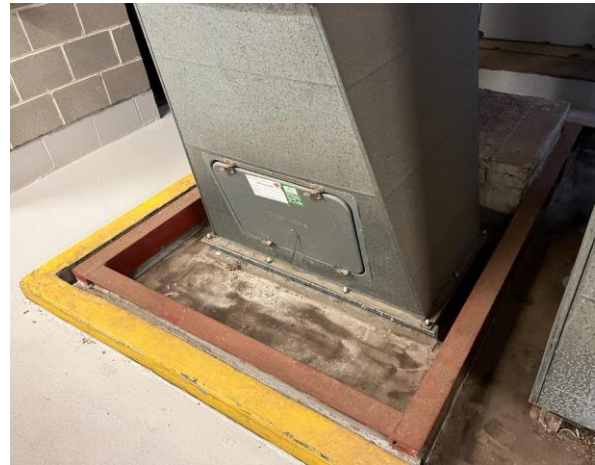
Line ID 10: Internal, L32, Plant Room, Floor at Base of AC Unit, Dust - Lead Detected (33mg/kg)

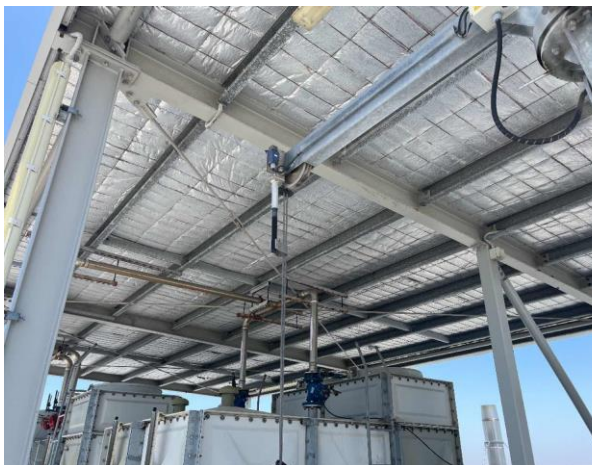
Line ID 11: External, Roof, Water Tank Area, To Ceiling, Insulation Material - Suspected SMF

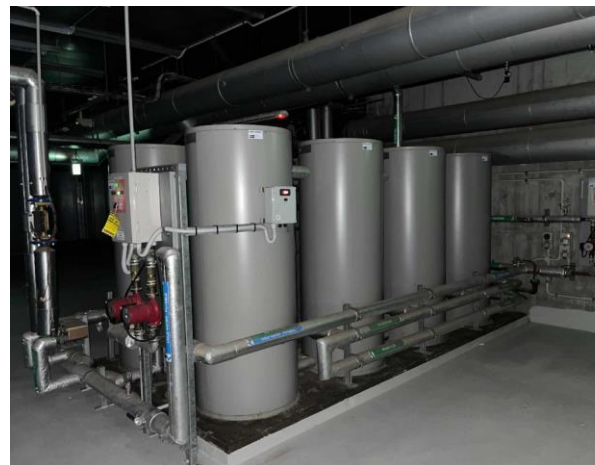
Line ID 12: Internal, L1, Plant Room, Throughout, Pipework, Internal Insulation - Suspected SMF

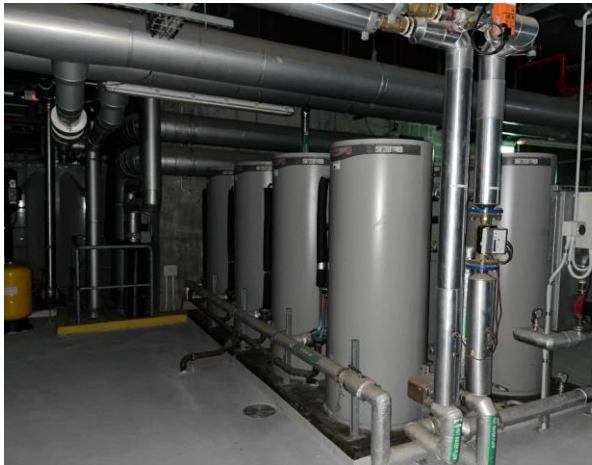
Line ID 13: Internal, L1, Plant Room, Within Hot Water Heaters, Insulation Material - Suspected SMF

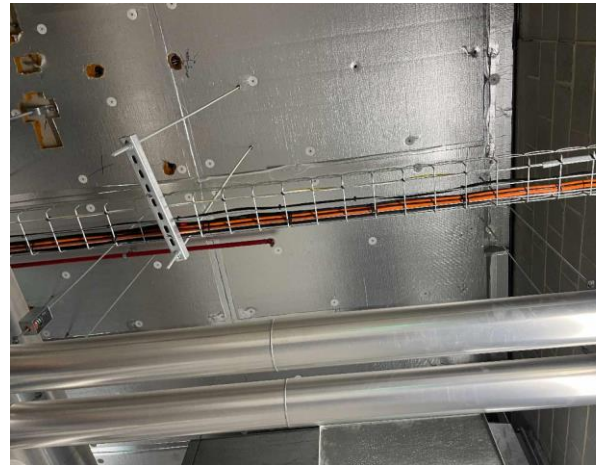
Line ID 14: Internal, L18, Generator Room, Ceiling, Insulation Material - Suspected SMF

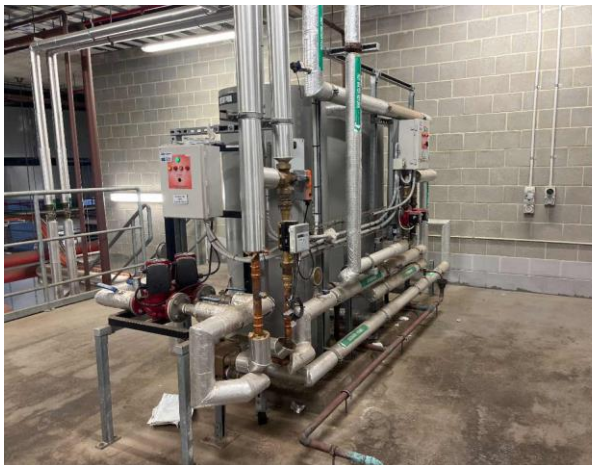
Internal	L32 / Mezzanine Area / Surrounding Pipework	Insulation Material	SMF	754-SYDEN364426 David Malcom Justice Center168S4	Suspected SMF	-	100 m	-	Very Low	-	Maintain in current condition if to remain in-situ. Remove under controlled SMF conditions as per the Code of Practice for the Safe Use of Synthetic Mineral Fibres [NOHSC: 2006 (1990)].	15

Line ID 15: Internal, L32, Mezzanine Area, Surrounding Pipework, Insulation Material - Suspected SMF

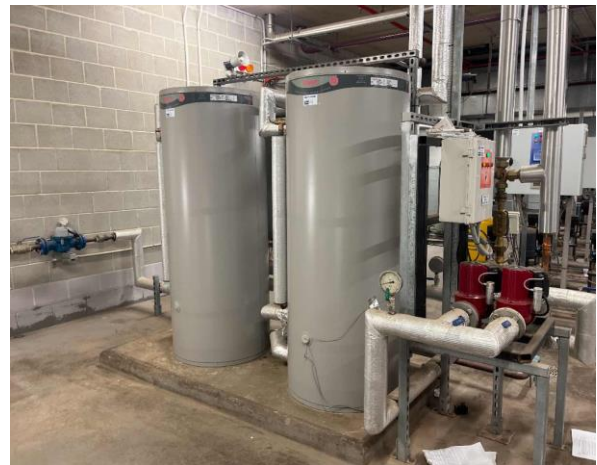
Line ID 16: Internal, L32, Mezzanine Area, Within Hot water Heaters, Internal Insulation - Suspected SMF

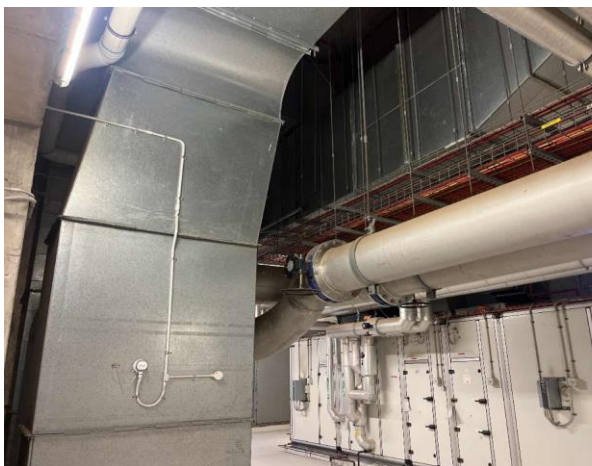
Line ID 17: Internal, L32, Plant Room, AC Ductwork, Internal Insulation - Suspected SMF

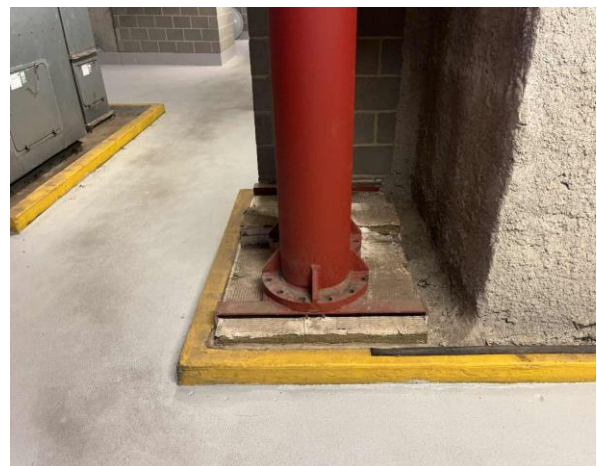
Line ID 19: Internal, L32, Plant Room, Surrounding Base of Pipes, Insulation Material - Suspected SMF

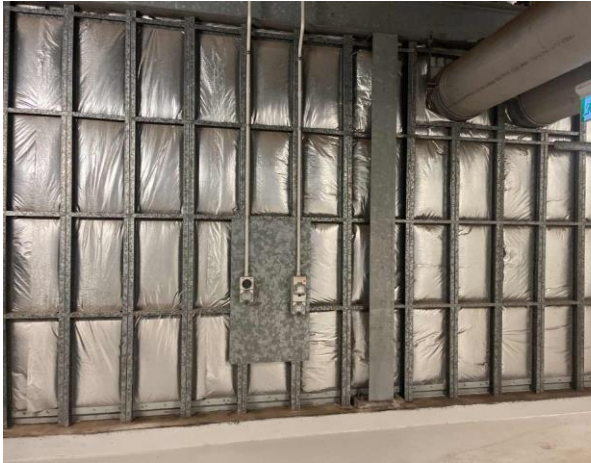
Internal	L32 / Plant Room / Surrounding Base of Pipes	Insulation Material	SMF	754-SYDEN364426 David Malcom Justice Center168S5	Suspected SMF	-	2 m ²	-	Very Low	-	Maintain in current condition if to remain in-situ. Remove under controlled SMF conditions as per the Code of Practice for the Safe Use of Synthetic Mineral Fibres [NOHSC: 2006 (1990)].	19
Internal	L32 / Plant Room / Throughout Walls	Insulation Material	SMF	754-SYDEN364426 David Malcom	Suspected SMF	-	500 m ²	-	Very Low	-	Maintain in current condition if to remain in-situ. Remove under controlled SMF conditions as per the Code of Practice for the Safe Use of Synthetic Mineral Fibres [NOHSC: 2006 (1990)].	20

Line ID 20: Internal, L32, Plant Room, Throughout Walls, Insulation Material - Suspected SMF

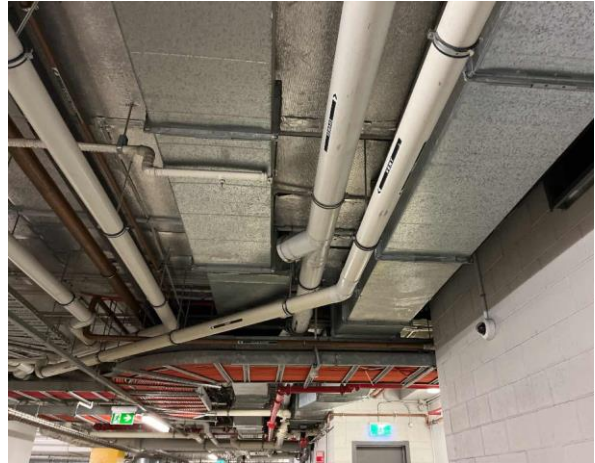
Line ID 24: Internal, Basement, Throughout, AC Ductwork, Insulation Material - Suspected SMF

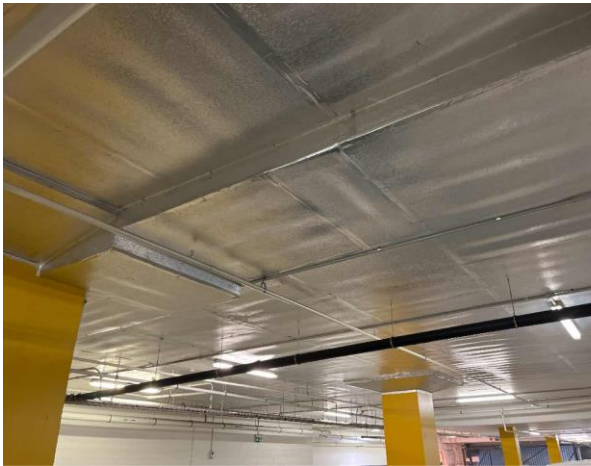
Internal	Basement / Throughout / AC Ductwork	Insulation Material	SMF	754-SYDEN364426 David Malcom Justice Center168S8	Suspected SMF	-	1000 m ²	-	Very Low	-	Maintain in current condition if to remain in-situ. Remove under controlled SMF conditions as per the Code of Practice for the Safe Use of Synthetic Mineral Fibres [NOHSC: 2006 (1990)].	24
Internal	Basement / Throughout / Ceiling	Insulation Material	SMF	754-SYDEN364426 David Malcom	Suspected SMF	-	1000 m ²	-	Very Low	-	Maintain in current condition if to remain in-situ. Remove under controlled SMF conditions as per the Code of Practice for the Safe Use of Synthetic Mineral Fibres [NOHSC: 2006 (1990)].	25

Line ID 25: Internal, Basement, Throughout, Ceiling, Insulation Material - Suspected SMF

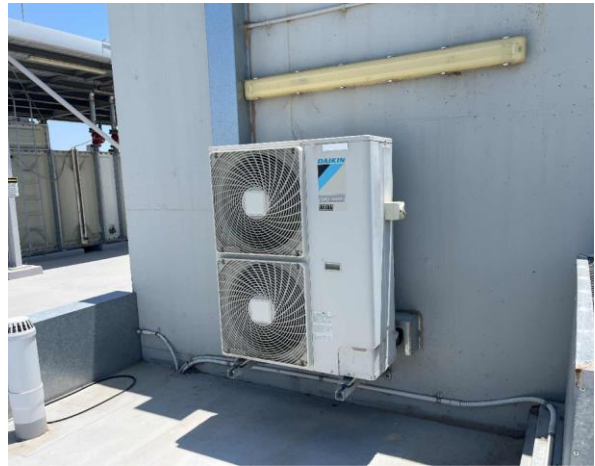
Line ID 26: External, Roof, East Side, Daikin AC Unit, R410A Hydrofluorocarbon (HFC) - Non ODS Refrigerant

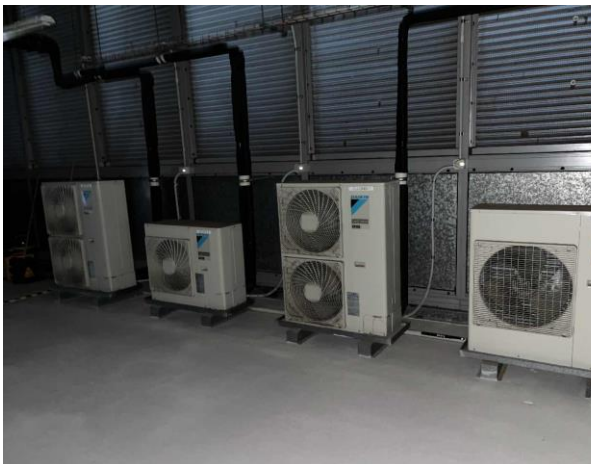
Line ID 27: Internal, L1, Plant Room, Daikin AC units, R410A Hydrofluorocarbon (HFC) - Non ODS Refrigerant

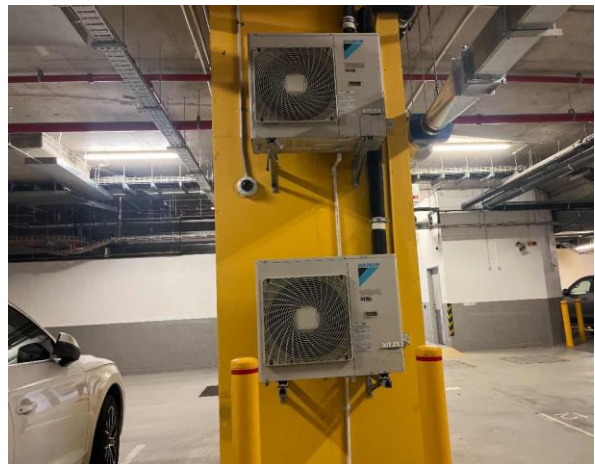
Line ID 28: Internal, Basement, Throughout, AC units, R410A Hydrofluorocarbon (HFC) - Non ODS Refrigerant
