CUSTOMER JOB NO. 204569 - 5515 - Dave Berry Utility Mapping & Surveying - During NDD

Project Name Locate, Pothole + Survey - Including Telecoms

Name Mirvac - Station Street Menangle
Address Cnr Menangle & Station Street
Menangle NSW 2568
Contact Nicole Franklin
Telephone
Mobile
Email

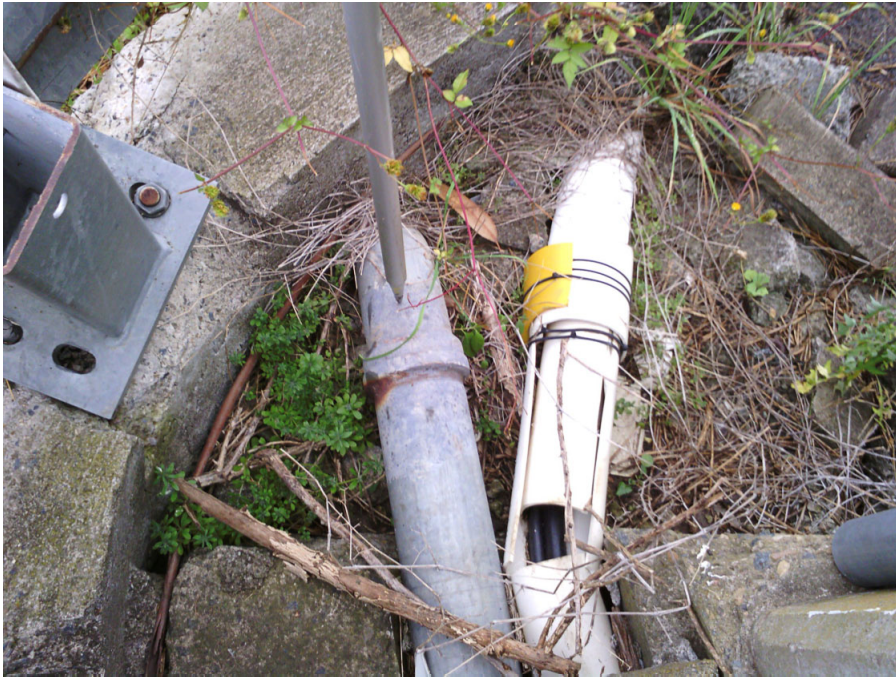
1. Water Main - Railway Bridge

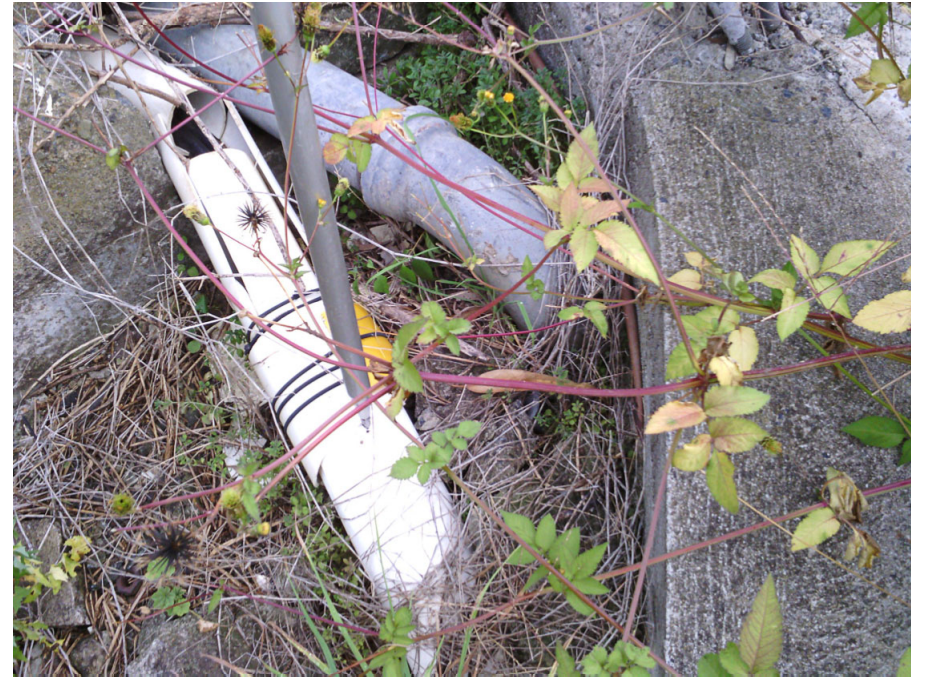
6. Telecom - Railway Bridge

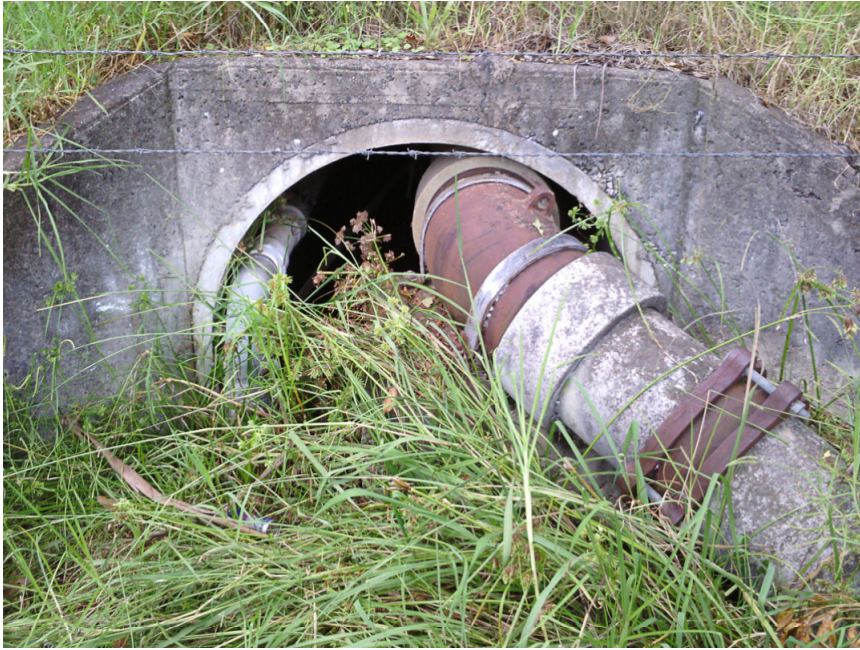
looked for comms pit near old gate at Hume Highway. Spotted the cables and conduit in the culvert. Cable does not appear to enter the property. It crosses the Hume Highway and turns parallel inside the culvert

17. 250mm Water and Redundant 100mm Water, Comms turns inside Culvert

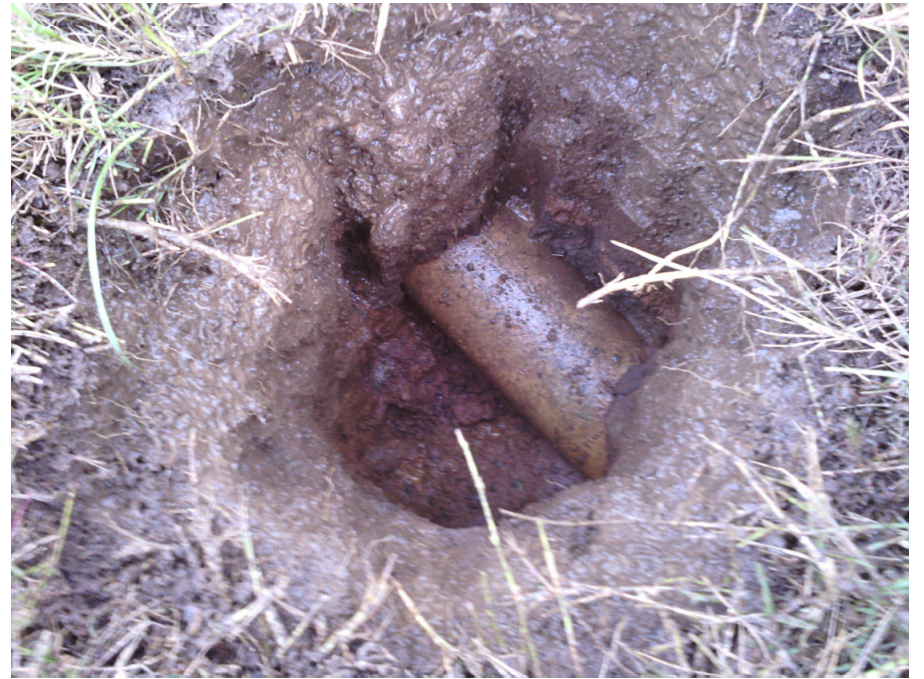
PH 1 - 100mm Water - Asbestos

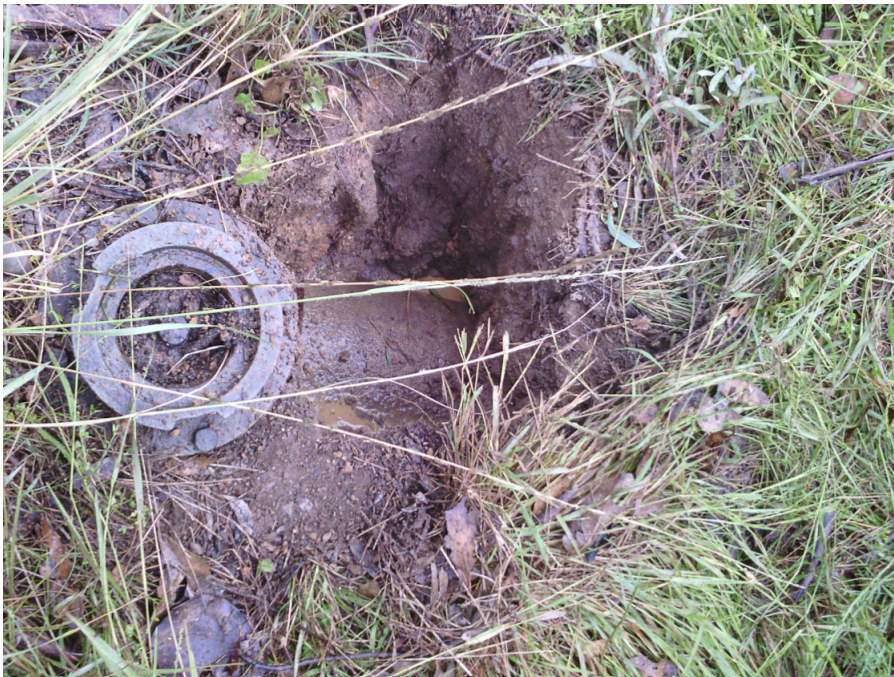
PH 3A - 250mm Water and Valve

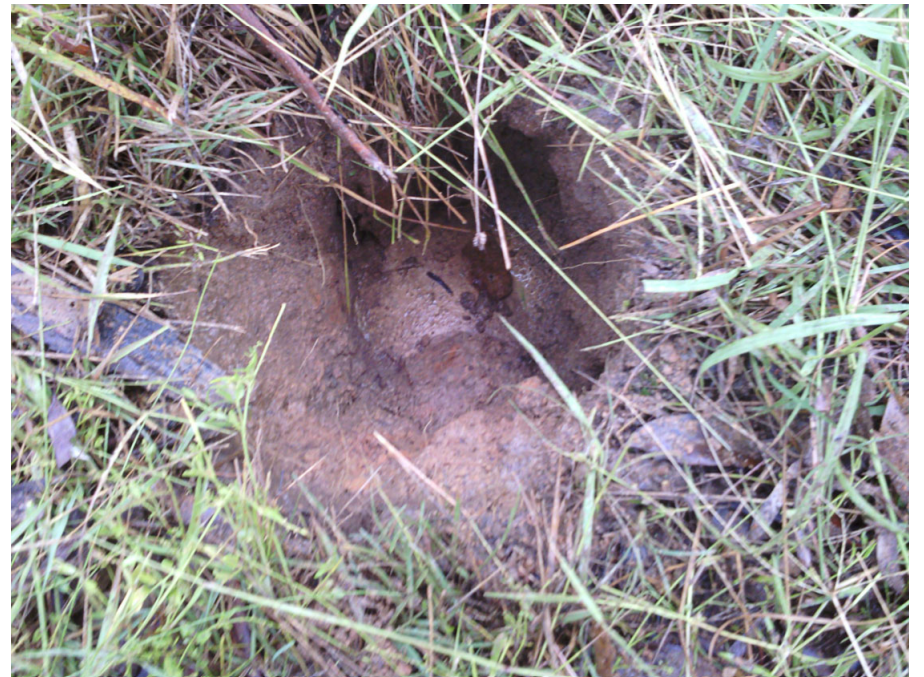
PH 3B - 250mm Water - Asbestos

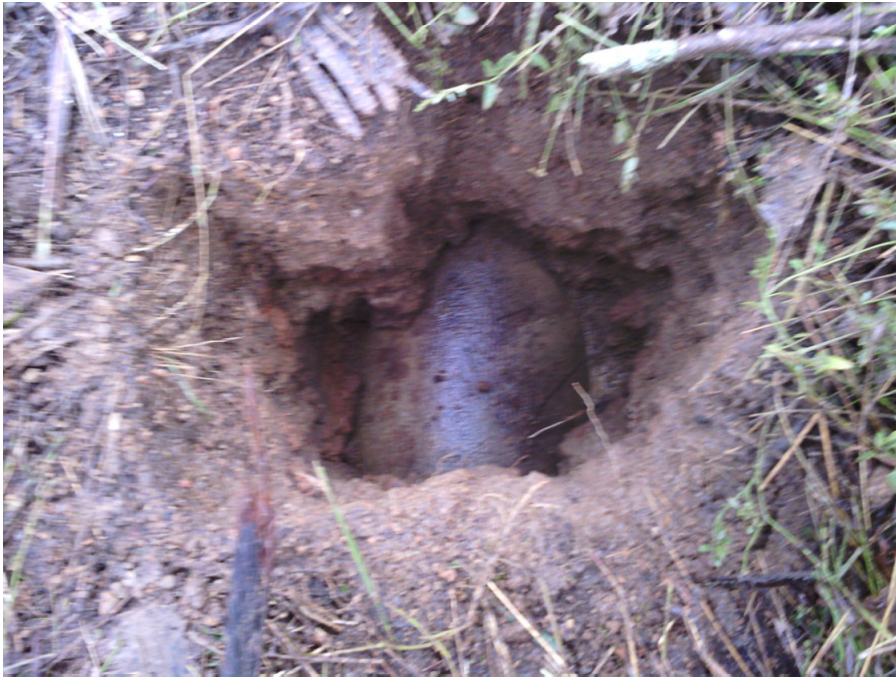
PH 3D - 250mm Water - Asbestos

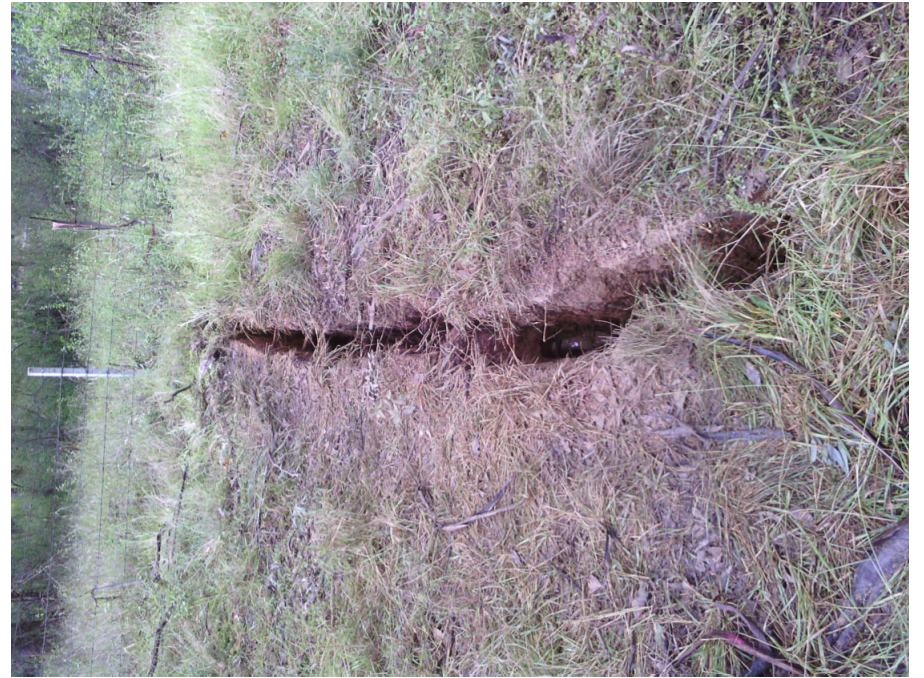
Pothole 3E 5m trench no services found

PH 3E - Slit Trench - No Services Found

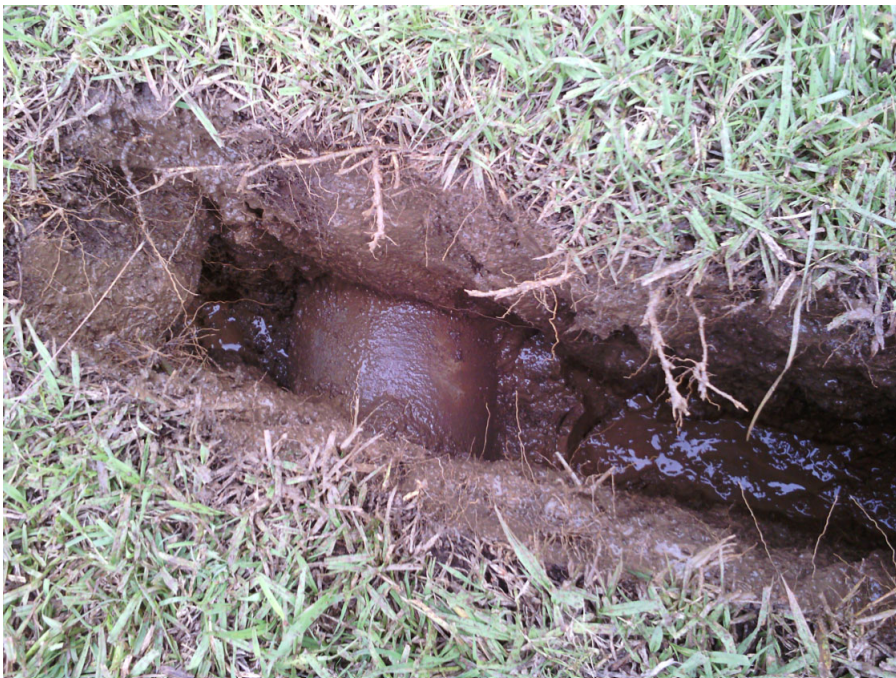
Pothole 4 was moved to location 5 and included in a trench across the gate

PH 5 - 250mm Water - Asbestos

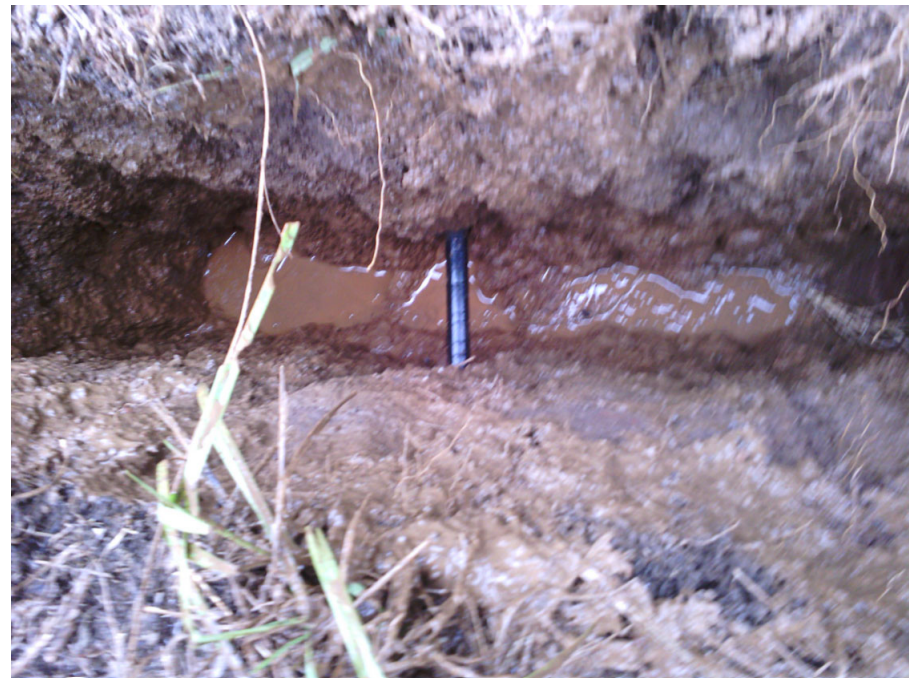
PH 6 - 1 x Direct buried comms cable

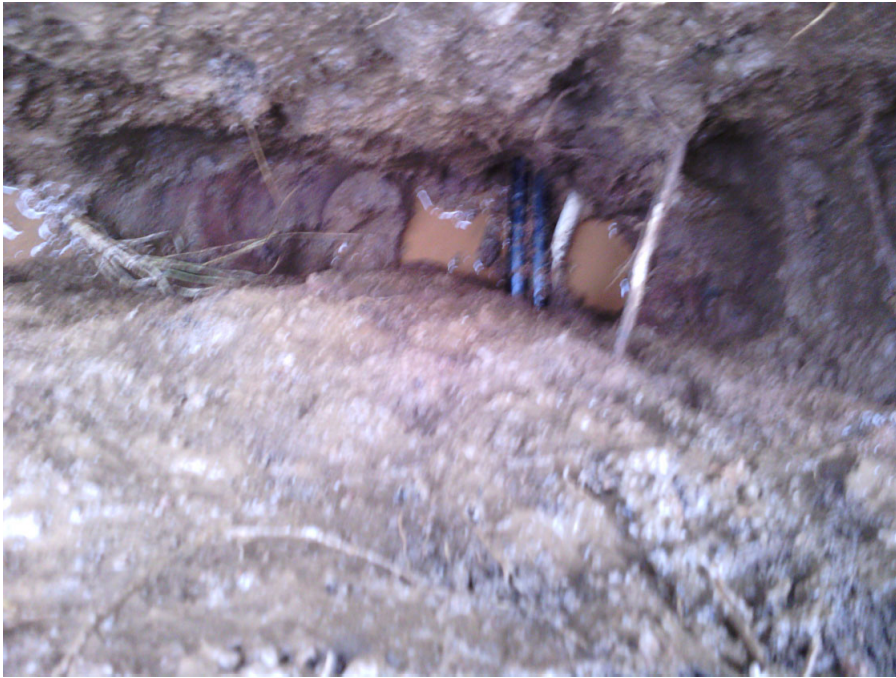
PH 6 - 2 x Direct buried comms cables

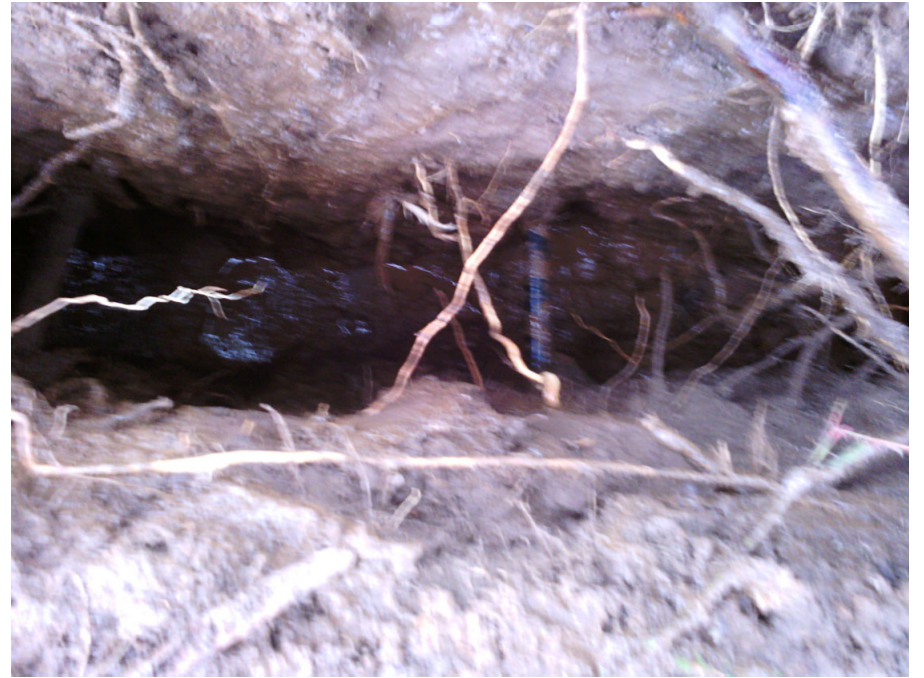
PH 7 - 1 x Direct buried comms cable

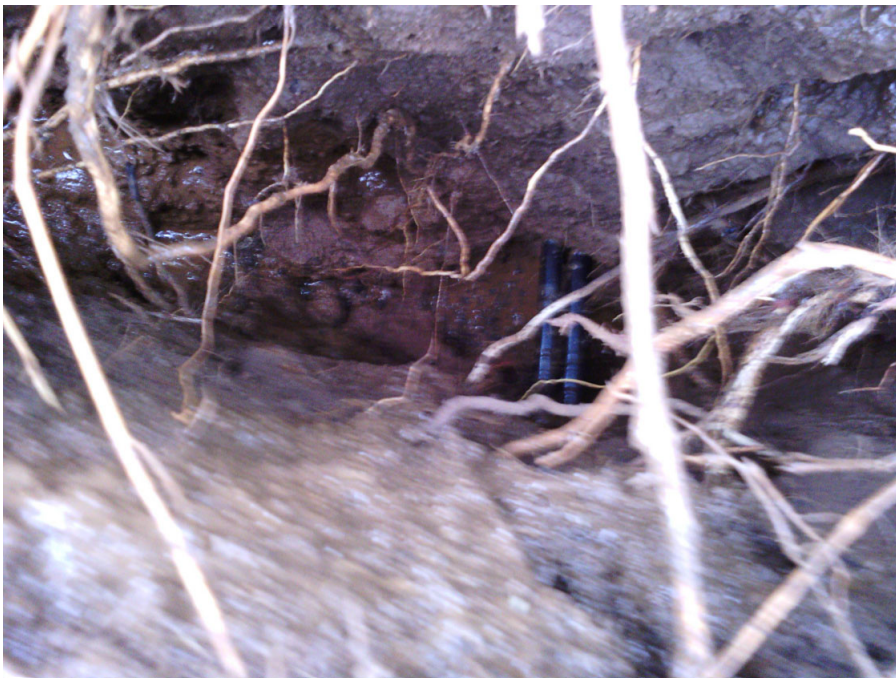
PH 7 - 2 x Direct buried comms cables

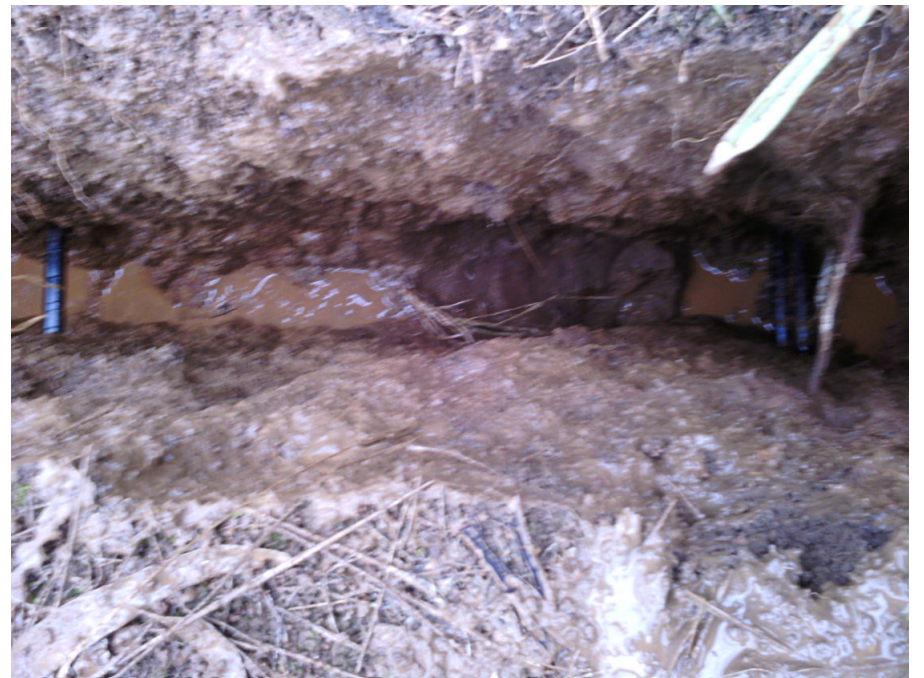
PH 7 - 3 x Direct buried comms cables

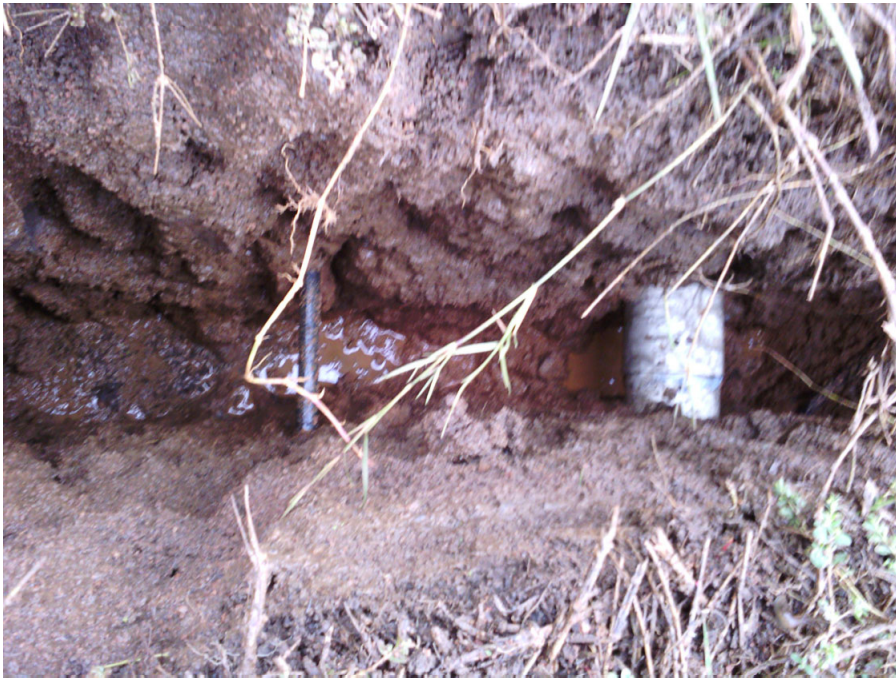
PH 8 - 100mm Comms and direct buried cable

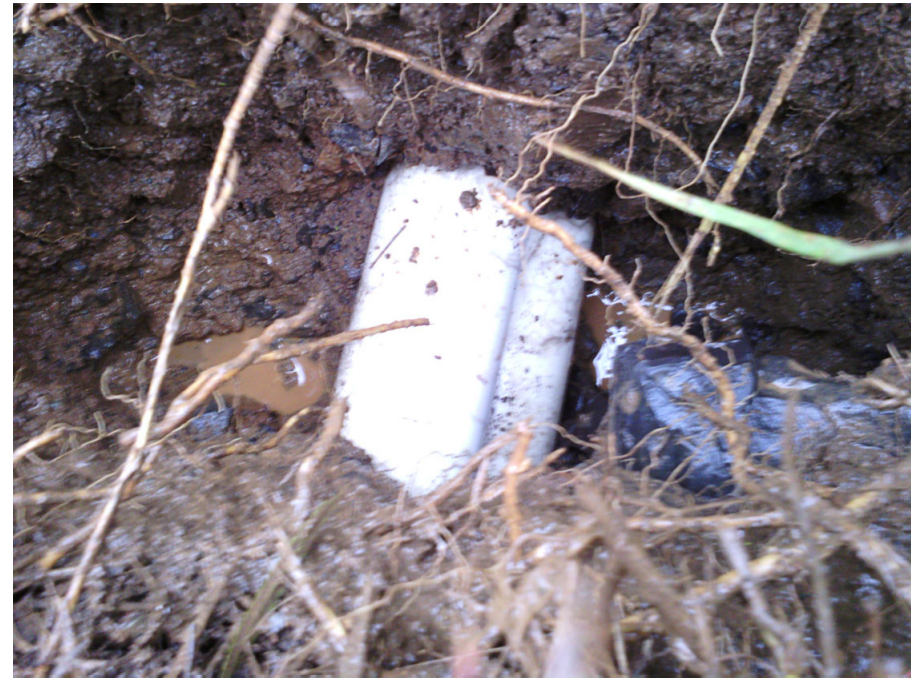
PH 9 - 2 x 100mm Comms

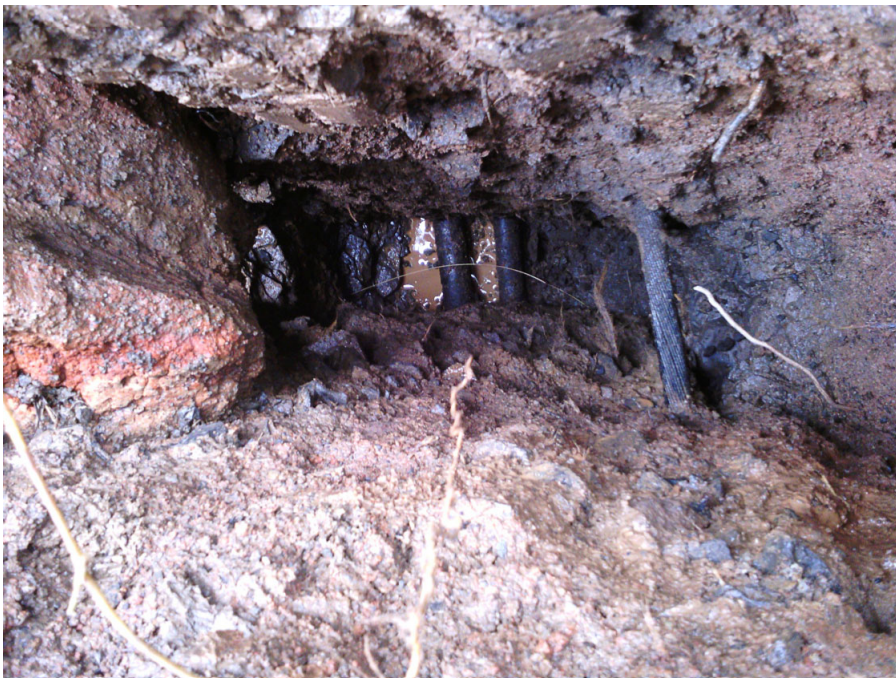
PH 10 - 3 x Direct buried cables

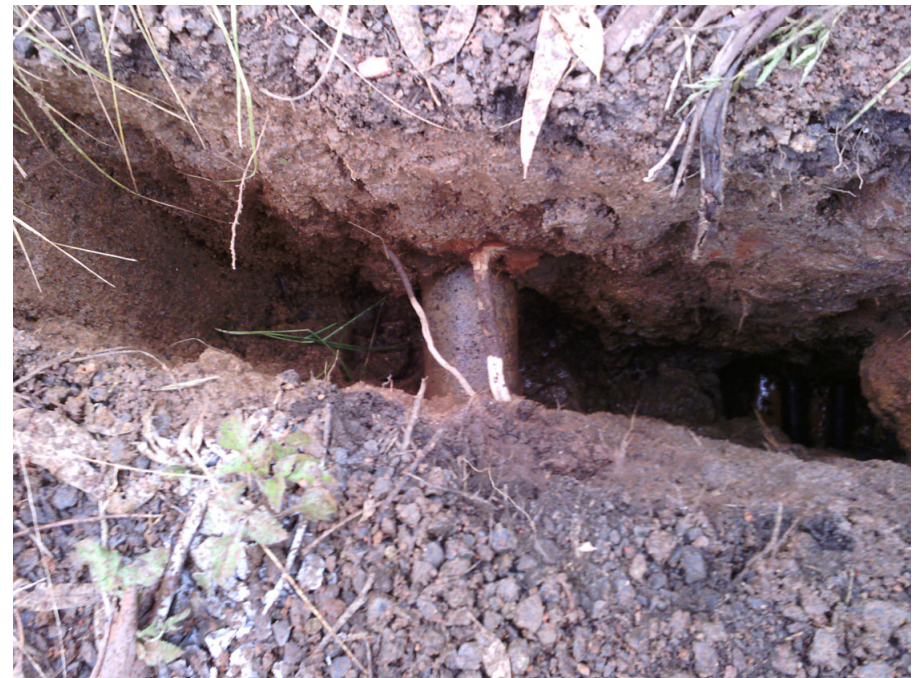
PH 10 - 100mm Comms

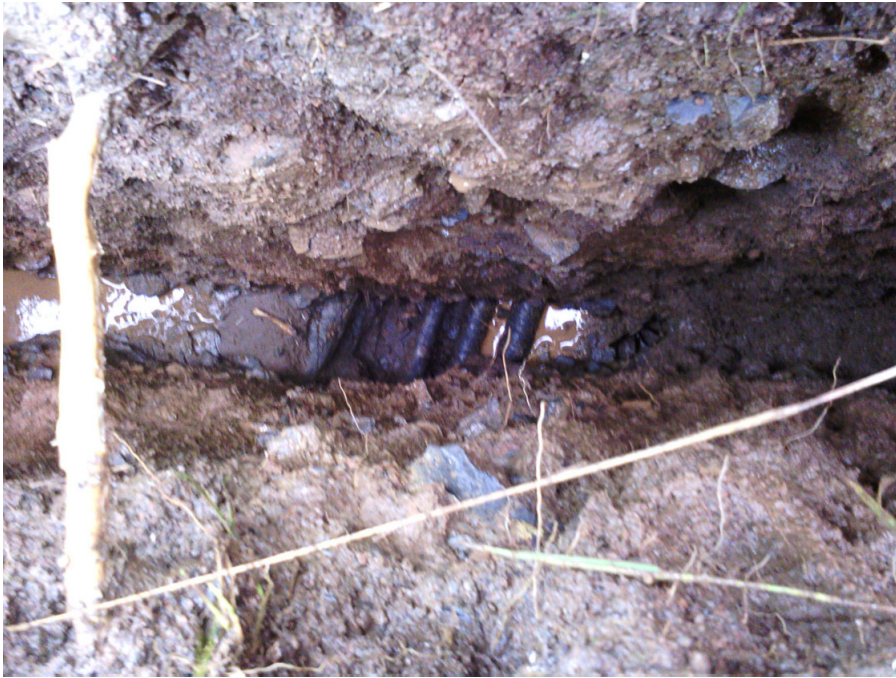
PH 11 - 3 x Direct buried cables

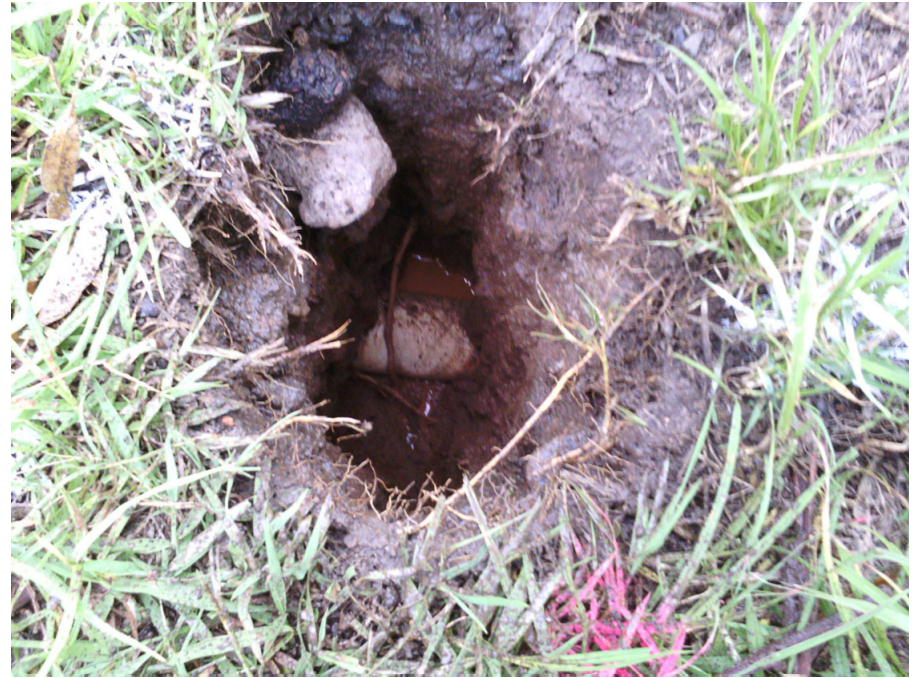
PH 12 - 100mm Comms

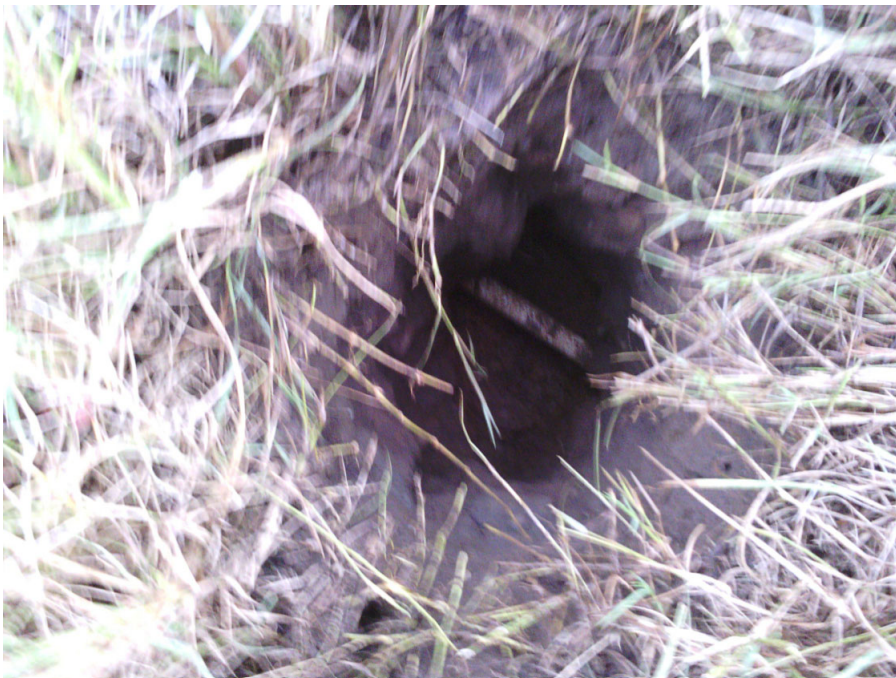
PH 13 - 25mm Comms

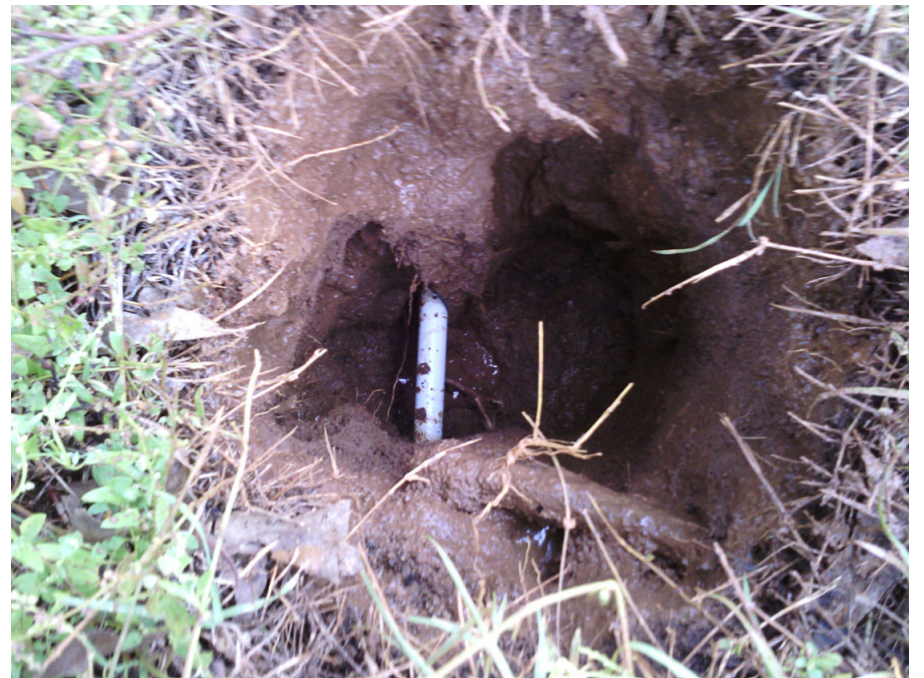
PH 14 - 25mm Comms

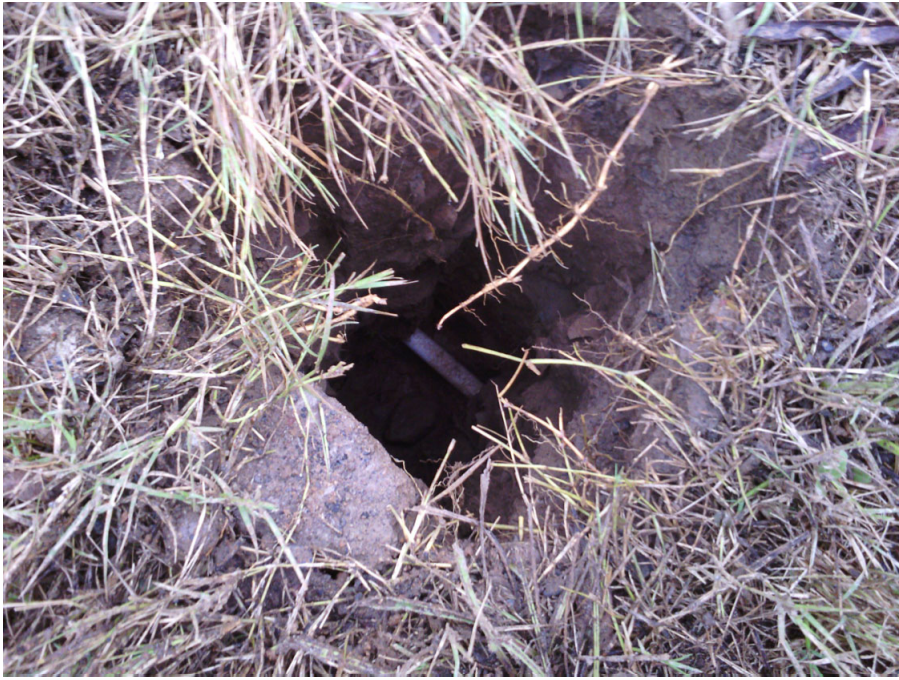
PH 15 - 25mm Comms

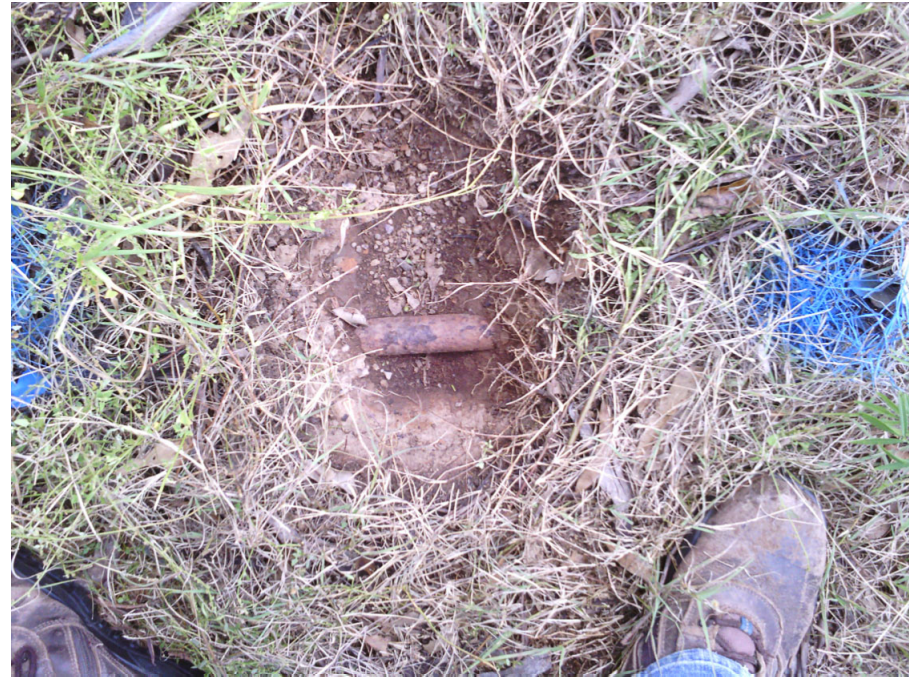
- No pipe is running along easement A4
- Doesn't believe there is a second pipe in the easement running along the Hume Hwy boundary and no tee under the overhead power lines where the 0.1 line enters the property
- Irrigation line runs from hydrant to hydrant (north east to south west) and turns towards Moreton Park Road
- Many other irrigation lines and connections off the main
- The only line to leave the property is the 0.25 asbestos feeding neighbouring properties and the 0.1 asbestos that crosses the bridge and runs to the dairy
- The 100mm pipe coming from culvert is redundant and was used to feed their property years ago
- Thinks 0.025 gal pipe that we found is a redundant feed to the house

PH 16 - 25mm Water
