HAZARDOUS MATERIALS REPORT AND REGISTER RHODES WATERSIDE SHOPPING CENTRE 1 RIDER BLVD, RHODES NSW, 2138

Hazardous Materials Report and Register Rhodes Waterside Shopping Centre 1 Rider Blvd, Rhodes NSW, 2138 MIRVAC

PS214355-103-OHH RevA1 - Rhodes Waterside Shopping Centre - 2024 Hazardous Materials Report.docx

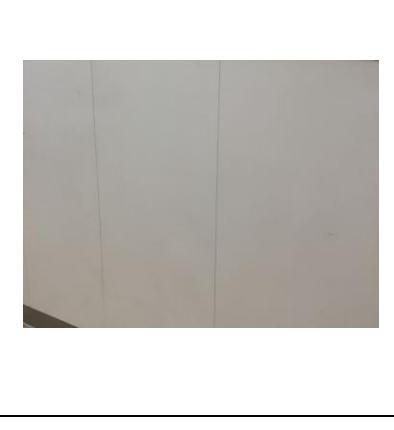
NON-ASB	ESTOS CO	ONTAININ	G MATERIAL
Photo Ref	<u>157039</u>	Sample No	Previously Sampled J160473-001- 004
Building	Rhodes Wa	aterside Sh	opping Centre
Level	External		
Room	Sprinkler v	alve cupbo	pard 3
Application	Wall lining	5	
Material	Fibre ceme	ent sheeting	5
Risk Rating	No Asbest	os

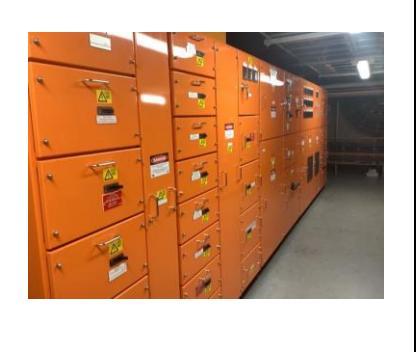
NON-ASBE	ESTOS CO	NTAINING	MATERIAL
Photo Ref	<u>157037</u>	Sample No	Visual Observation
Building	Rhodes Wa	aterside Sho	pping Centre
Level	Level 1		
Room	Switchroor	ns	
Application	Electrical c	omponents	
Material	Electrical r	nounting bo	ard
Risk Rating	No Asbesto	DS

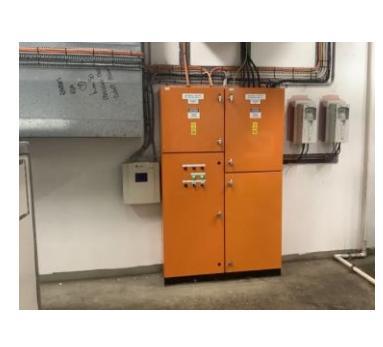
NON-ASBE	ESTOS CO	NTAINING	MATERIAL
Photo Ref	<u>157030</u>	Sample No	Visual Observation
Building	Rhodes Wa	aterside Sho	pping Centre
Level	Level 9		
Room	Office towe	er - Plant ro	om
Application	Electrical c	components	
Material	Electrical n	nounting bo	ard
Risk Rating	No Asbesto	DS

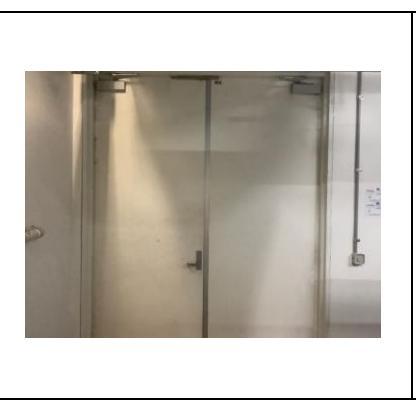
NON-ASBE	ESTOS CO	NTAINING	MATERIAL
Photo Ref	<u>157029</u>	Sample No	Visual Observation
Building	Rhodes Wa	aterside Sho	pping Centre
Level	Level 10		
Room	Office tow	er	
Application	Plant room	- Fire door	core
Material	Insulation	material	
Risk Rating	No Asbesto	DS

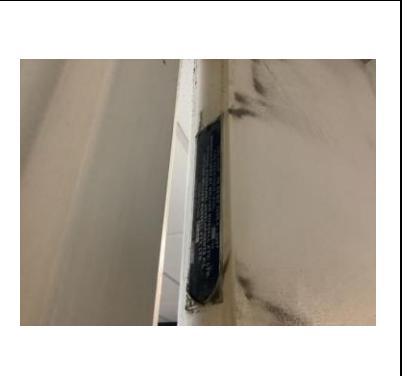
NON-ASB	ESTOS C	ONTAININ	G MATERIAL
Photo Ref	<u>157038</u>	Sample No	Visual Observation
Building	Rhodes W	aterside Sho	opping Centre
Level	Level 10		
Room	Office toy	ver - Plant ro	oom
Application	Electrical	components	5
Material	Electrical	mounting be	oard
Risk Rating	No Asbes	tos

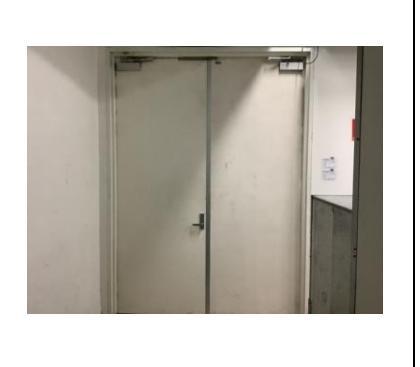
NON-ASB	ESTOS CO	ONTAINING	G MATERIAL
Photo Ref	<u>157031</u>	Sample No	Ref: WSP- J160473-001- 001
Building	Rhodes W	aterside Sho	opping Centre
Level	Level 11		
Room	Fire stairs		
Application	South and	North - Infi	ll panels
Material	Fibre ceme	ent sheeting	
Risk Rating	No Asbest	os

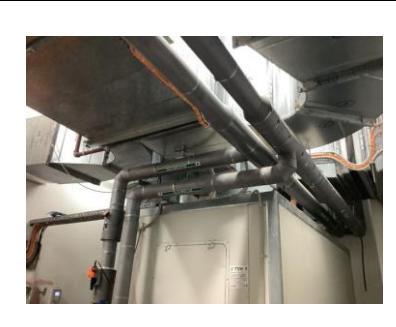
SYI	NTHETIC I	MINERAL I	IBRE
Photo Ref	<u>SMF-</u> 28773	Sample No	Visual Observation
Building	Rhodes W	aterside Sho	pping Centre
Level	Level 9		
Room	Office tow	er - Plant ro	om
Application	Ducts		
Risk Rating	Low Risk

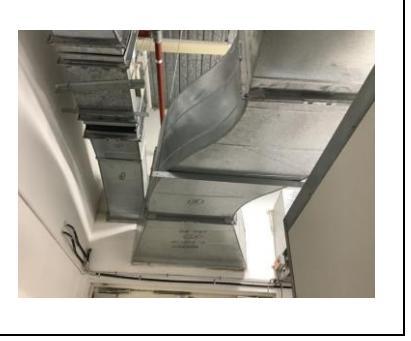
SY	NTHETIC	MINERAL	FIBRE
Photo Ref	<u>SMF-</u> 28772	Sample No	Visual Observation
Building	Rhodes W	aterside Sho	opping Centre
Level	Level 10		
Room	Office tow	ver - Plant ro	oom
Application	Ducts		
Risk Rating	Low Risk

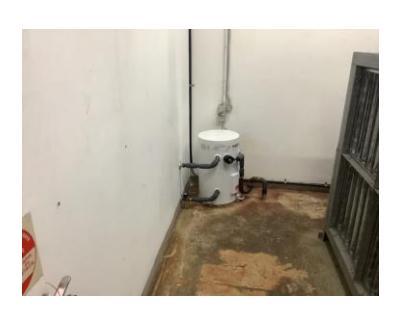
SYI	NTHETIC N	MINERAL F	IBRE
Photo Ref	<u>SMF-</u> 28771	Sample No	Visual Observation
Building	Rhodes Wa	aterside Sho	pping Centre
Level	Level 10		
Room	Office tow	er - Plant ro	om
Application	Insulation		
Risk Rating	Low Risk

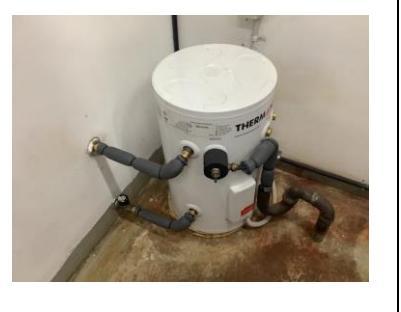
SY	NTHETIC	MINERAL	FIBRE
Photo Ref	<u>SMF-</u> 28769	Sample No	Visual Observation
Building	Rhodes V	Waterside Sh	opping Centre
Level	All Floor	rs	
Room	Risers		
Application	Insulatio	n	
Risk Rating	Low Ris	k

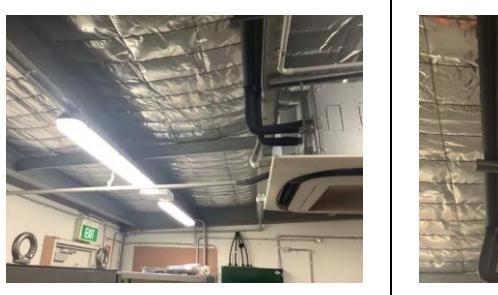
SYNTHETIC MINERAL FIBRE			
Photo Ref	<u>SMF-</u> 28768	Sample No	Visual Observation
Building	Rhodes W	aterside Sho	opping Centre
Level	All Floors		
Room	Various ro	oms	
Application	Susp. Ceili	ing	
Risk Rating	Low Risk

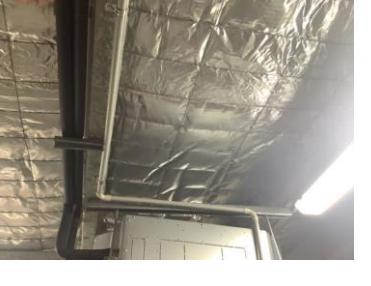
SYNTHETIC MINERAL FIBRE								
Photo Ref	<u>SMF-</u> 28770	SMF- 28770Sample NoVisual Observation						
Building	Rhodes W	Rhodes Waterside Shopping Centre						
Level	Roof	Roof						
Room	Lift motor	Lift motor room						
Application	Sarking insulation							
Risk Rating	Low Risk
