**Environmental Representative (ER) Quarterly Report**  
**Project: SSD-10448 – Aspect Industrial Estate Stage 1**  
**Period: March 2023 to May 2023**

Project: SSD-10448 – Aspect Industrial Estate

Period: March 2023 to May 2023

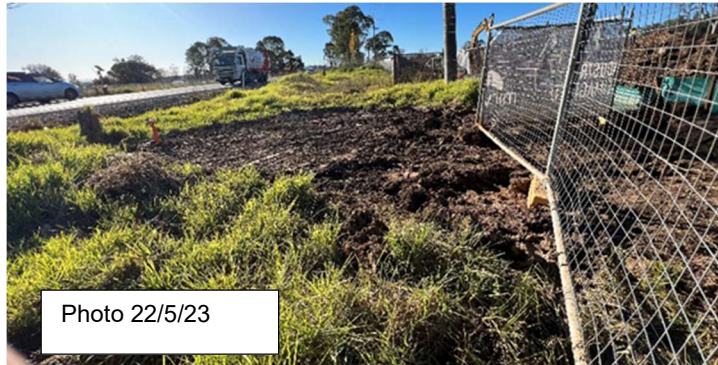
Photo 22/5/23

Sensitive works along the western boundary caused a minor breach of sediment along the western boundary. The impacted area was locally contained by Mamre Road and the heavily grassed verges.

The event was reported to DPE as an incident.

Erosion and sediment controls in the vicinity were renewed to reduce the risk of re-occurrence

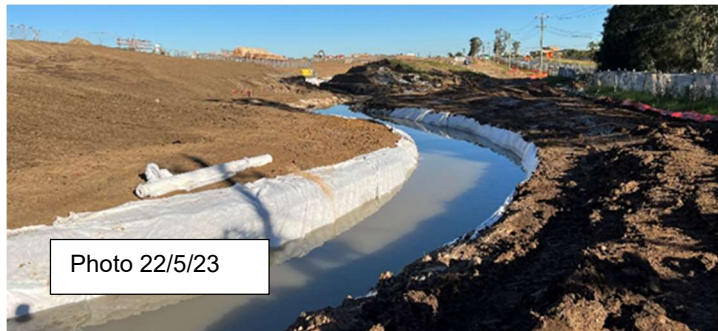
Photo 22/5/23

Sensitive riparian works were progressing along the western boundary at the interface of the temporary clean water channel and the permanent riparian channel.

Geofabric, rock armour, sediment fences and polymer was applied to upgradient slopes to reduce the risk of sediment laden water exiting the site.

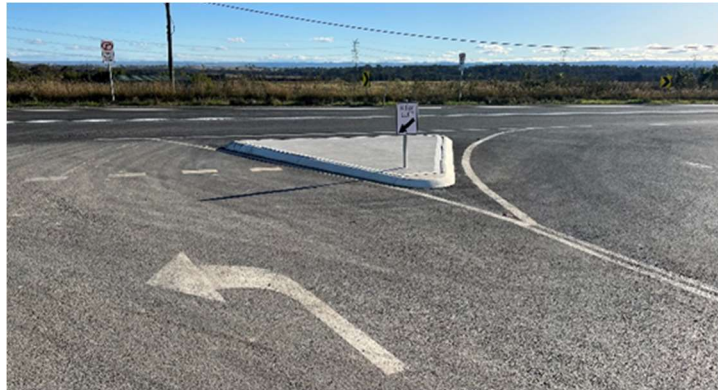
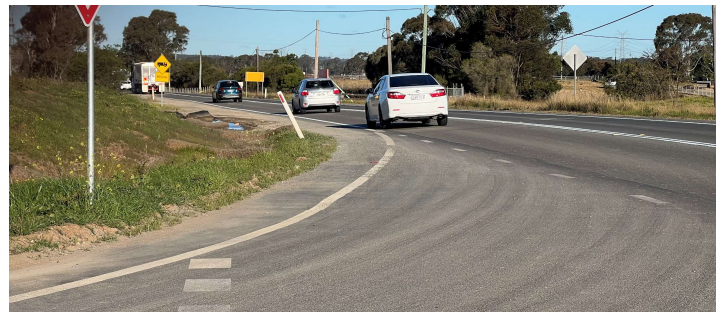
The CAR and its intersection with Mamre Road was in good condition with only minor dusting of surfaces present. (Photo 29/5/23)

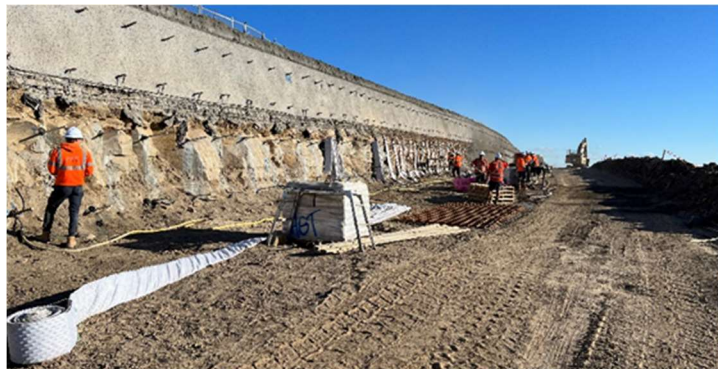
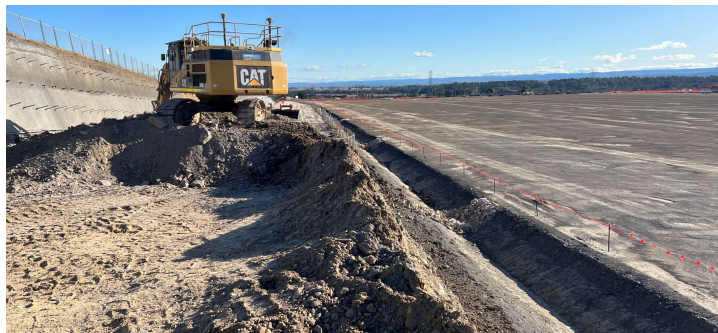
The retaining wall on the southern boundary to Pad 9 was being constructed. This involves the excavation of the embankment, drilling and installation of rock nails and shotcrete (Photos 29/5/23).

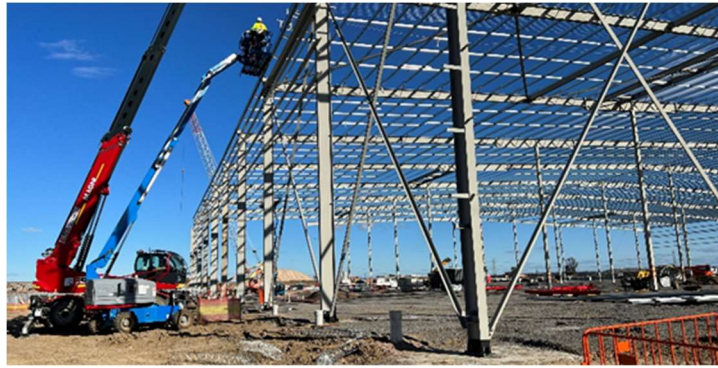
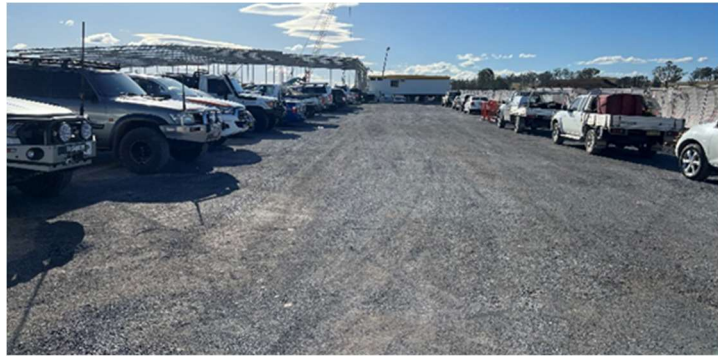
The site compound has been established and the steel from for the warehouse is progressing.

The site is covered in DGB to provide a clean working surface and reduce the potential for tracking (Photos 29/5/23).
