EME Guide

RFNSA No: 4300024

Document Issue No: 02

**1 Main Street
SPRINGFIELD LAKES
QLD, 4300**

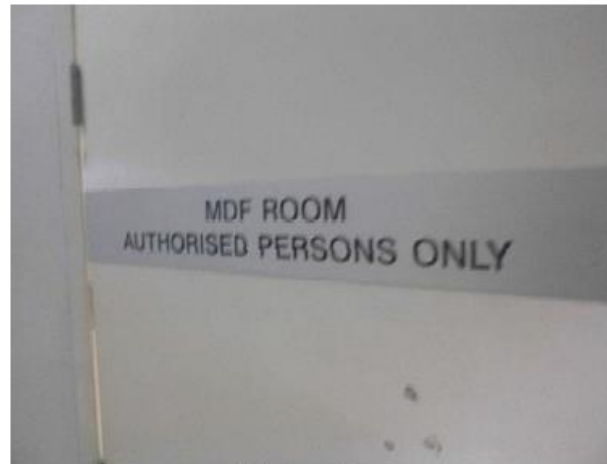
MDF Room signage

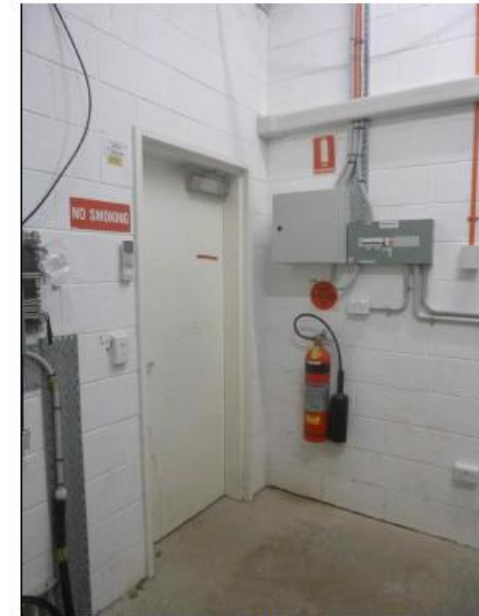
DB adjacent door
