Asbestos Management Plan

Bourke Place
600 Bourke Street,
Melbourne VIC

October 2019

Report For:	AMP Capital
Address:	600 Bourke Street, Melbourne VIC
Prepared By:	Matthew Hyde, Senior Consultant (RiskTech Compliance)

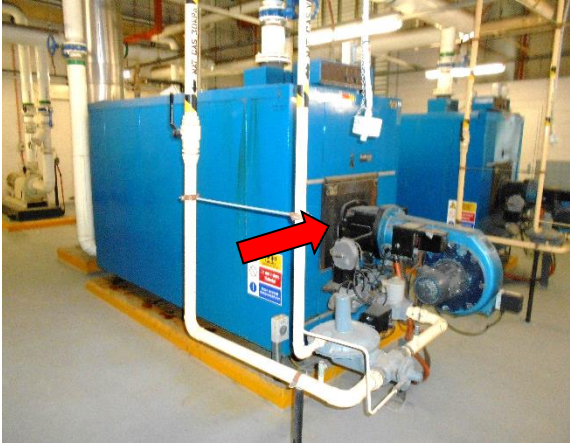
Level 51, Plant Room, Boiler Room Boiler, Inlet Manifold – Asbestos containing gasket	Level B3, Sprinkler Pump Room, Large Diesel Fire Pump, Vent Pipe, Flange Joint – Asbestos containing gasket

These materials should be replaced with non-asbestos alternatives during regular maintenance if they would be impacted upon. In most cases it is considered safe to leave them in-situ and remove them when decommissioning the item of plant.
