Erosion and Sediment Control Plan

CLIENT  
**MIRVAC QLD PTY LTD**  
 PROJECT  
**EVERLEIGH PRECINCT 9.4 SUBDIVISION DEVELOPMENT**  
 LOCATION  
**TEVIOT ROAD, GREENBANK**  
 SHEET TITLE  
**OVERALL EROSION & SEDIMENT CONTROL KEY PLAN**

# Bushfire Hazard Assessment and **Fire** Management Plan

## *Melaleuca irbyana*

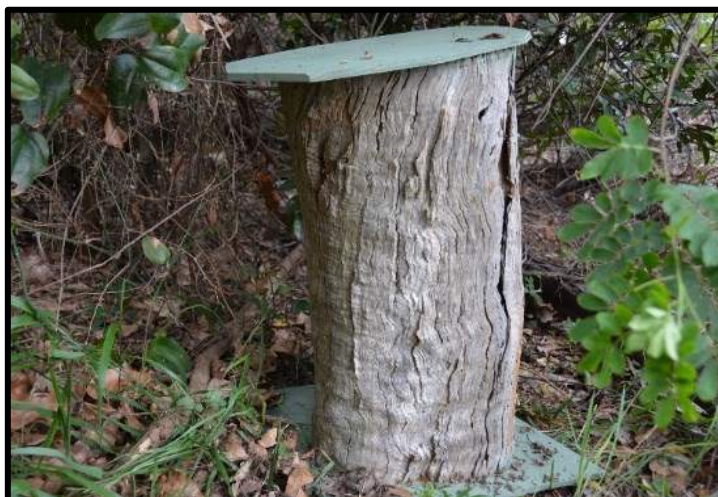
**FIGURE 2- RELOCATED NATIVE BEEHIVE**

If a native beehive is located on site, its entrance is to be blocked off prior to sunrise. The extent of the beehive within the hollow is to be established using a fibre optic camera. The beehive is then to be cut out and both ends of the hive sealed off using treated wood. The beehive is then to be relocated to a suitable location and left-over night. The next morning at sunrise the entrance is to be opened.

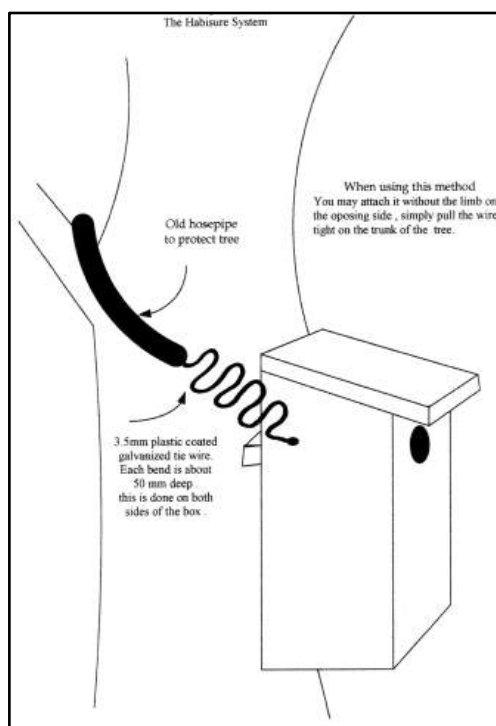
**FIGURE 3- NEST BOX INSTALLATION**

Nest boxes will be sourced from Hollow Log Homes and hollows suitable to the species sighted/signs of species sighted/captured on site will be ordered. Nest boxes will be fixed to trees using a method designed to ensure no damage is done to the tree as the tree matures (See Figure 3). Possum and glider boxes will be placed in the foliage to protect them from hot afternoon sun and can be positioned facing any direction except for west. The nest boxes should be placed in an area that gives protection from direct sunlight and the entrance should face away from prevailing winds and rain. Nest boxes for possums should be attached 2-4m off the ground and 3- 6m high for glider and bird boxes (Franks, 2006). The nest boxes should be placed within an area that contains suitable species and quantities of food trees that are favoured by the species that the nest box was designed for.

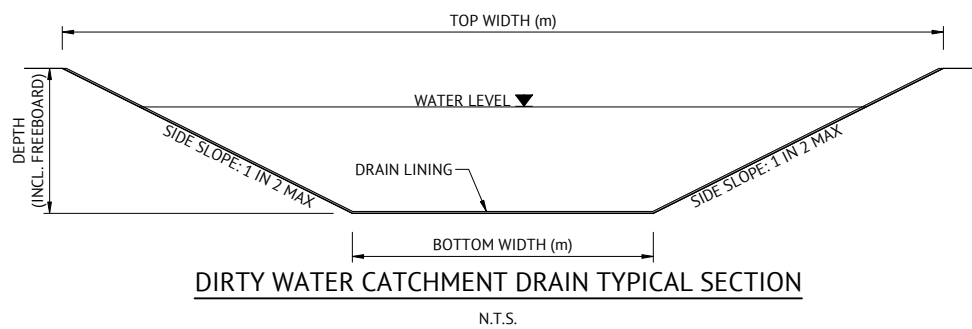
**DIRTY WATER CATCH DRAIN DETAILS**

DRAIN ID	SLOPE	LINING	BASE WIDTH (m)	TOP WIDTH (m)	DEPTH INCLUDING FREEBOARD (m)
DWD-01	4.50%	BLACK PLASTIC	2.000	3.350	0.330
DWD-02	5.20%	BLACK PLASTIC	2.000	3.050	0.260
DWD-03	8.20%	BLACK PLASTIC	2.000	3.100	0.280
DWD-04	3.20%	BLACK PLASTIC	2.000	3.070	0.270

REFER TYPICAL SECTION ABOVE FOR DETAILS  
NOTE: CATCH DRAINS SIZED FOR Q2 FLOW

CATCH DRAIN SIZING	
$Q_y = (C_y \cdot I_{tc,y} \cdot A) / 360$ [Equation 1 (IECA 2008)]	
where:	
$Q_y$	PEAK FLOW RATE (m <sup>3</sup> /s) OF AVERAGE RECURRENCE INTERVAL (ARI) OF Y YEARS
$C_y$	RUNOFF COEFFICIENT (DIMENSIONLESS) FOR ARI OF Y YEARS
$I_{tc,y}$	AVERAGE RAINFALL INTENSITY (mm/hr) FOR DESIGN DURATION OF TC HOURS AND ARI OF Y YEARS
A	AREA OF CATCHMENTS (ha)
360	CONVERSION FACTOR
FLOW HEIGHT IS SOLVED BY TRIAL AND ERROR USING THE THREE EQUATIONS BELOW AS PER IECA 2008.	
$Q = 1/n \cdot A \cdot R^{2/3} \cdot S^{1/2}$ [Equation 2 (IECA 2008)]	
where:	
Q	PEAK FLOW RATE (m <sup>3</sup> /s) OF AVERAGE RECURRENCE INTERVAL (ARI) OF Y YEARS
n	MANNING'S COEFFICIENT (UNITLESS)
A	CROSS SECTIONAL AREA OF FLOW (m <sup>2</sup> ), REFER TO EQUATION 3
R	HYDRAULIC RADIUS (m), REFER TO EQUATION 4
S	SLOPE OF ENERGY LINE, EQUAL TO SLOPE OF CHANNEL BED (m/m)
$A = (b + xy)y$ [Equation 3 (IECA 2008)]	
where:	
A	CROSS SECTIONAL AREA OF FLOW (m <sup>2</sup> )

b	BASE WIDTH OF CHANNEL (m)
x	SIDE SLOPE OF CHANNEL
y	DEPTH OF FLOW IN CHANNEL (m) + REQUIRED 0.15m FREEBOARD
$R = ((b + xy)y) / (b + 2y(1 + x^2)^{1/2})$ [Equation 4 (IECA 2008)]	
where:	
R	HYDRAULIC RADIUS OF FLOW (m)
b	BASE WIDTH OF CHANNEL (m)
x	SIDE SLOPE OF CHANNEL
y	DEPTH OF FLOW IN CHANNEL (m) + REQUIRED 0.30m FREEBOARD

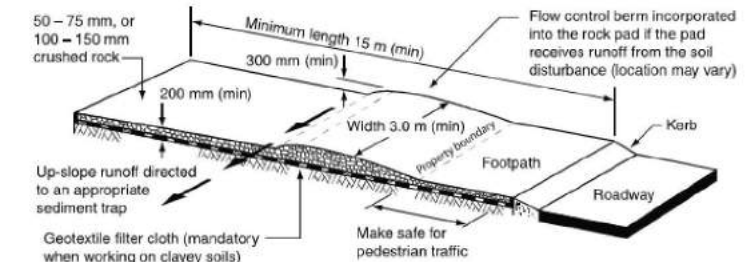
**(a) Rock entry/exit pad for construction sites (refer to Standard Drawing Exit-03 for building sites)**

**CONSTRUCTION ENTRANCE DETAIL**

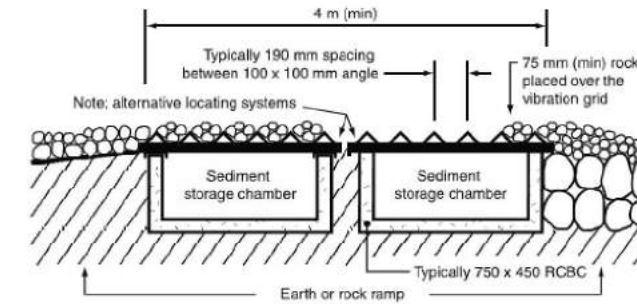
**(c) Alternative low maintenance arrangement (still under development)**

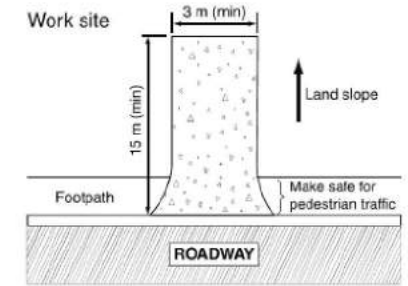
**(b) Rock pad sloping away from road**

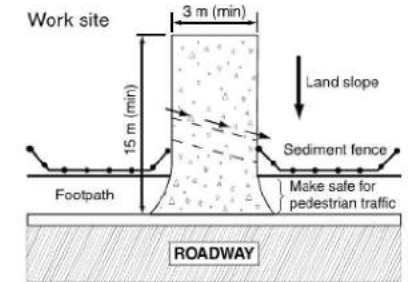
**(d) Rock pad sloping towards the road**

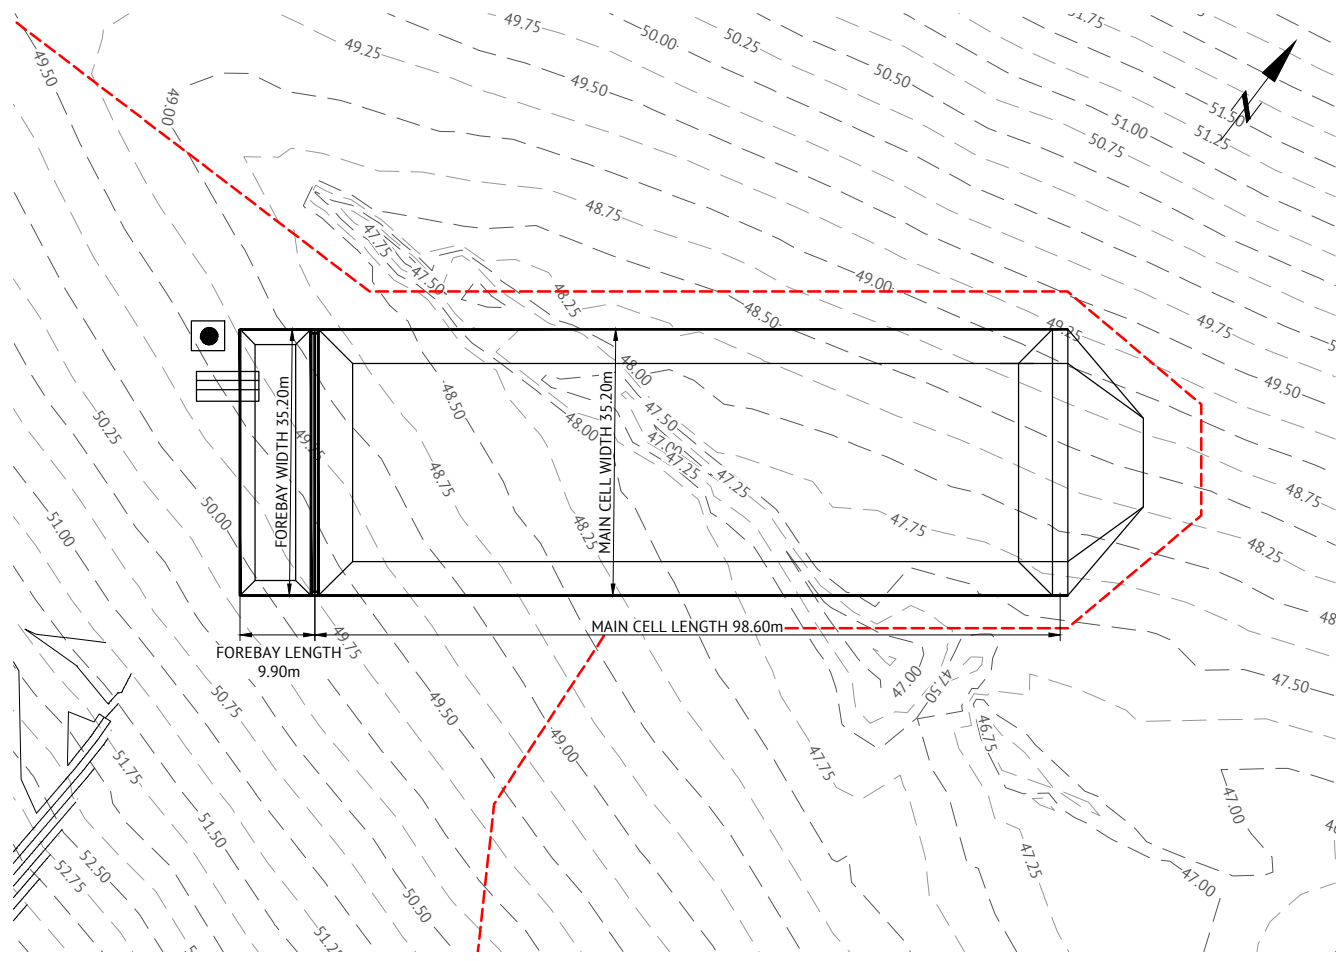
HES BASIN 1

HES BASIN DETAILS

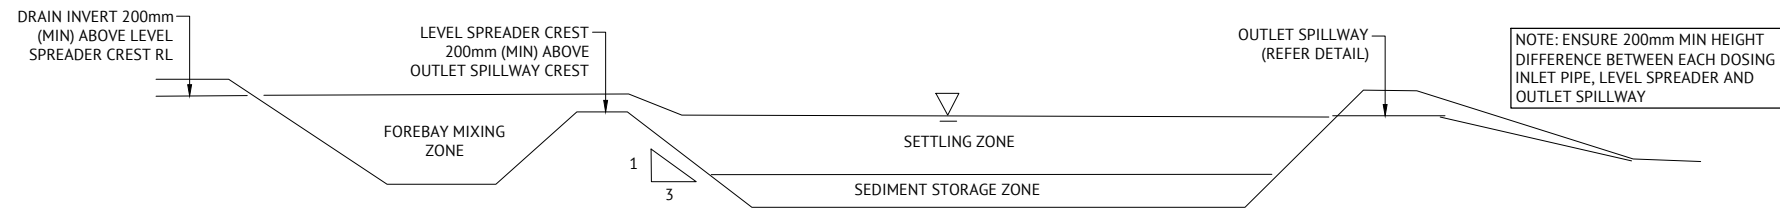
**TYPE B SEDIMENT BASIN LONG SECTION**  
N.T.S.

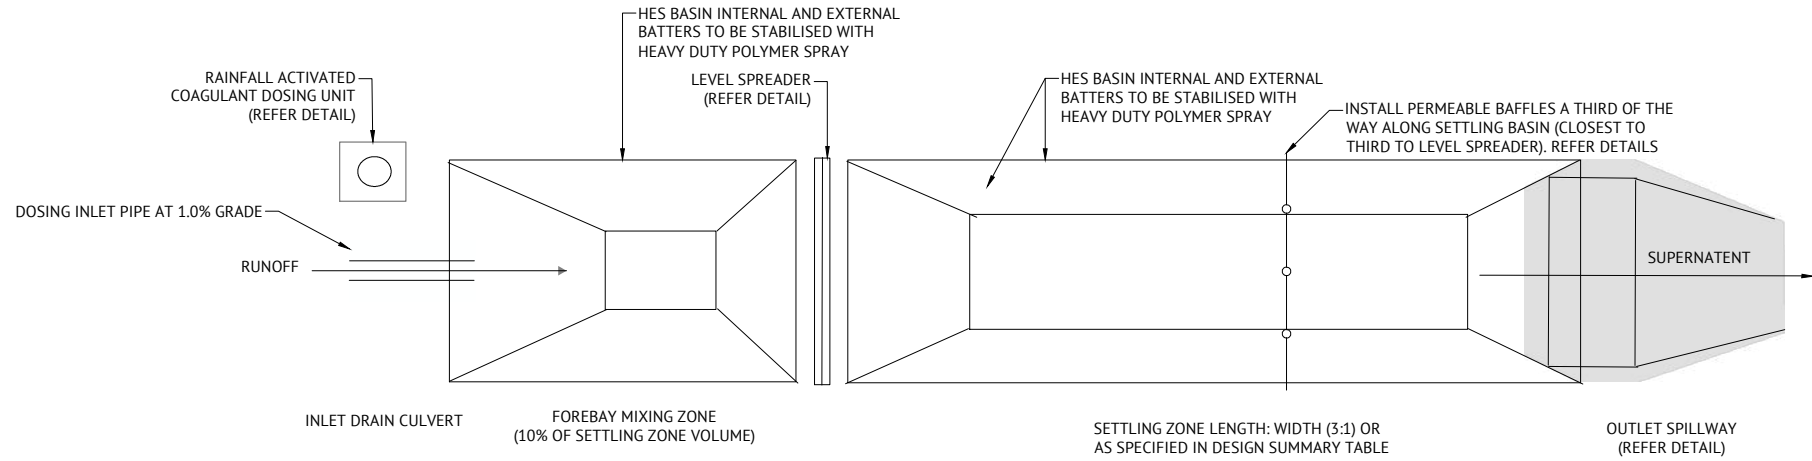
**TYPE B SEDIMENT BASIN PLAN VIEW**  
N.T.S.

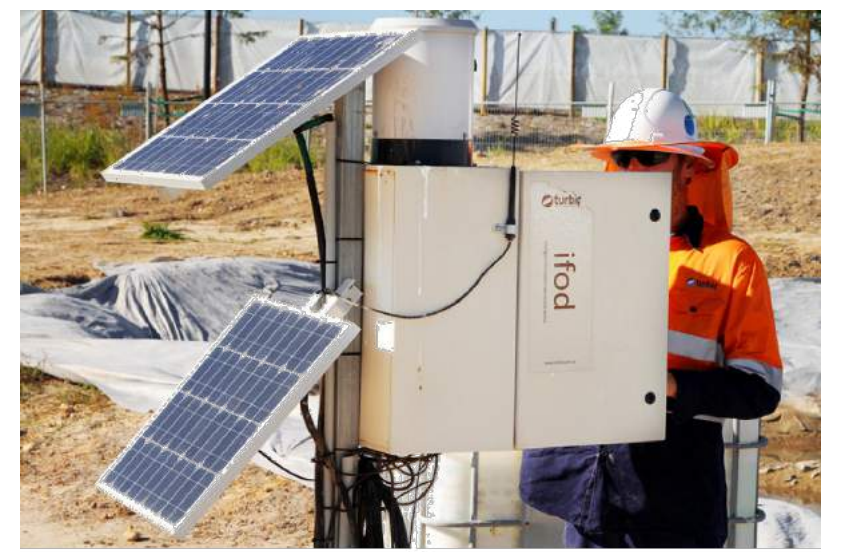
**iFOD FLOW DOSING UNIT (CUSTOM BUILT)**

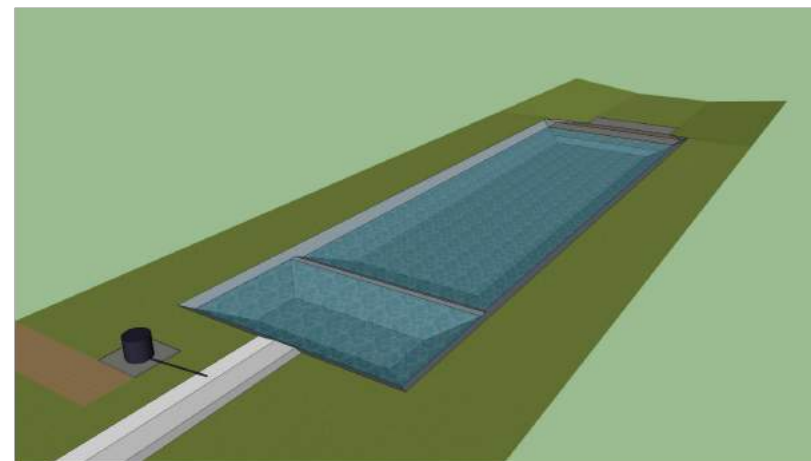
**BASIN PERSPECTIVE (LOOKING DOWNSTREAM)**

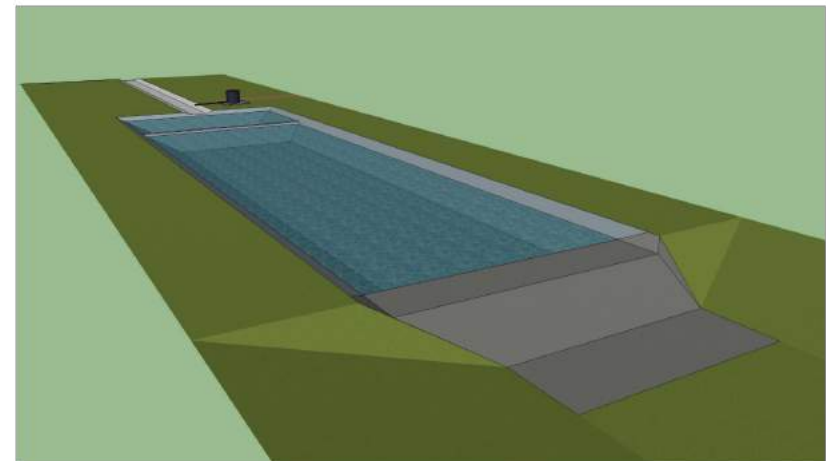
**BASIN PERSPECTIVE (LOOKING UPSTREAM)**

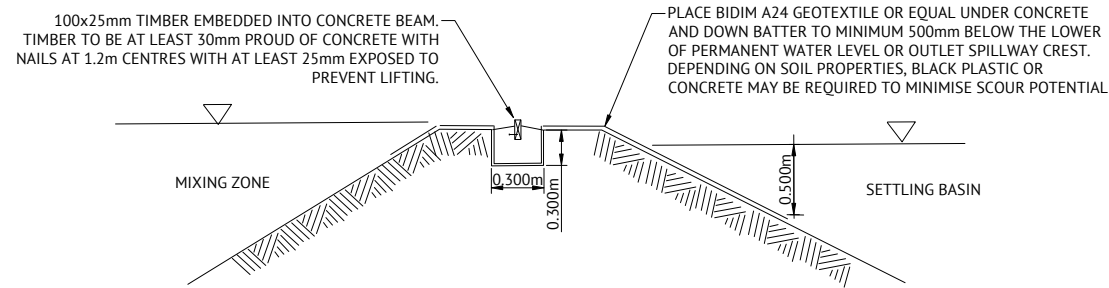
**LEVEL SPREADER DETAILS - TYPICAL CROSS SECTION**  
N.T.S.

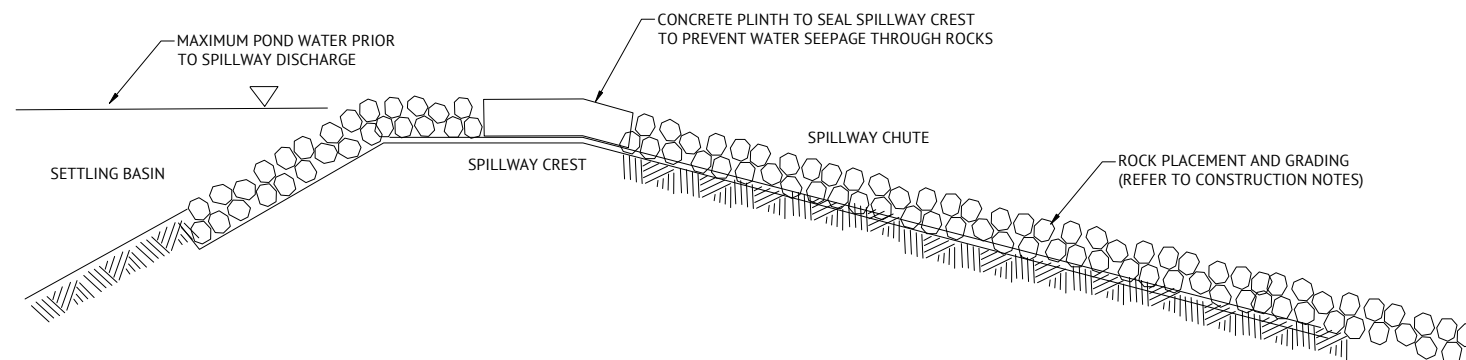
**OUTLET SPILLWAY DETAILS - TYPICAL CROSS SECTION**  
N.T.S.

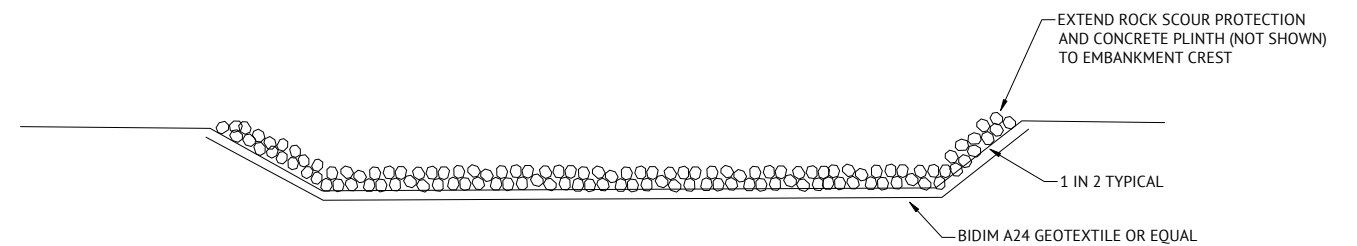
**OUTLET SPILLWAY DETAILS - TYPICAL LONG SECTION**  
N.T.S.

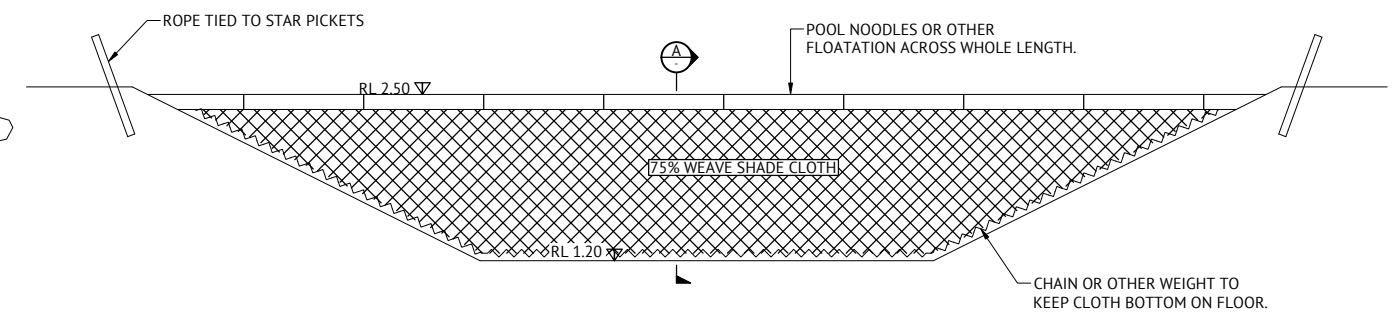
**PERMEABLE BAFFLE SECTION**  
N.T.S.

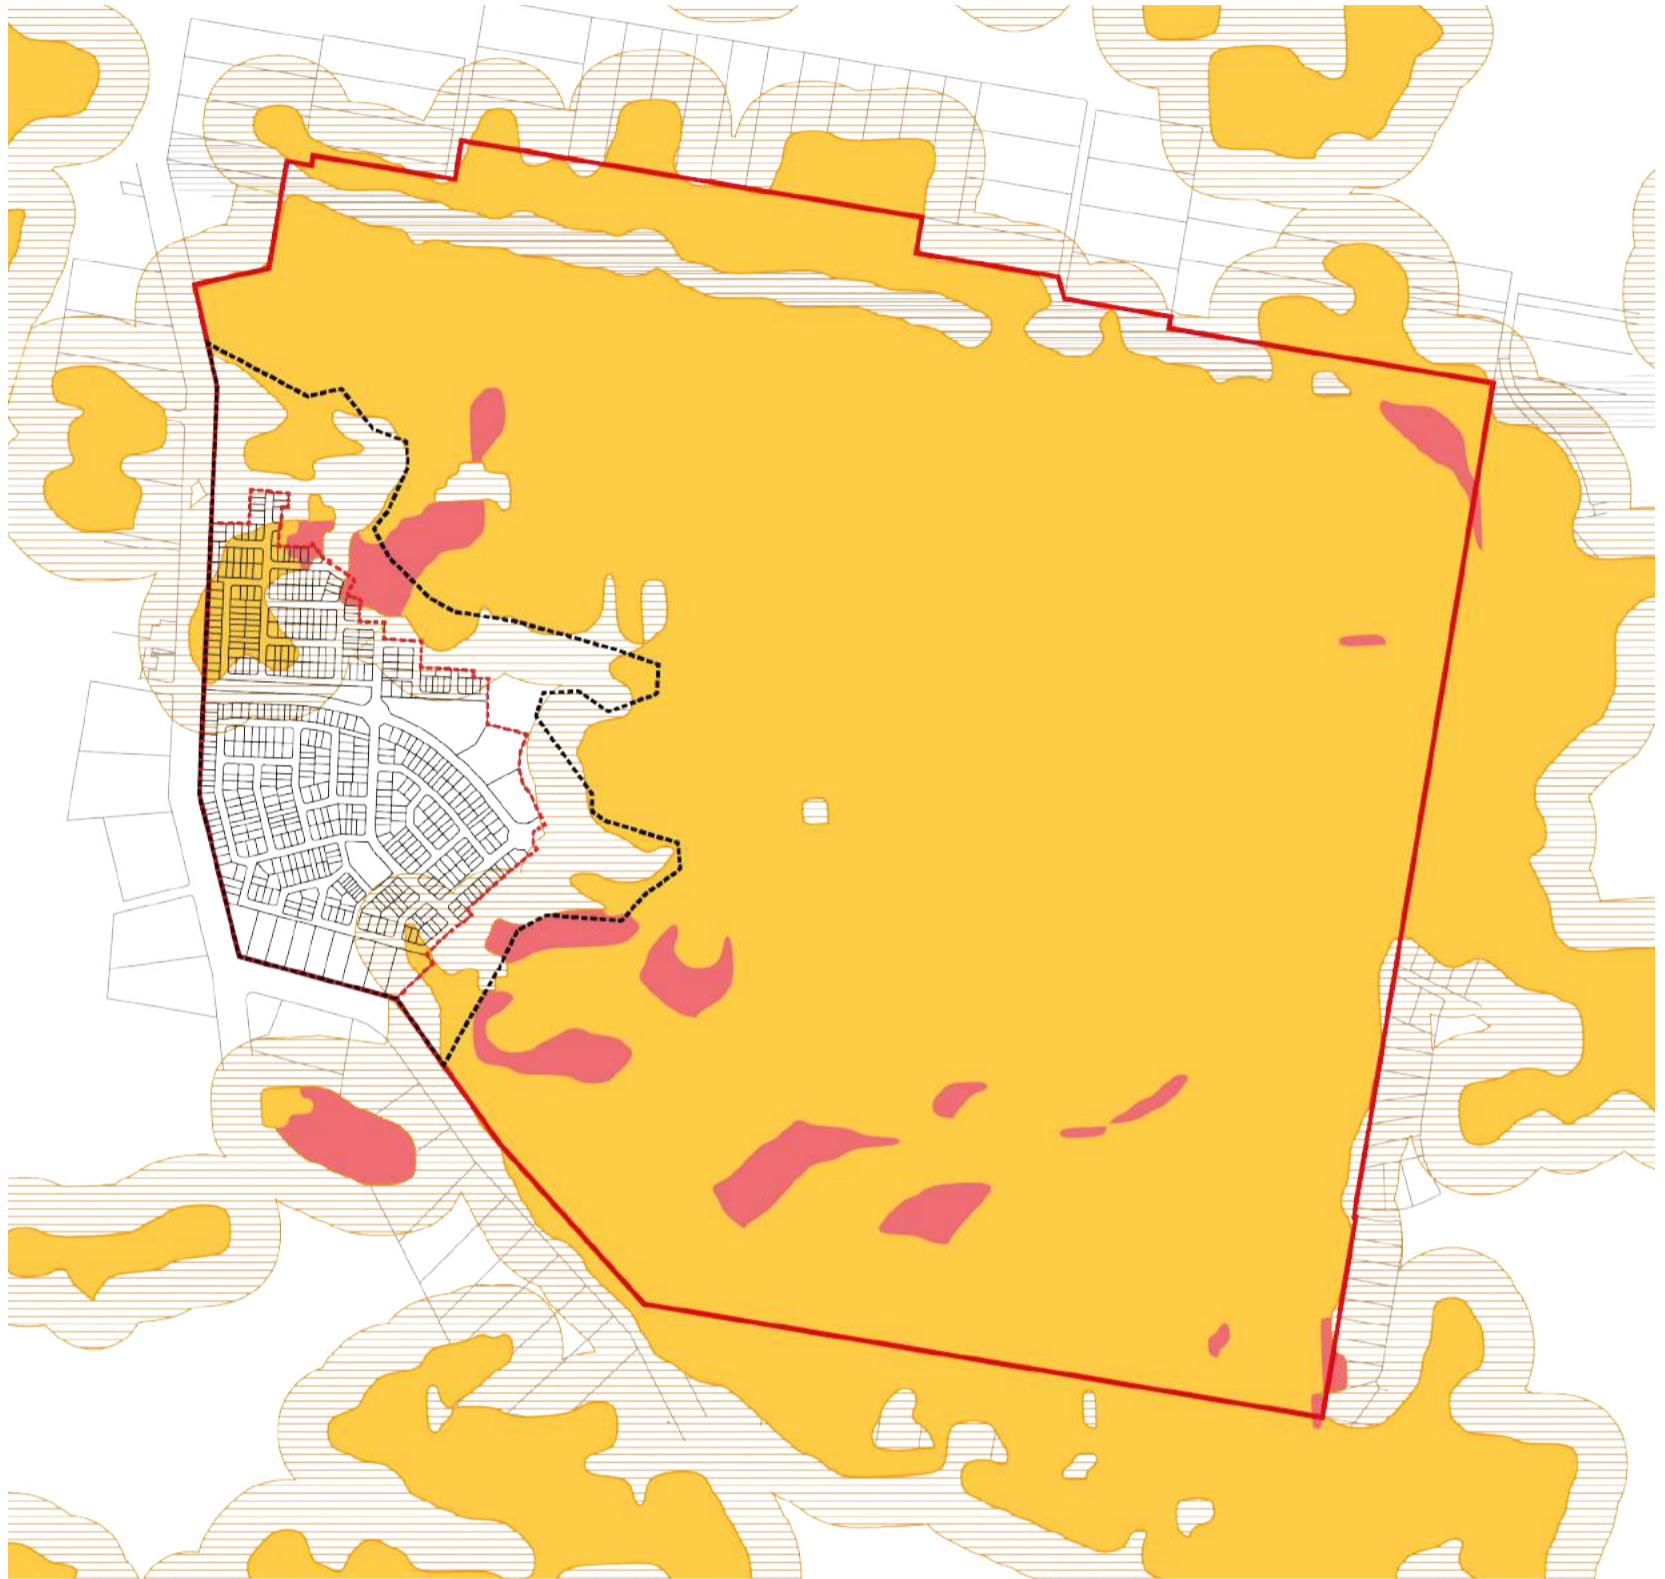
Figure 2 – Bushfire hazard plan – Area 1 – Pre-clearing

- SITE BOUNDARY
- CADASTRE BOUNDARIES
- AREA 1 BOUNDARY
- EPBC EXCISION BOUNDARY
- HIGH POTENTIAL BUSHFIRE INTENSITY
- MEDIUM POTENTIAL BUSHFIRE INTENSITY
- POTENTIAL IMPACT BUFFER (100M)

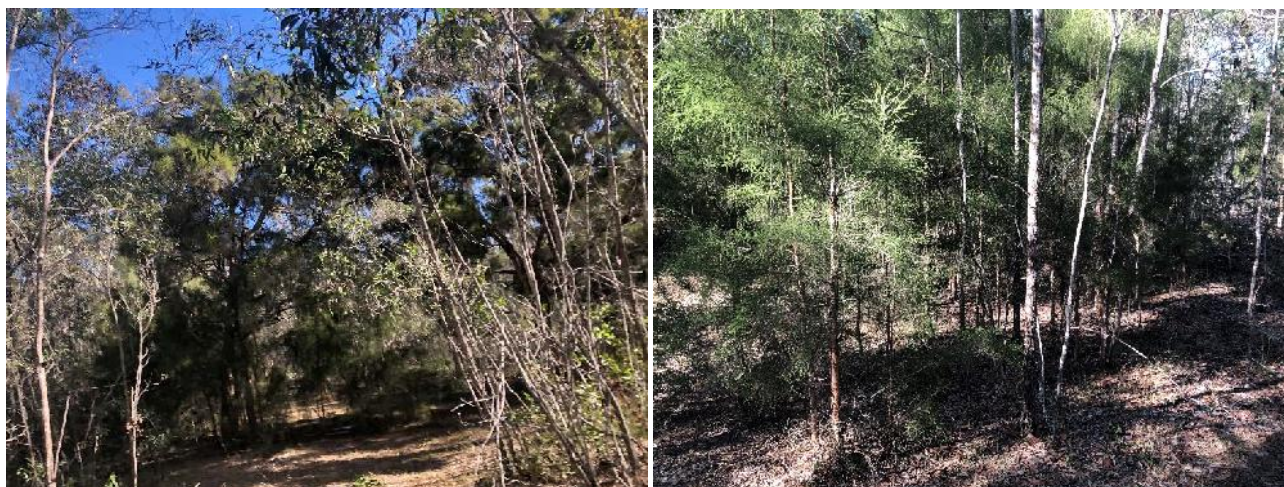
**Photo Plate 1: Location 1**

Location 1 is situated in the northern aspect of the site, adjacent to the power easement. This patch is located within mapped composite 'Of Concern' Regional Ecosystem RE12.9-10.2/12.9-10.7 as confirmed via PMAV 2016/002969 certified on the 11<sup>th</sup> of May 2017. This patch of *M. irbyana* consists of two (2) established specimens, sixty-seven (67) semi-mature specimens. This patch of is surrounded by vegetation dominated by *Acacia spp.*, *Allocasuarina littoralis* (Black She-oak) and *Alphitonia excelsa* (Soap Tree) regrowth with a *Corymbia citriodora* (Spotted Gum) dominated canopy, representing the Least Concern RE12.9-10.2.

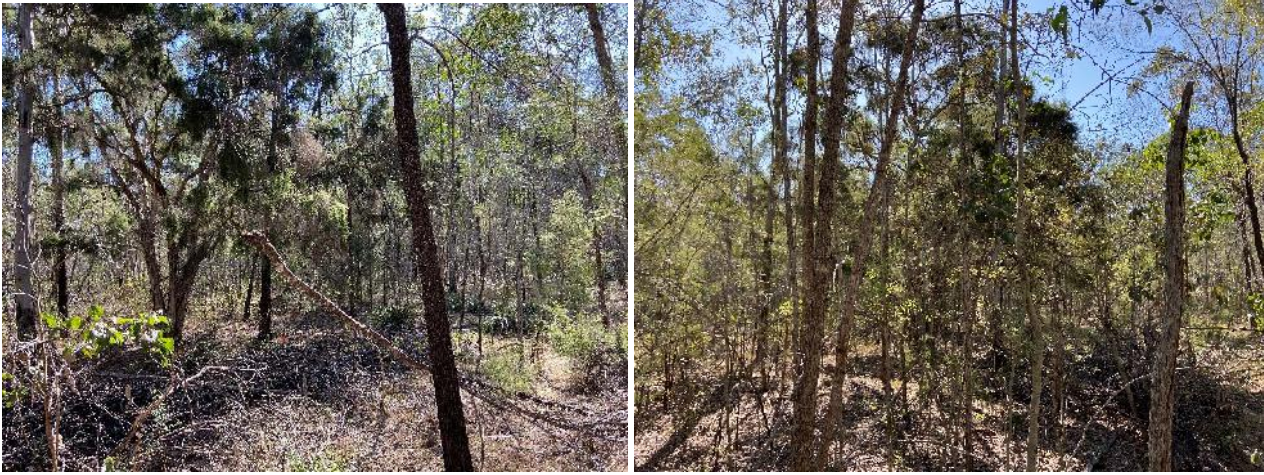
**Photo Plate 2: Location 2**

Location 2 is situated towards the south-western property boundary, adjacent to Greenbank Road. This patch is located within mapped non-remnant vegetation as confirmed via PMAV 2016/002969 certified on the 11<sup>th</sup> of May 2017. This *M. irbyana* patch consists of three (3) established (mature) specimens, eleven (11) semi-mature specimens and ten (10) juvenile specimens. This patch was recorded within a regrowth vegetation community, with surrounding vegetation dominated by *Allocasuarina littoralis* (Black She-oak) and *Acacia spp.* regrowth.

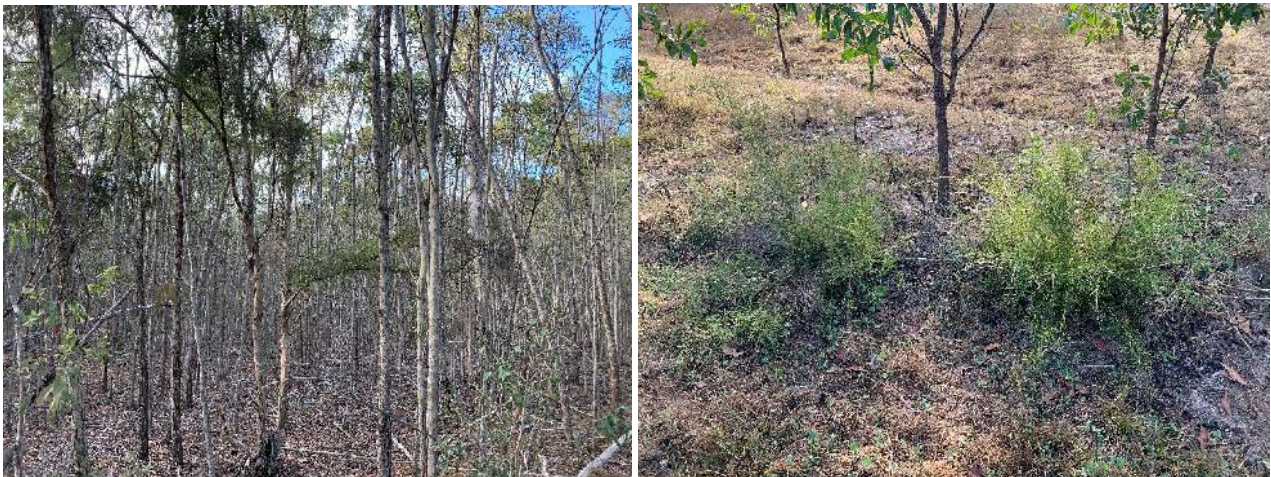
**Photo Plate 3: Location 3**

Location 3 is situated towards the south-western property boundary, adjacent to Greenbank Road and approximately 380 m west of Location 2. This patch is located within mapped non-remnant vegetation as confirmed via PMAV 2016/002969 certified on the 11<sup>th</sup> of May 2017. This patch of *M. irbyana* consists of six (6) mature specimens, eleven (11) semi-mature specimens and fourteen (14) juvenile specimens. The overall patch was recorded within a regrowth vegetation community, with surrounding vegetation dominated by *Acacia leiocalyx* (Early Flowering Black Wattle), *Allocasuarina littoralis* (Black She-oak) and *Alphitonia excelsa* (Soap Tree) regrowth. The patch is separated into four separate patches.

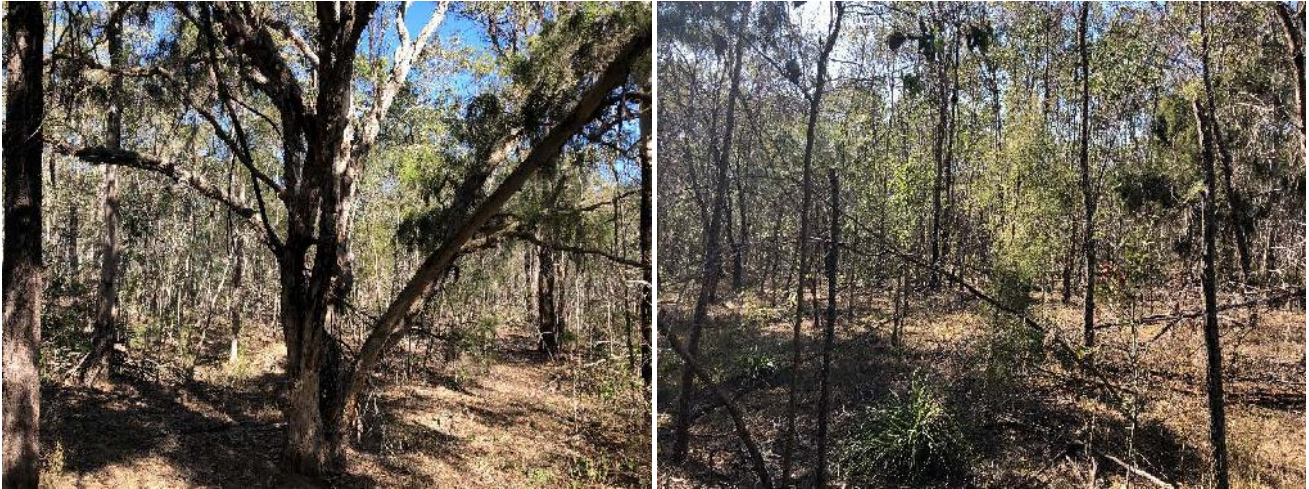
Photo Plate 4: Location 4

Location 4 is situated towards the southern property boundary, approximately 800 m east of Location 3. This patch is located within mapped composite 'Of Concern' Regional Ecosystem RE12.9-10.2/12.9-10.7 as confirmed via PMAV 2016/002969 certified on the 11<sup>th</sup> of May 2017. This *M. irbyana* patch consists of five (5) mature specimens, one hundred and seven (107) semi-mature specimens and eight (8) juvenile specimens with a height less than two (2) meters. This patch is surrounded by vegetation dominated by *Acacia spp.*,

*Allocasuarina littoralis* (Black She-oak) and *Alphitonia excelsa* (Soap Tree) regrowth with *Corymbia citriodora* (Spotted Gum) dominated canopy, typically representing the Least Concern RE12.9-10.2.
