## COMPLIANCE HAZARDOUS MATERIAL RE-INSPECTION AND RISK ASSESSMENT

JANUARY 2023

J051894

80 Bay Street  
Ultimo NSW  
2007

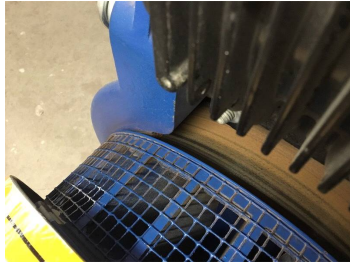
| Item Number | 5 | Material Score | 3 | Disturbance Score | 1 | |

| Location | | 80 Bay Street, Ultimo NSW - Z-Sub Level 1 - Loading Dock - Northeast - A/C Unit - ODS - R22 | | | | |
| Hazard Type | ODS | Material Assessment | | Disturbance Assessment | | |

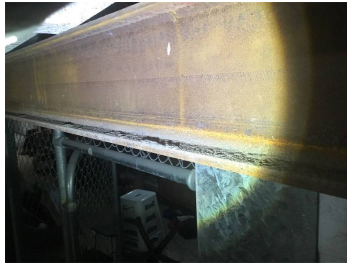
| Item Number | 57 | Material Score | - | Disturbance Score | - | |

| Location | | 80 Bay Street, Ultimo NSW - Z-Sub Level 1 - Sprinkler and Hydrant Pump Room - Throughout Pipework - Insulation | | | |
| Hazard Type | SMF | Material Assessment | | Disturbance Assessment | |

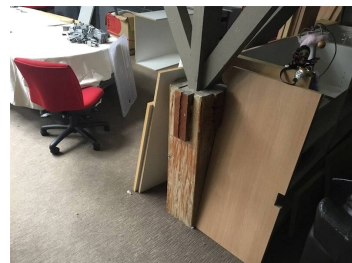
| Item Number | 41 | Material Score | Disturbance Score |

| Location | 80 Bay Street, Ultimo NSW - Mezzanine - Open Area - Ceiling - Timber Beams - Grey Paint | | |
| Hazard Type | Lead Paint | Material Assessment | Disturbance Assessment |

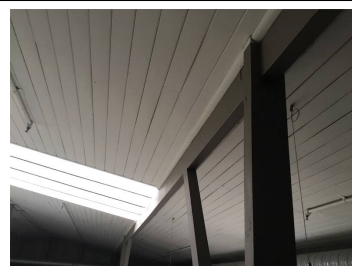
| Item Number | 42 | Material Score | Disturbance Score |

| Location | 80 Bay Street, Ultimo NSW - Mezzanine - Open Area - Wall - Throughout - White Paint | | |
| Hazard Type | Lead Paint | Material Assessment | Disturbance Assessment |

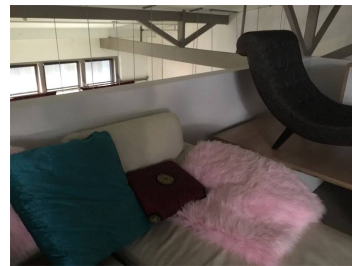
| Item Number | 43 | Material Score | Disturbance Score |

| Location | 80 Bay Street, Ultimo NSW - Mezzanine - Open Area - Throughout Ceiling - Ductwork - Insulation | | |
| Hazard Type | SMF | Material Assessment | Disturbance Assessment |

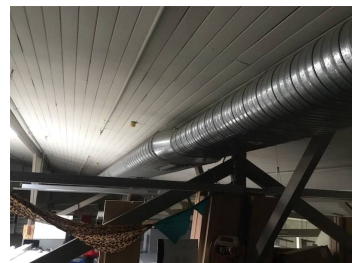
| Item Number | 45 | Material Score | Disturbance Score |

| Location | 80 Bay Street, Ultimo NSW - Mezzanine - Open Area - Roof Lining - White Paint | | |
| Hazard Type | Lead Paint | Material Assessment | Disturbance Assessment |
