COMPLIANCE HAZARDOUS MATERIAL RE-INSPECTION AND RISK ASSESSMENT

JANUARY 2023

Broadway Shopping Centre
1 Bay Street
Glebe NSW
2037

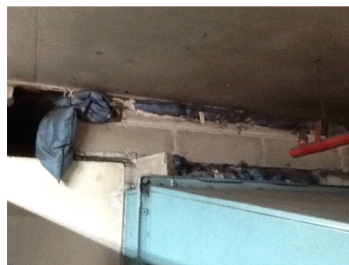
Location Greek Street - Basement 1 - Air Conditioning Plant Room - Pipework - Insulation			
Hazard Type	SMF	Material Assessment	Disturbance Assessment
Friability	Bonded	Product Type	Occupancy
Sample No.	Visual	Extent of damage	Disturbance
Result	Assumed Positive	Surface Treatment	Exposure
		Asbestos Type	Maintenance
Item Number	259	Material Score	Disturbance Score
		Priority Score	-

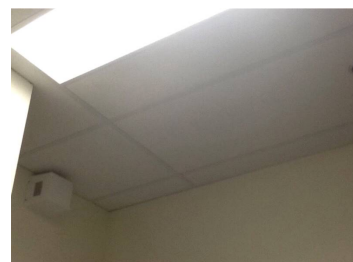
Location	Greek Street - Ground Floor - Australia Post - Ductwork - Insulation		
Hazard Type	SMF	Material Assessment	Disturbance Assessment
Friability	Bonded	Product Type	Occupancy
Sample No.	Visual	Extent of damage	Disturbance
Result	Assumed Positive	Surface Treatment	Exposure
		Asbestos Type	Maintenance
Item Number	220	Material Score	Disturbance Score
		Priority Score	-

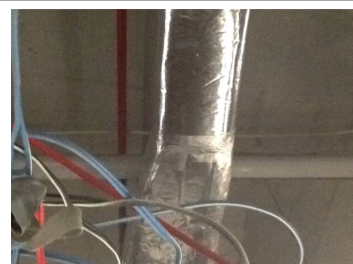
Location Greek Street - Ground Floor - Australia Post - Flexible Ductwork - Insulation

Hazard Type	SMF	Material Assessment	Disturbance Assessment	
Friability	Bonded	Product Type	- Occupancy	
Sample No.	Visual	Extent of damage	- Disturbance	
Result	Assumed Positive	Surface Treatment	- Exposure	
		Asbestos Type	- Maintenance	
Item Number	221	Material Score	- Disturbance Score	
		Priority Score	-

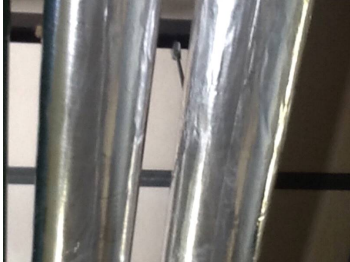
Location Greek Street - Ground Floor - Australia Post - Pipework - Insulation

Hazard Type	SMF	Material Assessment	Disturbance Assessment	
Friability	Bonded	Product Type	- Occupancy	
Sample No.	Visual	Extent of damage	- Disturbance	
Result	Assumed Positive	Surface Treatment	- Exposure	
		Asbestos Type	- Maintenance	
Item Number	222	Material Score	- Disturbance Score	
		Priority Score	-

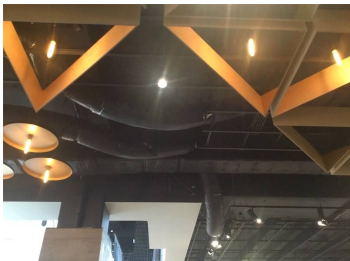
Location Greek Street - Ground Floor - Common Area - Ceiling - Ductwork - Insulation

Hazard Type	SMF	Material Assessment	Disturbance Assessment	
Friability	Bonded	Product Type	- Occupancy	
Sample No.	Visual	Extent of damage	- Disturbance	
Result	Assumed Positive	Surface Treatment	- Exposure	
		Asbestos Type	- Maintenance	
Item Number	224	Material Score	- Disturbance Score	
		Priority Score	-

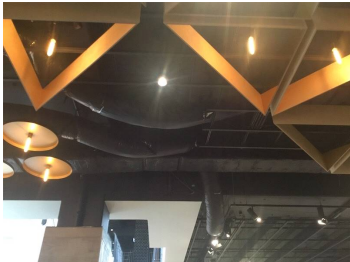
Location Greek Street - Ground Floor - Common Area - Ceiling - Flexible Ductwork - Insulation

Hazard Type	SMF	Material Assessment	Disturbance Assessment	
Friability	Bonded	Product Type	- Occupancy	
Sample No.	Visual	Extent of damage	- Disturbance	
Result	Assumed Positive	Surface Treatment	- Exposure	
		Asbestos Type	- Maintenance	
Item Number	225	Material Score	- Disturbance Score	
		Priority Score	-

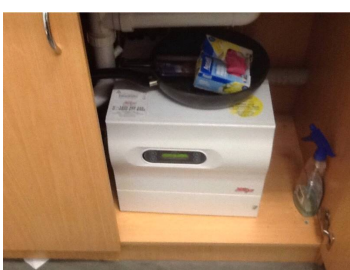
Location Greek Street - Level 1 - Harvey Norman - Lunch Room - Below Sink - Hot Water Unit - Insulation

Hazard Type	SMF	Material Assessment	Disturbance Assessment	
Friability	Bonded	Product Type	- Occupancy	
Sample No.	Visual	Extent of damage	- Disturbance	
Result	Assumed Positive	Surface Treatment	- Exposure	
		Asbestos Type	- Maintenance	
Item Number	208	Material Score	- Disturbance Score	
		Priority Score	-

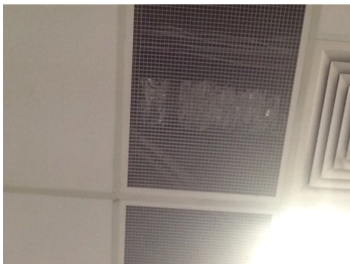
Location Greek Street - Level 1 - Harvey Norman - Ceiling Space - Ductwork - Insulation

Hazard Type	SMF	Material Assessment	Disturbance Assessment	
Friability	Bonded	Product Type	Occupancy	
Sample No.	Visual	Extent of damage	Disturbance	
Result	Assumed Positive	Surface Treatment	Exposure	
		Asbestos Type	Maintenance	
Item Number	210	Material Score	Disturbance Score	
		Priority Score	-

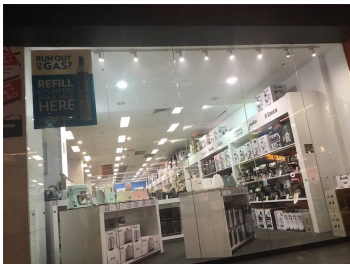
Location Greek Street - Level 1 - Harvey Norman - Ceiling - Compressed Ceiling Tiles - Insulation

Hazard Type	SMF	Material Assessment	Disturbance Assessment	
Friability	Bonded	Product Type	Occupancy	
Sample No.	Visual	Extent of damage	Disturbance	
Result	Assumed Positive	Surface Treatment	Exposure	
		Asbestos Type	Maintenance	
Item Number	211	Material Score	Disturbance Score	
		Priority Score	-

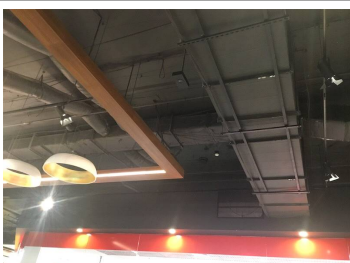
Location Greek Street - Level 1 - Common Area - Ceiling - Ductwork - Insulation

Hazard Type	SMF	Material Assessment	Disturbance Assessment	
Friability	Bonded	Product Type	Occupancy	
Sample No.	Visual	Extent of damage	Disturbance	
Result	Assumed Positive	Surface Treatment	Exposure	
		Asbestos Type	Maintenance	
Item Number	212	Material Score	Disturbance Score	
		Priority Score	-

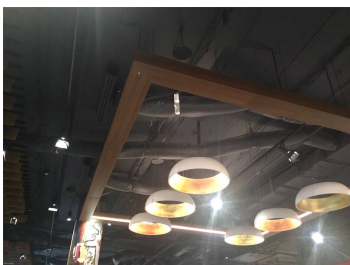
Location Greek Street - Level 1 - Common Area - Ceiling - Flexible Ductwork - Insulation

Hazard Type	SMF	Material Assessment	Disturbance Assessment	
Friability	Bonded	Product Type	Occupancy	
Sample No.	Visual	Extent of damage	Disturbance	
Result	Assumed Positive	Surface Treatment	Exposure	
		Asbestos Type	Maintenance	
Item Number	213	Material Score	Disturbance Score	
		Priority Score	-

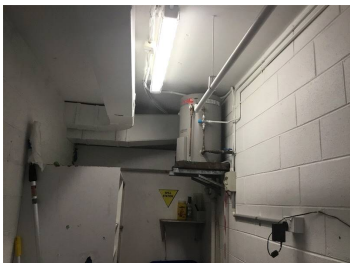
Location Greek Street - Level 2 - Cleaners Room - North - Hot Water Unit - Insulation

Hazard Type	SMF	Material Assessment	Disturbance Assessment	
Friability	Bonded	Product Type	Occupancy	
Sample No.	Visual	Extent of damage	Disturbance	
Result	Assumed Positive	Surface Treatment	Exposure	
		Asbestos Type	Maintenance	
Item Number	171	Material Score	Disturbance Score	
		Priority Score	-

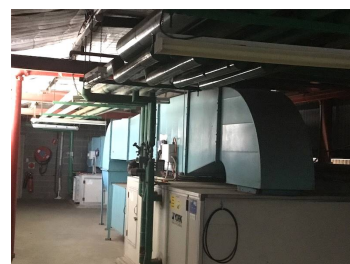
Location	Greek Street - Level 2 - Hoyts - Projection Room - Ductwork - Insulation		
Hazard Type	SMF	Material Assessment	Disturbance Assessment
Friability	Bonded	Product Type	Occupancy
Sample No.	Visual	Extent of damage	Disturbance
Result	Assumed Positive	Surface Treatment	Exposure
		Asbestos Type	Maintenance
Item Number	190	Material Score	Disturbance Score
		Priority Score	-

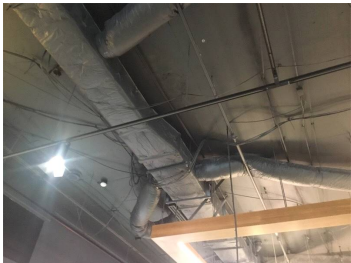
Location Greek Street - Level 2 - Common Area - Ceiling - Ductwork - Insulation

Hazard Type	SMF	Material Assessment	Disturbance Assessment	
Friability	Bonded	Product Type	- Occupancy	
Sample No.	Visual	Extent of damage	- Disturbance	
Result	Assumed Positive	Surface Treatment	- Exposure	
		Asbestos Type	- Maintenance	
Item Number	228	Material Score	- Disturbance Score	
		Priority Score	-

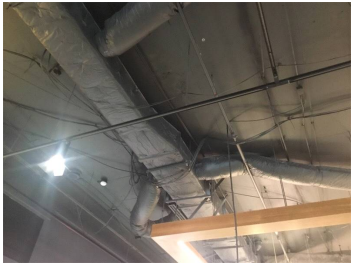
Location Greek Street - Level 2 - Common Area - Ceiling - Flexible Ductwork - Insulation

Hazard Type	SMF	Material Assessment	Disturbance Assessment	
Friability	Bonded	Product Type	- Occupancy	
Sample No.	Visual	Extent of damage	- Disturbance	
Result	Assumed Positive	Surface Treatment	- Exposure	
		Asbestos Type	- Maintenance	
Item Number	229	Material Score	- Disturbance Score	
		Priority Score	-

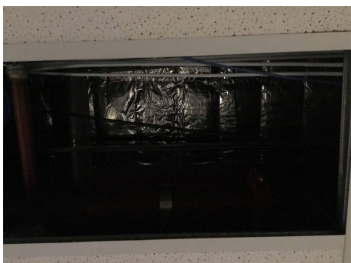
Location Greek Street - Level 3 - Priceline - Ceiling Space - Roof Lining - Sarking - Insulation

Hazard Type	SMF	Material Assessment	Disturbance Assessment	
Friability	Bonded	Product Type	- Occupancy	
Sample No.	Visual	Extent of damage	- Disturbance	
Result	Assumed Positive	Surface Treatment	- Exposure	
		Asbestos Type	- Maintenance	
Item Number	186	Material Score	- Disturbance Score	
		Priority Score	-

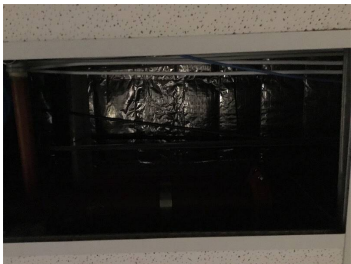
Location Greek Street - Level 3 - Priceline - Throughout - Compressed Ceiling Tiles - Insulation

Hazard Type	SMF	Material Assessment	Disturbance Assessment	
Friability	Bonded	Product Type	- Occupancy	
Sample No.	Visual	Extent of damage	- Disturbance	
Result	Assumed Positive	Surface Treatment	- Exposure	
		Asbestos Type	- Maintenance	
Item Number	187	Material Score	- Disturbance Score	
		Priority Score	-

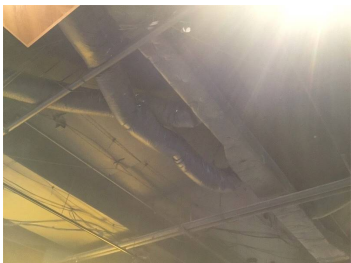
Location Greek Street - Level 3 - Common Area - Ceiling - Ductwork - Insulation

Hazard Type	SMF	Material Assessment	Disturbance Assessment	
Friability	Bonded	Product Type	- Occupancy	
Sample No.	Visual	Extent of damage	- Disturbance	
Result	Assumed Positive	Surface Treatment	- Exposure	
		Asbestos Type	- Maintenance	
Item Number	231	Material Score	- Disturbance Score	
		Priority Score	-

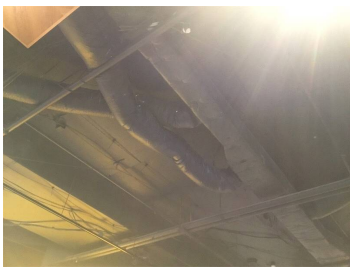
Location	Greek Street - Level 3 - Common Area - Ceiling - Flexible Ductwork - Insulation

Hazard Type	SMF	Material Assessment	Disturbance Assessment	
Friability	Bonded	Product Type	-	
Sample No.	Visual	Extent of damage	-	
Result	Assumed Positive	Surface Treatment	-	
		Asbestos Type	-	
Item Number	232	Material Score	-	
		Priority Score	-

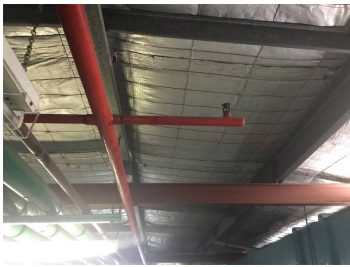
Location	Greek Street - Level 3 - Hoyts - Roof Top Plant Room - Roof Lining - Sarking - Insulation

Hazard Type	SMF	Material Assessment	Disturbance Assessment	
Friability	Bonded	Product Type	-	
Sample No.	Visual	Extent of damage	-	
Result	Assumed Positive	Surface Treatment	-	
		Asbestos Type	-	
Item Number	188	Material Score	-	
		Priority Score	-

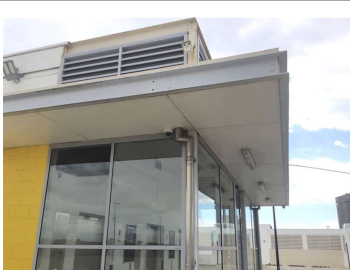
Location	Greek Street - Level 4 - Carpark - Plant Room - Penetration - Pillow Insulation - Insulation - No Safe Access

Hazard Type	SMF	Material Assessment	Disturbance Assessment	
Friability	Bonded	Product Type	-	
Sample No.	Visual	Extent of damage	-	
Result	Assumed Positive	Surface Treatment	-	
		Asbestos Type	-	
Item Number	197	Material Score	-	
		Priority Score	-

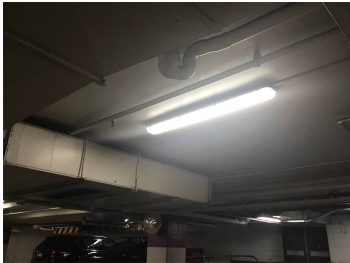
Location	Main Building - 1. Basement Level - Carpark - Car Park, B1 South - Throughout Ceiling - Fluorescent Light Fitting - Capacitor- New Style

Hazard Type	PCB	Material Assessment	Disturbance Assessment	
Friability	Good Condition	Product Type	-	
Sample No.	Visual	Extent of damage	-	
Result	Assumed Positive	Surface Treatment	-	
		Asbestos Type	-	
Item Number	161	Material Score	-	
		Priority Score	-

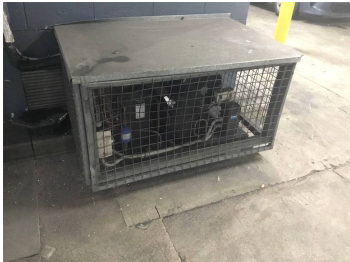
Location	Main Building - 1. Basement Level - Carpark - South East- Adjacent lift no. 4 - R22

Hazard Type	ODS	Material Assessment	Disturbance Assessment	
Friability	Good Condition	Product Type	-	
Sample No.	Visual	Extent of damage	-	
Result	Assumed Positive	Surface Treatment	-	
		Asbestos Type	-	
Item Number	162	Material Score	-	
		Priority Score	-

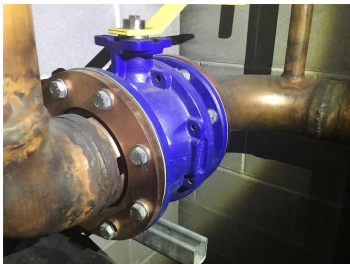
Location	Main Building - 1. Basement Level - Carpark - Gas meter room- on the pipe work - Gasket - Live plant

Hazard Type	Asbestos	Material Assessment	Disturbance Assessment	
Friability	Non-friable	Product Type	2	
Sample No.	Visual	Extent of damage	0	
Result	Assumed Positive Amosite	Surface Treatment	0	
		Asbestos Type	2	
Item Number	163	Material Score	4	
		Priority Score	5

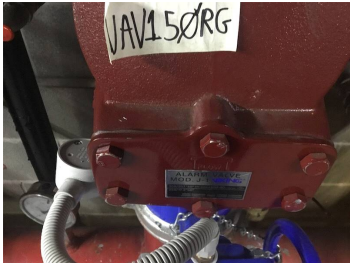
Location	Main Building - 1. Basement Level - Carpark - Sprinkler valve room- Pipe Work - Gasket - Live plant

Hazard Type	Asbestos	Material Assessment	Disturbance Assessment	
Friability	Non-friable	Product Type	2	
Sample No.	Visual	Extent of damage	0	
Result	Assumed Positive Amosite	Surface Treatment	0	
		Asbestos Type	2	
Item Number	164	Material Score	4	
		Priority Score	5

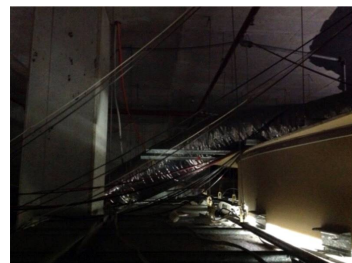
Location		Main Building - 3. Ground Level - Loading Dock - Ductwork - Insulation	
Hazard Type	SMF	Material Assessment	Disturbance Assessment
Friability	Bonded	Product Type	-
Sample No.	Visual	Extent of damage	-
Result	Assumed Positive	Surface Treatment	-
		Asbestos Type	-
Item Number	141	Material Score	-
		Priority Score	-

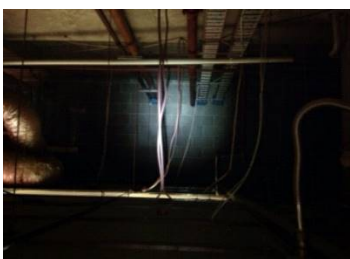
Location Main Building - 3. Ground Level - Liquorland - Ceiling Space - West - Hot Water Unit - Insulation Materials

Hazard Type	SMF	Material Assessment	Disturbance Assessment	
Friability	Bonded	Product Type	- Occupancy	
Sample No.	Visual	Extent of damage	- Disturbance	
Result	Assumed Positive	Surface Treatment	- Exposure	
		Asbestos Type	- Maintenance	
Item Number	271	Material Score	- Disturbance Score	
		Priority Score	-

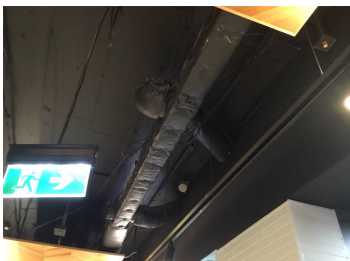
Location Main Building - 4. Level 1 - Common Areas - Ceiling - Throughout - Insulation

Hazard Type	SMF	Material Assessment	Disturbance Assessment	
Friability	Bonded	Product Type	- Occupancy	
Sample No.	Visual	Extent of damage	- Disturbance	
Result	Assumed Positive	Surface Treatment	- Exposure	
		Asbestos Type	- Maintenance	
Item Number	66	Material Score	- Disturbance Score	
		Priority Score	-

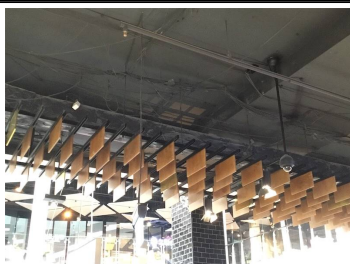
Location		Main Building - 4. Level 1 - Kmart - Front Trading Areas - Ceiling - Compressed Ceiling Tiles - Insulation	
Hazard Type	SMF	Material Assessment	Disturbance Assessment
Friability	Bonded	Product Type	-
Sample No.	Visual	Extent of damage	-
Result	Assumed Positive	Surface Treatment	-
		Asbestos Type	-
Item Number	128	Material Score	-
		Priority Score	-

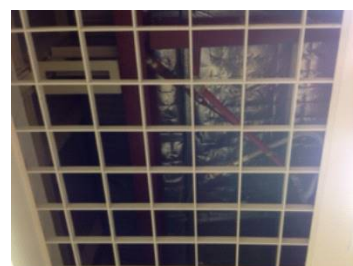
Location	Main Building - 5. Level 2 - Food Court Female Toilet - Ceiling Space - Hot Water Unit - Insulation

Hazard Type	SMF	Material Assessment	Disturbance Assessment	
Friability	Bonded	Product Type	Occupancy	
Sample No.	Visual	Extent of damage	Disturbance	
Result	Assumed Positive	Surface Treatment	Exposure	
		Asbestos Type	Maintenance	
Item Number	114	Material Score	Disturbance Score	
		Priority Score	-

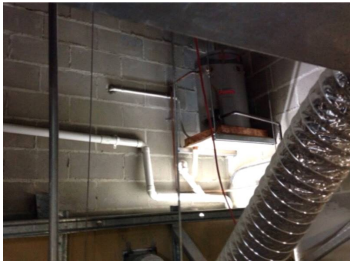
Location	Main Building - 5. Level 2 - Mechanical Plant Room - A/C Unit (AC L1A.1) - R22

Hazard Type	ODS	Material Assessment	Disturbance Assessment	
Friability	Good Condition	Product Type	Occupancy	
Sample No.	Visual	Extent of damage	Disturbance	
Result	Assumed Positive	Surface Treatment	Exposure	
		Asbestos Type	Maintenance	
Item Number	116	Material Score	Disturbance Score	
		Priority Score	-

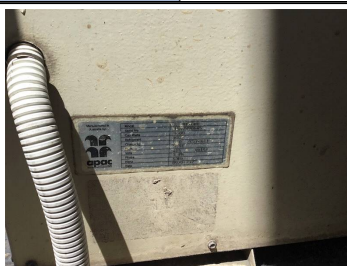
Location	Main Building - 5. Level 2 - Mechanical Plant Room - A/C Unit (AC L1A.4) - Unknown Gas

Hazard Type	ODS	Material Assessment	Disturbance Assessment	
Friability	Good Condition	Product Type	Occupancy	
Sample No.	Visual	Extent of damage	Disturbance	
Result	Assumed Positive	Surface Treatment	Exposure	
		Asbestos Type	Maintenance	
Item Number	117	Material Score	Disturbance Score	
		Priority Score	-

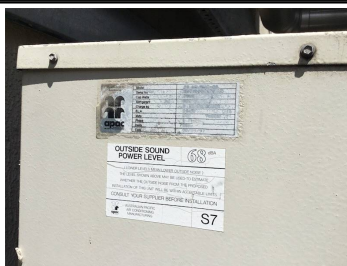
Location	Main Building - 5. Level 2 - Mechanical Plant Room - A/C Unit - Adjacent to Door - R22

Hazard Type	ODS	Material Assessment	Disturbance Assessment	
Friability	Good Condition	Product Type	Occupancy	
Sample No.	Visual	Extent of damage	Disturbance	
Result	Assumed Positive	Surface Treatment	Exposure	
		Asbestos Type	Maintenance	
Item Number	118	Material Score	Disturbance Score	
		Priority Score	-

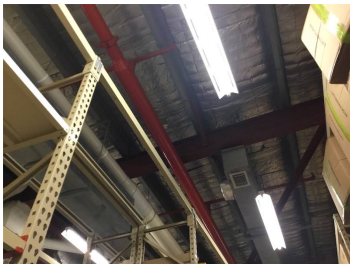
Location	Main Building - 7, Level 3 - Target - Back of House - Ductwork - Insulation

Hazard Type	SMF	Material Assessment	Disturbance Assessment	
Friability	Bonded	Product Type	-	
Sample No.	Visual	Extent of damage	-	
Result	Assumed Positive	Surface Treatment	-	
		Asbestos Type	-	
Item Number	94	Material Score	-	
		Priority Score	-

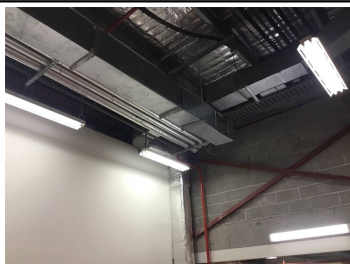
Location	Main Building - 7, Level 3 - Target - Back of House - West Wall - Sarking - Insulation

Hazard Type	SMF	Material Assessment	Disturbance Assessment	
Friability	Bonded	Product Type	-	
Sample No.	Visual	Extent of damage	-	
Result	Assumed Positive	Surface Treatment	-	
		Asbestos Type	-	
Item Number	95	Material Score	-	
		Priority Score	-

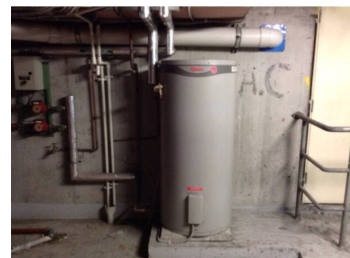
Location		Main Building - 2. Lower Ground Level - Tenancy - Off Broadway Hotel - Keg Room - Hot Water Unit - Insulation	
Hazard Type	SMF	Material Assessment	Disturbance Assessment
Friability	Bonded	Product Type	- Occupancy
Sample No.	Visual	Extent of damage	- Disturbance
Result	Assumed Positive	Surface Treatment	- Exposure
		Asbestos Type	- Maintenance
Item Number	242	Material Score	- Disturbance Score
		Priority Score	-

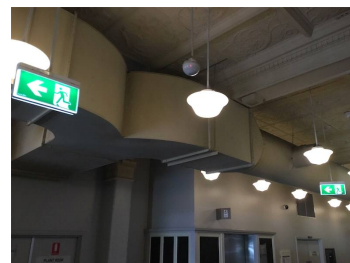
Location		Model & Maxham Building - 2. Ground Level - Common Area - Ceiling Lining and Beams - Cream Paint - Height Restricted			
Hazard Type	Lead Paint	Material Assessment		Disturbance Assessment	
Friability	-	Product Type	-	Occupancy	-
Sample No.	Visual	Extent of damage	-	Disturbance	-
Result	Assumed Positive	Surface Treatment	-	Exposure	-
		Asbestos Type	-	Maintenance	-
Item Number	4	Material Score	-	Disturbance Score	-
		Priority Score	-	-

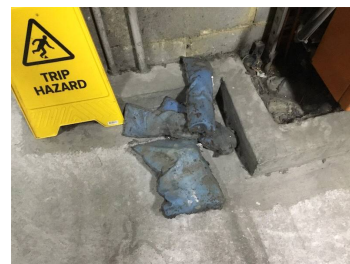
Location		Model & Maxham Building - 2. Ground Level - Plant Room - Floor Penetration - Pillow Insulation - Insulation	
Hazard Type	SMF	Material Assessment	Disturbance Assessment
Friability	Bonded	Product Type	-
Sample No.	Visual	Extent of damage	-
Result	Assumed Positive	Surface Treatment	-
		Asbestos Type	-
Item Number	9	Material Score	-
		Priority Score	-

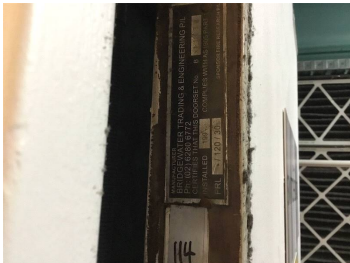
Location		Model & Maxham Building - 3. Level 1 - Plant Room - Entry Door - Fire Door Core - Year of Manufacture in 1990s	
Hazard Type	Asbestos	Material Assessment	Disturbance Assessment
Friability	Friable	Product Type	-1
Sample No.	Visual	Extent of damage	0
Result	Assumed Positive Amosite	Surface Treatment	1
		Asbestos Type	2
Item Number	46	Material Score	2
		Priority Score	4

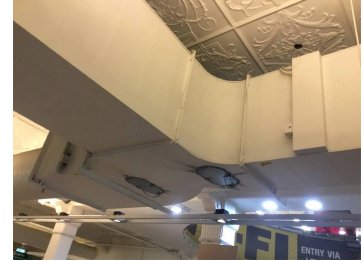
Location		Model & Maxham Building - 3. Level 1 - Common Area - Ceiling - A/C Heater Unit - Millboard Insulation - Live Plant			
Hazard Type	Asbestos	Material Assessment		Disturbance Assessment	
Friability	Friable	Product Type	2	Occupancy	1
Sample No.	Visual	Extent of damage	0	Disturbance	1
Result	Assumed Positive Unknown or Crocidolite	Surface Treatment	1	Exposure	3
		Asbestos Type	3	Maintenance	0
Item Number	47	Material Score	6	Disturbance Score	5
		Priority Score	11	Low

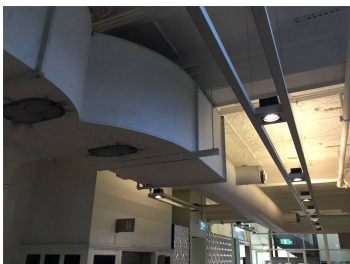
Location	Model & Maxham Building - 3. Level 1 - Common Area - Ceiling - Ductwork - Insulation

Hazard Type	SMF	Material Assessment	Disturbance Assessment	
Friability	Bonded	Product Type	-	
Sample No.	Visual	Extent of damage	-	
Result	Assumed Positive	Surface Treatment	-	
		Asbestos Type	-	
Item Number	48	Material Score	-	
		Priority Score	-

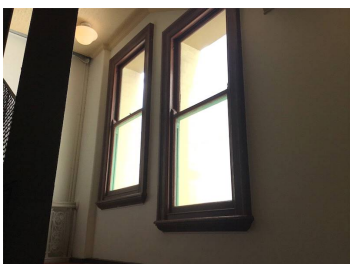
Location	Model & Maxham Building - 3. Level 1 - Northwest Stairway - North - Window Frame - Upper Brown Paint and Lower Off White Paint

Hazard Type	Lead Paint	Material Assessment	Disturbance Assessment	
Friability	-	Product Type	-	
Sample No.	As AQ001446	Extent of damage	-	
Result	Positive - 10 %w/w	Surface Treatment	-	
		Asbestos Type	-	
Item Number	52	Material Score	-	
		Priority Score	-

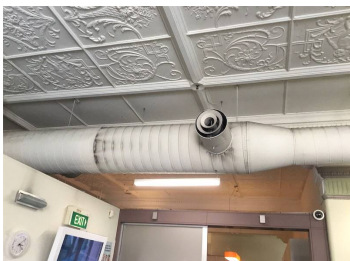
Location	Model & Maxham Building - 3. Level 1 - M105/M106 - Ceiling Ductwork - Insulation

Hazard Type	SMF	Material Assessment	Disturbance Assessment	
Friability	Bonded	Product Type	-	
Sample No.	Visual	Extent of damage	-	
Result	Assumed Positive	Surface Treatment	-	
		Asbestos Type	-	
Item Number	53	Material Score	-	
		Priority Score	-

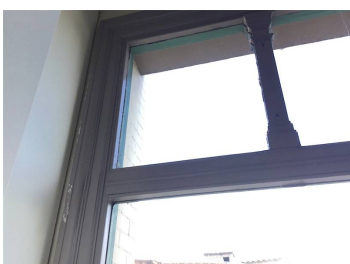
Location	Model & Maxham Building - 3. Level 1 - M105/M106 - Waiting Rooms, Staff Room and Doctor's Rooms - Window Frame - Grey Paint

Hazard Type	Lead Paint	Material Assessment	Disturbance Assessment	
Friability	-	Product Type	-	
Sample No.	AQ001455	Extent of damage	-	
Result	Positive - 17 %w/w	Surface Treatment	-	
		Asbestos Type	-	
Item Number	54	Material Score	-	
		Priority Score	-

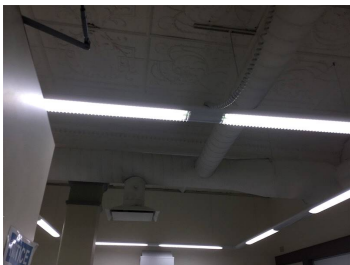
Location	Model & Maxham Building - 3. Level 1 - M103/M104 - Ceiling Ductwork - Insulation

Hazard Type	SMF	Material Assessment	Disturbance Assessment	
Friability	Bonded	Product Type	-	
Sample No.	Visual	Extent of damage	-	
Result	Assumed Positive	Surface Treatment	-	
		Asbestos Type	-	
Item Number	56	Material Score	-	
		Priority Score	-

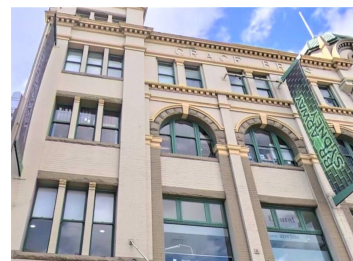
Location Model & Maxham Building - 3. Level 1 - Exterior - Southern Window Frames - Green Paint			
Hazard Type	Lead Paint	Material Assessment	Disturbance Assessment
Friability	-	Product Type	Occupancy
Sample No.	As Greencap J178464-005 {AQ001476}	Extent of damage	Disturbance
Result	Positive	Surface Treatment	Exposure
		Asbestos Type	Maintenance
Item Number	265	Material Score	Disturbance Score
		Priority Score	-

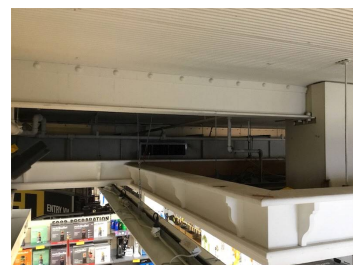
Location Model & Maxham Building - 4. Level 2 - JB HiFi Tenancy - Ceiling Ductwork - Insulation			
Hazard Type	SMF	Material Assessment	Disturbance Assessment
Friability	Bonded	Product Type	Occupancy
Sample No.	Visual	Extent of damage	Disturbance
Result	Assumed Positive	Surface Treatment	Exposure
		Asbestos Type	Maintenance
Item Number	59	Material Score	Disturbance Score
		Priority Score	-

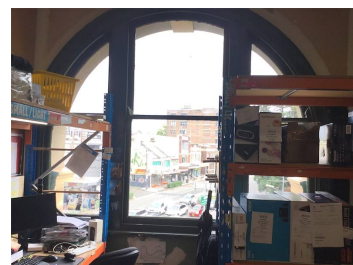
Location Model & Maxham Building - 4. Level 2 - JB HiFi Tenancy - Front of House and Back of House - Window Frame - Upper Green Paint			
Hazard Type	Lead Paint	Material Assessment	Disturbance Assessment
Friability	-	Product Type	Occupancy
Sample No.	AQ001456	Extent of damage	Disturbance
Result	Positive - 2.7 %w/w	Surface Treatment	Exposure
		Asbestos Type	Maintenance
Item Number	60	Material Score	Disturbance Score
		Priority Score	-

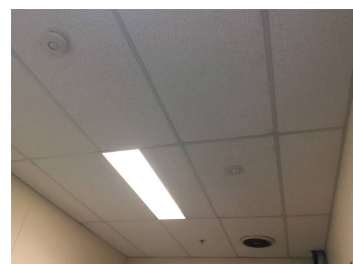
Location Model & Maxham Building - 4. Level 2 - JB HiFi Tenancy - Staff Room - Compressed Ceiling Tiles - Insulation			
Hazard Type	SMF	Material Assessment	Disturbance Assessment
Friability	Bonded	Product Type	Occupancy
Sample No.	Visual	Extent of damage	Disturbance
Result	Assumed Positive	Surface Treatment	Exposure
		Asbestos Type	Maintenance
Item Number	62	Material Score	Disturbance Score
		Priority Score	-

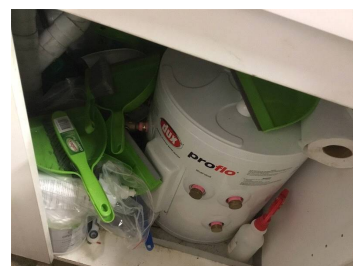
Location Model & Maxham Building - 4. Level 2 - JB HiFi Tenancy - Staff Room - Below Sink - Hot Water Unit - Insulation			
Hazard Type	SMF	Material Assessment	Disturbance Assessment
Friability	Bonded	Product Type	Occupancy
Sample No.	Visual	Extent of damage	Disturbance
Result	Assumed Positive	Surface Treatment	Exposure
		Asbestos Type	Maintenance
Item Number	63	Material Score	Disturbance Score
		Priority Score	-

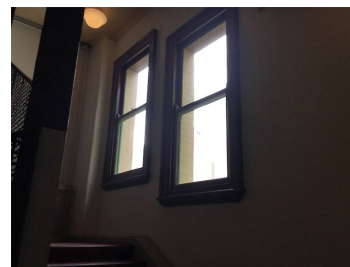
Location Model & Maxham Building - 4. Level 2 - Northwest Stairway - North - Window Frame - Upper Brown Paint and Lower Off White Paint			
Hazard Type	Lead Paint	Material Assessment	Disturbance Assessment
Friability	-	Product Type	Occupancy
Sample No.	As AQ001446	Extent of damage	Disturbance
Result	Positive - 10 %w/w	Surface Treatment	Exposure
		Asbestos Type	Maintenance
Item Number	65	Material Score	Disturbance Score
		Priority Score	-

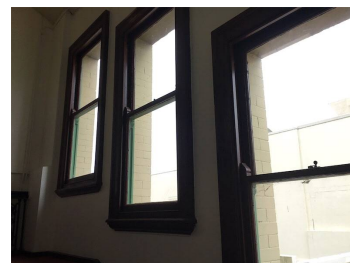
Location Model & Maxham Building - 5. Level 3 - Northwest Stairway - North - Window Frame - Upper Brown Paint and Lower Off White Paint			
Hazard Type	Lead Paint	Material Assessment	Disturbance Assessment
Friability	-	Product Type	Occupancy
Sample No.	As AQ001446	Extent of damage	Disturbance
Result	Positive - 10 %w/w	Surface Treatment	Exposure
		Asbestos Type	Maintenance
Item Number	30	Material Score	Disturbance Score
		Priority Score	-

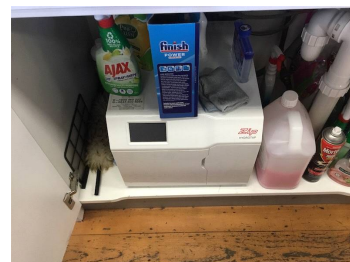
Location Model & Maxham Building - 5. Level 3 - Centre Management Office - Kitchenette - Below Sink - Hot Water Unit - Insulation			
Hazard Type	SMF	Material Assessment	Disturbance Assessment
Friability	Bonded	Product Type	Occupancy
Sample No.	Visual	Extent of damage	Disturbance
Result	Assumed Positive	Surface Treatment	Exposure
		Asbestos Type	Maintenance
Item Number	31	Material Score	Disturbance Score
		Priority Score	-

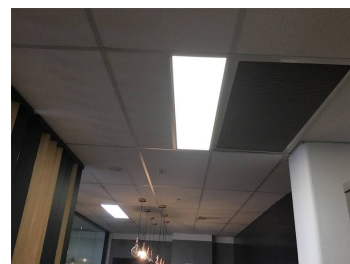
Location Model & Maxham Building - 5. Level 3 - Centre Management Office - Compressed Ceiling Tiles - Insulation			
Hazard Type	SMF	Material Assessment	Disturbance Assessment
Friability	Bonded	Product Type	Occupancy
Sample No.	Visual	Extent of damage	Disturbance
Result	Assumed Positive	Surface Treatment	Exposure
		Asbestos Type	Maintenance
Item Number	34	Material Score	Disturbance Score
		Priority Score	-

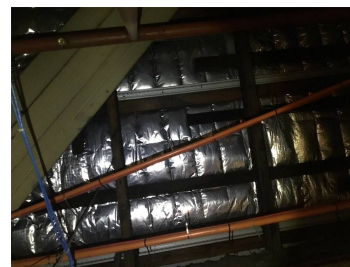
Location		Model & Maxham Building - 5. Level 3 - Ceiling Space - Ceiling - Roof Lining - Sarking - Insulation						
Hazard Type		SMF	Material Assessment		Disturbance Assessment			
Friability		Bonded	Product Type		-	Occupancy	-	
Sample No.		Visual	Extent of damage		-	Disturbance	-	
Result		Assumed Positive		Surface Treatment		-	Exposure	-
				Asbestos Type		-	Maintenance	-
Item Number		35		Material Score		-	Disturbance Score	-
				Priority Score		-	-

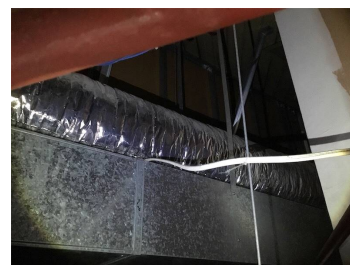
Location		Model & Maxham Building - 5. Level 3 - Ceiling Space - Flexible Ductwork - Insulation				
Hazard Type		SMF	Material Assessment		Disturbance Assessment	
Friability		Bonded	Product Type	-	Occupancy	-
Sample No.		Visual	Extent of damage	-	Disturbance	-
Result		Assumed Positive	Surface Treatment	-	Exposure	-
			Asbestos Type	-	Maintenance	-
Item Number	36	Material Score	-	Disturbance Score	-	
		Priority Score	-		-

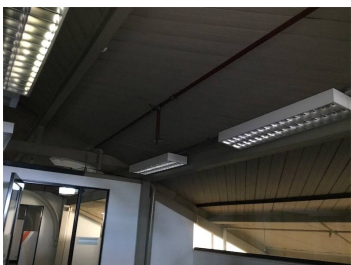
Location		Model & Maxham Building - 5. Level 3 - Tenancy M302 - Mezzanine - Ceiling - Timber Lining - Upper Grey Paint and Lower Beige Paint				
Hazard Type		Lead Paint	Material Assessment		Disturbance Assessment	
Friability		-	Product Type	-	Occupancy	-
Sample No.		AQ001452	Extent of damage	-	Disturbance	-
Result		Positive - 17 %w/w	Surface Treatment	-	Exposure	-
			Asbestos Type	-	Maintenance	-
Item Number	37	Material Score	-	Disturbance Score	-	
		Priority Score	-		-

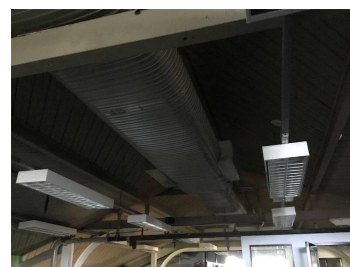
Location		Model & Maxham Building - 5. Level 3 - Tenancy M302 - Mezzanine - Ceiling - Ductwork - Insulation						
Hazard Type		SMF	Material Assessment		Disturbance Assessment			
Friability		Bonded	Product Type		-	Occupancy	-	
Sample No.		Visual	Extent of damage		-	Disturbance	-	
Result		Assumed Positive		Surface Treatment		-	Exposure	-
				Asbestos Type		-	Maintenance	-
Item Number		38		Material Score		-	Disturbance Score	-
				Priority Score		-	-

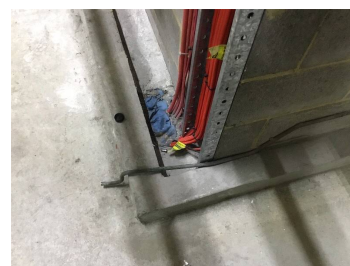
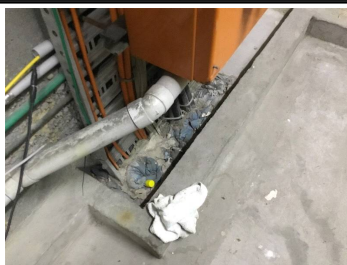
Location		Model & Maxham Building - 5. Level 3 - Plant Room - Floor Penetration - Pillow Insulation - Insulation				
Hazard Type		SMF	Material Assessment		Disturbance Assessment	
Friability		Bonded	Product Type	-	Occupancy	-
Sample No.		Visual	Extent of damage	-	Disturbance	-
Result		Assumed Positive	Surface Treatment	-	Exposure	-
			Asbestos Type	-	Maintenance	-
Item Number	40	Material Score	-	Disturbance Score	-	
		Priority Score	-		-

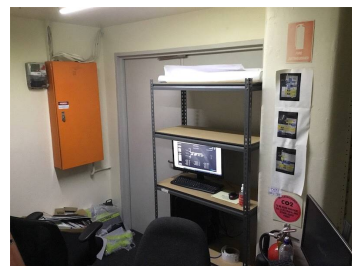
Location	Model & Maxham Building - 5. Level 3 - Plant Room - Wall - Throughout - Off White Paint		
Hazard Type	Lead Paint	Material Assessment	Disturbance Assessment
Friability	-	Product Type	Occupancy
Sample No.	Greencap J131662-003-BWAY-LP-001 {AQ001708}	Extent of damage	Disturbance
Result	Positive	Surface Treatment	Exposure
		Asbestos Type	Maintenance
Item Number	41	Material Score	Disturbance Score
		Priority Score	-

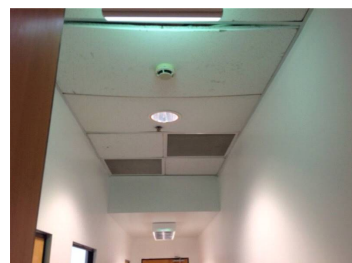
Location	Model & Maxham Building - 5. Level 3 - Corridor to Toilet - Compressed Ceiling Tiles - Insulation		
Hazard Type	SMF	Material Assessment	Disturbance Assessment
Friability	Bonded	Product Type	Occupancy
Sample No.	Visual	Extent of damage	Disturbance
Result	Assumed Positive	Surface Treatment	Exposure
		Asbestos Type	Maintenance
Item Number	263	Material Score	Disturbance Score
		Priority Score	-

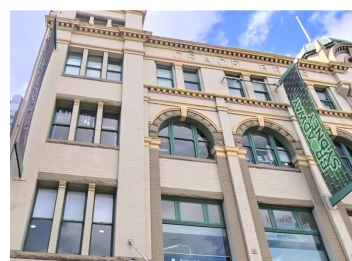
Location	Model & Maxham Building - 5. Level 3 - Exterior - Southern Window Frames - Green Paint		
Hazard Type	Lead Paint	Material Assessment	Disturbance Assessment
Friability	-	Product Type	Occupancy
Sample No.	Greencap J178464-005 {AQ001476}	Extent of damage	Disturbance
Result	Positive	Surface Treatment	Exposure
		Asbestos Type	Maintenance
Item Number	80	Material Score	Disturbance Score
		Priority Score	-

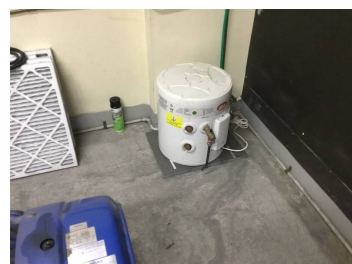
Location	Model & Maxham Building - 6. Roof - Northwest Plant Room - Northwest - Hot Water Unit - Insulation		
Hazard Type	SMF	Material Assessment	Disturbance Assessment
Friability	Bonded	Product Type	Occupancy
Sample No.	Visual	Extent of damage	Disturbance
Result	Assumed Positive	Surface Treatment	Exposure
		Asbestos Type	Maintenance
Item Number	19	Material Score	Disturbance Score
		Priority Score	-

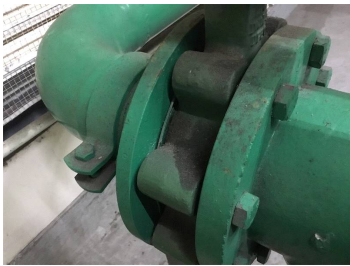
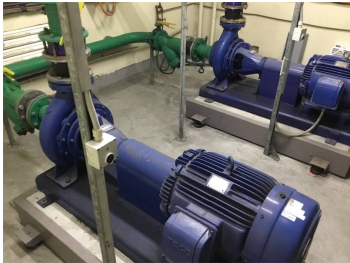
Location		Model & Maxham Building - 6. Roof - Northwest Plant Room - Plant & Equipment - Pipework Flange Joint - Gasket - Live Plant			
Hazard Type	Asbestos	Material Assessment		Disturbance Assessment	
Friability	Non-friable	Product Type	2	Occupancy	0
Sample No.	Visual	Extent of damage	0	Disturbance	2
Result	Assumed Positive Amosite	Surface Treatment	0	Exposure	0
		Asbestos Type	2	Maintenance	0
Item Number	21	Material Score	4	Disturbance Score	2
		Priority Score	6	Very Low

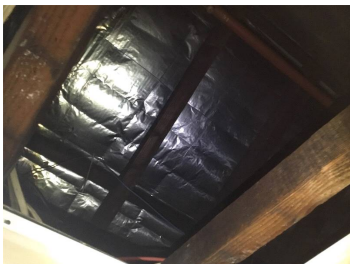
Location		Model & Maxham Building - 6. Roof - Southwest Plant Room - Roof Lining - Sarking - Insulation			
Hazard Type	SMF	Material Assessment		Disturbance Assessment	
Friability	Bonded	Product Type	-	Occupancy	-
Sample No.	Visual	Extent of damage	-	Disturbance	-
Result	Assumed Positive	Surface Treatment	-	Exposure	-
		Asbestos Type	-	Maintenance	-
Item Number	18	Material Score	-	Disturbance Score	-
		Priority Score	-	-

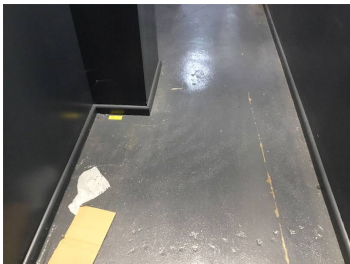
Location		Model & Maxham Building - 1. Lower Ground Level - Western Dock Corridor (Behind Rebel Sport) - Central, adjacent to Sprinkler Pump Room - Vinyl Tiles			
Hazard Type	Asbestos	Material Assessment		Disturbance Assessment	
Friability	Non-friable	Product Type	1	Occupancy	1
Sample No.	Greencap J131662-003-BWAY-003 {AQ001444}	Extent of damage	2	Disturbance	2
		Surface Treatment	0	Exposure	2
Result	Positive Chrysotile	Asbestos Type	1	Maintenance	0
		Material Score	4	Disturbance Score	5
Item Number	10	Priority Score	9	Low

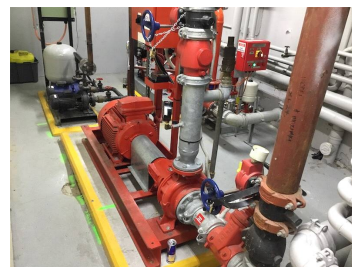
Location		Model & Maxham Building - 1. Lower Ground Level - Sprinkler Pump Room - Plant & Equipment - Pipework - Gasket - Live Plant			
Hazard Type	Asbestos	Material Assessment		Disturbance Assessment	
Friability	Non-friable	Product Type	2	Occupancy	0
Sample No.	Visual	Extent of damage	0	Disturbance	1
Result	Assumed Positive Amosite	Surface Treatment	0	Exposure	0
		Asbestos Type	2	Maintenance	0
Item Number	13	Material Score	4	Disturbance Score	1
		Priority Score	5	Very Low

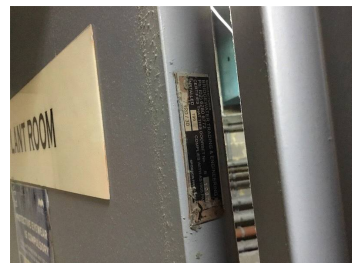
Location		Model & Maxham Building - 1. Lower Ground Level - Plant Room - Entry Door - Fire Door Core - Insulation - Year of Manufacture in 1990s			
Hazard Type	Asbestos	Material Assessment		Disturbance Assessment	
Friability	Friable	Product Type	-1	Occupancy	0
Sample No.	Visual	Extent of damage	0	Disturbance	2
Result	Assumed Positive Amosite	Surface Treatment	1	Exposure	0
		Asbestos Type	2	Maintenance	0
Item Number	14	Material Score	2	Disturbance Score	2
		Priority Score	4	Very Low
