# **Asbestos Materials Management Plan**

**Buildings 1, 2, & 3  
Riverside Quay,  
Docklands, Victoria**

**Mirvac  
July 2023**

**Client No: M0095  
Job No: 116647M**

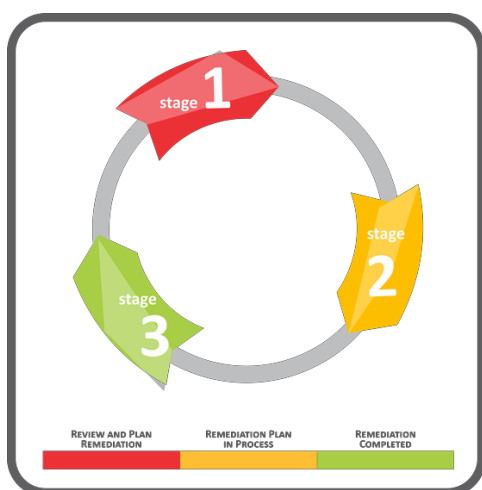
To assist with the on-going management of ACM, below are general stages that could be adopted for the Site.

**Stage 1** – Identify ACM in **Appendix B: Hazardous Building Materials Register** which require on-going management.

**Stage 2** – Implement on-going management recommendations, for example, label identified ACM, regularly monitor condition of identified or assumed ACM and undertake a Division 6 Asbestos Assessment (intrusive works) prior to any demolition or refurbishment works.

**Stage 3** – Typically, ACM must be reinspected every 5 years as a minimum and the asbestos register updated by a competent person, unless the risk conditions differ. It should also be noted, that the asbestos register may need to be revised following significant asbestos remediation works or additional finds of ACM.

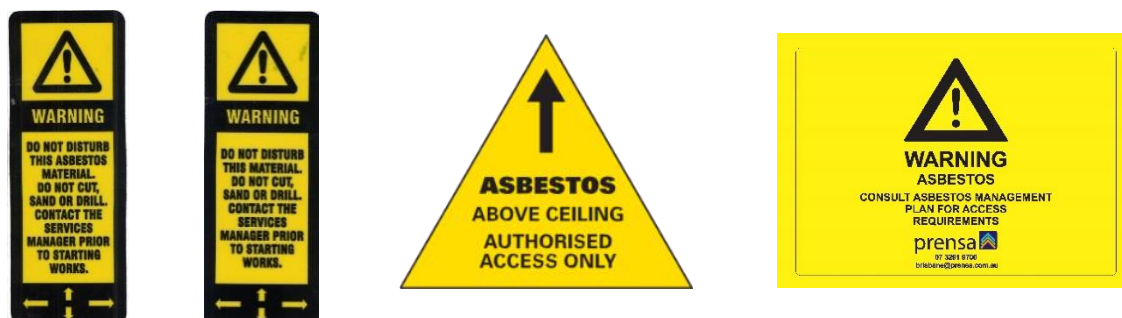
Possible asbestos warning label to be used at the site are shown below:

Note: The above warning signs and labels comply with AS 1319 – 1994 *Safety signs for the Occupational Environment*.

As the placement of warning labels could be unnecessarily alarming to staff and the public, labels warning of a hazard but omitting the word 'asbestos' can be used in public areas such as toilets, lobbies, offices and common areas. An example of this type of label is provided below.
