Environmental Representative (ER) Quarterly Report
Project: SSD-10448 – Aspect Industrial Estate Stage 1
Period: September to November 2023

Project: SSD-10448 – Aspect Industrial Estate

Period: September to November 2023

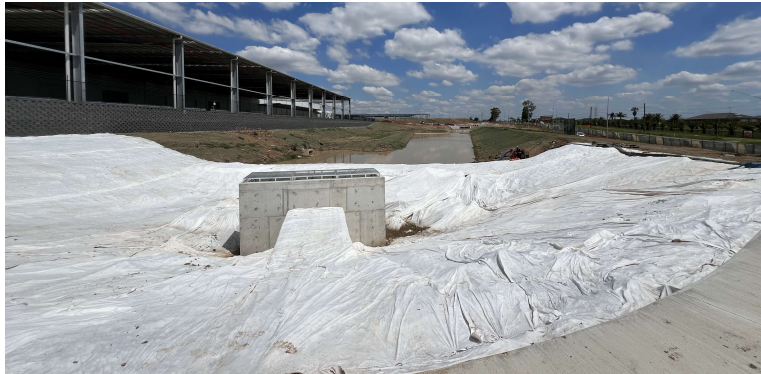
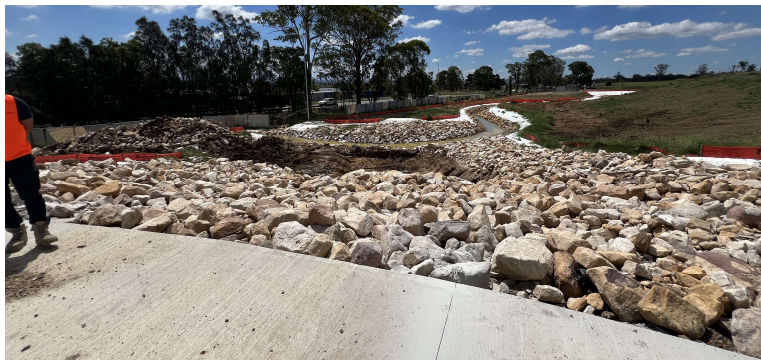
WEM – Sediment Pond 1

Discharge structure and spillway for Sediment Pond 1 has been completed. Works were progressing for the outlet from the structure to link to the riparian channel (Photos 4/12/23)

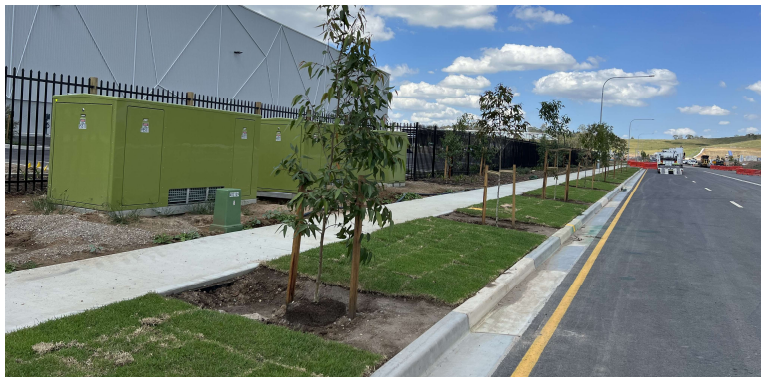
WEM Internal Road 1

Line markings and landscaping progressing in preparation for Lot 1 becoming operation (Photos 4/12/23)

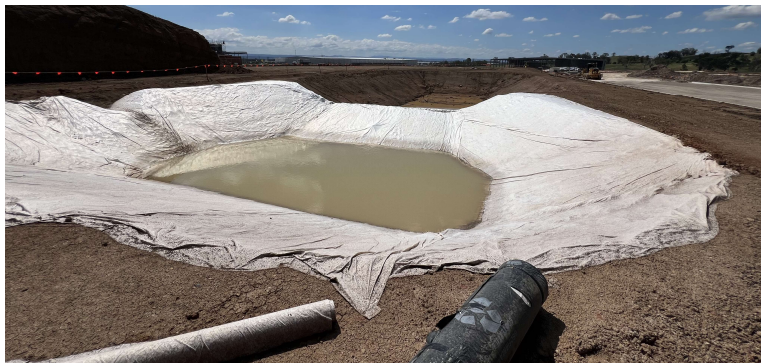
WEM - Lot 6

Sediment ponds are being constructed in preparation to Type B specifications (Photos 4/12/23).
