Asbestos and Hazardous Materials Pre-Demolition Assessment

90 Collins St

Melbourne CBD Vic 3000

17/03/2023

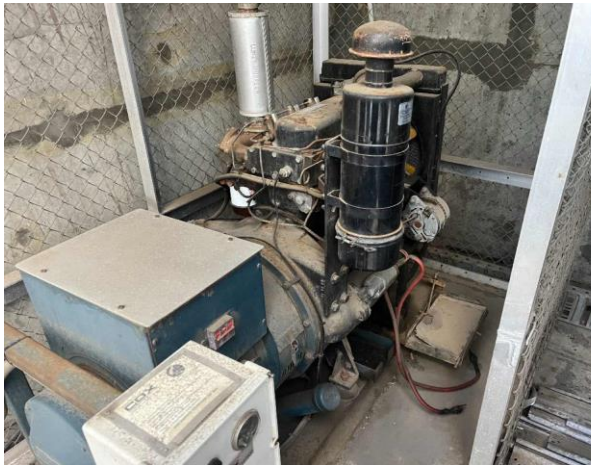
Line ID 1: External, Roof, East Plant Area, Generator or Motor for Motorised Basket, Gaskets - Suspected Asbestos

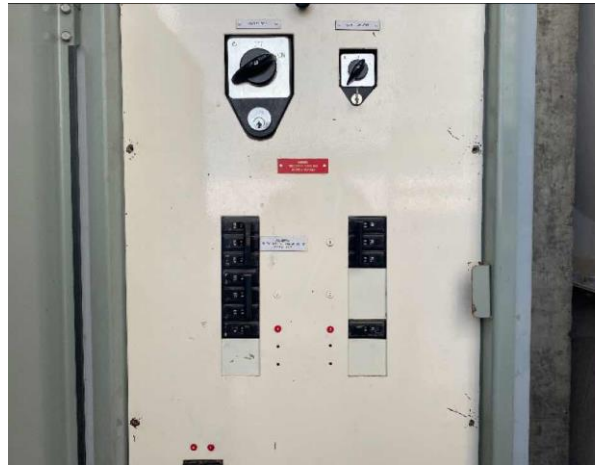
Line ID 2: External, Roof, East Plant Area, Switchboard Adjacent Cooling Tower Tank, HRC Fuses - Suspected Asbestos

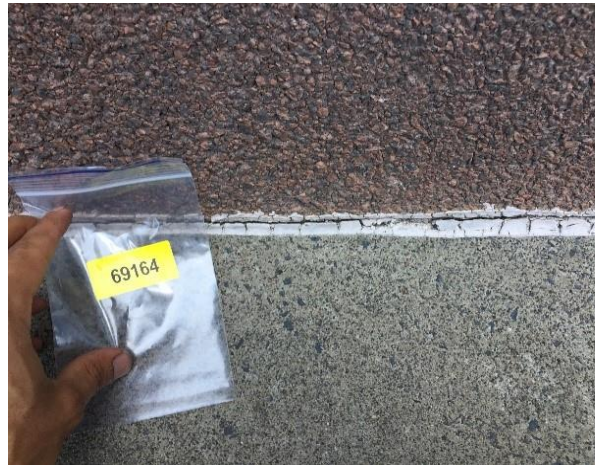
Line ID 4: External, Roof, Throughout, Walls, Mastic Sealant - No Asbestos Detected

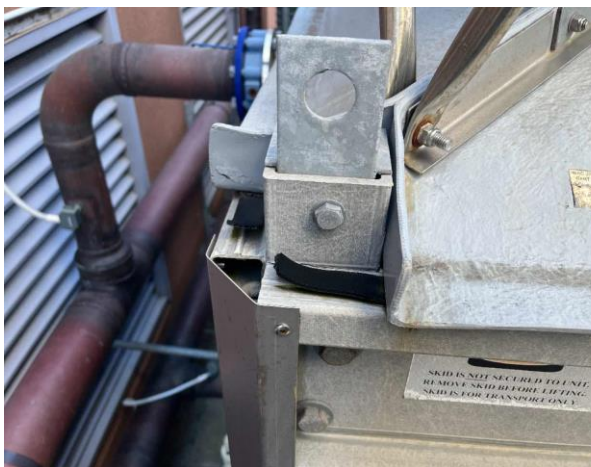
Line ID 5: External, Roof, West Plant Area, Cooling Tower Pipe , Gaskets - None Suspected

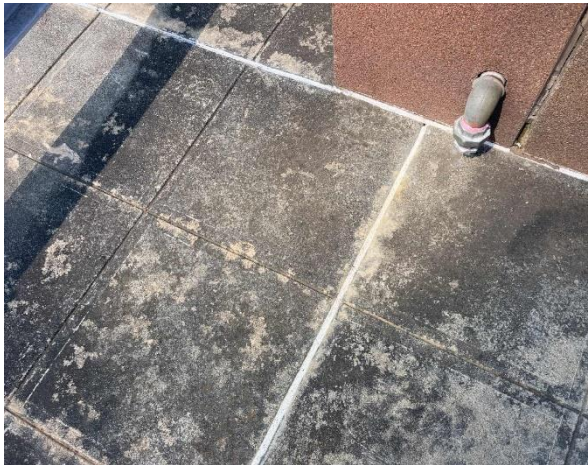
Line ID 7: External, Roof, West Plant Area, White Mastic To Concrete Floor Pavers, Mastic Sealant - No Asbestos Detected

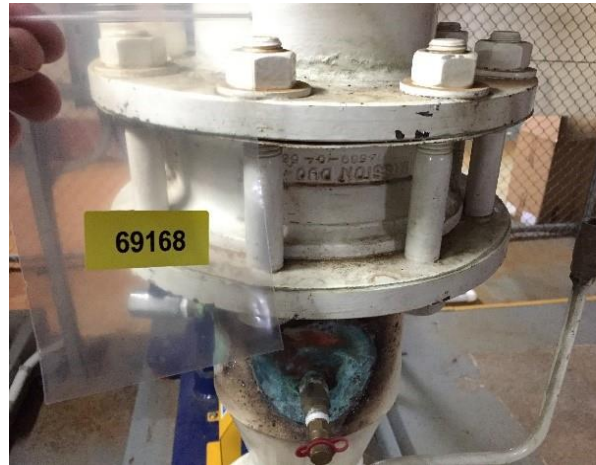
Line ID 11: Internal, B1, Plant Room, Gaskets to Pump Machinery, Green Gasket Material - No Asbestos Detected

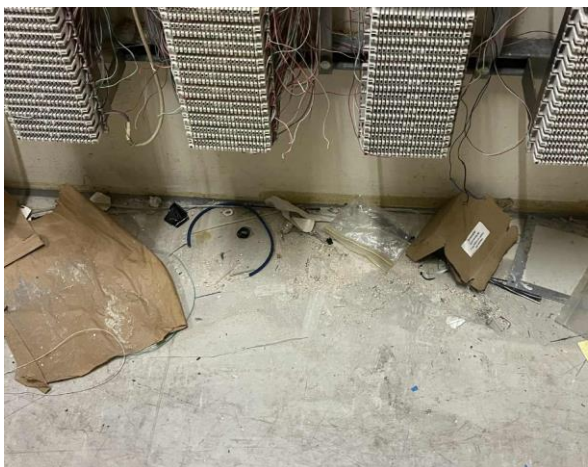
Line ID 12: Internal, B2, MDF Room, To Ledges and Floor Below Penetration to Floor Above, Vermiculite Debris - No Asbestos Detected

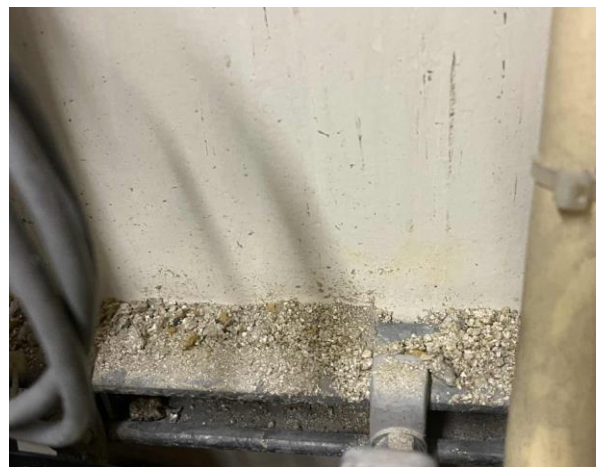
Line ID 12.1: Internal, B2, MDF Room, To Ledges and Floor Below Penetration to Floor Above, Vermiculite Debris - No Asbestos Detected

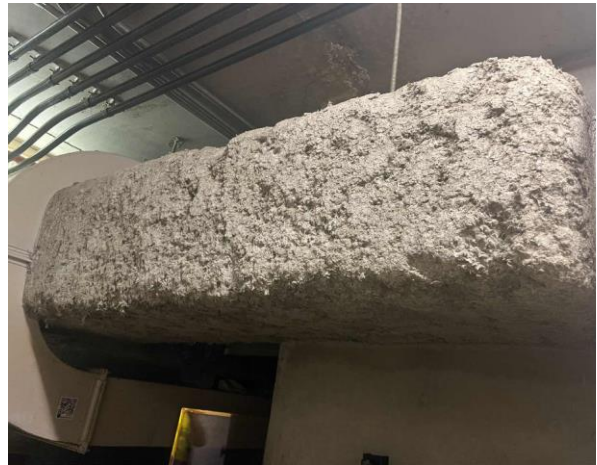
Line ID 14: Internal, B2, Store Room Adjacent Lift Lobby, To Small Ductwork, Sprayed Vermiculite - No Asbestos Detected

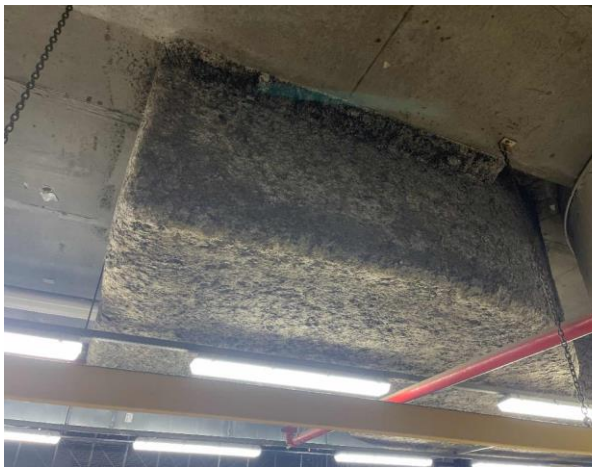
Line ID 17: Internal, GF, Car Park Plant Room, To Large Ductwork, Sprayed Vermiculite - No Asbestos Detected

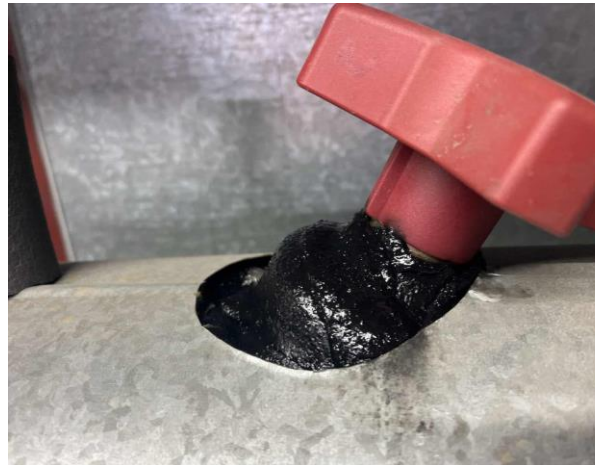
Line ID 20: Internal, GF, External Plant Room, Bitumen to Pipes Under Metal Casing, Bituminous Membrane - No Asbestos Detected

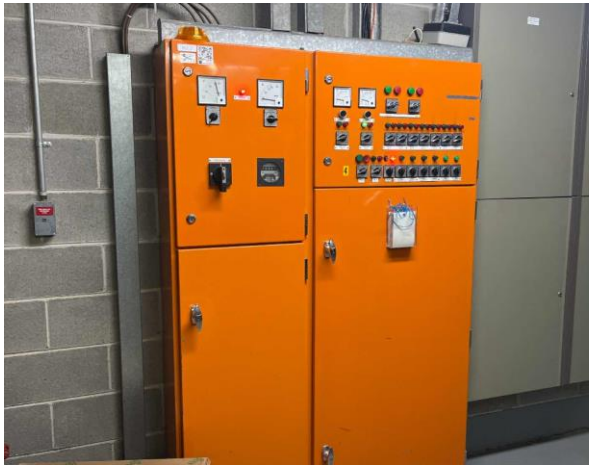
Line ID 21: Internal, GF, External Plant Room, Electrical Cupboards, HRC Fuses - Suspected Asbestos

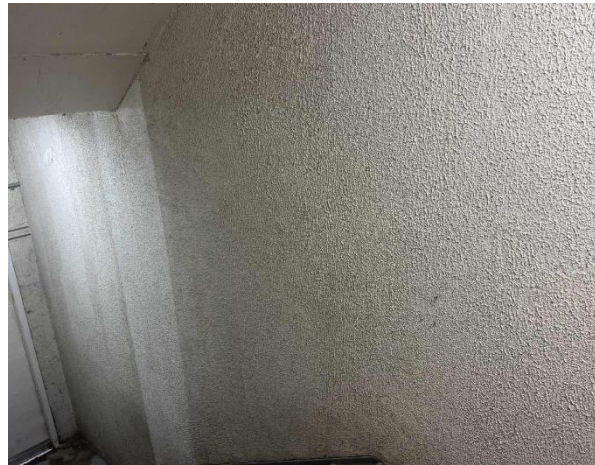
Line ID 22: Internal, GF, External Plant Room, Stairwell to Plant Room, Textured Coating - No Asbestos Detected

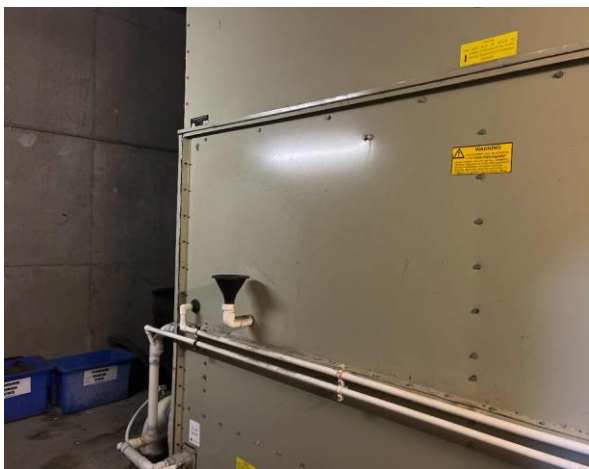
Line ID 23: Internal, GF, External Plant Room, To Water Tank in Room 1141 Tower 1, Bituminous Membrane - No Asbestos Detected

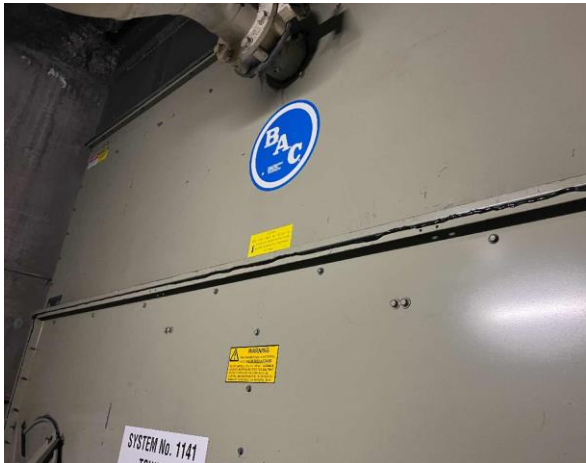
Line ID 24.1: Internal, GF, External Plant Room, To Water Tank in Room 1141 Tower 2, Bituminous Membrane - No Asbestos Detected

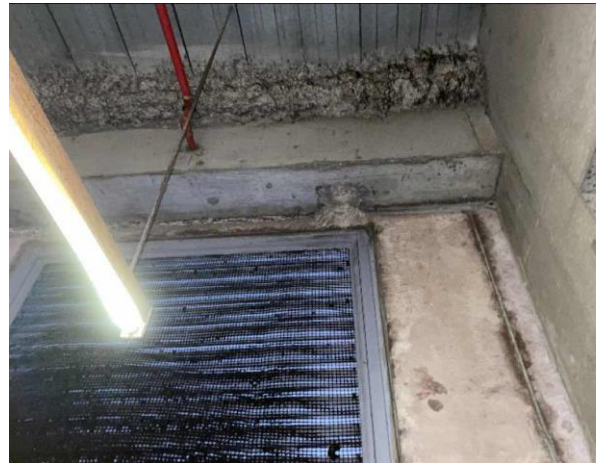
Line ID 25: Internal, GF, External Plant Room, West Ductwork Room Window Grills, To Small External Window Frame Supports, Sprayed Vermiculite - No Asbestos Detected

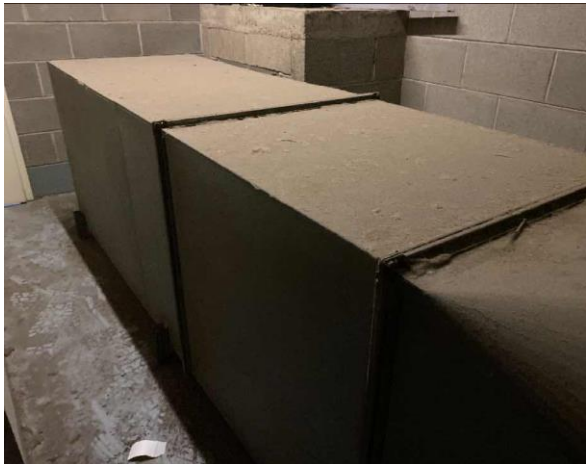
Line ID 26: Internal, GF, External Plant Room, West Exhaust Air Rooms, Ductwork Mastic - No Asbestos Detected

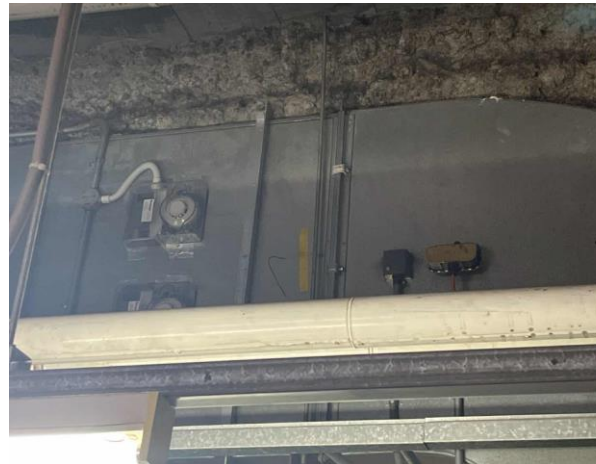
Line ID 27: Internal, GF, External Plant Room, Within AC Ductwork, Heater Bank Insulation - Suspected Asbestos

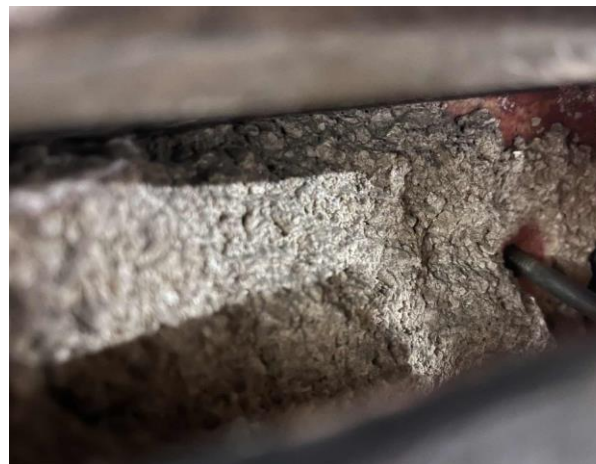
Line ID 28.1: Internal, GF, Loading Dock, Hatch Door to Riser, Vermiculite - No Asbestos Detected

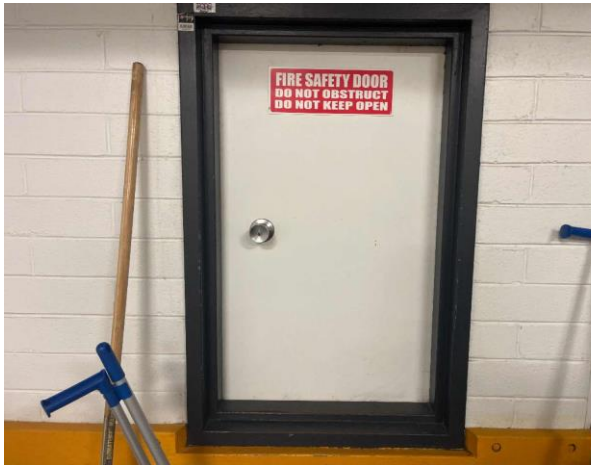
Line ID 29: Internal, GF, Loading Dock, Small Fire Door to Loading Bay, Fire Door Core - Suspected Asbestos

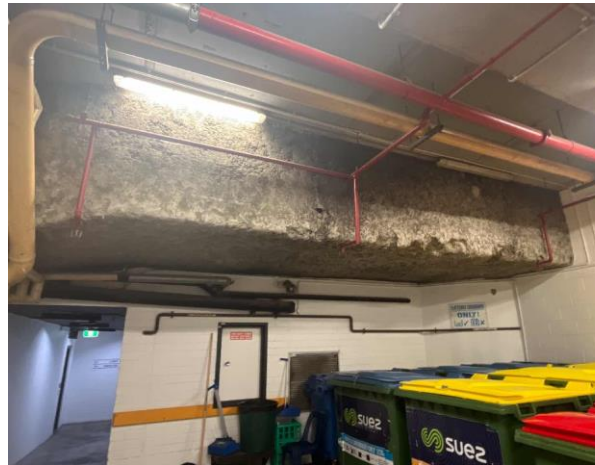
Line ID 30: Internal, GF, Loading Dock, To High Level Ceiling and Ductwork, Sprayed Vermiculite - No Asbestos Detected

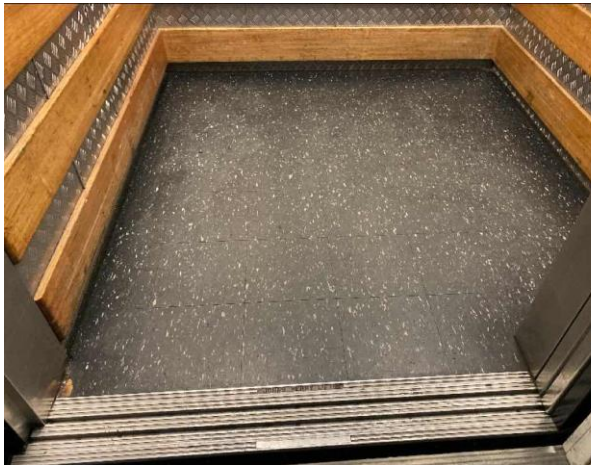
Line ID 31: Internal, Goods Lift, Floor, Black Speckled Floor Tiles, Vinyl Floor Tiles - No Asbestos Detected

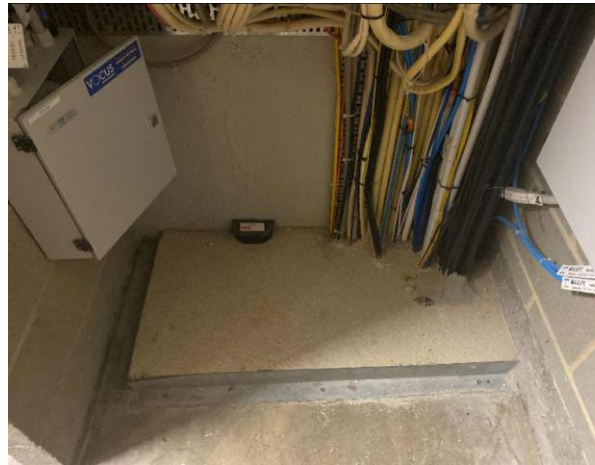
Line ID 32: Internal, L10, Lift Lobby Electrical Services Room, Fire Stop to Penetrations, Vermiculite - No Asbestos Detected

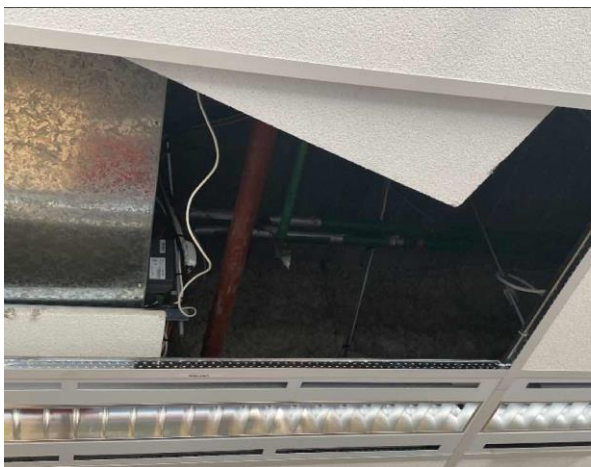
Line ID 33: Internal, L10, Main Office Areas, Throughout the Underside of the Ceiling to Concrete Columns, Sprayed Vermiculite - No Asbestos Detected

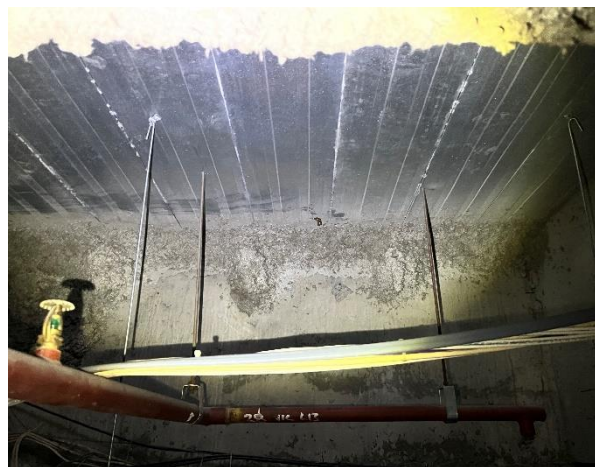
Line ID 35: Internal, L11, Main Office Areas, Throughout the Underside of the Ceiling to Concrete Columns, Sprayed Vermiculite - No Asbestos Detected

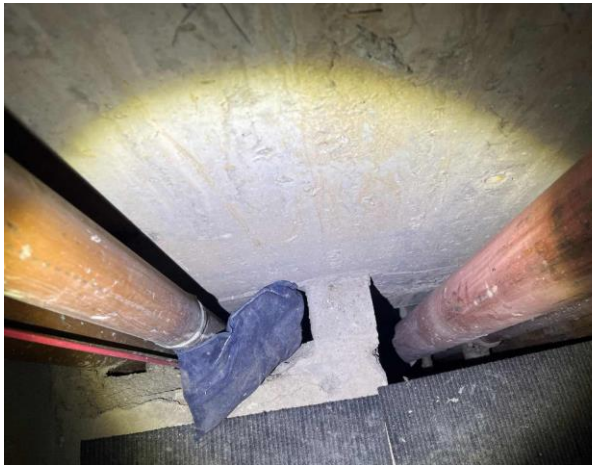
Line ID 36: Internal, L11, Pipe Riser, To Base of Riser, Vermiculite Debris - No Asbestos Detected

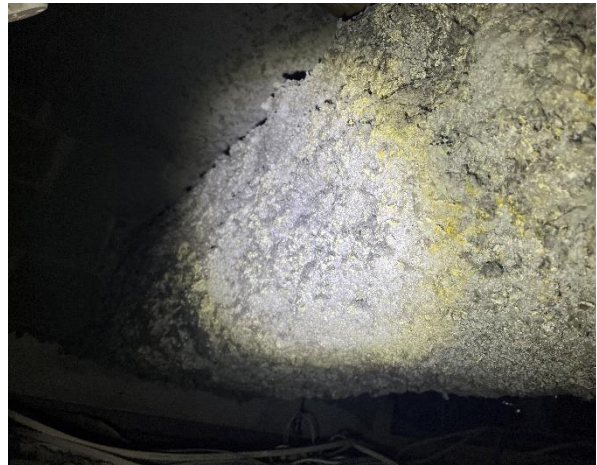
Line ID 37: Internal, L12, Main Office Areas, Throughout the Underside of the Ceiling to Concrete Columns, Sprayed Vermiculite - No Asbestos Detected

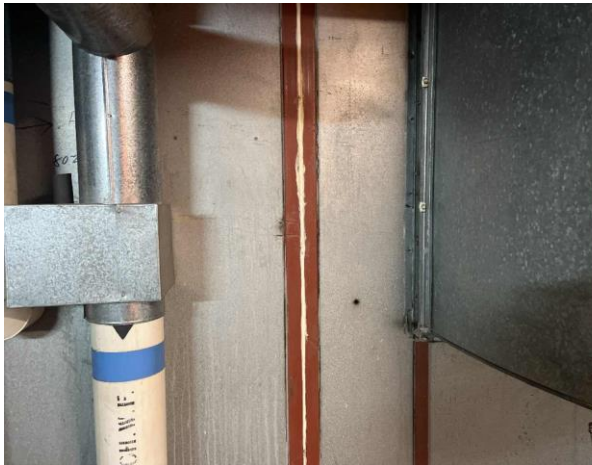
Line ID 47: Internal, L14, Plant Room, Air Handling Unit Panel Sealant, Mastic Sealant (Black & Dark Grey) - No Asbestos Detected

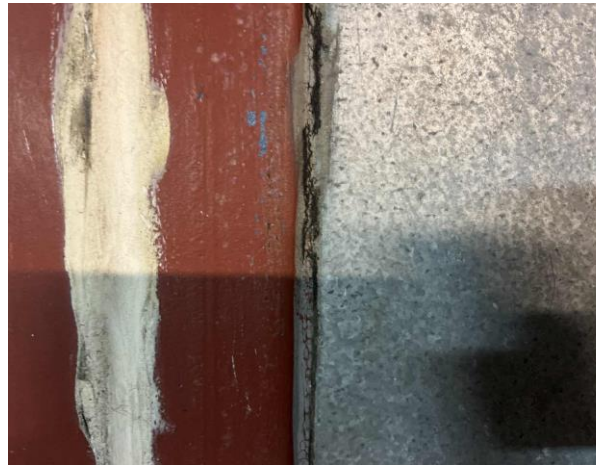
Line ID 47.1: Internal, L14, Plant Room, Air Handling Unit Panel Sealant, Mastic Sealant (Black & Dark Grey) - No Asbestos Detected

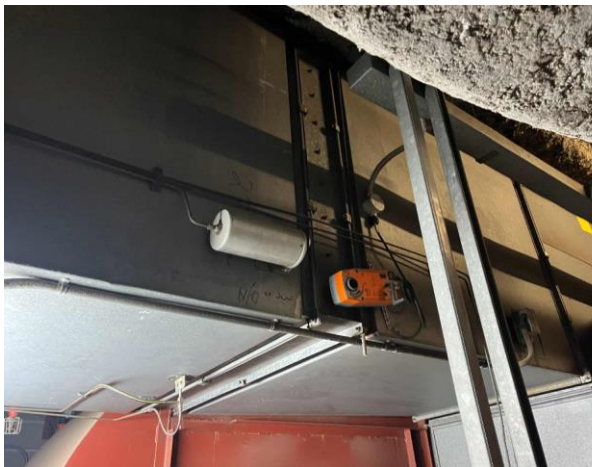
Line ID 48: Internal, L14, Plant Room, Around the Heater Core to the Ductwork, Heater Bank Insulation - Suspected Asbestos

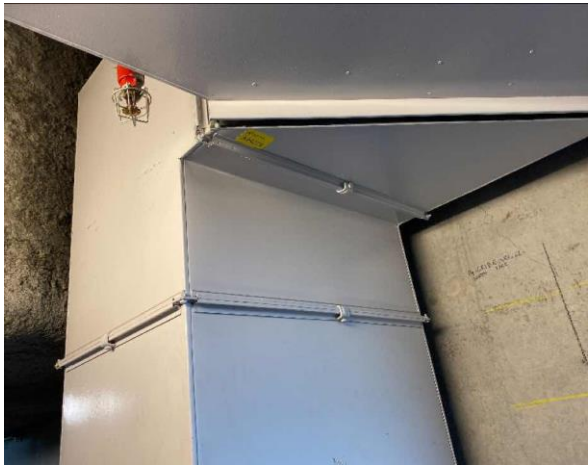
Line ID 50: Internal, L14, Plant Room, Exhaust Fan 4 Ductwork To South Room, Ductwork Mastic - No Asbestos Detected

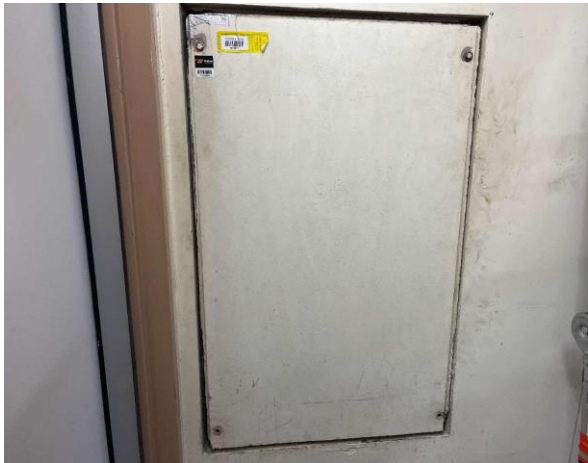
Line ID 52: Internal, L14, Plant Room, Hatch Door to Riser, Vermiculite - No Asbestos Detected

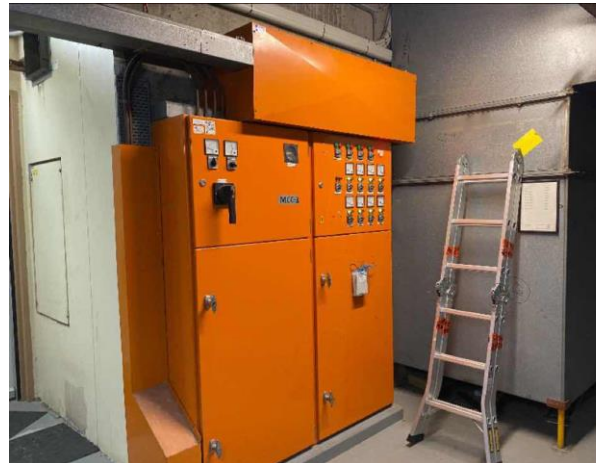
Line ID 53: Internal, L14, Plant Room, Switchboard Adjacent Main Entry Door, HRC Fuses - Suspected Asbestos

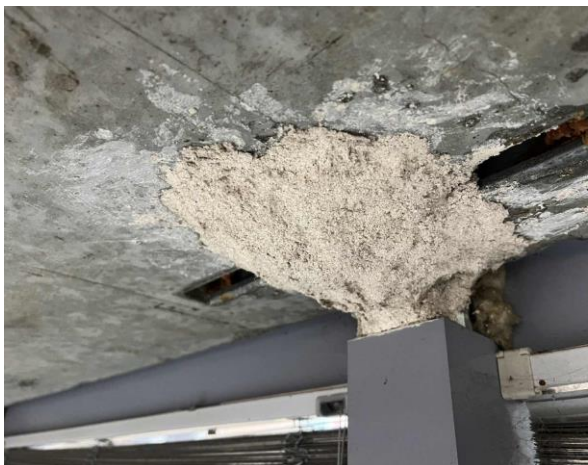
Line ID 54: Internal, L14, Plant Room, To Small External Window Frame Supports, Sprayed Vermiculite - No Asbestos Detected

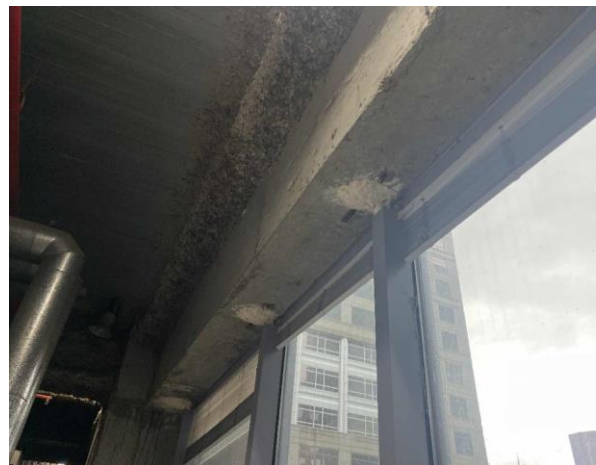
Line ID 54.1: Internal, L14, Plant Room, To Small External Window Frame Supports, Sprayed Vermiculite - No Asbestos Detected

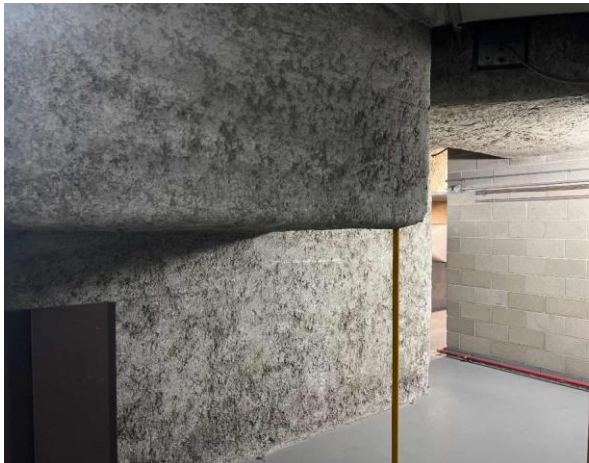
Line ID 55: Internal, L14, Plant Room, To Walls, Ductwork and Steel Beams, Sprayed Vermiculite - No Asbestos Detected

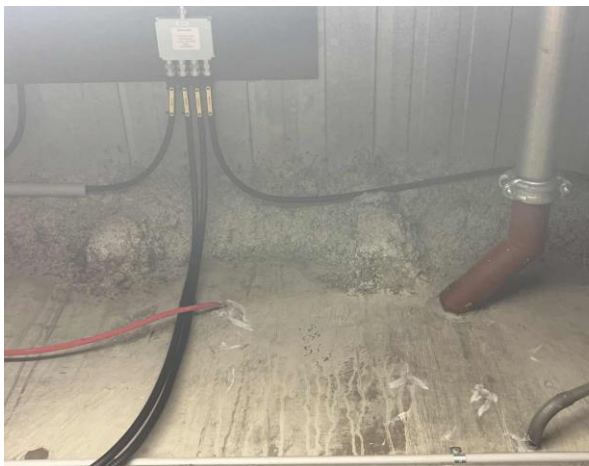
Line ID 55.2: Internal, L14, Plant Room, To Walls, Ductwork and Steel Beams, Sprayed Vermiculite - No Asbestos Detected

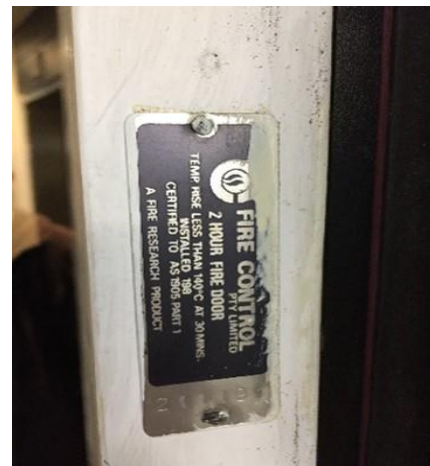
Line ID 56: Internal, L14, Lift Motor Room, Fire Door, Fire Door Core - Suspected Asbestos

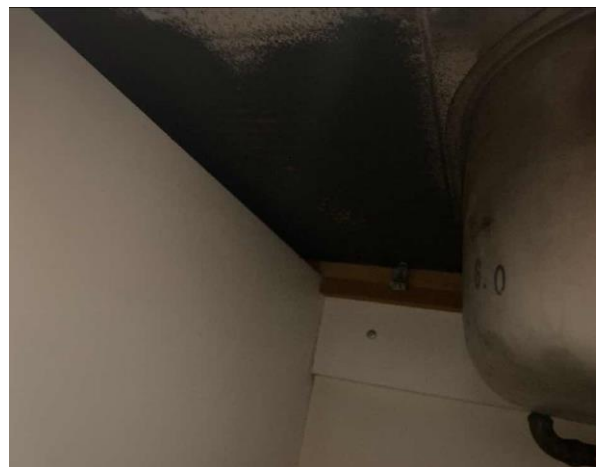
Line ID 58: Internal, L16, Lift Lobby Electrical Services Room, Under Sink Adjacent Fire Door, Bitumen Coating - No Asbestos Detected

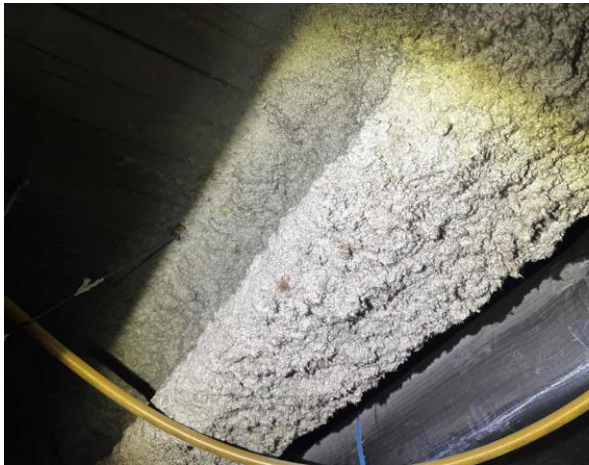
Line ID 60: Internal, L17, Main Office Areas, Throughout the Underside of the Ceiling to Concrete Columns, Sprayed Vermiculite - No Asbestos Detected

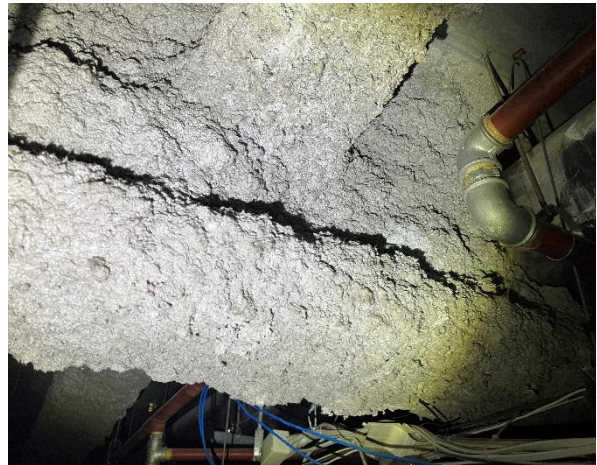
Line ID 62: Internal, L2, L5, L8, L9, L15, L19 and L21, Main Office Areas, Throughout the Underside of the Ceiling to Concrete Columns, Sprayed Vermiculite - No Asbestos Detected

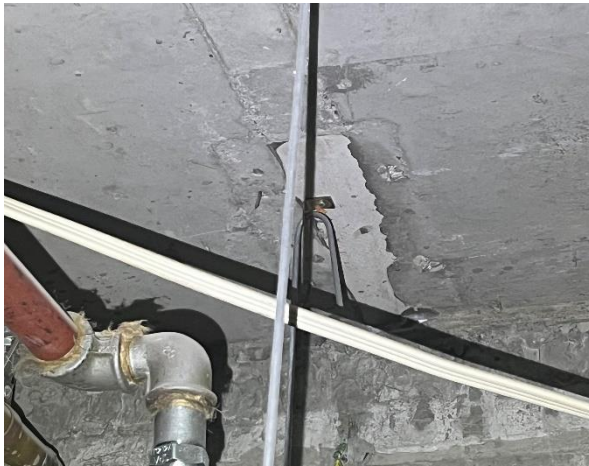
Line ID 63: Internal, L20, Female Toilet, Formwork to the Concrete Soffit within the Ceiling Void, Fibre Cement Sheet - No Asbestos Detected

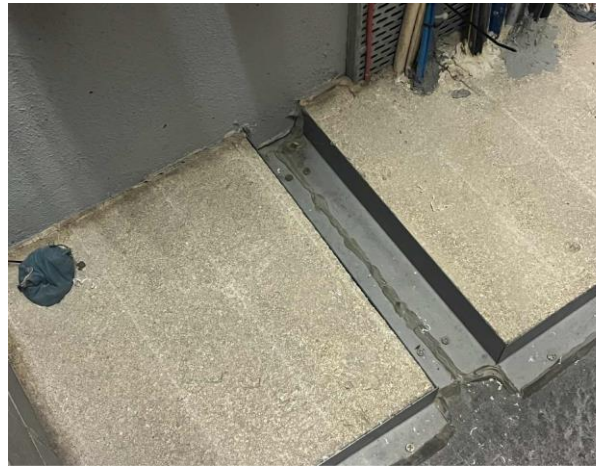
Line ID 64: Internal, L20, Lift Lobby Electrical Services Room, Fire Stop to Penetrations, Vermiculite - No Asbestos Detected

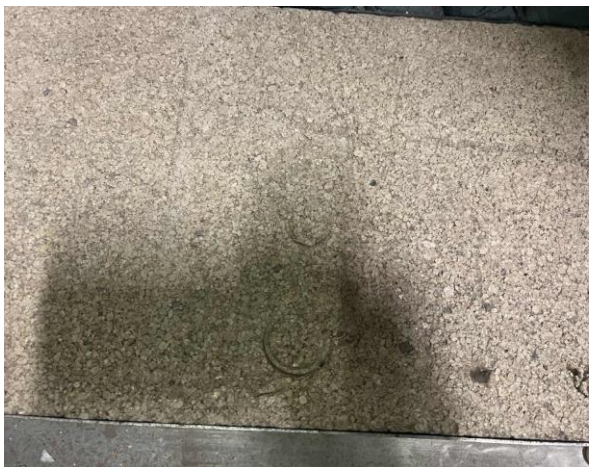
Line ID 64.1: Internal, L20, Lift Lobby Electrical Services Room, Fire Stop to Penetrations, Vermiculite - No Asbestos Detected

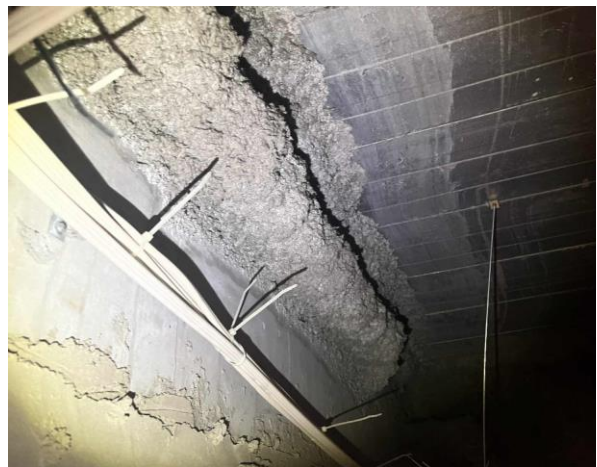
Line ID 65: Internal, L20, Main Office Areas, Throughout the Underside of the Ceiling to Concrete Columns, Sprayed Vermiculite - No Asbestos Detected

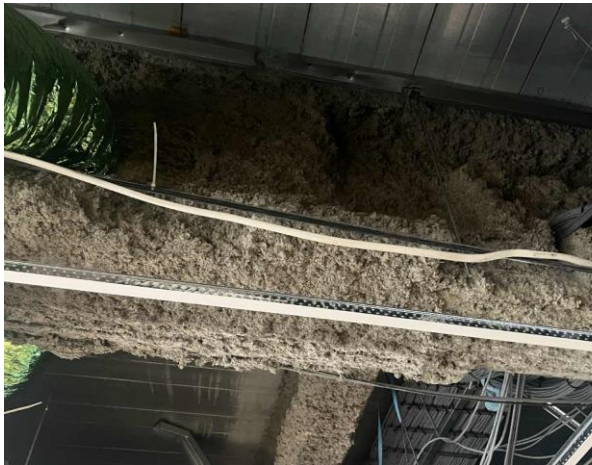
Line ID 65.1: Internal, L20, Main Office Areas, Throughout the Underside of the Ceiling to Concrete Columns, Sprayed Vermiculite - No Asbestos Detected

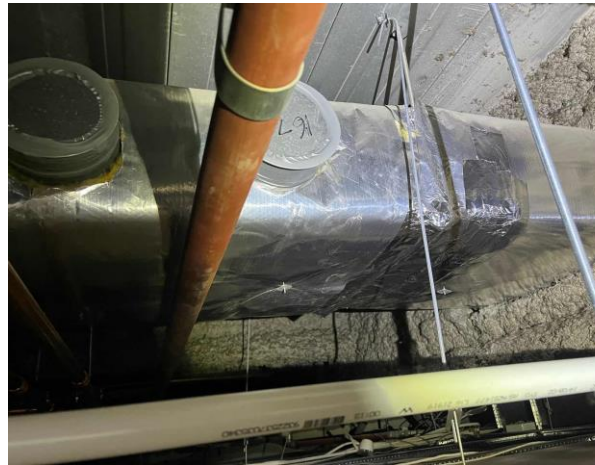
Line ID 66: Internal, L20, Main Office Areas, To Rigid Ductwork, Mastic Sealant (Green) - No Asbestos Detected

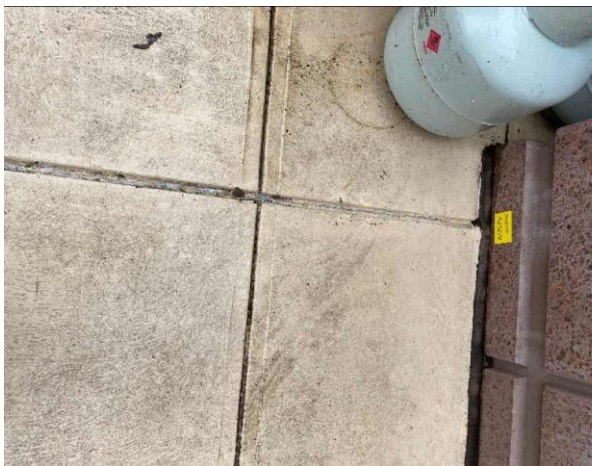
Line ID 67: Internal, L21, External Balcony, Grey Floor Mastic, Construction Joint Mastic - No Asbestos Detected

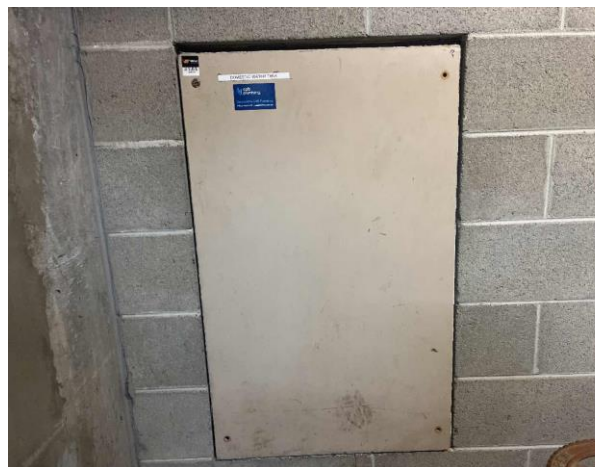
Line ID 70: Internal, L22, Plant Room, Hatch Door to Domestic Water Tank, Vermiculite - No Asbestos Detected

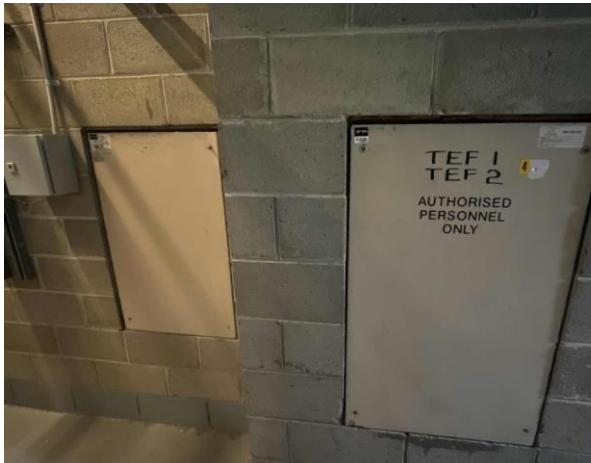
Line ID 71: Internal, L22, Plant Room, Hatch Door to TEF 1 & 2 & Relief Air, Vermiculite - No Asbestos Detected

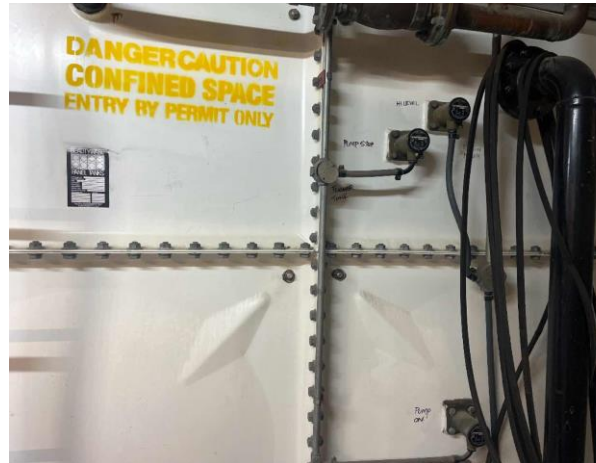
Line ID 72: Internal, L22, Plant Room, To Panels of Water Tank, Mastic Sealant (grey) - No Asbestos Detected

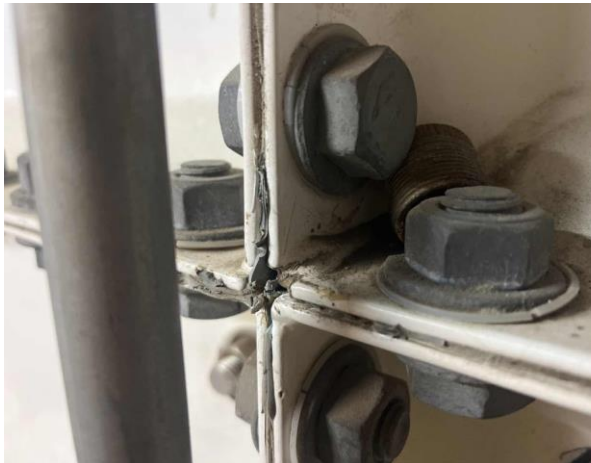
Line ID 72.1: Internal, L22, Plant Room, To Panels of Water Tank, Mastic Sealant (grey) - No Asbestos Detected

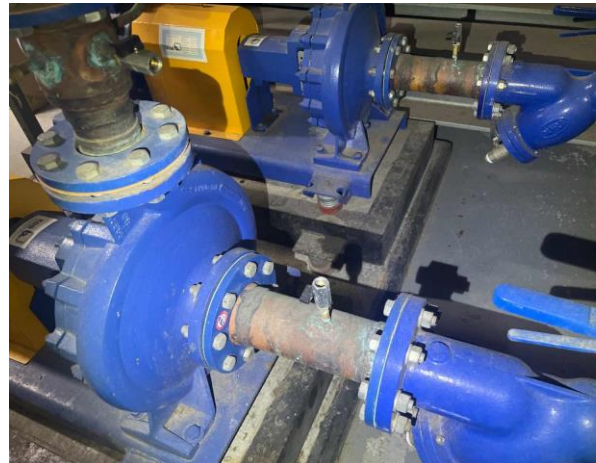
Line ID 73: Internal, L22, Plant Room, To Pipe Work of Pump Machinery, Blue Gasket Material - No Asbestos Detected

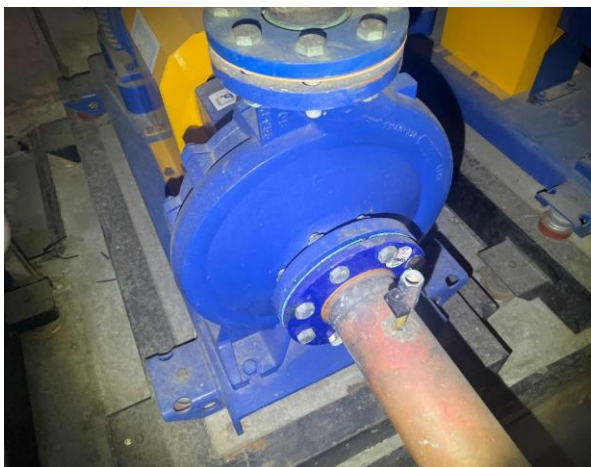
Line ID 74: Internal, L22, Plant Room, To Pipe Work of Pump Machinery, Green Gasket Material - No Asbestos Detected

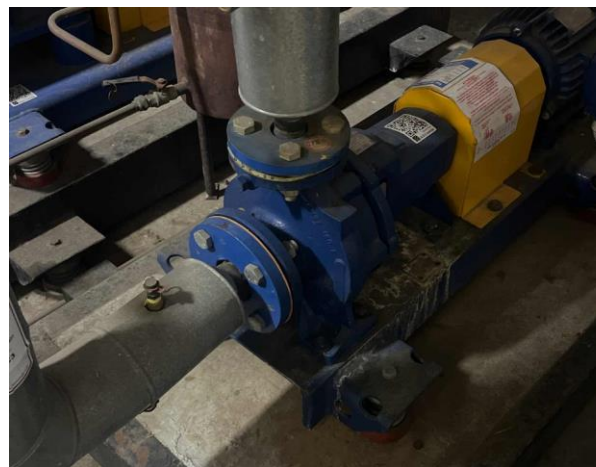
Line ID 75: Internal, L22, Plant Room, To Pipe Work of Pump Machinery, Orange Gasket Material - No Asbestos Detected

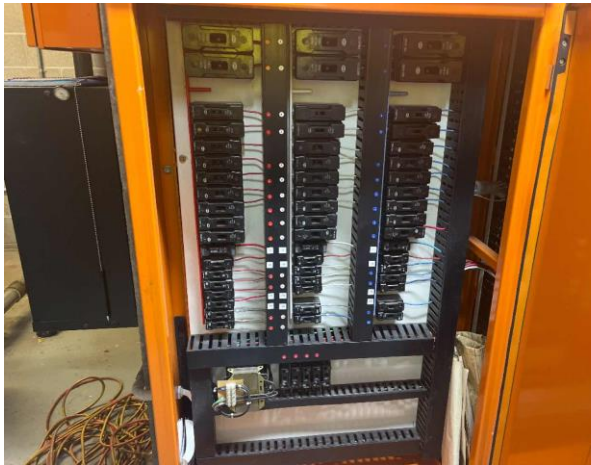
Line ID 76: Internal, L22, Plant Room, Within Electrical Cupboards, HRC Fuses - Suspected Asbestos

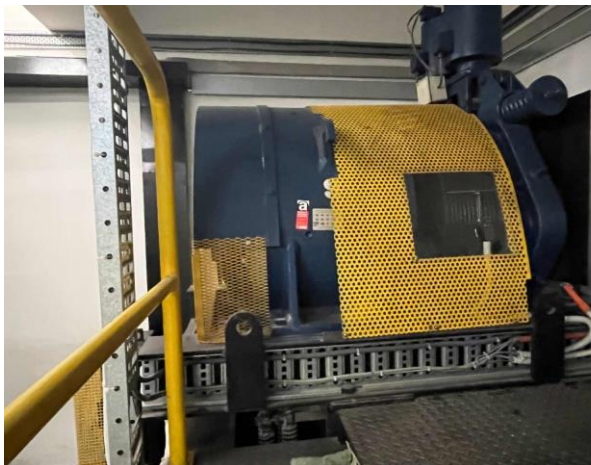
Line ID 77.1: Internal, L23, Lift Motor Room, Lift Motor Brake Pads, Friction Material - No Asbestos Detected

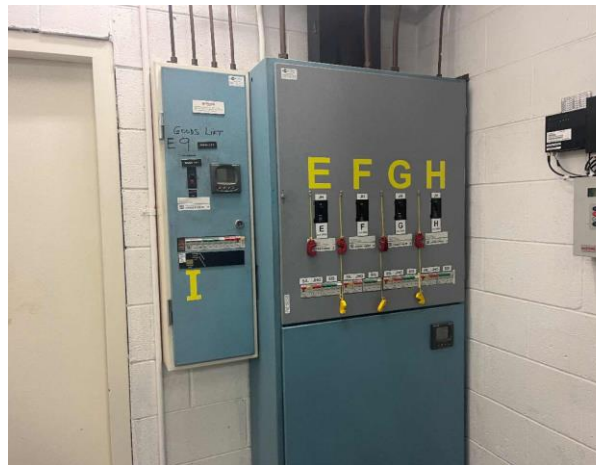
Line ID 78: Internal, L23, Lift Motor Room, Lift Motor Electrical Boards, HRC Fuses - Suspected Asbestos

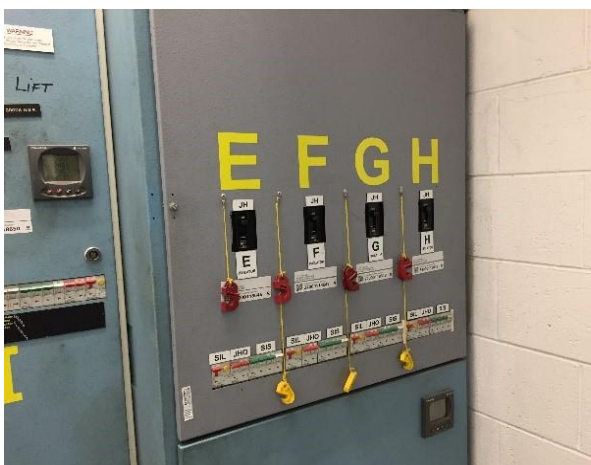
Line ID 79: Internal, L23, Lift Motor Room, Switchboard, Arc Shields - Suspected Asbestos

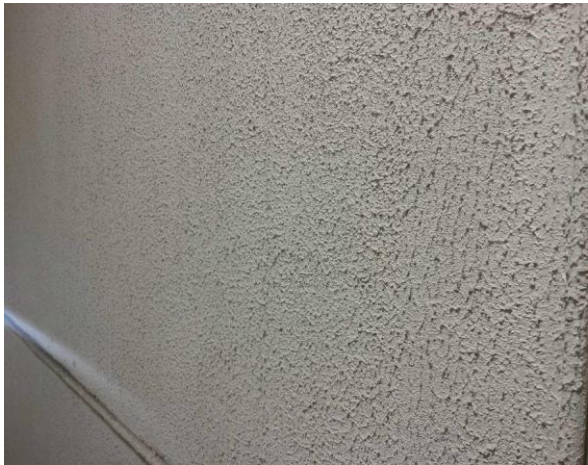
Line ID 81: Internal, L23, North Fire Stairwell, To Concrete Walls, Textured Coating - No Asbestos Detected

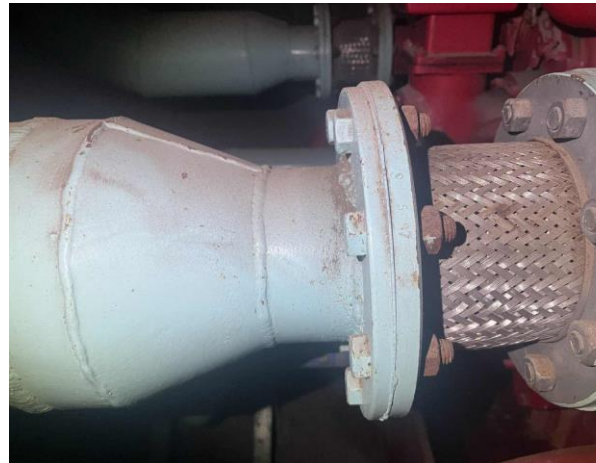
Line ID 84: Internal, L23, Plant Room, Green Pipes to Generator Flange Gaskets, Green Gasket Material - No Asbestos Detected

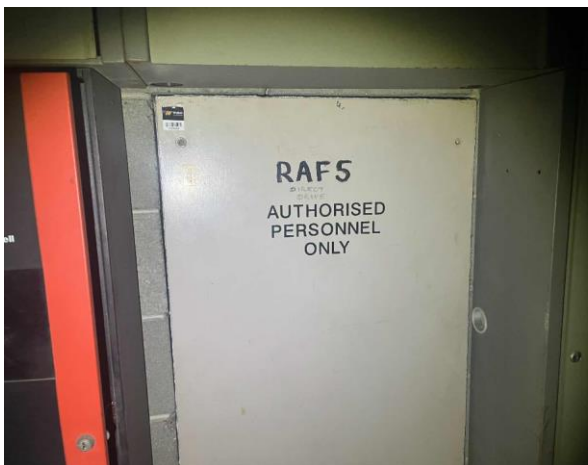
Line ID 85: Internal, L23, Plant Room, Hatch Doors throughout the Plant Room, Vermiculite - No Asbestos Detected

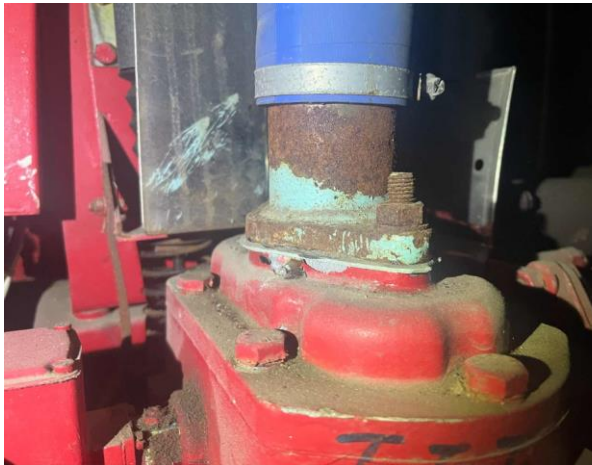
Line ID 87: Internal, L23, Plant Room, Top Flange to Generator, Light Green Gasket Material - No Asbestos Detected

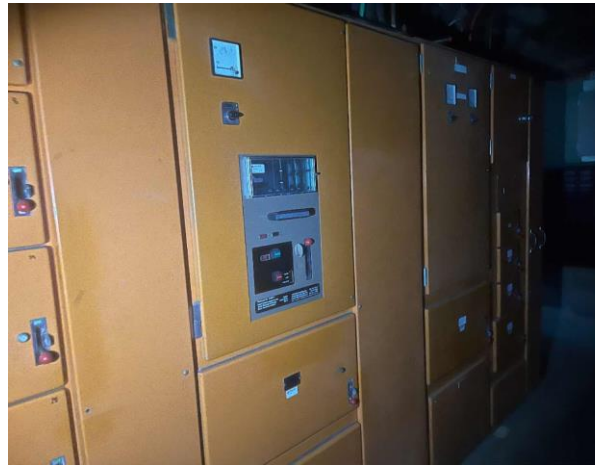
Line ID 88: Internal, L23, Plant Room, Within Electrical Cupboards, HRC Fuses - Suspected Asbestos

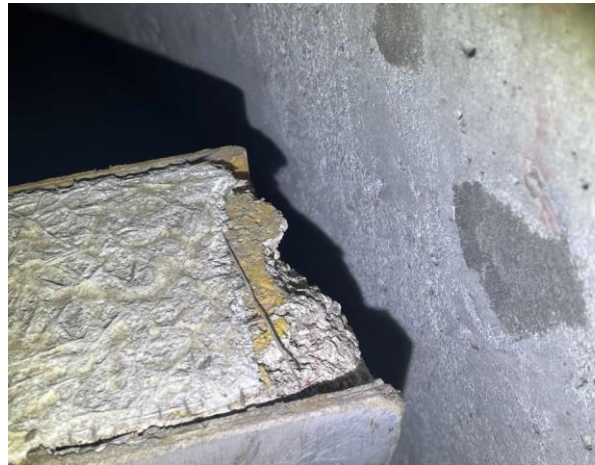
Line ID 89: Internal, L23, South Air Handling Unit AHU-7, Between Brickwork and Concrete, Construction Joint Mastic - No Asbestos Detected

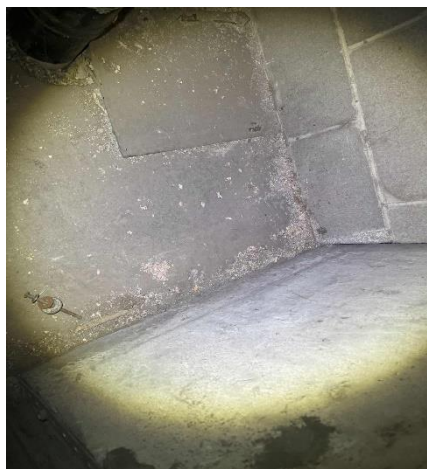
Line ID 90: Internal, L23, South Air Handling Unit AHU-7, To Hatch Door Internals to RAF6, Vermiculite - No Asbestos Detected

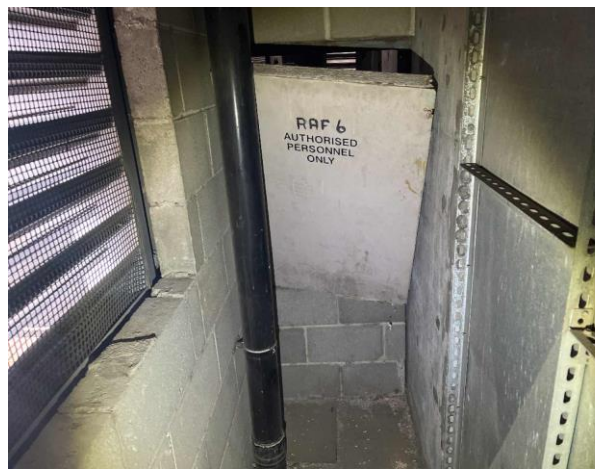
Line ID 90.1: Internal, L23, South Air Handling Unit AHU-7, To Hatch Door Internals to RAF6, Vermiculite - No Asbestos Detected

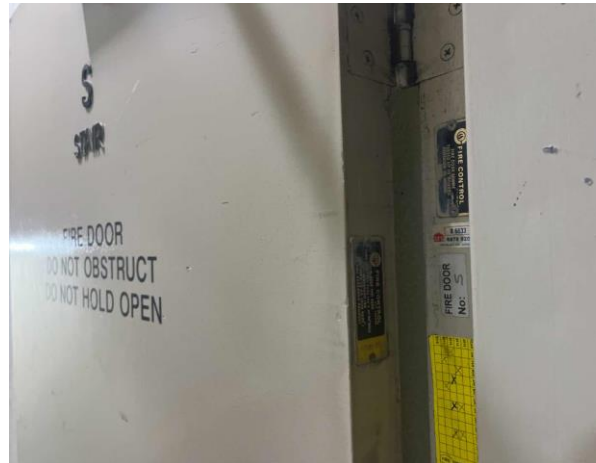
Line ID 91: Internal, L23, South Air Handling Unit AHU-7, To Wall Panels of the AHU-7, Mastic Sealant (grey) - No Asbestos Detected

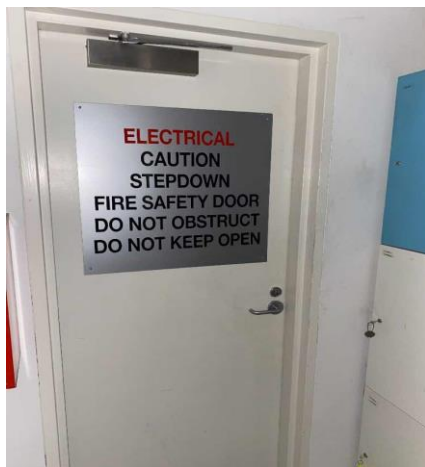
Line ID 94: Internal, L2-3, L5-13 and 15-21, Lift Lobby and Electrical Service Room, Fire Entry Door, Fire Door Core - Suspected Asbestos

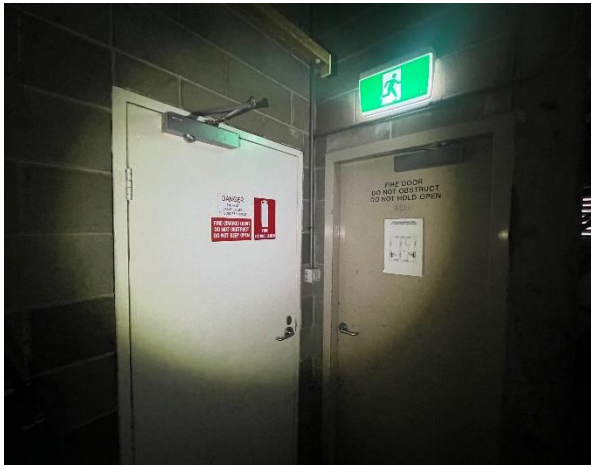
Line ID 94.2: Internal, L2-3, L5-13 and 15-21, Lift Lobby and Electrical Service Room, Fire Entry Door, Fire Door Core - Suspected Asbestos

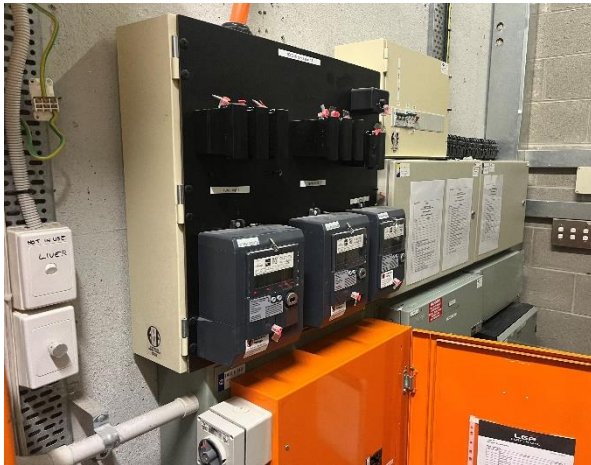
Line ID 95: Internal, L2-3, L5-13 and 15-21, Lift Lobby and Electrical Service Room, Grey Switchboards, HRC Fuses - Suspected Asbestos

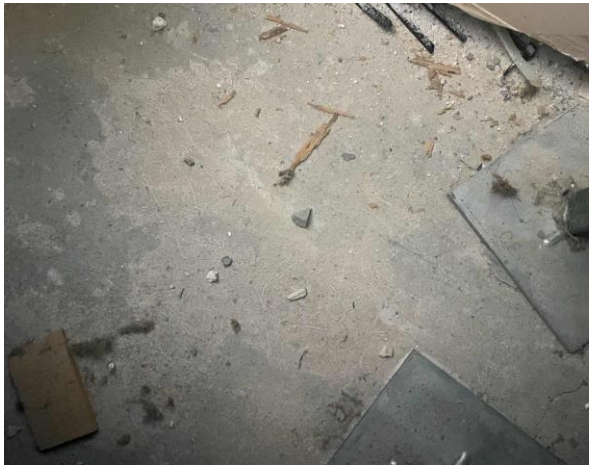
Line ID 96: Internal, L2-3, L5-13 and 15-21, Main Office, Below False Floors to Office Area, None - None Suspected

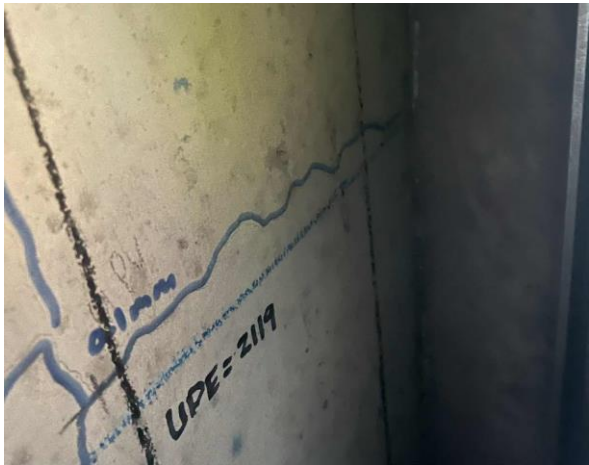
Line ID 97: Internal, L2-3, L5-13 and 15-21, Main Office, Concrete Columns to Outer Walls, None - None Suspected

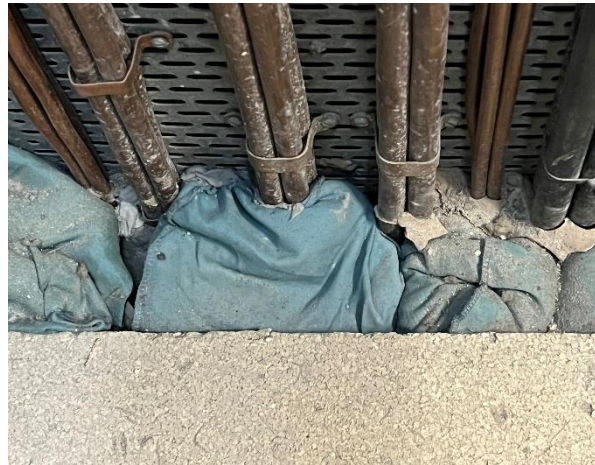
Line ID 97.1: Internal, L2-3, L5-13 and 15-21, Main Office, Concrete Columns to Outer Walls, None - None Suspected

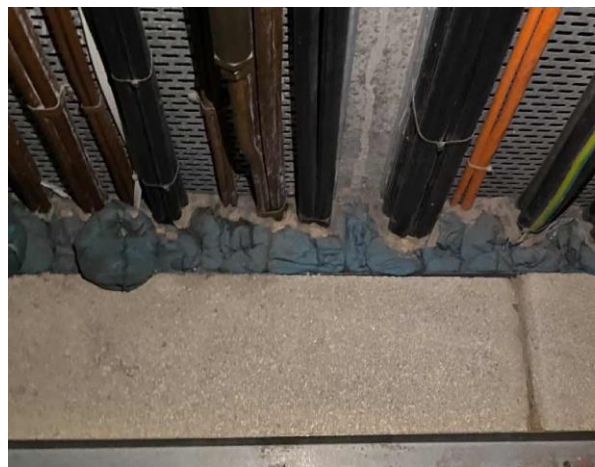
Line ID 99.1: Internal, L2-3, L5-L13, L15-19 and L21, Lift Lobby Electrical Services Room, Fire Stop to Penetrations, Vermiculite - No Asbestos Detected
