Asbestos and Hazardous Materials Pre-Demolition Assessment

90 Collins St

Melbourne CBD Vic 3000

17/03/2023

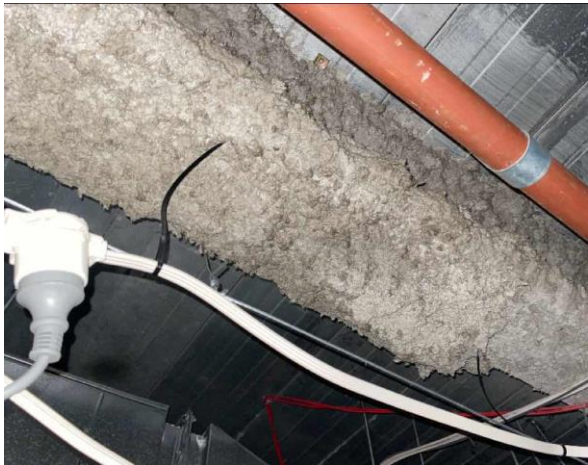
Line ID 99.2: Internal, L2-3, L5-L13, L15-19 and L21, Lift Lobby Electrical Services Room, Fire Stop to Penetrations, Vermiculite - No Asbestos Detected

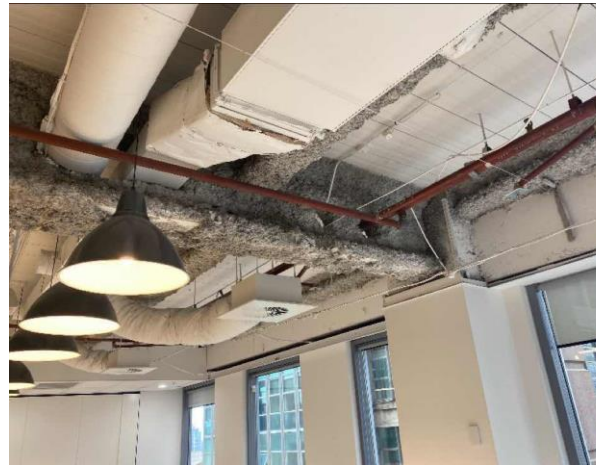
Line ID 103: Internal, L6, Main Office Areas, Throughout the Underside of the Ceiling to Concrete Columns, Sprayed Vermiculite - No Asbestos Detected

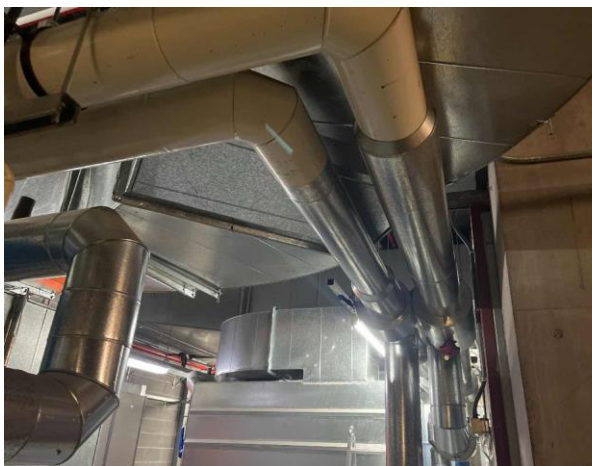
Line ID 118: Internal, GF, Car Park Plant Room, Rigid Ductwork, Insulation Material - Suspected SMF

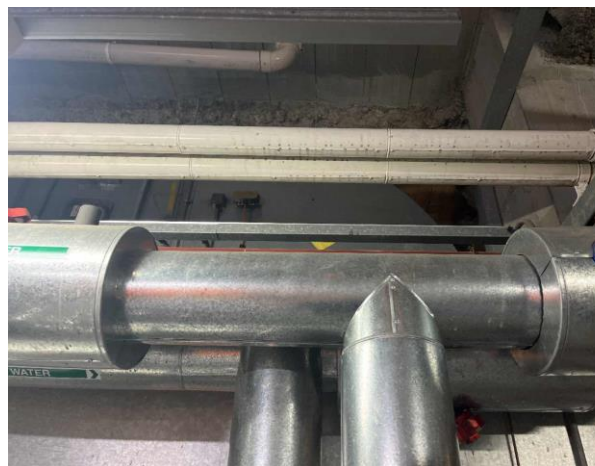
Line ID 119: Internal, GF, External Plant Room, AC Ductwork, Insulation Material - Suspected SMF

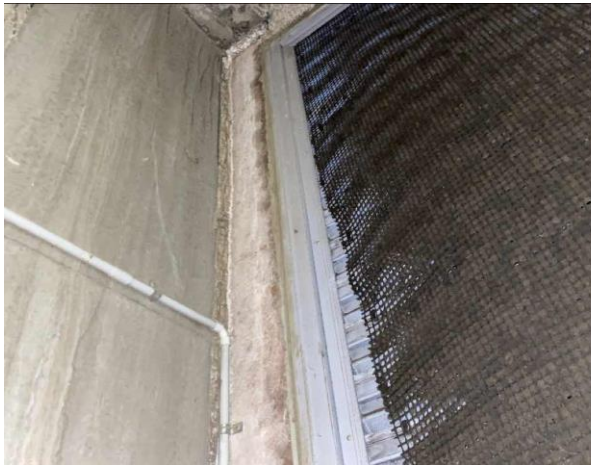
Line ID 122: Internal, GF, External Plant Room, To AHU Wall Lining, Insulation Material - Suspected SMF

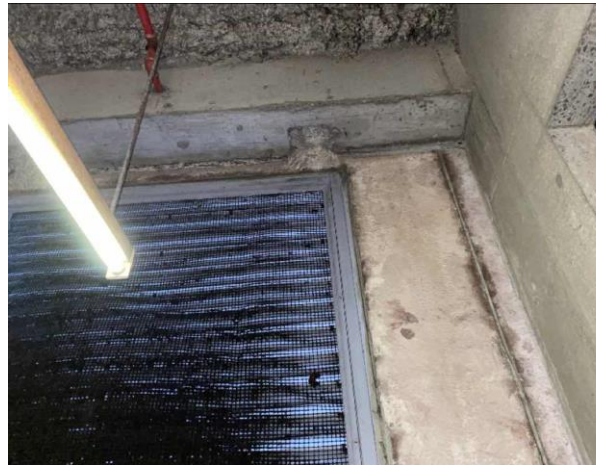
Line ID 123: Internal, GF, External Plant Room, West Ductwork Room Construction Joints, Ceramic Fibre - Suspected SMF

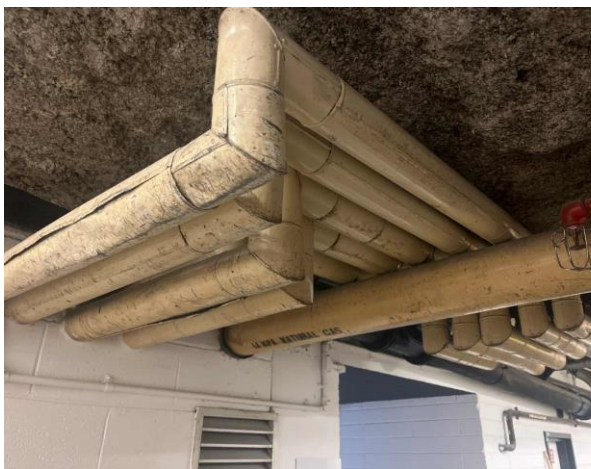
Line ID 124: Internal, GF, External Plant Room, West Ductwork Room Window Frames, Insulation Material - Suspected SMF

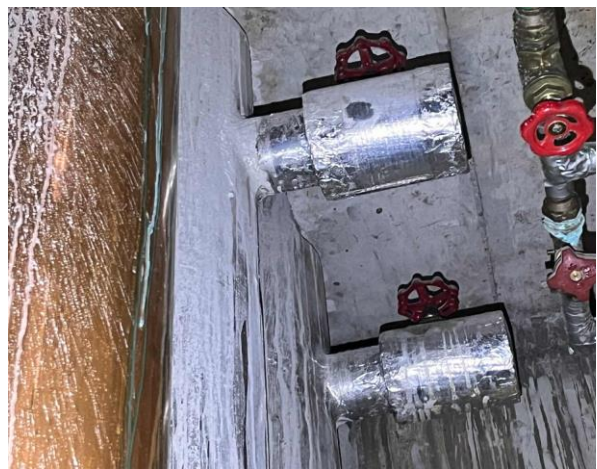
Line ID 125: Internal, GF, Loading Dock, High Level Pipes, Insulation Material - Suspected SMF

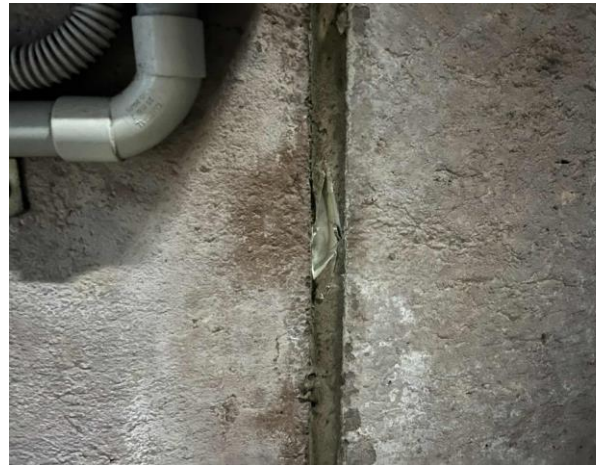
Line ID 131: Internal, L14, Plant Room, Air Handling Unit Wall Lining, Insulation Material - Suspected SMF

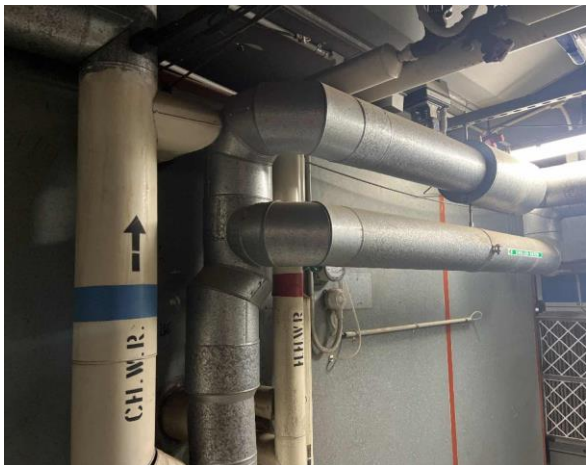
Line ID 132: Internal, L14, Plant Room, Behind Grey Mastic Expansion Joint, Ceramic Fibre - Suspected SMF

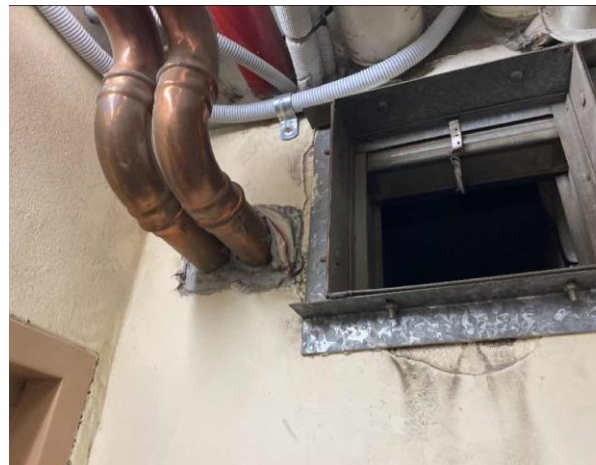
Line ID 135: Internal, L14, Plant Room, Metal Covered Pipes, Insulation Material - Suspected SMF

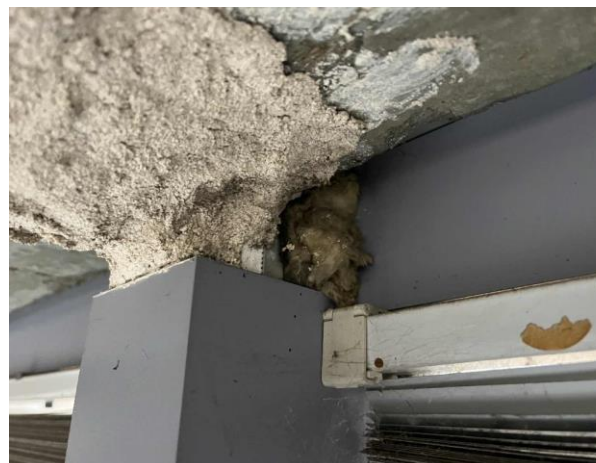
Line ID 137: Internal, L14, Plant Room, Rigid Ductwork, Insulation Material - Suspected SMF

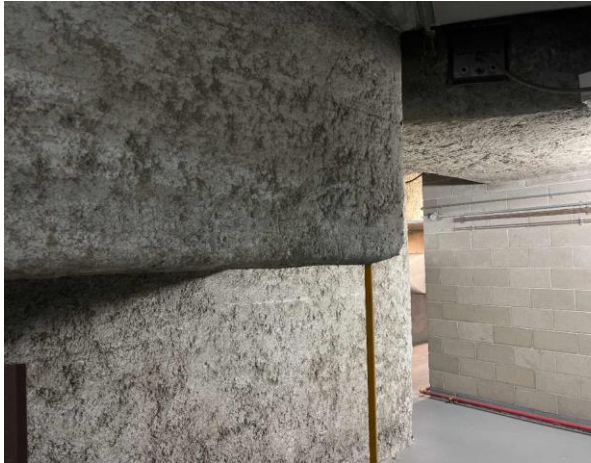
Line ID 138: Internal, L14, Plant Room, To Outer Window Frame Supports, Insulation Material - Suspected SMF

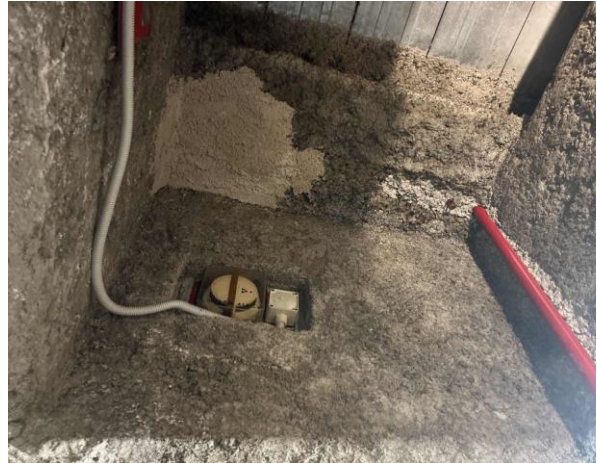
Line ID 139: Internal, L14, Plant Room, To Walls, Ductwork and Steel Beams, Sprayed Vermiculite - SMF Detected

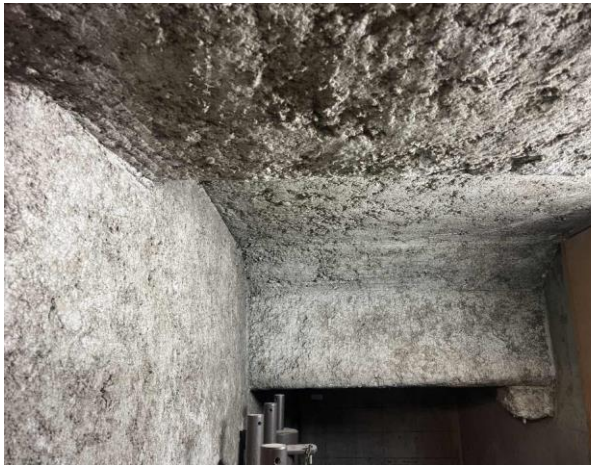
Line ID 139.1: Internal, L14, Plant Room, To Walls, Ductwork and Steel Beams, Sprayed Vermiculite - SMF Detected

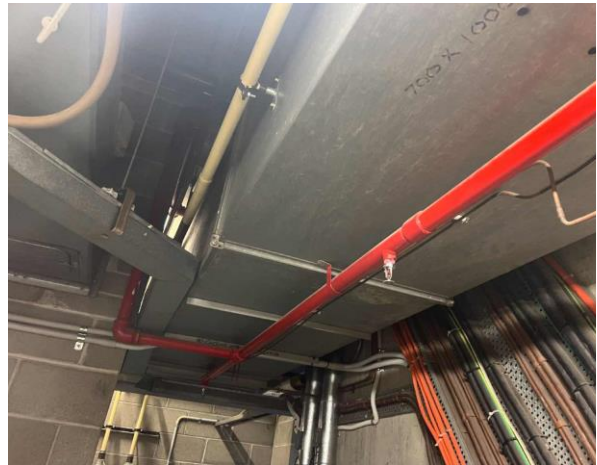
Line ID 139.2: Internal, L14, Plant Room, To Walls, Ductwork and Steel Beams, Sprayed Vermiculite - SMF Detected

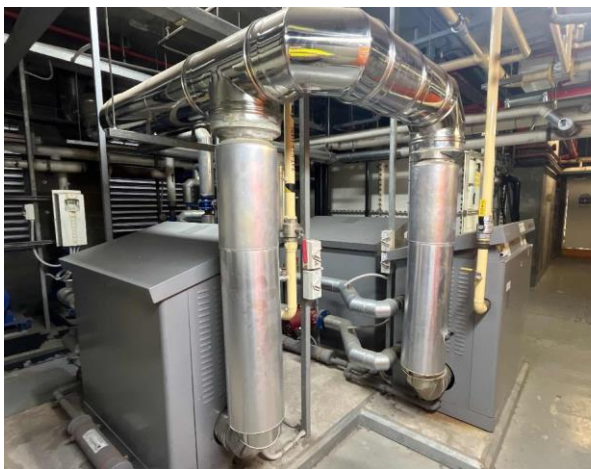
Line ID 143: Internal, L22, Plant Room, AC Ductwork, Insulation Material - Suspected SMF

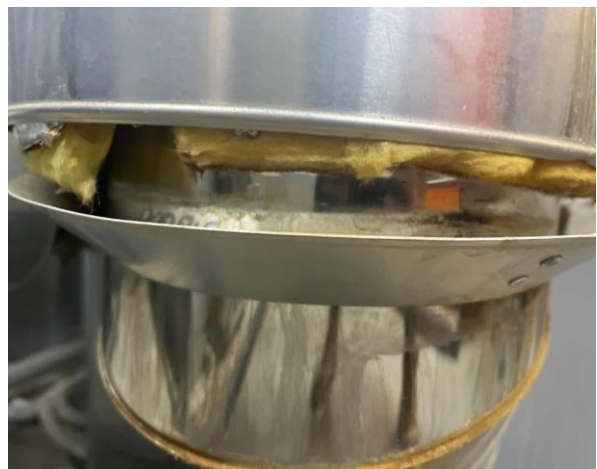
Line ID 144: Internal, L22, Plant Room, Exhaust Units from Boilers, Insulation Material - Suspected SMF

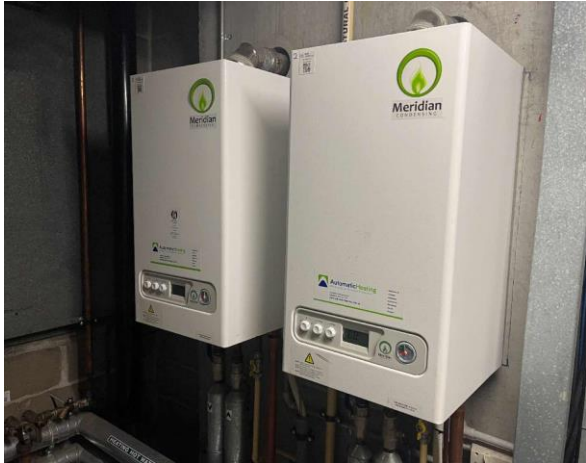
Line ID 144.1: Internal, L22, Plant Room, Exhaust Units from Boilers, Insulation Material - Suspected SMF

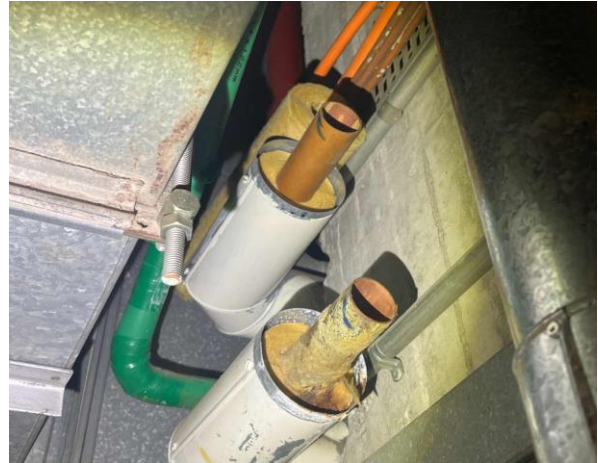
Line ID 145: Internal, L22, Plant Room, Hot Water Units, Insulation Material - Suspected SMF

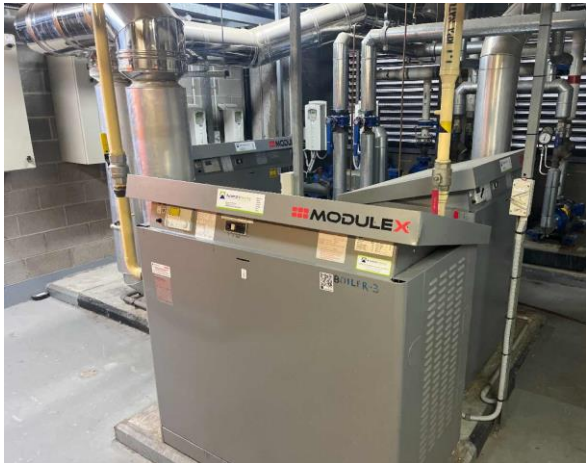
Line ID 146: Internal, L22, Plant Room, Metal Covered Redundant Pipe Work Painted White, Insulation Material - Suspected SMF

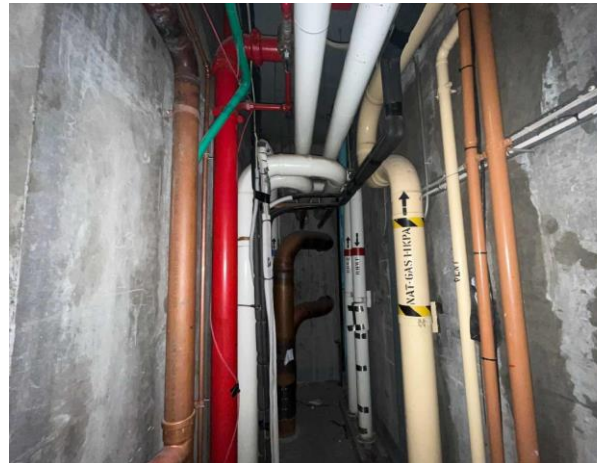
Line ID 147: Internal, L22, Plant Room, Modules Boilers Internals, Insulation Material - Suspected SMF

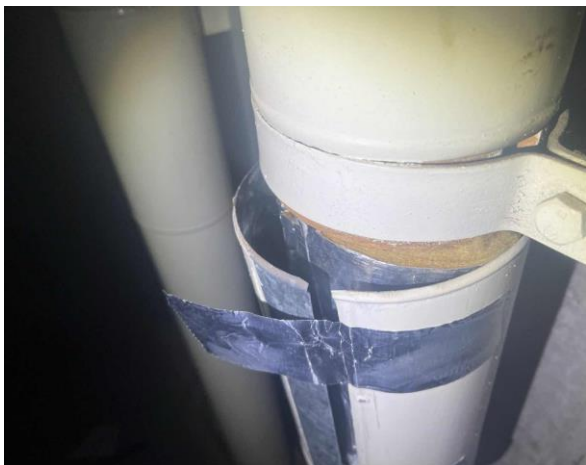
Line ID 148: Internal, L22, Plant Room, Pipe Riser Pipes, Insulation Material - Suspected SMF

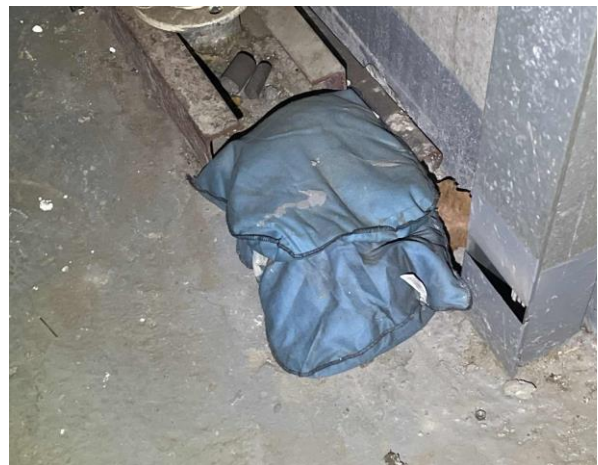
Line ID 148.1: Internal, L22, Plant Room, Pipe Riser Pipes, Insulation Material - Suspected SMF

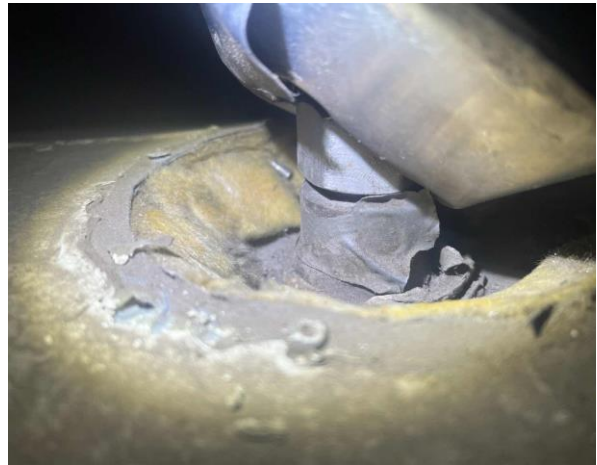
Line ID 149.1: Internal, L22, Plant Room, To Floor Slab Penetrations, Pillow Insulation - Suspected SMF

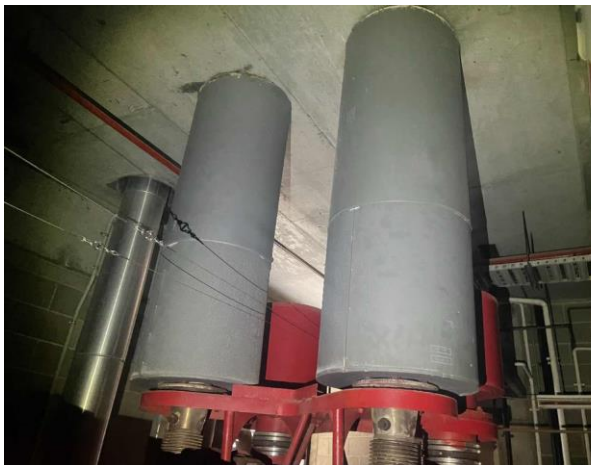
Line ID 150: Internal, L23, Plant Room, Calorifier Insulation, Insulation Material - Suspected SMF

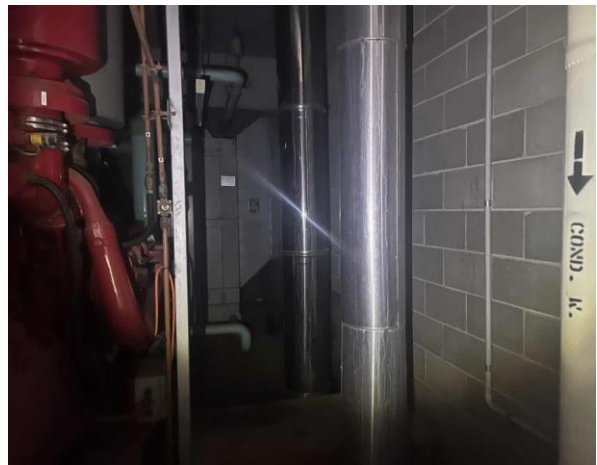
Line ID 151: Internal, L23, Plant Room, Generator Exhausts, External Insulation - Suspected SMF

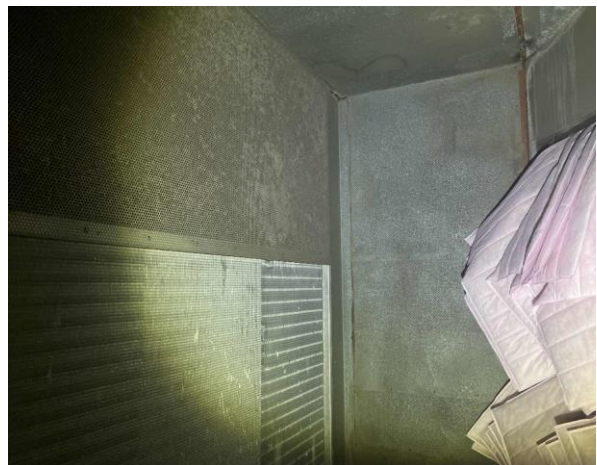
Line ID 153: Internal, L23, Plant Room, Metal Covered Pipes to the Calorifier, Insulation Material - Suspected SMF

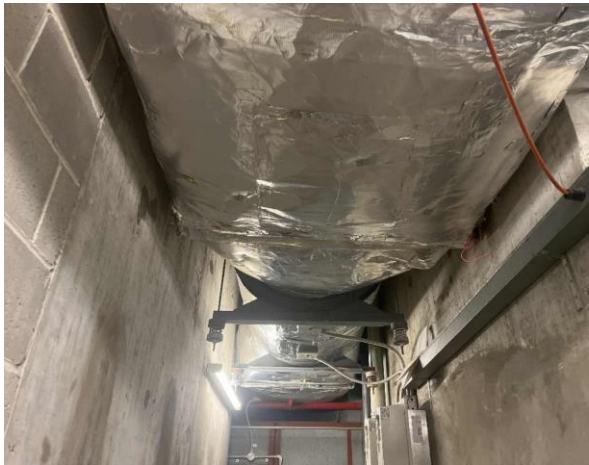
Line ID 154: Internal, L23, South Air Handling Unit AHU-7, AHU-7 Wall Lining, Insulation Material - Suspected SMF

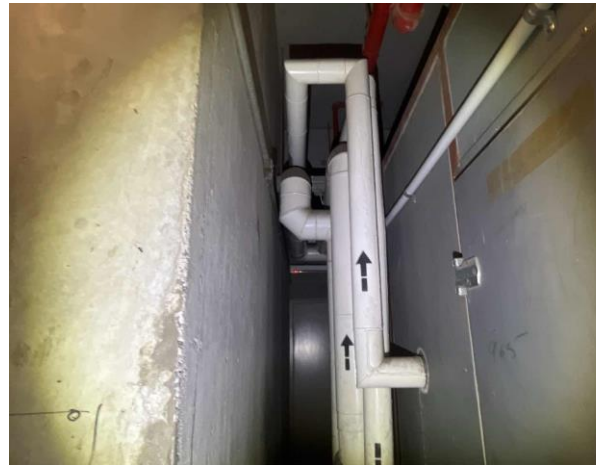
Line ID 155: Internal, L23, South Air Handling Unit AHU-7, Ductwork Foil Lined Insulation, Insulation Material - Suspected SMF

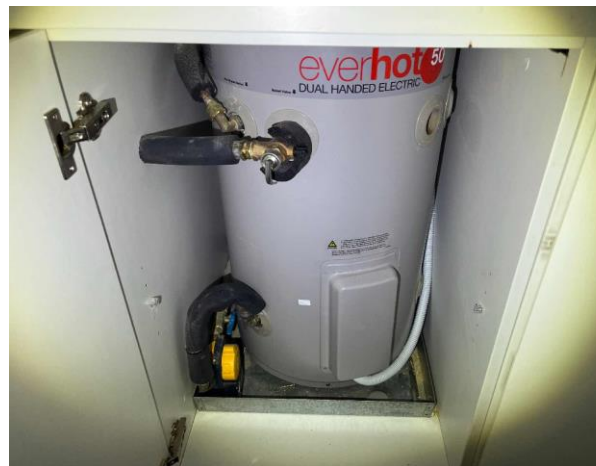
Line ID 157: Internal, L2-3, L5-11, L13, and L15-21, Kitchen Area, Hot Water Unit, Insulation Material - Suspected SMF

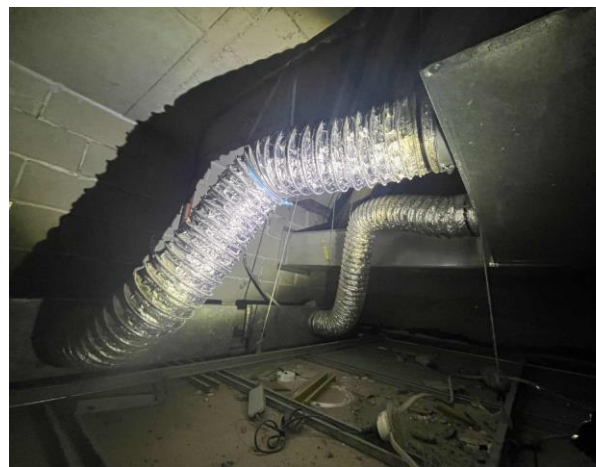
Line ID 158: Internal, L2-3, L5-13 and 15-21, Female Toilet, To Rigid and Flexible Ductwork, Insulation Material - Suspected SMF

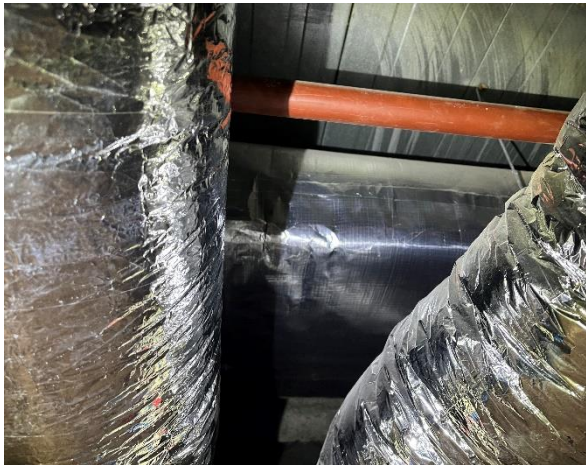
Line ID 159.1: Internal, L2-3, L5-13 and 15-21, Lift Lobby and Electrical Service Room, Pipe Work Riser, Insulation Material - Suspected SMF

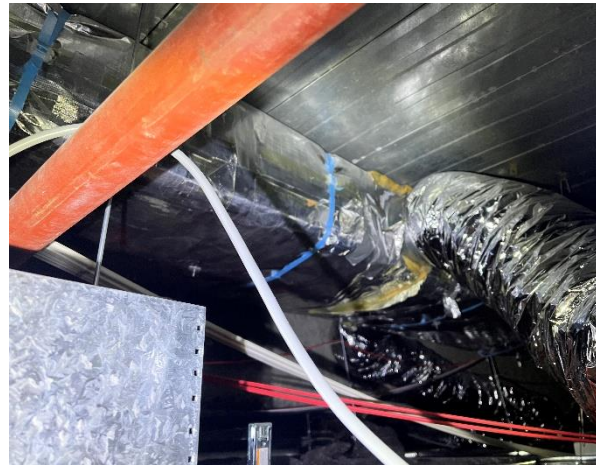
Line ID 160: Internal, L2-3, L5-13 and 15-21, Lift Lobby and Electrical Service Room, Rigid and Flexible Ductwork, Insulation Material - Suspected SMF

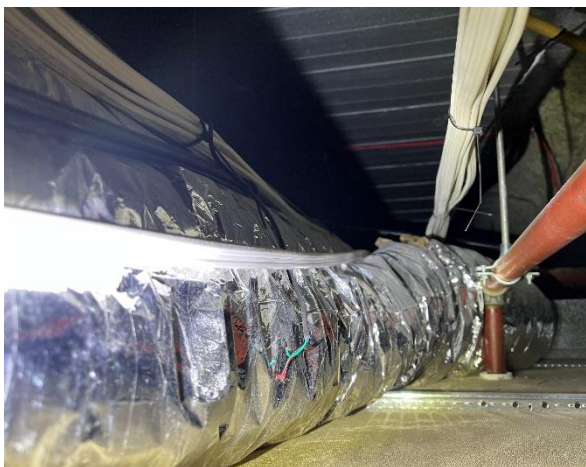
Line ID 160.1: Internal, L2-3, L5-13 and 15-21, Lift Lobby and Electrical Service Room, Rigid and Flexible Ductwork, Insulation Material - Suspected SMF

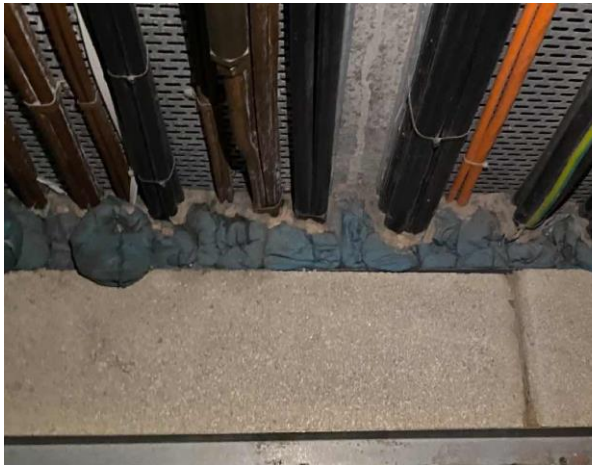
Line ID 161: Internal, L2-3, L5-13 and 15-21, Lift Lobby and Electrical Service Room, To Cable Penetrations, Pillow Insulation - Suspected SMF

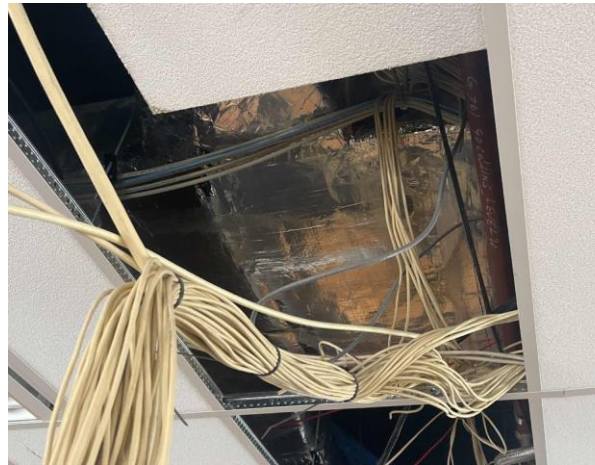
Line ID 161.1: Internal, L2-3, L5-13 and 15-21, Lift Lobby and Electrical Service Room, To Cable Penetrations, Pillow Insulation - Suspected SMF

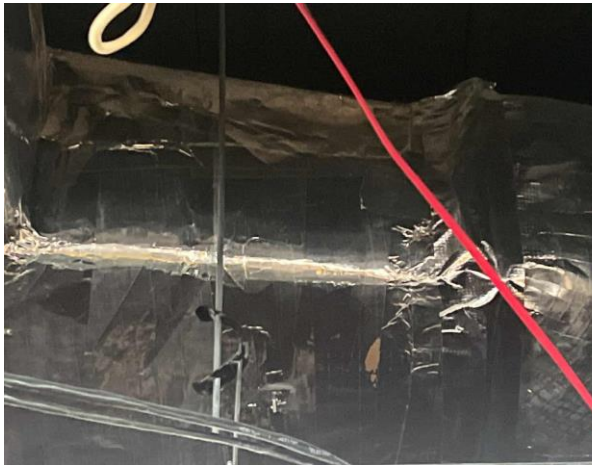
Line ID 162: Internal, L2-3, L5-13 and 15-21, Main Office, Rigid Ductwork, Insulation Material - Suspected SMF

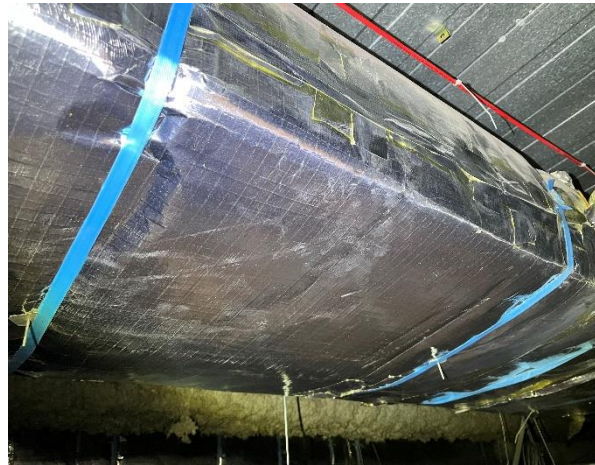
Line ID 162.1: Internal, L2-3, L5-13 and 15-21, Main Office, Rigid Ductwork, Insulation Material - Suspected SMF

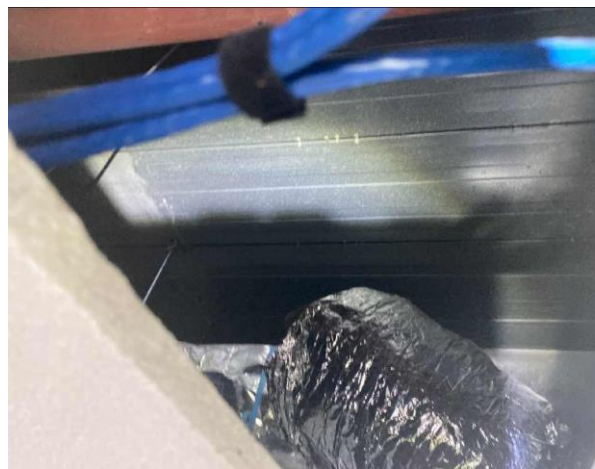
Line ID 162.3: Internal, L2-3, L5-13 and 15-21, Main Office, Rigid Ductwork, Insulation Material - Suspected SMF

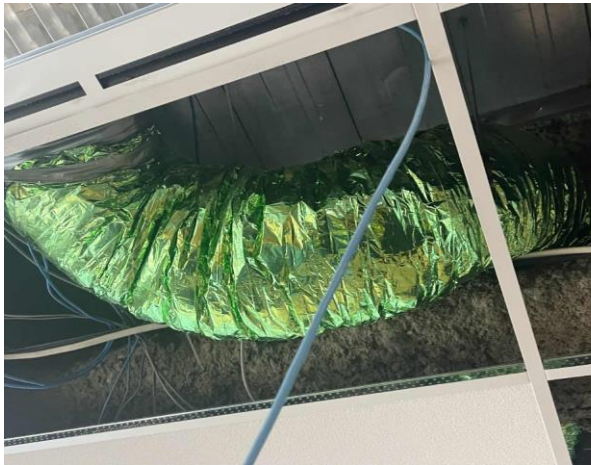
Line ID 163: Internal, L2-3, L5-13 and 15-21, Main Office Areas, Flexible Ductwork, Insulation Material - Suspected SMF

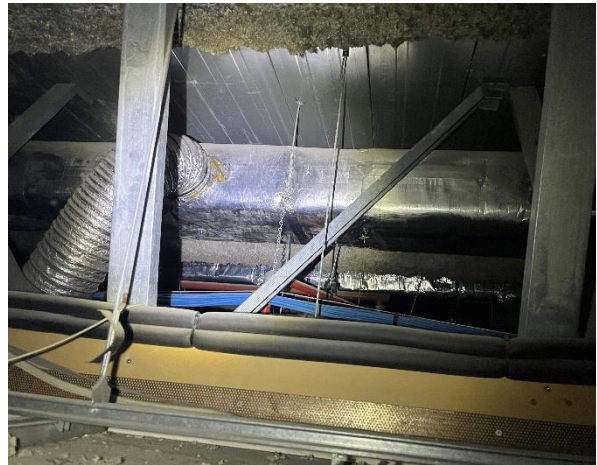
Line ID 163.1: Internal, L2-3, L5-13 and 15-21, Main Office Areas, Flexible Ductwork, Insulation Material - Suspected SMF

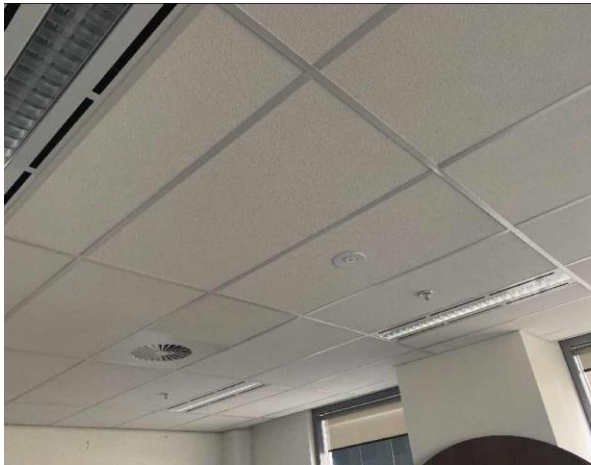
Line ID 163.2: Internal, L2-3, L5-13 and 15-21, Main Office Areas, Flexible Ductwork, Insulation Material - Suspected SMF

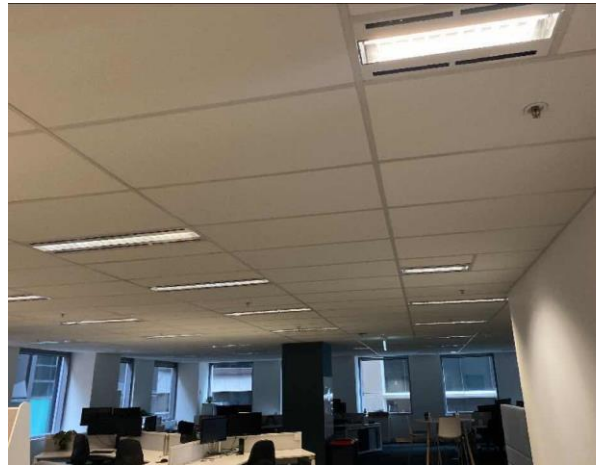
Line ID 164: Internal, L2-3, L5-13 and 15-21, Main Office Areas, Throughout Office Areas, Compressed Ceiling Tiles - Suspected SMF

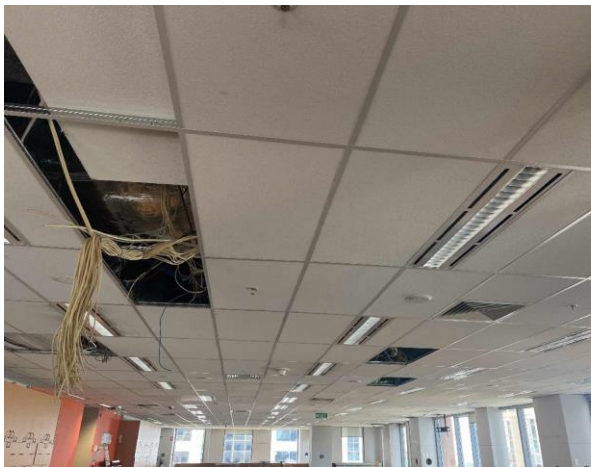
Line ID 164.1: Internal, L2-3, L5-13 and 15-21, Main Office Areas, Throughout Office Areas, Compressed Ceiling Tiles - Suspected SMF

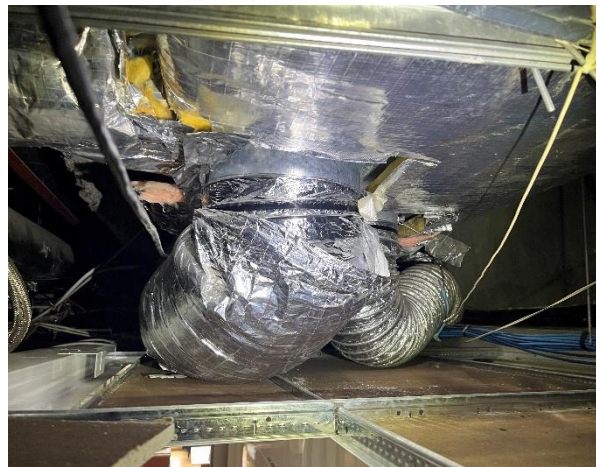
Line ID 164.2: Internal, L2-3, L5-13 and 15-21, Main Office Areas, Throughout Office Areas, Compressed Ceiling Tiles - Suspected SMF

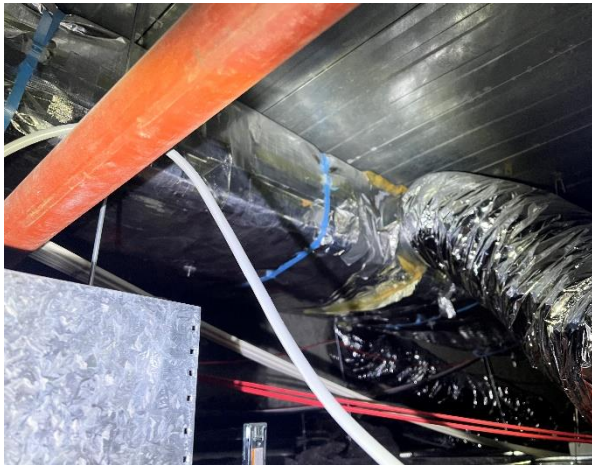
Line ID 165: Internal, L2-3, L5-13 and 15-21, Male Toilet, Ceiling Void to Rigid and Flexible Ductwork, Insulation Material - Suspected SMF

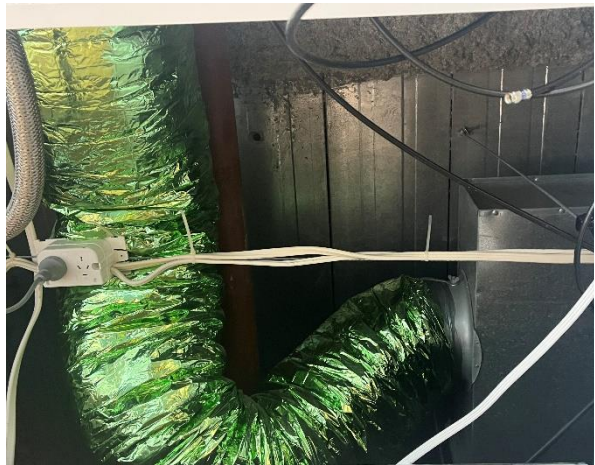
Line ID 165.1: Internal, L2-3, L5-13 and 15-21, Male Toilet, Ceiling Void to Rigid and Flexible Ductwork, Insulation Material - Suspected SMF

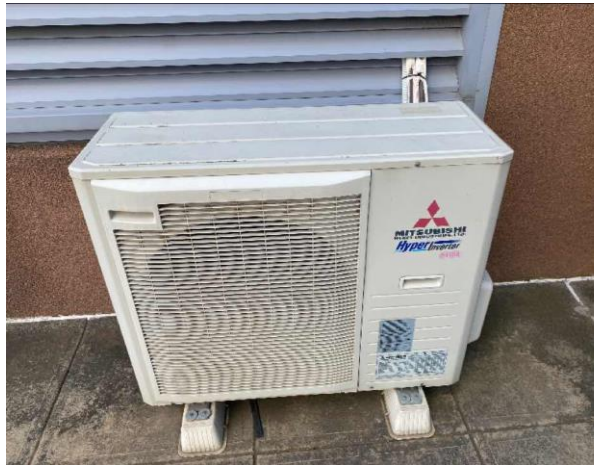
Line ID 168: External, Roof, Throughout, Adjacent Roof Entry Door, R410A Hydrofluorocarbon (HFC) - Non ODS Refrigerant

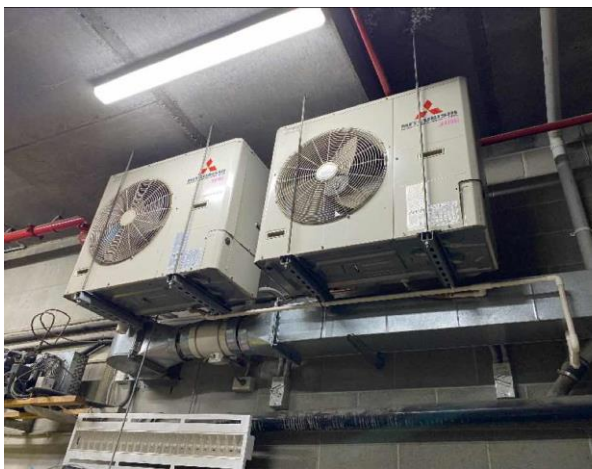
Line ID 169: External, Roof, West Plant Area, West Wall Adjacent Cooling Tower, R410A Hydrofluorocarbon (HFC) - Non ODS Refrigerant

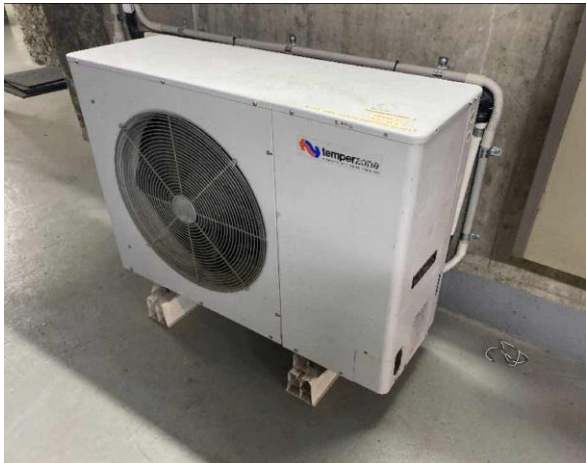
Line ID 171: Internal, GF, Car Park Plant Room, South Wall, Unknown Refrigerant - Suspected ODS
